**SUPPORT SERVICES FOR CERAMIC FIBER- CERAMIC MATRIX COMPOSITES**

Final Annual Technical Progress Report

September 28, 2001

Report Prepared by  
John P. Hurley and Charlene R. Crocker  
Energy & Environmental Research Center  
University of North Dakota  
PO Box 9018  
Grand Forks, North Dakota 58202-9018  
under  
Subcontract No. 19X-SS 112V

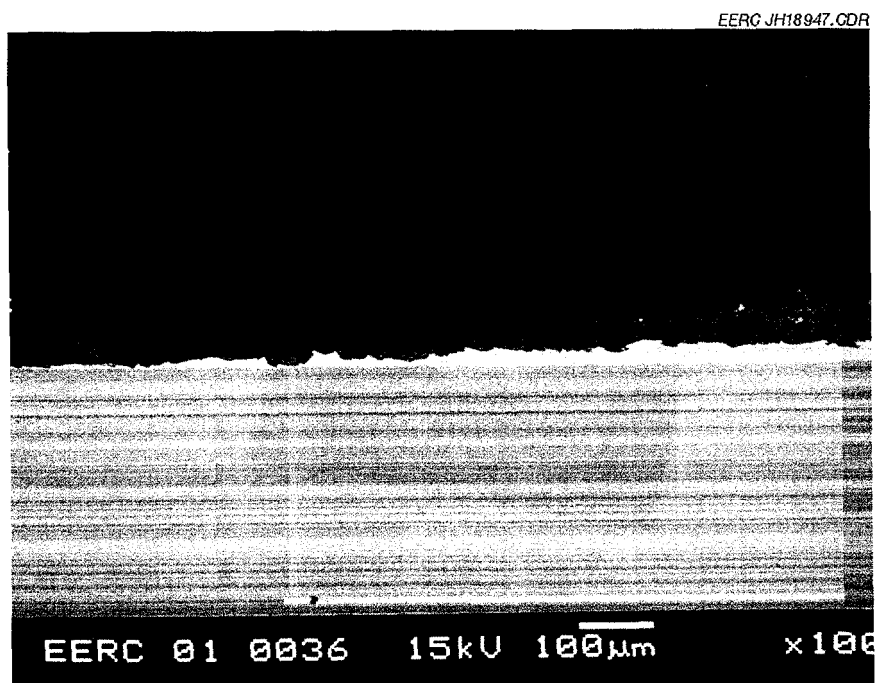
The metal is reported to contain 51.54 wt% Fe, 25.65 wt% Cr, 20.15 wt% Ni, 1.22 wt% Mn, 0.64 wt% Si, 0.32 wt% Nb-Ta, and 0.2 wt% N. Figure 89 shows a representative example of the cross-sectioned alloy material, corrosion layer, and ash deposit at 100 $\times$  magnification. The alloy material appears as a homogeneous white field. There are, however, fine white particles scattered throughout the alloy material. SEM analysis of the bulk material indicated a composition of 53 wt% Fe, 28 wt% Ni, 14 wt% Cr, and <2 wt% Mo and O. The fine particles include 44 wt% Fe, 34 wt% Cr, 18 wt% Ni, and <1 wt% O, Si, Mn, and Nb.

Figure 89. Example of cross-sectioned alloy material, corrosion layer, and ash deposit at 100× magnification (ORNL #310HCbN SS [HRC3 Weld]-1).

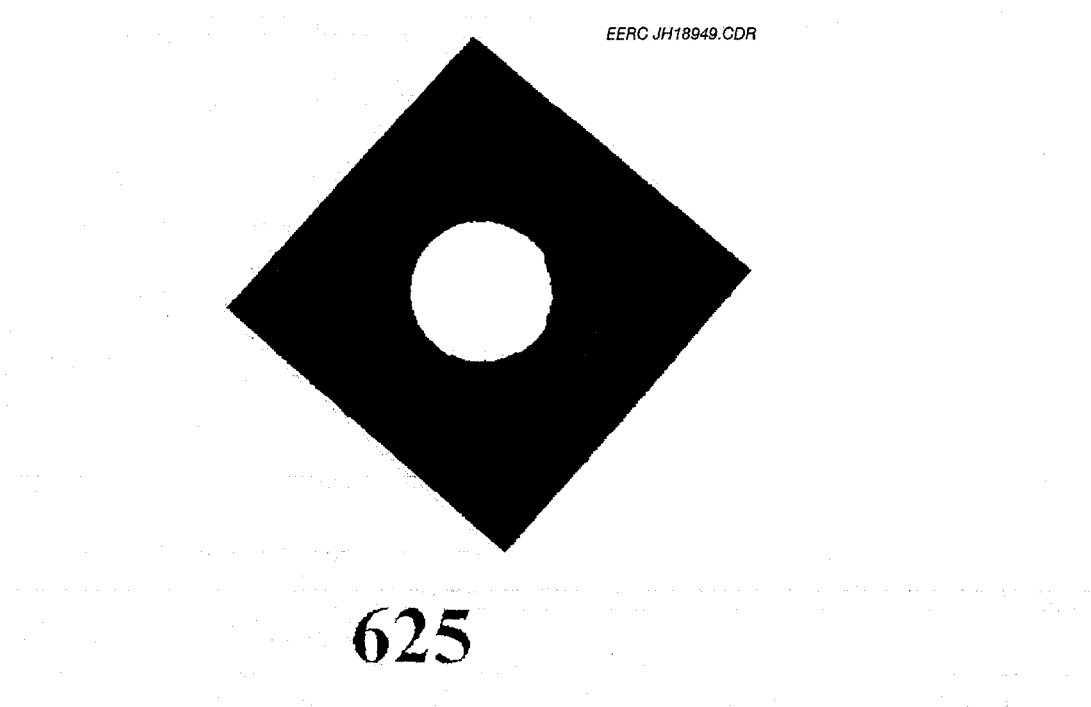
**Postexposure appearance:** The Swindeman samples were all exposed in an elbow following the process air tube-and-shell heat exchanger, which immediately follows the convective pass in which the previous samples were exposed. Average gas temperature for the Swindeman samples was 708°C. Figure 91 shows the sample removed from the sample holder after the June test run. The surface looks dull gray through a thin coating of ash deposit. The sample appears intact. The color change suggests surface corrosion.

Figure 91. Alloy ORNL #625-1 removed from the sample holder after the June test run.

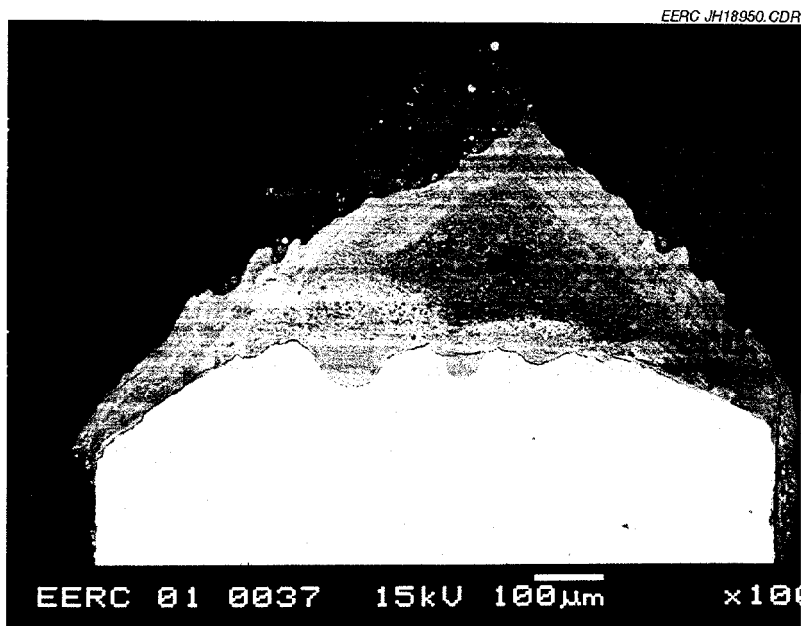
Figure 92. Example of cross-sectioned alloy material, corrosion layer, and ash deposit at 100× magnification (ORNL #625-1).

No subsurface corrosion was indicated in the sample cross section. Formation of broad, deep pits and an extensive corrosion layer at the surface are the dominant features of this sample. Figure 92 shows three large and two smaller areas of pitting that extend into the sample below an imaginary line of smooth recession. The homogeneous appearance of the corrosion product within these pitted areas is different than the look of the corrosion product projecting from the surface. The largest pit contains 66 µm of chromium oxide corrosion product (56 wt% Cr, 16 wt% O, 9 wt% Ni, 7 wt% Nb, 4 wt% MO, 3 wt% S, and trace Fe). Figure 93 shows the leftmost pit at 1500× magnification. The content of this corrosion pit matches that of the large pit. The submicron white spots and streaks in the corrosion product are rich in barium and sulfur. They most likely originated in the ash as barium sulfate (barite) particles that are still sticky at the exposure temperature (708 °C).

The ash deposit on the sample, visible in Figure 92, was limited to <200 µm thick. SEM analysis of the material indicated that the content of the ash deposited on samples in the elbow was similar to that of the ash deposited in the convective pass.

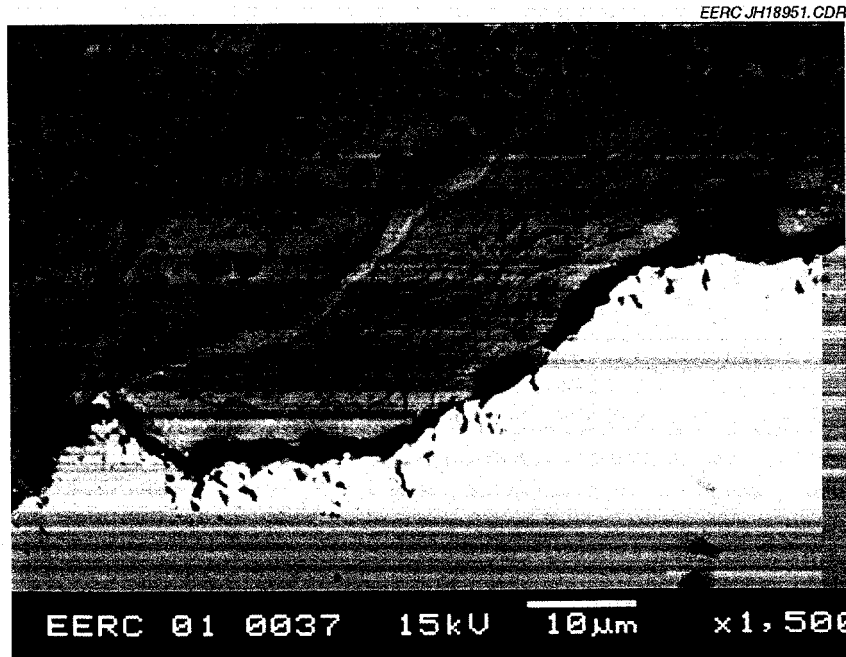
The surface of the sample is covered with a very thick, continuous layer of corrosion product ranging in thickness from 40 µm at the corners to 350 µm at the center point. Visual inspection and SEM analysis of this layer (visible in left corner of Figure 93 indicated a heterogeneous composition of entrained ash particles embedded in a nickel oxide matrix (55 wt% Ni, 15 wt% O, 8 wt% Fe and Cr, 2 wt% Si, and trace Al and Mg). The composition remains consistent to within 40 µm of the corrosion product-ash interface. In the outermost corrosion product layer, the embedded particle size and Ni content decrease, replaced by increasing Fe and

Figure 93. Sample surface at 1500× magnification (ORNL #625-1).

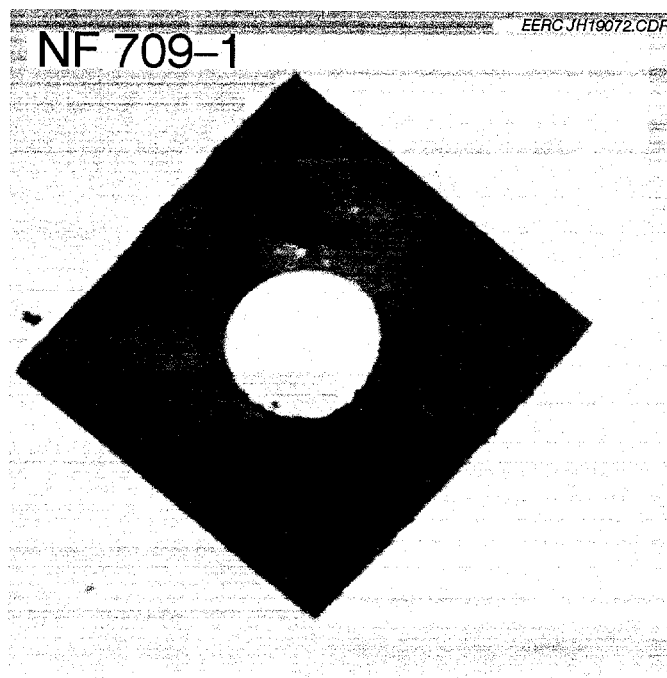
**Postexposure appearance:** The Swindeman samples were all exposed in an elbow following the process air tube-and-shell heat exchanger, which immediately follows the convective pass in which the previous samples were exposed. Average gas temperature for the Swindeman samples was 708°C. Figure 94 shows the sample removed from the sample holder after the June test run. The sample appears intact. The dull gray surface is partially obscured by the fine reddish brown layer of ash deposit. The color change suggests surface corrosion.

Figure 94. Alloy ORNL #NF709-1 removed from sample holder after the June test run.

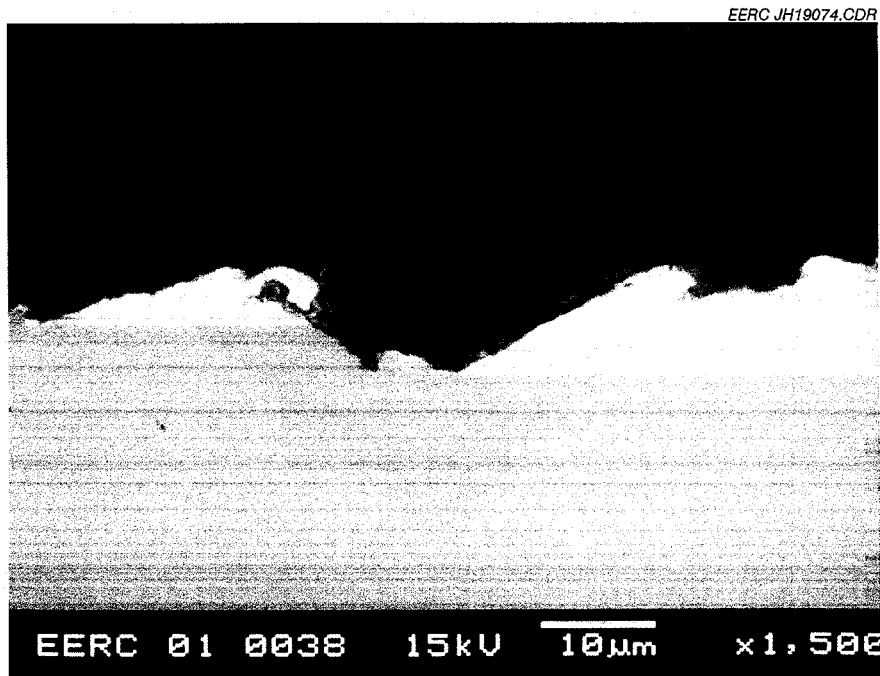
No subsurface corrosion was indicated in the sample cross section examined. Shallow surface pitting and a thin, discontinuous corrosion layer at the surface are the features of this sample. Figure 96 illustrates these features at 1500 $\times$  magnification. At the center is a small pit about 10  $\mu$ m deep and 30  $\mu$ m wide. The largest pit on the surface was 10  $\mu$ m deep by 30  $\mu$ m wide. The thickest corrosion layer above the sample surface was 7  $\mu$ m high. The composition of the alloy material near sites of corrosive attack appears slightly enriched in Fe (53 wt%), Ni (27 wt%), Mo (1-2 wt%), and Si (<1 wt%). One spot analyzed contained 4 wt% Ta. The Cr in these areas was reduced to 14 wt%. Most corrosion products in pits and attached to the surface contain mixtures of Fe (39-44 wt%) Ni (21-28 wt%) O (18 wt%) and Cr (32-63 wt%) Fe (14-27 wt%) O (11 wt%) with Ni (2-11 wt%). The average Si and Mn concentrations in the corrosion product were 1 and 2 wt%, respectively (ranging from <1 to 4 and 5 wt%). Mo, Nb, and Ta were present in trace amounts in the corrosion product. Ti was not present. The composition suggests an absence of the chromium oxide layer that could protect the alloy from further attack by flue gas constituents such as O. The irregular sample surface and discontinuity of the corrosion layer suggest a pattern of sequential pitting and scaling.

Figure 96. Sample surface at 1500× magnification (ORNL #NF709-1).

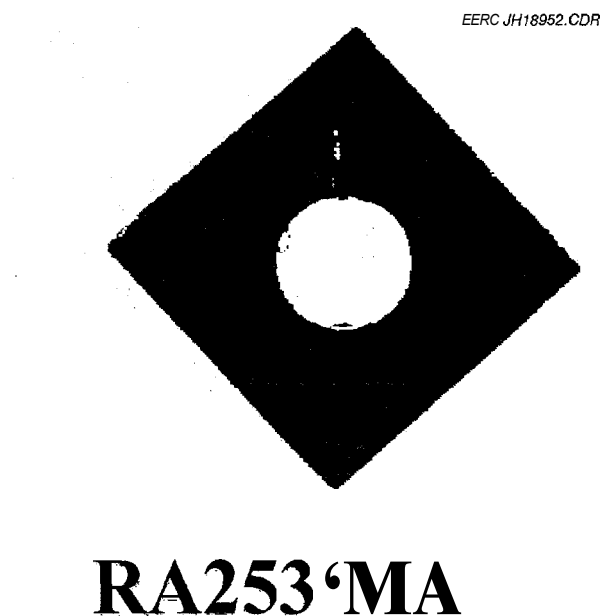
**Postexposure appearance:** The Swindeman samples were all exposed in an elbow following the process air tube-and-shell heat exchanger, which immediately follows the convective pass in which the previous samples were exposed. Average gas temperature for the Swindeman samples was 708°C. Figure 97 shows the sample removed from the sample holder after the June test run. The surface has hints of dark gray color under a thin brown coating of ash particle. The sample appears to be intact.

Figure 97. Alloy ORNL #RA253MA-1 removed from the sample holder after the June test run.

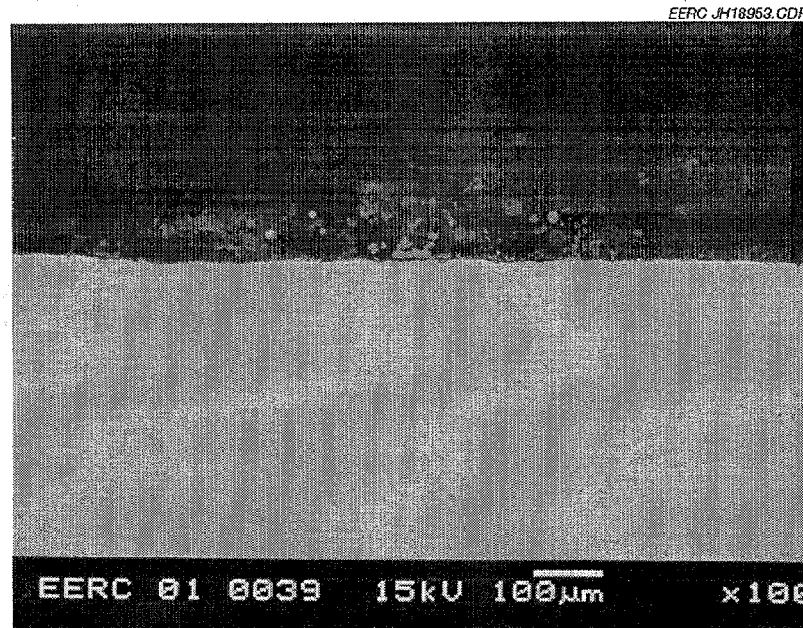
Figure 98. Example of cross-sectioned alloy material, corrosion layer, and ash deposit at 100× magnification (ORNL #RA253MA-1).

The ash deposit on the sample, visible in Figure 98, was very limited. SEM analysis of the material indicated a higher-than-average Fe content of the ash deposited on the sample. The Si and Al content were less than that of the ash deposited in the convective pass.

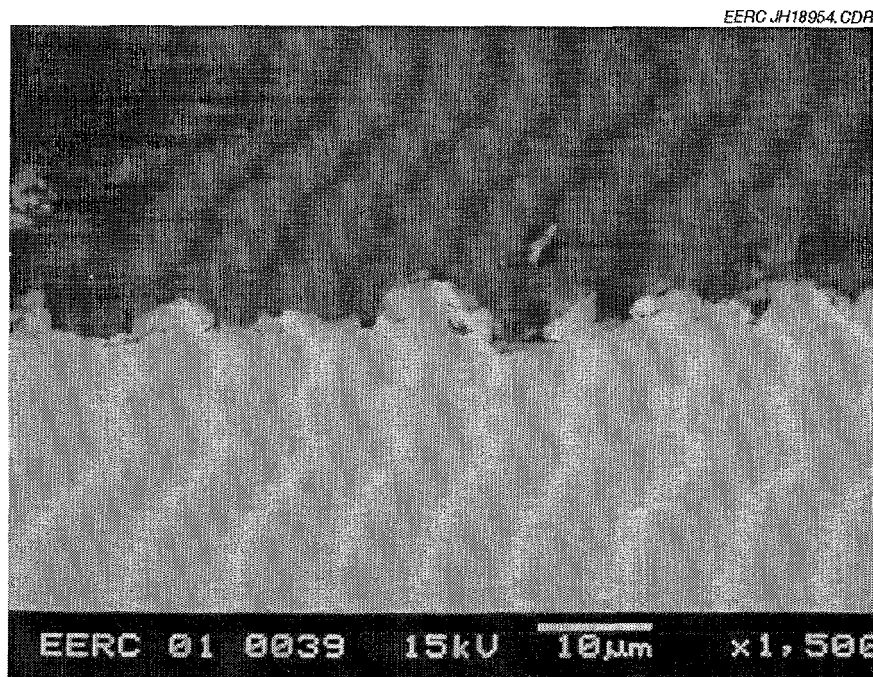
No subsurface corrosion was indicated in the sample cross section. Shallow surface pitting and a thin, discontinuous corrosion layer at the surface are the features of this sample. Figure 99 illustrates these features at 1500× magnification. To the left of center is a small pit, about 1  $\mu\text{m}$  deep and 5  $\mu\text{m}$  wide. The largest pit on the surface was 3  $\mu\text{m}$  deep by 65  $\mu\text{m}$  wide. The thickest corrosion layer above the sample surface was 24  $\mu\text{m}$  high. Most above-surface layers, however, were <10  $\mu\text{m}$  thick. The composition of the alloy material near sites of corrosive attack does not appear altered. Most corrosion products in pits and attached to the surface included a high percentage of Fe (37-58 wt%) with an average of 17 wt% Cr; 13 wt% Ni and O; 4 wt% Si; 1 wt% S, K, and Al; and trace Ca and Mg. Even areas high in Cr (40 wt%) and O (19 wt%) contained 27 wt% Fe, suggesting the absence of the chromium oxide layer that could protect the alloy from further attack by flue gas constituents such as O. The irregular sample surface and discontinuity of the corrosion layer suggest a pattern of sequential pitting and scaling. The corrosion mechanisms throughout appear to be oxidation and sulfidation. No halide attack or ash constituent interaction was indicated.

Figure 99. Sample surface at 1500× magnification (ORNL #RA253MA-1).

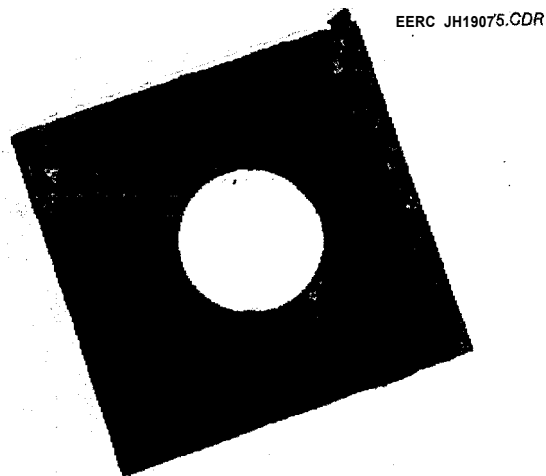
**12RN72**

**Postexposure appearance:** The Swindeman samples were all exposed in an elbow following the process air tube-and-shell heat exchanger, which immediately follows the convective pass in which the previous samples were exposed. Average gas temperature for the Swindeman samples was 708°C. Figure 100 shows the sample removed from the sample holder after the June test run. The surface is coated with a thin brown layer of ash particle. The sample appears intact.

Figure 100. Alloy ORNL #12RN72-1 removed from sample holder after the June test run.

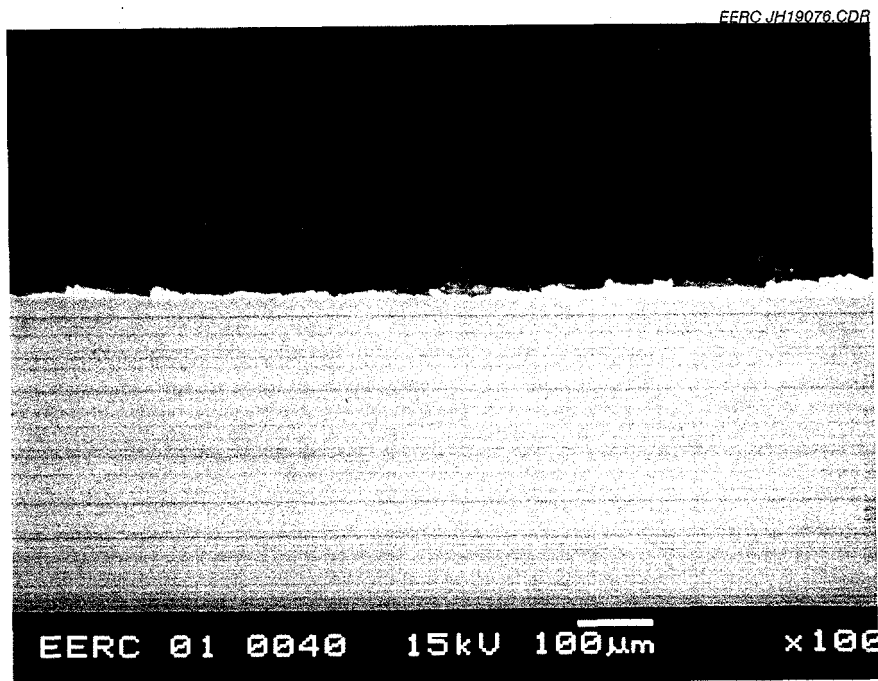
Figure 101. Cross-sectioned alloy material, corrosion layer, and ash deposit at 100× magnification (ORNL #12RN72-1).

No subsurface corrosion was indicated in the sample cross section examined. Surface corrosion consisted of a thin, discontinuous corrosion layer. Figure 101 includes the largest example of corrosion product at the center of the figure. Also illustrated in this figure is the typical irregular scaling observed throughout the sample surface in the cross section examined. Figure 102 is the large corrosion product at the center of Figure 101 at 1500 $\times$  magnification. The mass is 45 $\mu$ m high and 80  $\mu$ m wide. It includes large cracks and entrained ash particles and appears ready to separate from the sample surface. The composition of the alloy material near sites of corrosive attack was similar to the rest of the alloy material in the sample. The alloy-corrosion interface is mainly chromium (51-58 wt%) oxide (7-30 wt% O) with some Fe (7-25 wt%), Ni (4-7 wt%), Mn (<5 wt%), Si (<4 wt%), and Ti (<2 wt%) and includes the band presented as bright white spots and adjacent light gray in Figure 102. The white spots contain more Si, Mn, and Ti; trace of Nb and P; and less Ni than the alloy-corrosion interface. Above this band, the corrosion layer is made up of entrained ash particles in a matrix comprising iron (41-61 wt%) nickel (9-29 wt%) oxide (15-21 wt% O) with up to 20 wt% Cr and small amounts of Si and Mn and trace S. The entrained ash particles contain either Fe and aluminosilicates or Ca, S, and O. The irregular sample surface and discontinuity of the corrosion layer suggest a pattern of sequential pitting and scaling. The layered nature of the corrosion layer and its composition suggest initial formation of an FeO layer followed by a CrO layer once the Fe content decreases. The underlying CrO layer does not remain attached to the alloy. The corrosion mechanism throughout appears to be oxidation.

The ash deposit on the sample, visible in Figure 101, was very limited. SEM analysis of the material indicated a composition unusually high in Nb-39 wt% O; 15 wt% Si; 8 wt% Al and

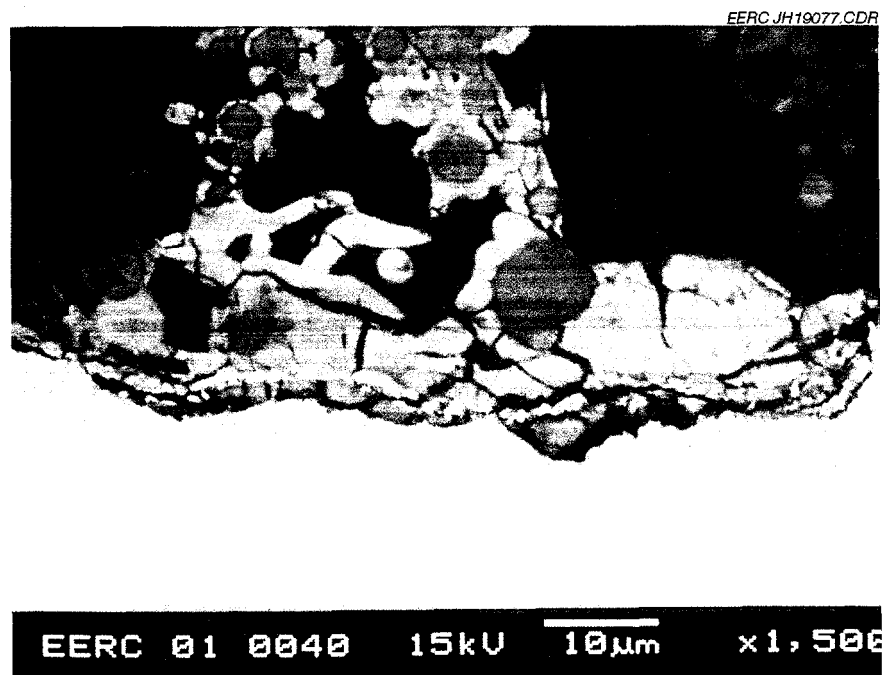
Figure 102. Sample surface at 1500 $\times$  magnification (ORNL #12RN72-1).

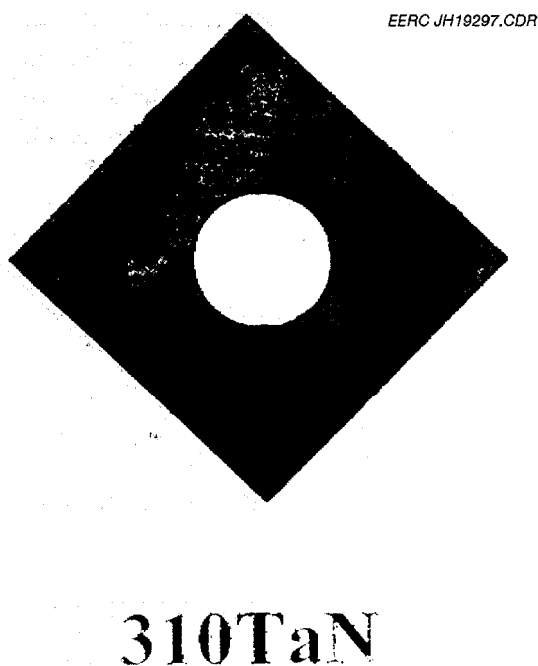
**Postexposure appearance:** The Swindeman samples were all exposed in an elbow following the process air tube-and-shell heat exchanger, which immediately follows the convective pass in which the previous samples were exposed. Average gas temperature for the Swindeman samples was 708°C. Figure 103 shows the sample removed from the sample holder after the June test run. The surface is coated with a thin brown layer of ash particle. The sample appears intact.

Figure 103. Alloy ORNL #310TaN-1 removed from the sample holder after the June test run.

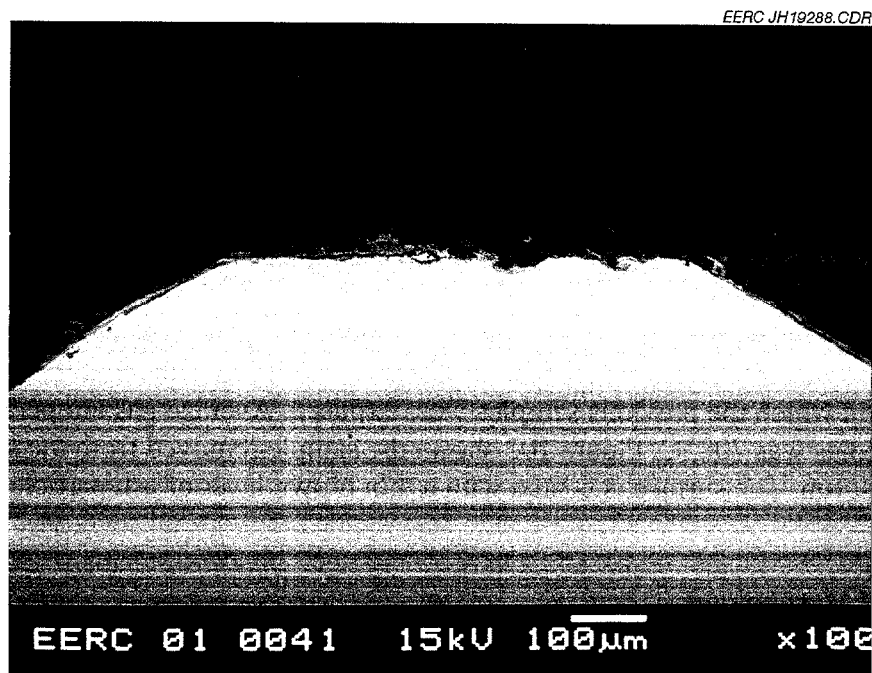
Figure 104. Example of cross-sectioned alloy material, corrosion layer, and ash deposit at 100× magnification (ORNL #310TaN-1).

Subsurface corrosion in the sample cross section examined was limited to a few thin intrusions extending less than 20 µm deep and 30-50 µm wide into the sample. Figure 104 includes two such intrusions and one pit 80 µm wide present on the upstream surface of the sample cross section. Figure 105 shows the sample surface at 1500× magnification, including the intrusion to the right of the pit in Figure 104. The alloy material adjacent to the intrusions shows loss of Cr and increased concentration of Fe (57-64 wt%) and Ni (25 wt%).

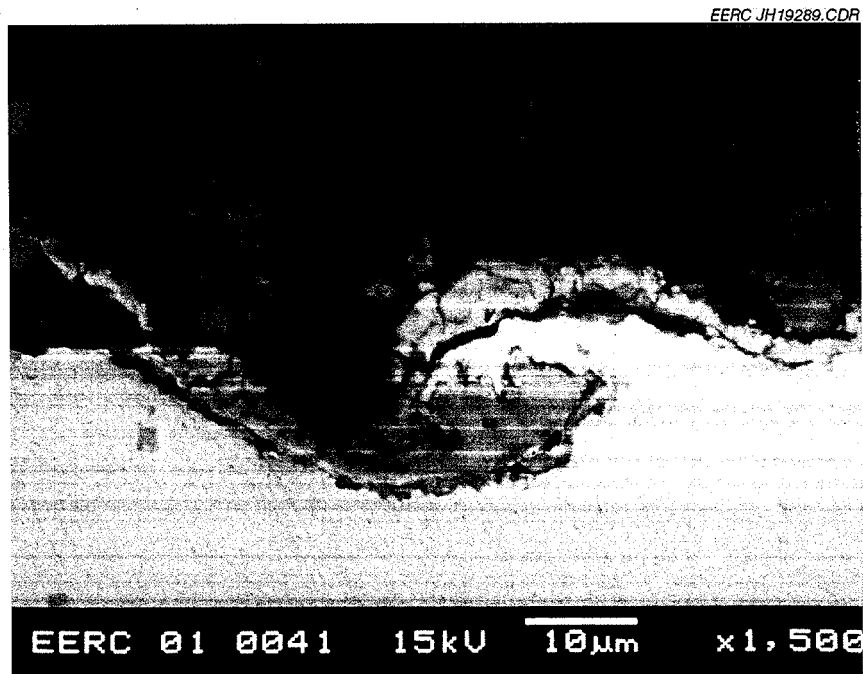
The Fe and Ni content of much of the corrosion product at the alloy interface is similar to that of the bulk alloy. Some of the Cr (now at 16 wt%) was replaced by O (13 wt%) and trace K, S, and P. Mn and Nb are not present. The white corrosion product layer visible in Figure 105 in the intrusion and surface corrosion product is Cr and O with high Nb (5-24 wt%) and low Fe (5-15 wt%) content. The light gray material at the center of the corrosion product is Cr (61 wt%) O (21 wt%) with 6 wt% Mn, 5 wt% Fe, and trace Si, Ni, Al, S, P, and K.

Figure 105. Sample surface at 1500× magnification (ORNL #310TaN-1).

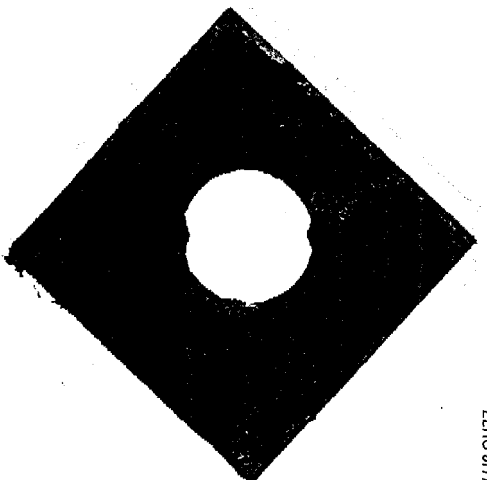
## 310HCbN

**Postexposure appearance:** The Swindeman samples were all exposed in an elbow following the process air tube-and-shell heat exchanger, which immediately follows the convective pass in which the previous samples were exposed. Average gas temperature for the Swindeman samples was 708°C. Figure 106 shows the sample removed from the sample holder after the June test run. The surface is coated with a thin brown layer of ash particle. The sample appears intact.

Figure 106. Alloy ORNL #310HCbN-1 removed from the sample holder after the June test run.

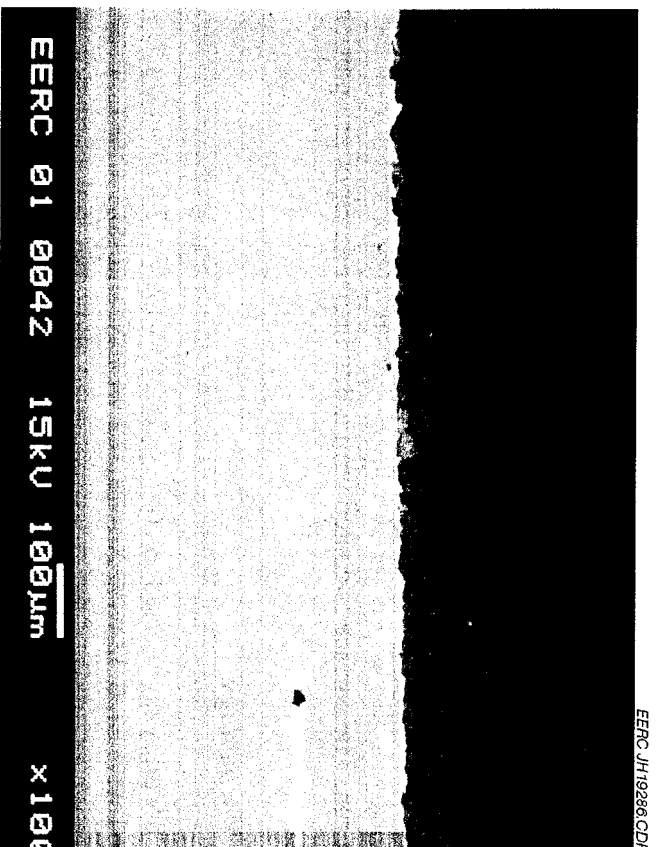
The 310HCbN alloy is reported to contain 54.243 wt% Fe, 24.23 wt% Cr, 18.68 wt% Ni, 1.61 wt% Mn, 0.64 wt% Si, 0.32 wt% Nb-Ta, 0.2 wt% N, and <0.1 wt% C, P, and S. Figure 107 shows a representative example of the cross-sectioned alloy material, corrosion layer, and ash deposit at 100× magnification. The alloy material appears as a homogeneous white field with occasional dark gray voids (depressions in the cross-section surface) scattered throughout the alloy material. Under high magnification (2000x), fine white particles become visible. SEM analysis of the bulk material indicated a composition of 49.8 wt% Fe, 25.1 wt% Cr, 20 wt% Ni,

Figure 107. Example of cross-sectioned alloy material, corrosion layer, and ash deposit at 100x magnification (ORNL #310HCbN-1).

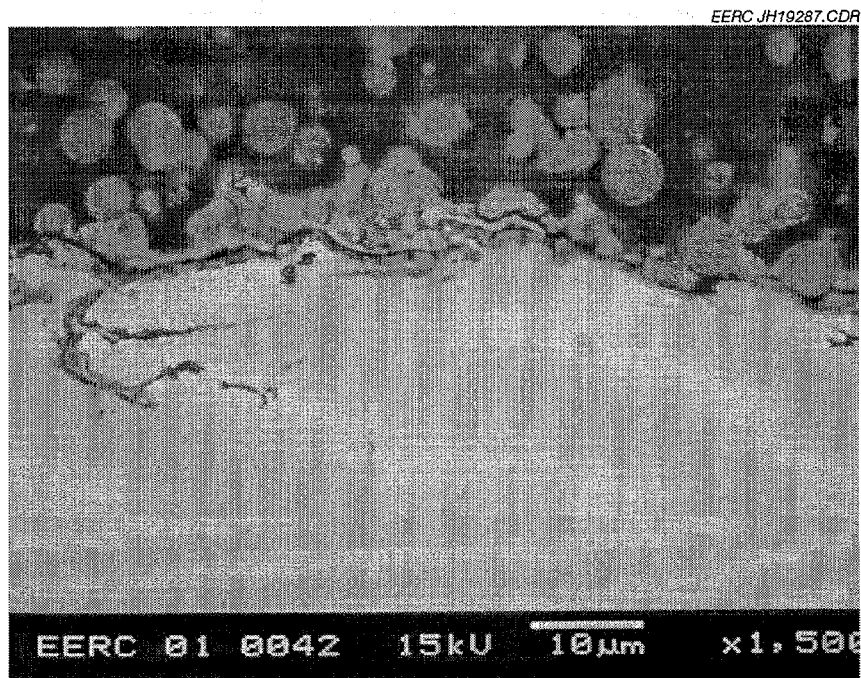
Subsurface corrosion in the sample cross section examined was limited to a few thin intrusions extending less than 20  $\mu\text{m}$  deep and 40  $\mu\text{m}$  wide into the sample. Figure 108 shows one such intrusion in the sample surface at 1500 $\times$  magnification. The content of the corrosion product in the intrusion is mainly Cr, with the thickest mass comprising Cr (55 wt%) O (18 wt%), with some Mn (10 wt%), Fe (6 wt%), Ni (4 wt%), Nb and Si (2 wt%), and traces of S, Ca, K, and Al. Thinner sections of the subsurface corrosion product contain more Fe (28 wt%) and Ni (10 wt%) and less O (11 wt%), possibly due to inclusion of underlying alloy material in the SEM analysis of the corrosion product. In any case, the corrosion product content indicates loss of Fe and Ni, oxidation into the near-subsurface, and limited infiltration by other ash constituents.

Figure 108. Sample surface at 1500 $\times$  magnification (ORNL #3 10HCbN-1).

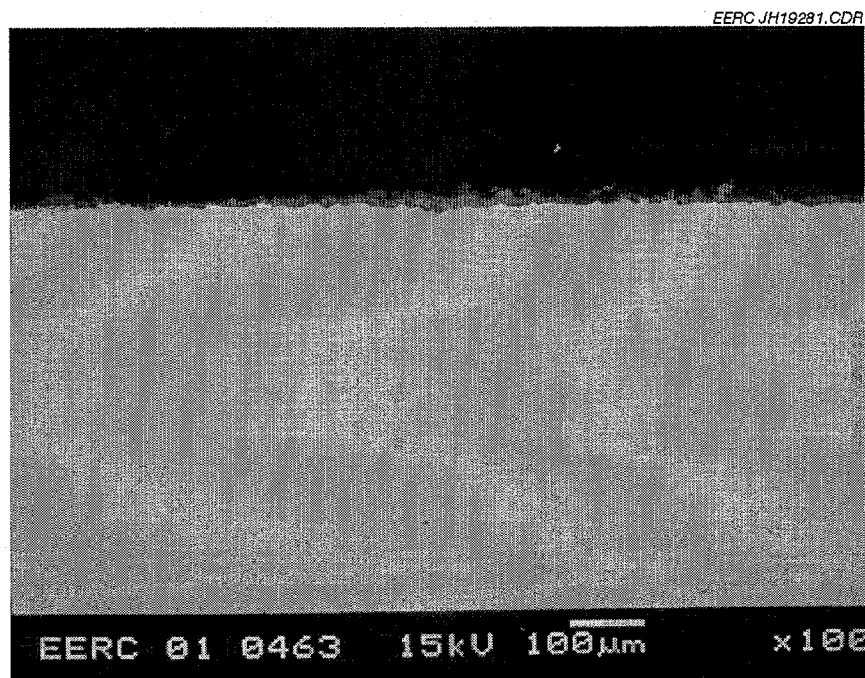
Metal Alloy 956 is reported to contain 73-75 wt% Fe, 19-21 wt% Cr, 4.5 wt% Al, 0.1-0.5 wt% Ti, and 0.5 wt%  $Y_2O_3$ . Figure 110 shows the cross-sectioned alloy material and corrosion layer at 100× magnification. The alloy material appears in the lower half of the figure as a homogeneous white field. Occasional dark spots in the material are depressions in the sample surface suggestive of voids inherent in the material. SEM analysis of the bulk material indicated a composition of 75.1 wt% Fe, 19.6 wt% Cr, 3.2 wt% Al, and trace 0 (<1 wt%).

Figure 110. Cross-sectioned alloy material, corrosion layer, and ash deposit at 100× magnification (956).

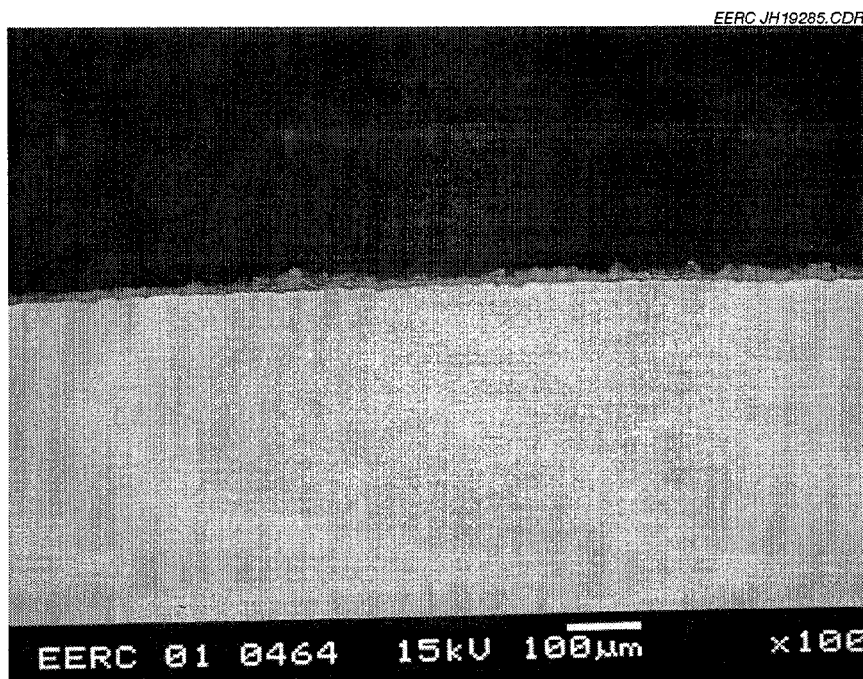
Metal Alloy 956 is reported to contain 73-75 wt% Fe, 19-21 wt% Cr, 4.5 wt% Al, 0.1-0.5 wt% Ti, and 0.5 wt%  $Y_2O_3$ . Alloy 956HT is expected to have a similar content. Figure 112 shows the cross-sectioned alloy material and corrosion layer at 100× magnification. The alloy material appears in the lower half of the figure as a white field. At higher magnification (Figures 113 and 114), medium and dark gray spots become visible. SEM analysis of the bulk material indicated a composition of 71.7 wt% Fe, 22.3 wt% Cr, 4.2 wt% Al, and trace Ti and O (<1 wt%). The medium gray spots are Ti-rich (50 wt% Ti replacing half of all other constituents). Occasional dark spots in the material are depressions in the sample surface suggestive of voids inherent in the material.

No subsurface corrosion was indicated in the sample cross section examined. Surface corrosion consisted of a thin, mostly continuous corrosion layer. Figure 113 includes a typical example of corrosion product at 1500× magnification. The composition of the alloy material near the corrosion product interface was similar to the bulk material with the addition of <1 wt% Si. The corrosion layer is < 20  $\mu m$  thick and is composed of two distinct layers. The inner layer of Al (63 wt%) O (34 wt%) with <3 wt% Cr, 1-2 wt% Fe, and trace Ti and Ca is uniformly 3  $\mu m$  thick. The outer layer comprises a heterogeneous mixture of Fe (50 wt%) O (22 wt%) and ash constituents. The SEM analysis also indicated voids in the outer corrosion layer. The

Figure 112. Cross-sectioned alloy material, corrosion layer, and ash deposit at 100× magnification (956HT).

heterogeneous layer of corrosion product measured  $<17\text{ }\mu\text{m}$  thick. The corrosion layer appeared well formed and well attached to the alloy surface except at one small section of the perimeter where the alloy surface was exposed. This area is shown at  $1500\times$  magnification in Figure 114. There appears to be damage to the alloy similar to the damage observed on NMARL sample 01-0463 at the corrosion layer interface. Although the source of this damage is unknown, it may be associated with sample removal or preparation for analysis. It is likely that the corrosion layer was separated and lost when this damage occurred. Overall, the alloy appears to be well protected from the ash constituents by the alumina scale. The doublelayer of the corrosion product suggests two reaction pathways in the formation of the corrosion product. One interesting observation is the disappearance of Cr from the alloy. While the corrosion layer contains remains of the Fe from the alloy, no Cr was found beyond 3 wt%.
