# **Wear Analysis of Wind Turbine Gearbox Bearings**

**P. J. Blau, L.R. Walker, H. Xu, R. Parten, J. Qu, and T. Geer  
Materials Science and Technology Division  
Oak Ridge National Laboratory**

## **Final report**

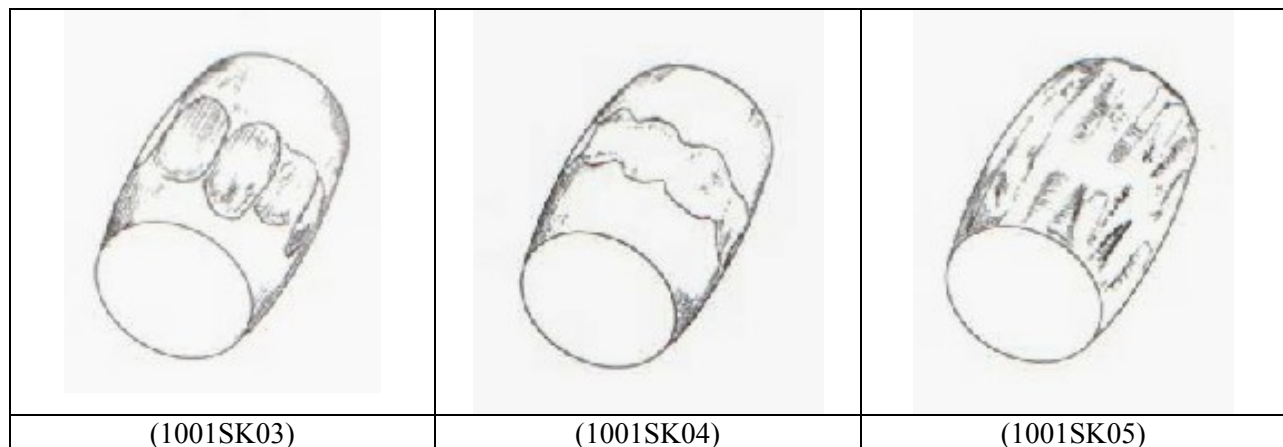
Thirteen loose rollers from the more severely-worn complement were examined, and showed three general types of damage. Three of thirteen rollers showed the circumferentially-dished appearance, as illustrated by the pencil drawing shown in (1001SK03); seven rollers showed the belted-scalloped appearance, as depicted in Figure (1001SK04); and two rollers had long, narrow features extending in from the edges, as shown in Figure (1001SK05).

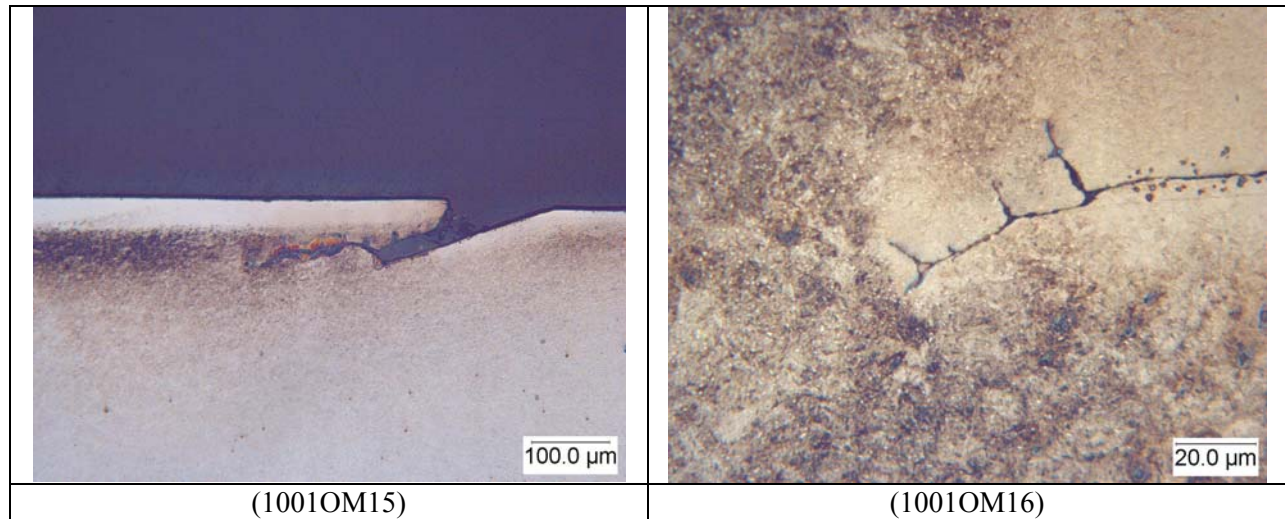
(1001OM15) Delamination indication on a plastically-deformed white layer at the surface of the rolling element. The cantilevered portion can oscillate to cause the crack tip to advance below the layer. (Ralph's etch).

(1001OM16) Branched tip of a microcrack shown at the center left of (1001OM13). Multiple branching is evident, as is the roll of a fine particle, possibly a microstructural inclusion in promoting branching at the crack tip (Ralph's etch).

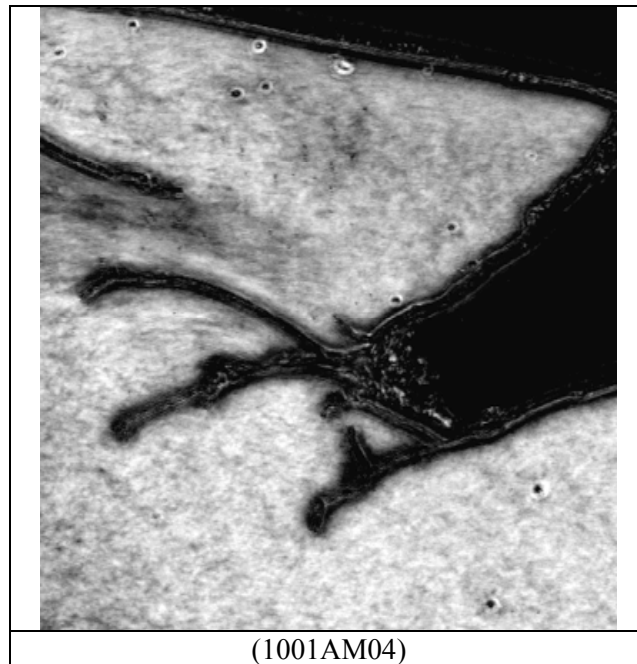
(1001AM04) Scanning acoustic microscope image of the edge of a spall at 1 GHz frequency and with a focus of  $z = -4.5\mu\text{m}$ . The magnification is the same as that for Fig. (1001OM33).

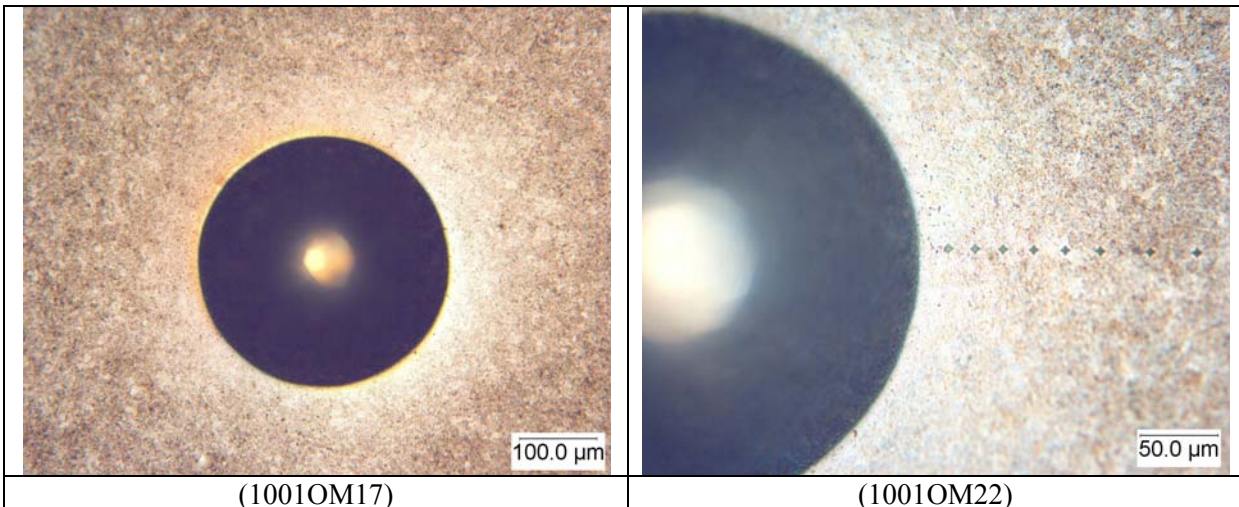
An etched image (Ralph's etch) of a Rockwell hardness test indentation near the center of a cross-section of the severely damaged rolling element bearing shows the pattern of deformation surrounding it. Note that the etchant fails to reveal the details in regions of highest deformation, nearest the edge of indentation. This suggests that the degree of etching is related to the degree of plastic deformation in the material. Vickers microindentations (see 14.2) were placed next to the impression of the Brale (diamond cone) indenter to study the relationship between etching characteristics and hardness of the lighter-etching zones in the microstructure.

(1001OM17) Etched Rockwell indentation near the center of a worn SRB element showing a halo of lighter-etching region. The higher the deformation, the less effect the etchant seems to have. We can infer that the white-etching layers shown in images of the near-surface zones of the bearings have also been highly deformed and cold-worked. (Ralph's etch).

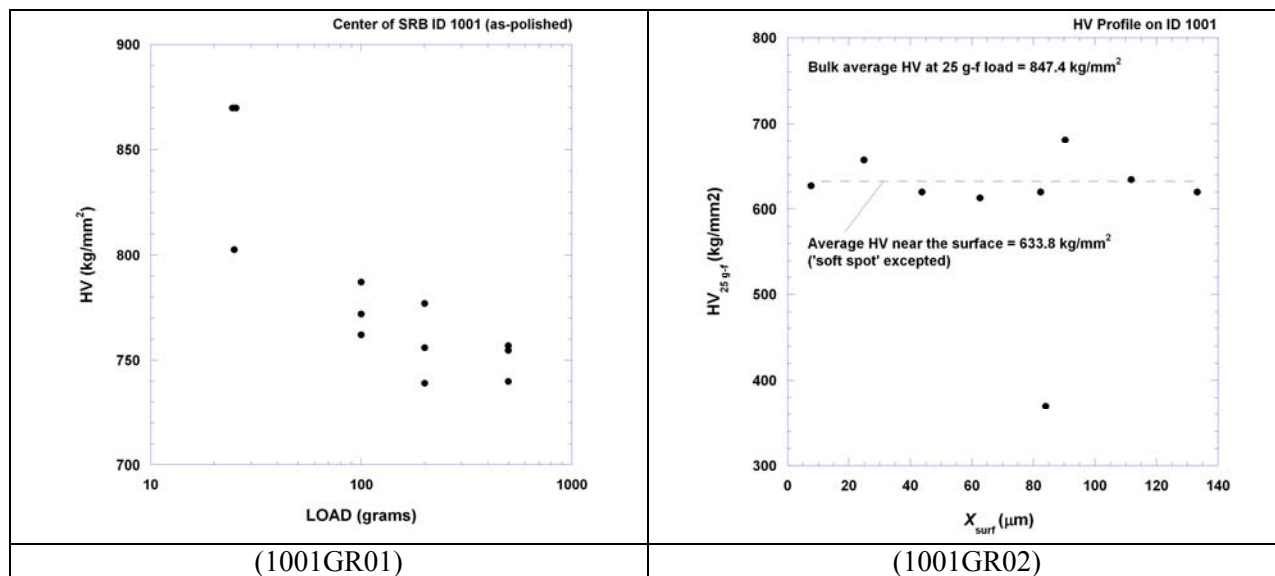
When the cross-section was acid-etched (see Figure 1001OM09), the reasons for the variations in hardness become clear. On some regions just below the surface, there was a very highly-deformed white-etching layer attached (see Figures 1001M11 to M14). The average and standard deviation in HV (100 g) for those white regions were 932.5 and 36.5 kg/mm<sup>2</sup>, respectively, while the more heavily etched substrate below the white region had an average and standard deviation of HV of 488.2 and 9.67 kg/mm<sup>2</sup>, respectively. Work-hardening during plastic shear of the near-surface material therefore produced a material with nearly twice the original bulk hardness, but these hard, near-surface areas were not always present and they also varied in thickness. The lack of a hardness gradient in Figure 100GR02 is because the profile was not near a deformed region. [Also note that the HV in 1001GR02 was obtained at a load of

(1001GR01) Plot of HV versus load for a bulk area on an SRB roller.

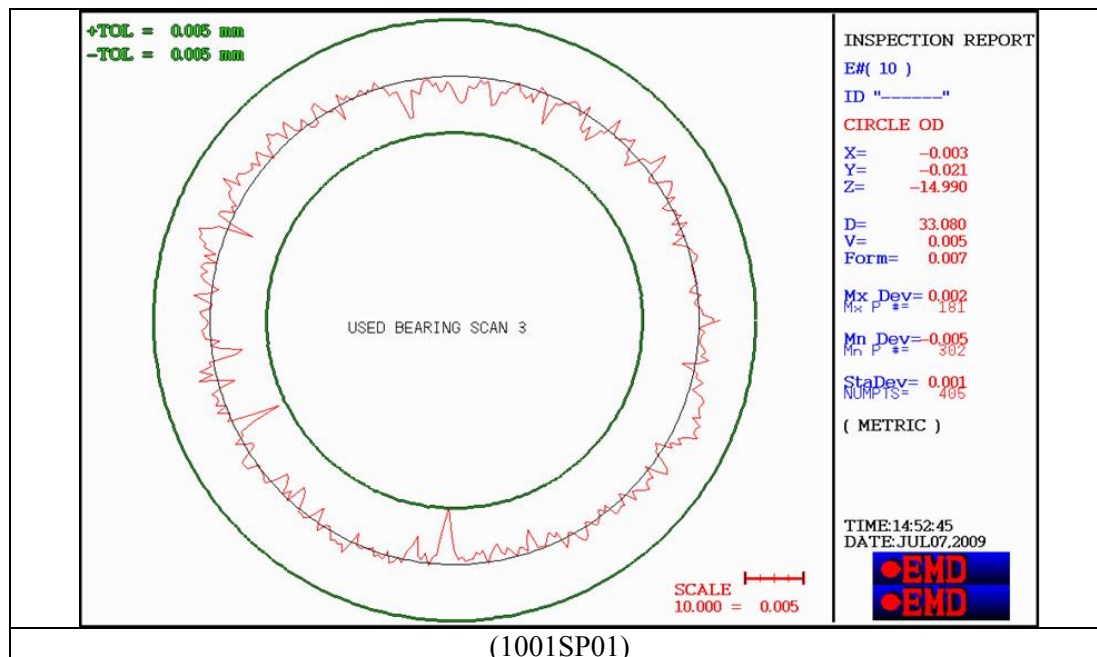
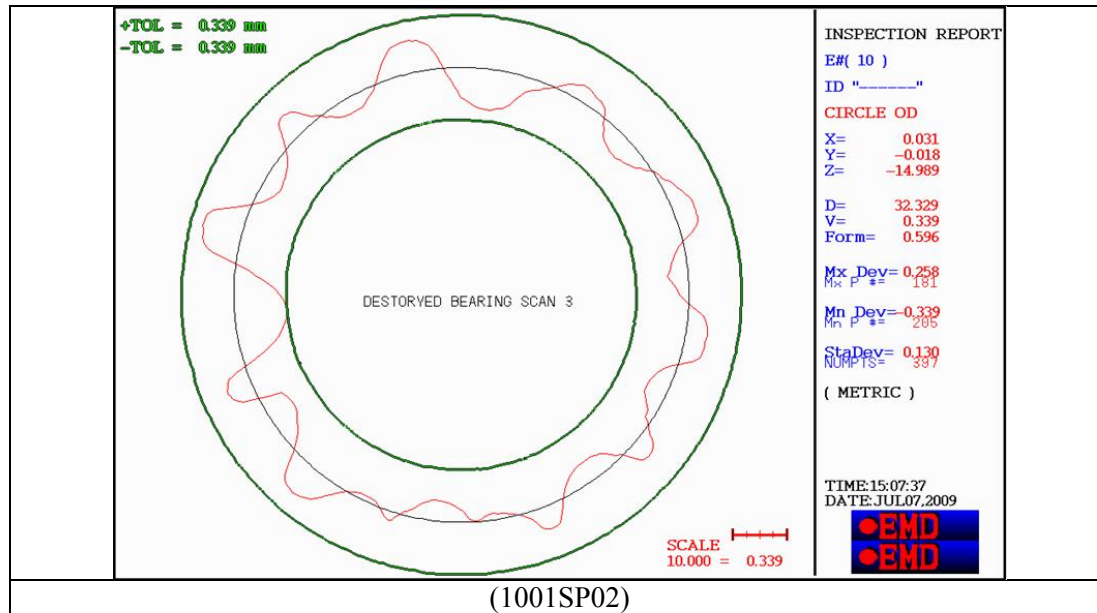
An EMD Legend™ Coordinate Measuring Machine (CMM) was used to scan the circumference of a highly-worn spherical rolling element from the overloaded side, and one that was obtained from the opposite complement of 16 spherical rollers that showed much less surface damage. Figure 1001SP01 shows its variation in diameter. By contrast, Figure 1001SP02 shows the much larger variation in diameter (lobing) of the heavily worn roller, reflecting its greater magnitude in peak-to-valley undulations.

(1001SP01) Variation in height of surface features around a SRB sustaining minor damage.

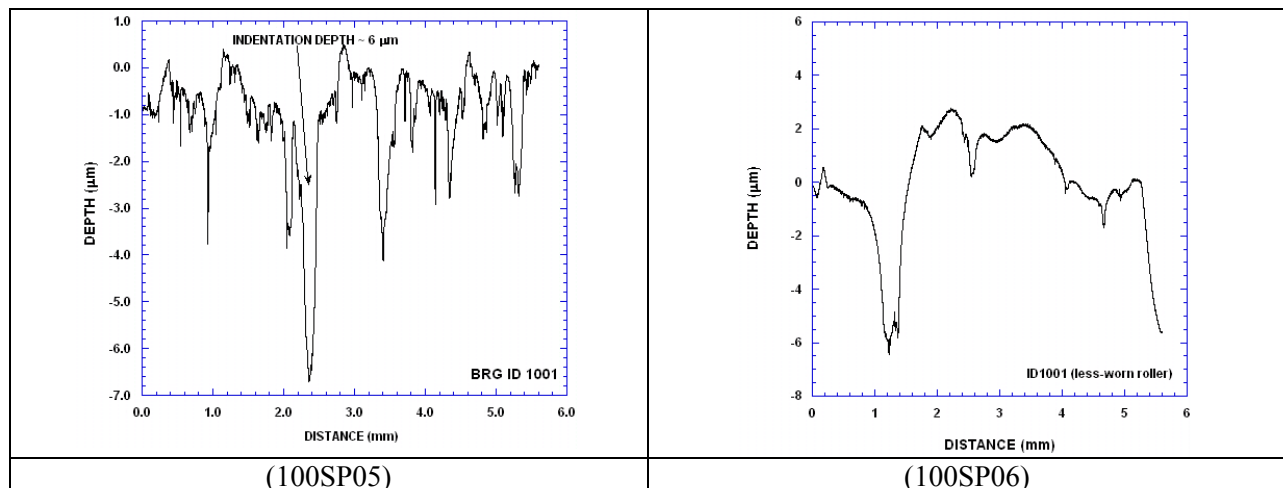
(1001SP05) Stylus trace along the surface of a worn roller. The trace direction is parallel to the axis of rotation and near the apex of the crown of the roller.

(1001SP06) Stylus trace along the surface of a less-worn roller. The trace direction is parallel to the axis of rotation and near the apex of the crown of the roller. Note that the profile is smoother and the edges of the indents are more rounded.

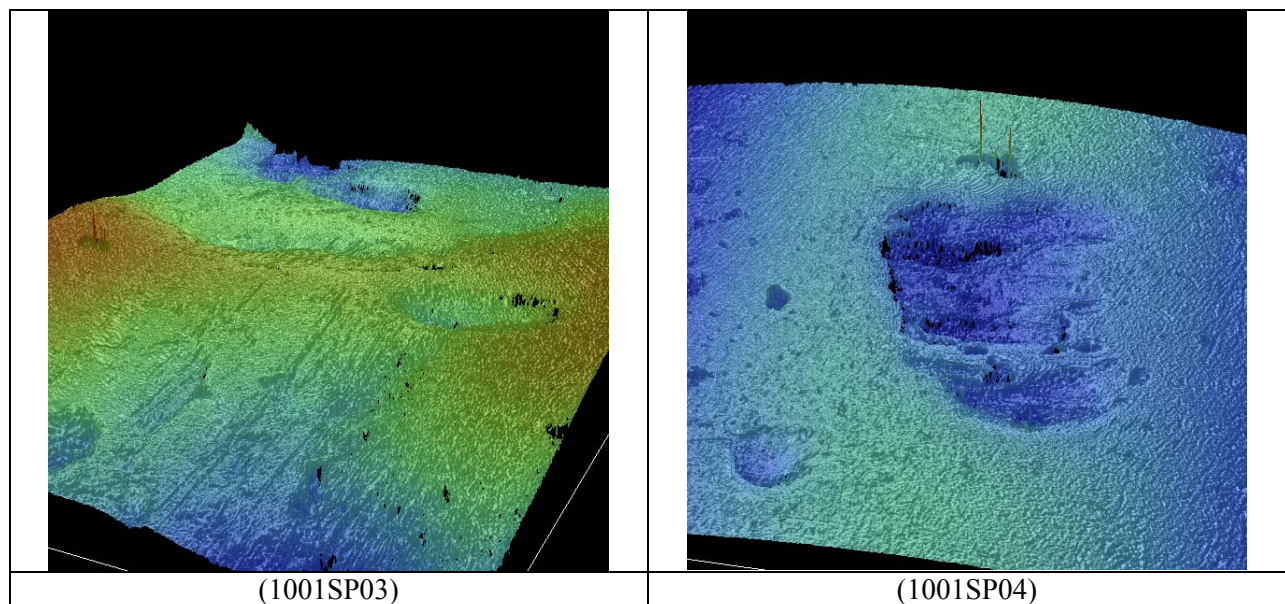
(1001SP03) 3D map of indents on the surface of a less-worn bearing. The area of analysis for this scan is approximately 0.878 mm long x 0.657 mm wide. Depressions measured about 2-6  $\mu\text{m}$  deep. The highest point to the lowest point on the entire figure (z-direction) is 40  $\mu\text{m}$ .

(1001SP04) 3D map of a relatively large indentation in the curved surface of the less-worn bearing. The area of analysis for this scan is approximately 0.878 mm long x 0.657 mm wide. Its depth is  $\sim 6\mu\text{m}$ .

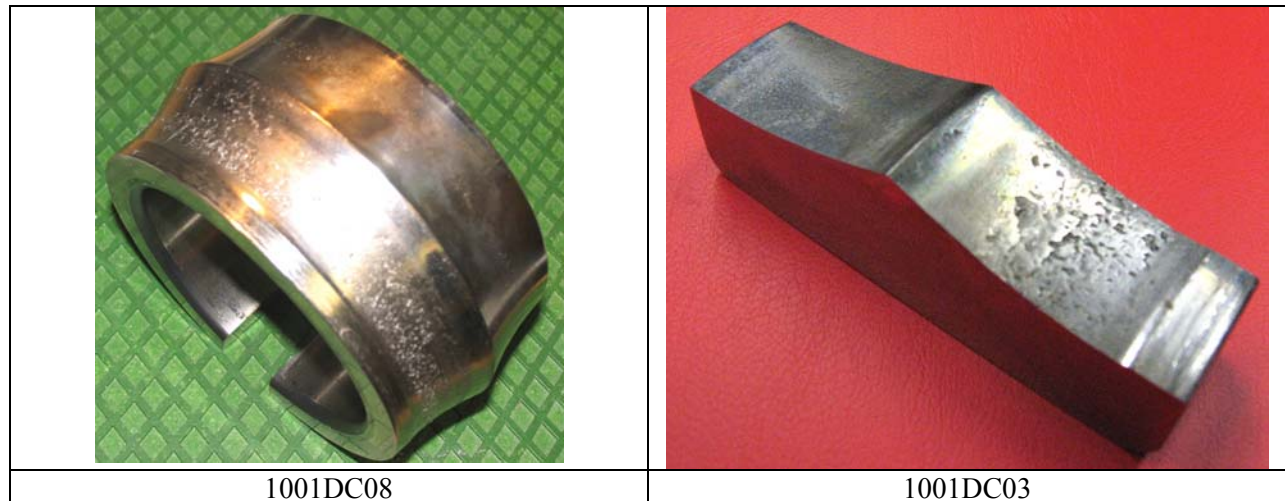
(1001DC08) Inner ring showing where a slice was removed. The slice is shown in (1001DC03).

(1001DC03) Section of the inner race with more wear on one side than the other. The width of the cut-out section is 20 mm, its length is 80 mm, and the height at the peak is 24 mm.

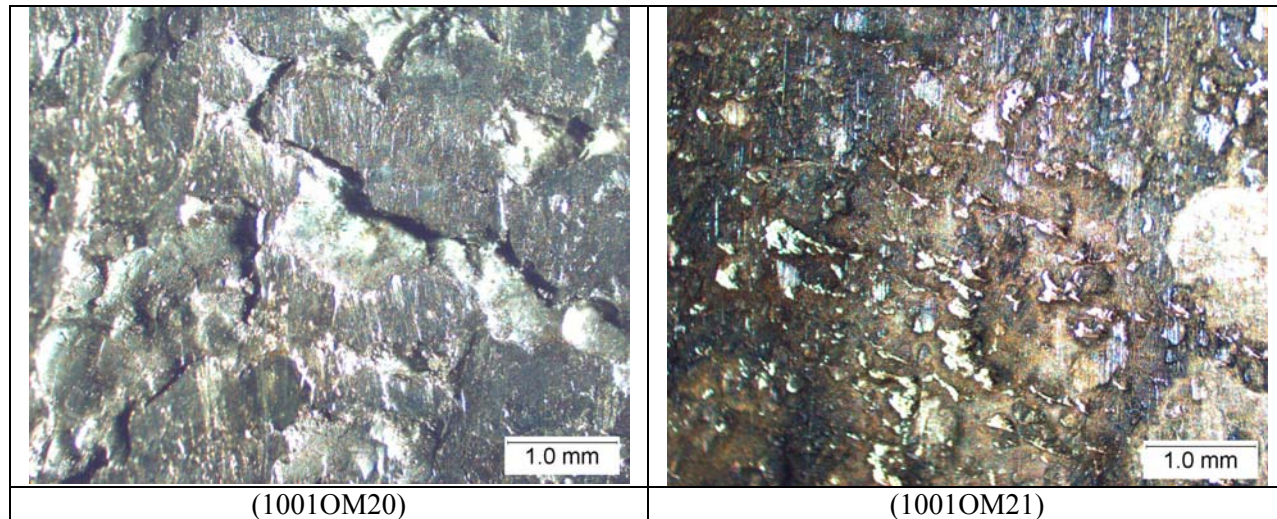
(1001OM20) MacI of the damage on the inner race that showed more wear. Significant subsurface cracking and delamination of sheared material is expected in this area.

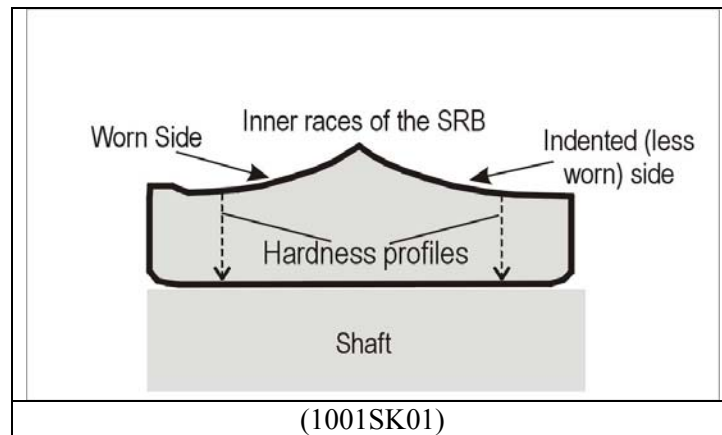
A schematic diagram of the cross-section of the race shown in (1001DC03) is shown in Figure (1001SK01). This section was used for hardness tests and metallurgical studies. The more heavily worn side is indicated on the left of the cross section. The wear step is represented in the figure, and the dashed lines show the direction of the hardness profiles referenced from the contact surfaces toward the center shaft.

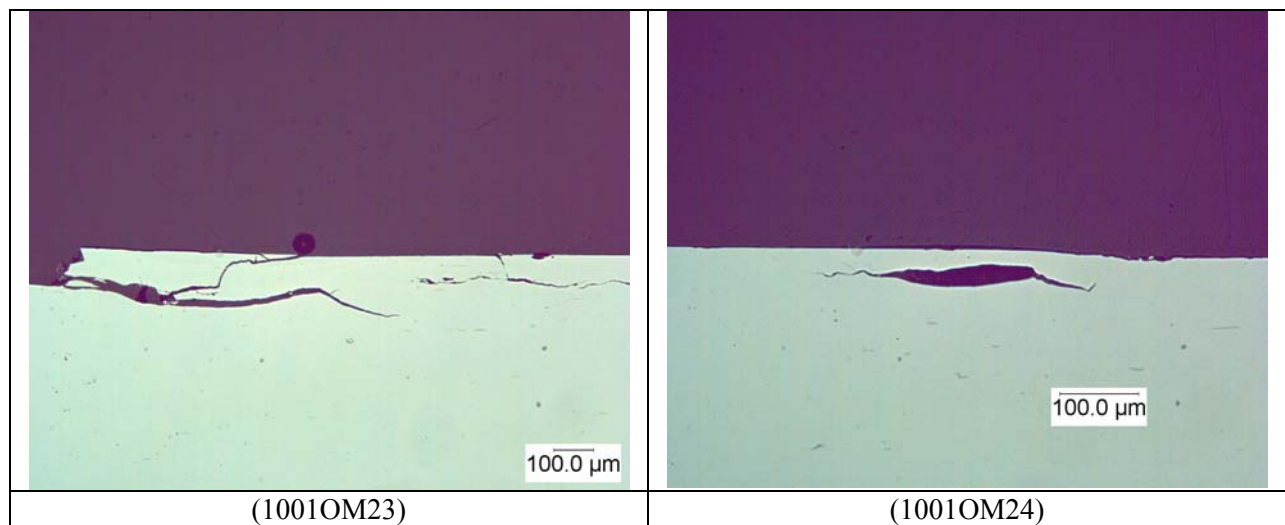
(1001OM23) PXS showing surface material removal and subsurface cracks running approximately parallel to the load-bearing surface

(1001OM24) PXS showing nucleation and lateral propagation of subsurface cracks probably in the zone of maximum Hertzian (elastic) contact stress. Flexure of the material 'bridge' above the void probably drove the cracks outward at both ends.

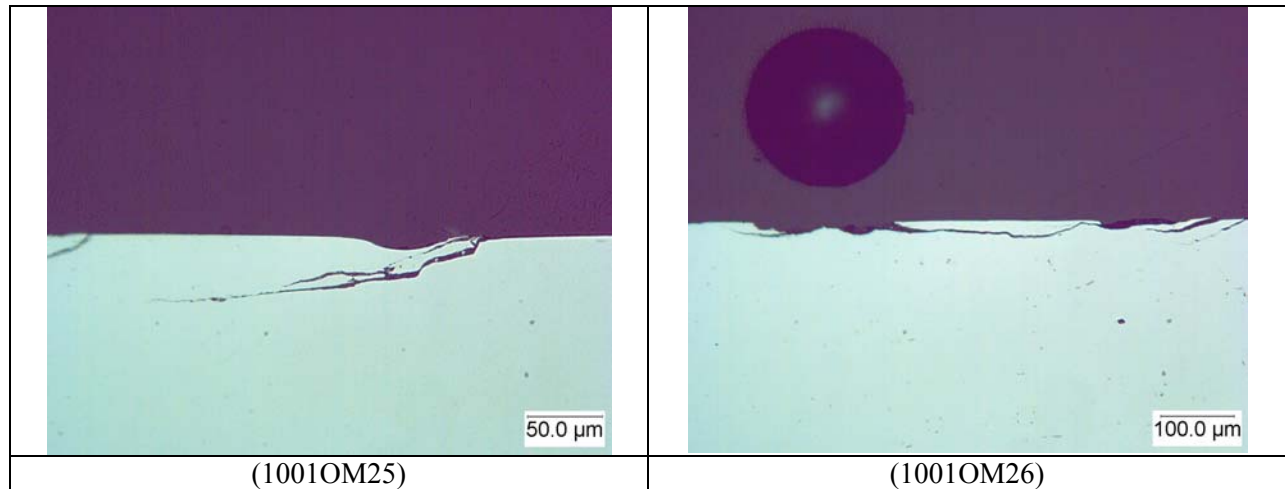
(1001OM25) Surface-breaking cracks below a shallow debris indentation in the less-worn side of the race.

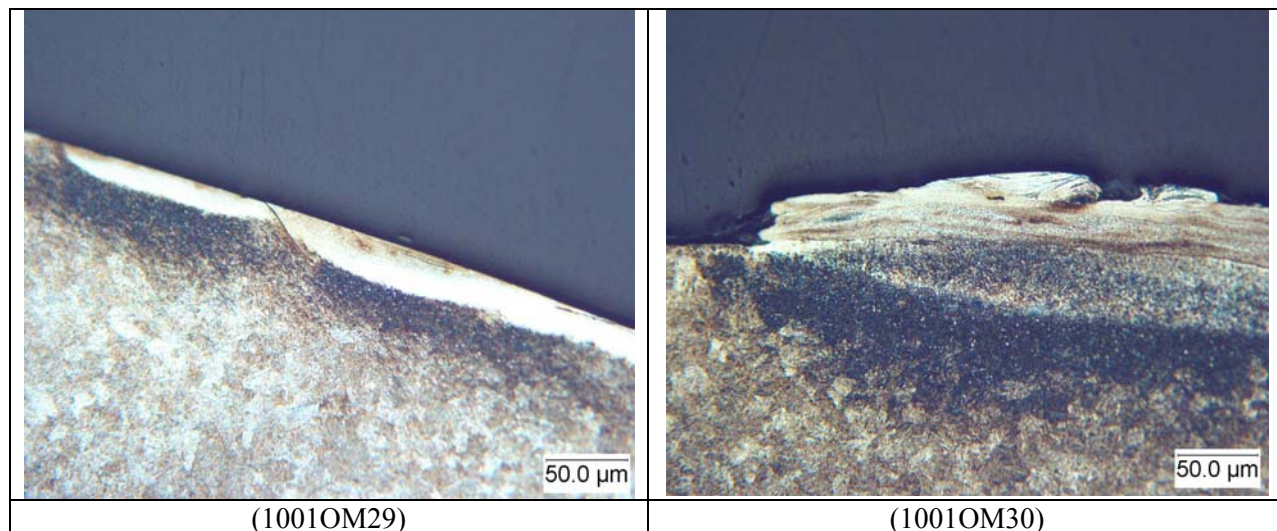
(1001OM29) Higher magnification view of the flowed material shown in (1001M28).

(1001OM30) Adherent deposit on a flat zone outboard of the wear step. Several distinct microstructural zones are evident. The tip feature seemed to be adhered (transferred) material. Underlying that was a lighter gray zone of finer grain structure, and below that a quite dark zone. Finally, the grain structure of the bulk material is below the dark etching zone.

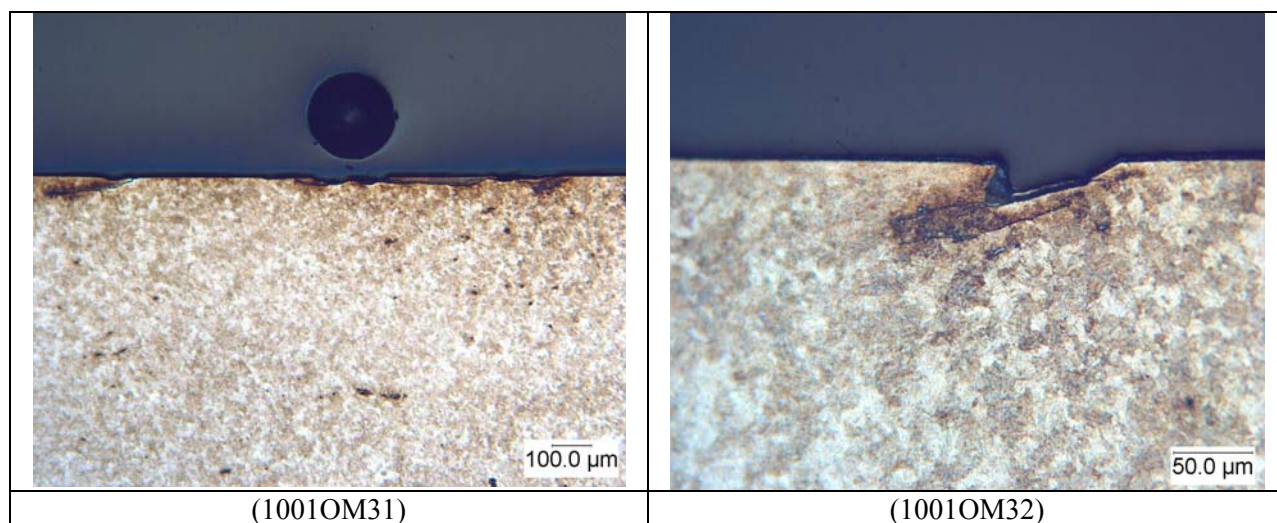
The less worn side of the inner race showed no evidence of white layers, but some of the shallow features associated with indentations were associated with micro-cracks. These microcracks were not nearly as long or deep as those on the more worn side (see below).

(1001OM31) Etched area of the less worn race indicating some indenting, but no white layers.

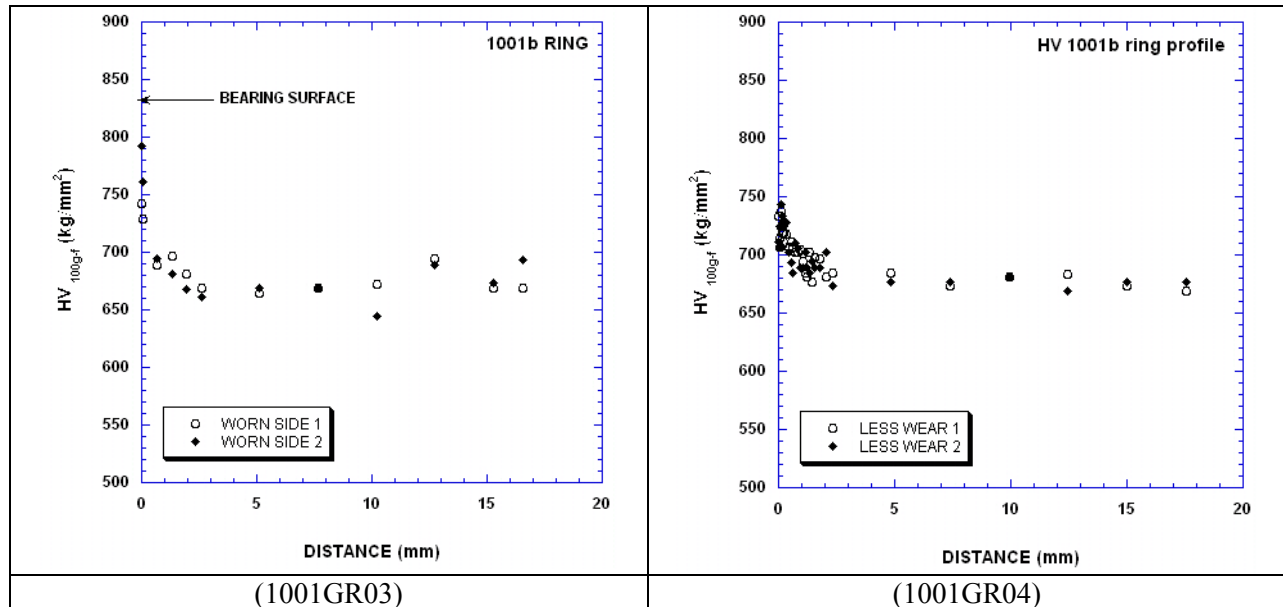
(1001GR03) Superimposed Vickers hardness versus depth traces below the surface on the more highly worn side. The hardness close to the surface is in the range 740 to 790 kg/mm<sub>2</sub>, and the bulk values are in the high 600s.

(1001GR04) Superimposed HV versus depth traces on the less worn side. The hardness close to the surface is in the range 710 to 740 kg/mm<sub>2</sub>, and the bulk values are in the high 600s. The hardness numbers nearest the surface are somewhat lower than those shown in (1001GR03). After these measurements, etching was done to reveal any microstructural differences of the near-surface materials.

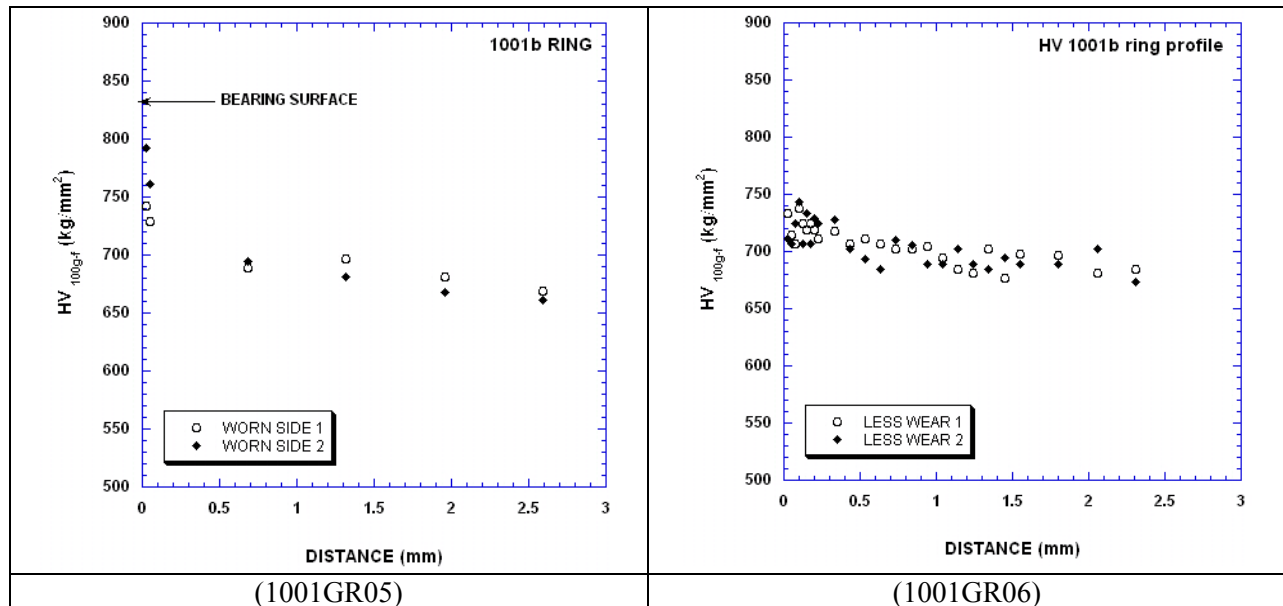
For clarification, magnified plots of the areas closest to the surfaces in Figures (1001GR03) and (1001GR04), respectively, are shown in Figures (1001GR05) and (1001GR06). The slight increase in HV toward the surface begins at a depth less than about 1-1.5 mm.

(1001GR05) Superimposed Vickers hardness versus depth traces corresponding to the first 3 mm of plot (1001GR03).

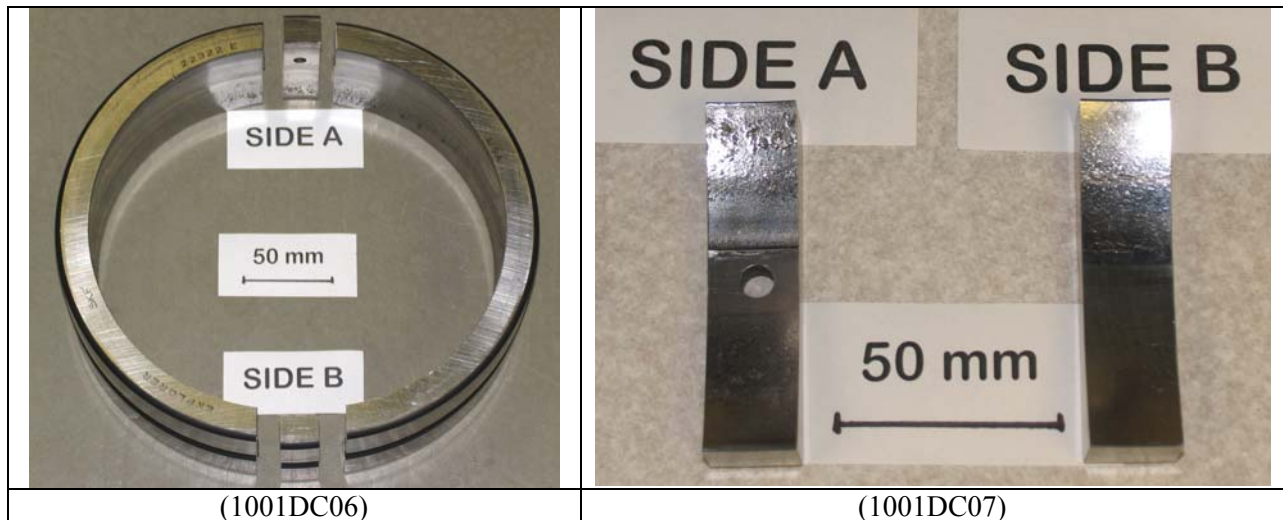
(1001DC06) OR showing cuts labeled “A” and “B” taken from opposite sides of the ring..

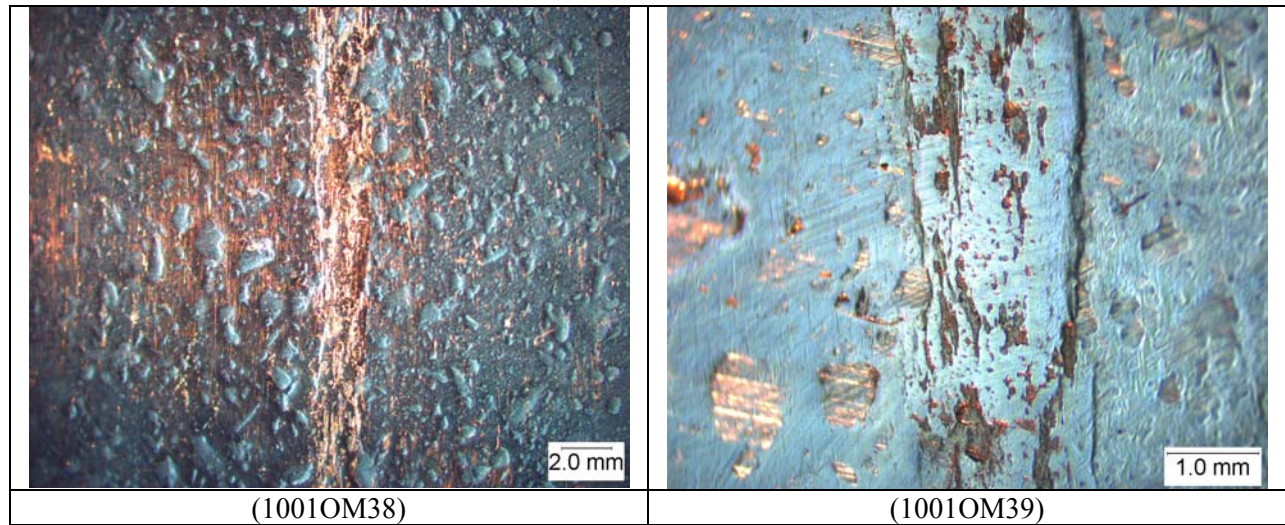
(1001OM38) Prominent groove on the centerline of the more worn race on Side B.

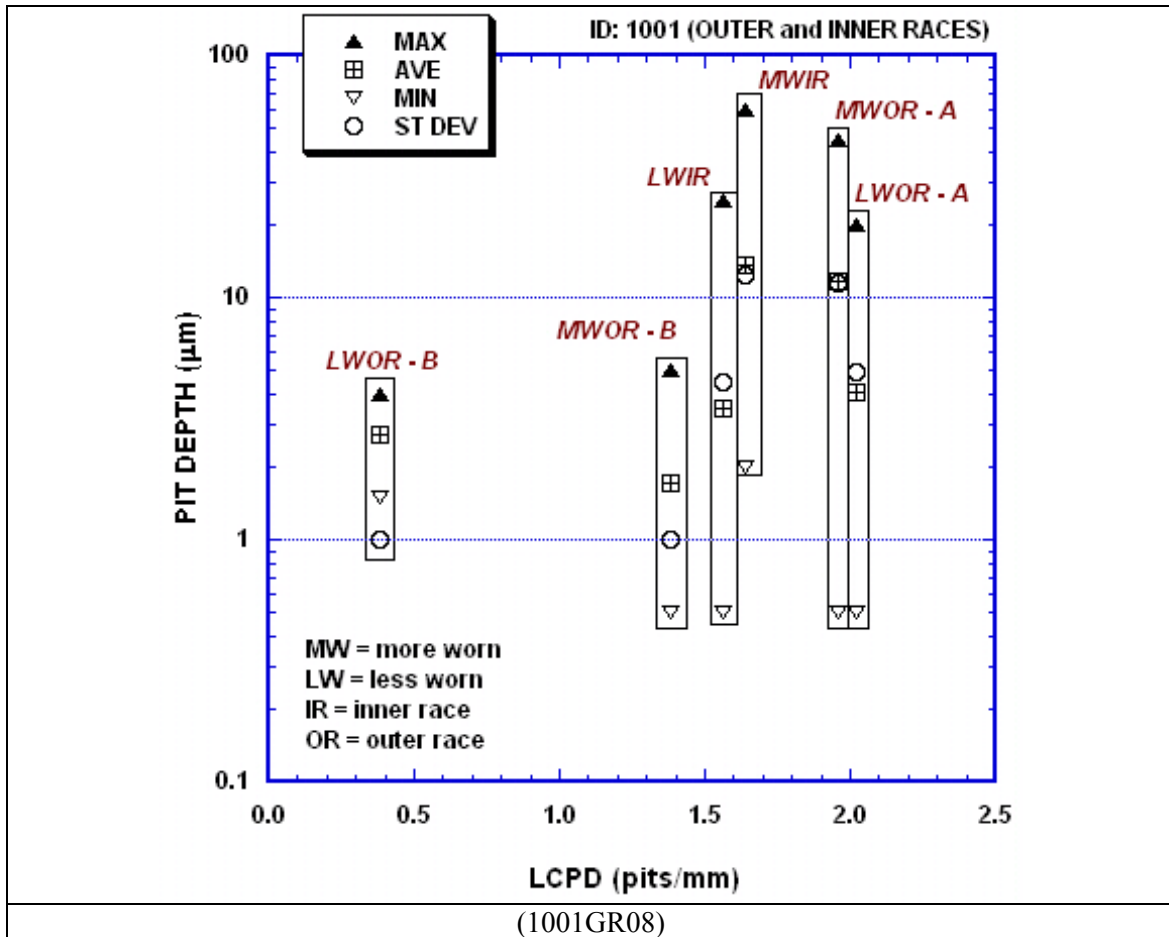
Clearly, the damage to side A of the outer race was significantly greater than that of Side B, 180 degrees from it. A semi-log plot of the maximum, minimum, and average pit depth versus PCPD is shown in Figure 1001GR08. Note that the lowest practical precision of pit detection by this method was about 0.5  $\mu\text{m}$  and that this limitation was compounded by the auto-scaling feature of the instrument display that scales to the largest depth feature, making smaller features less prominent and difficult to detect.

For the given bearing races, the shallowest and least numerous pits were found on Side B of the less-worn outer ring. This difference in wear severity can also be seen in Figure 1001DC07 in Section 15.1 of this report. This supports the conclusion that there was non-uniform axial loading on the bearings. The deeper pits ( $>\sim 10 \mu\text{m}$  deep) tended to be fatigue-induced spalls while the shallower pits ( $<\sim 10 \mu\text{m}$  deep) were mainly debris indentations. Furthermore, as the diameter of the pits becomes larger, there are fewer possible pits within a mm of traverse distance. Therefore, the magnitude of the LCPD parameter is not a direct measurement of damage severity when large pits are concerned, but maybe more useful in situations like micropitting.

(1001GR08) Plot of linear circumferential pit density versus pit depth. Data corresponding to more worn or less worn areas on the inner and outer races are indicated.

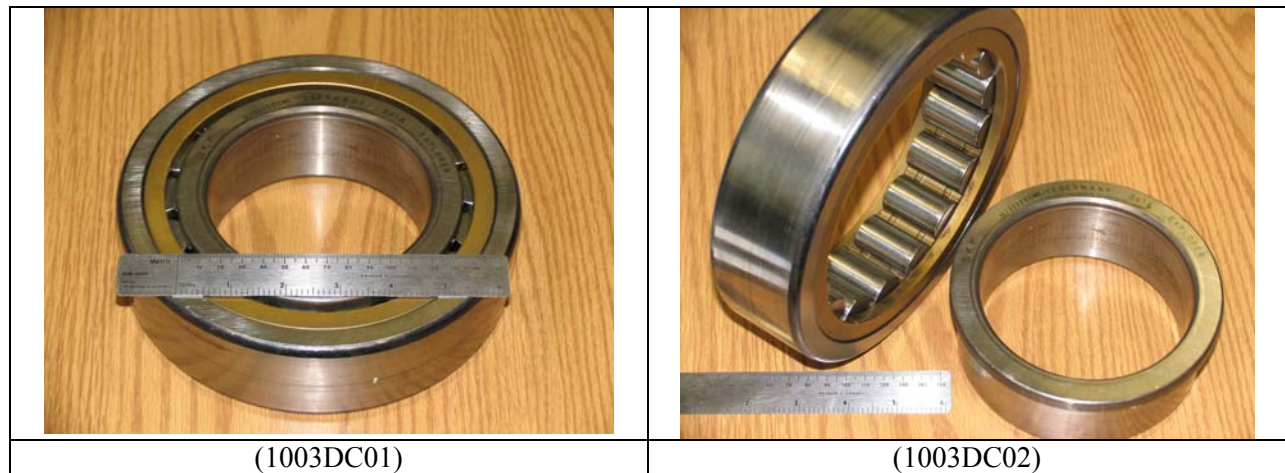
(1003DC01) Bearing assembly (20 mm outside diameter, 11 mm inside diameter)

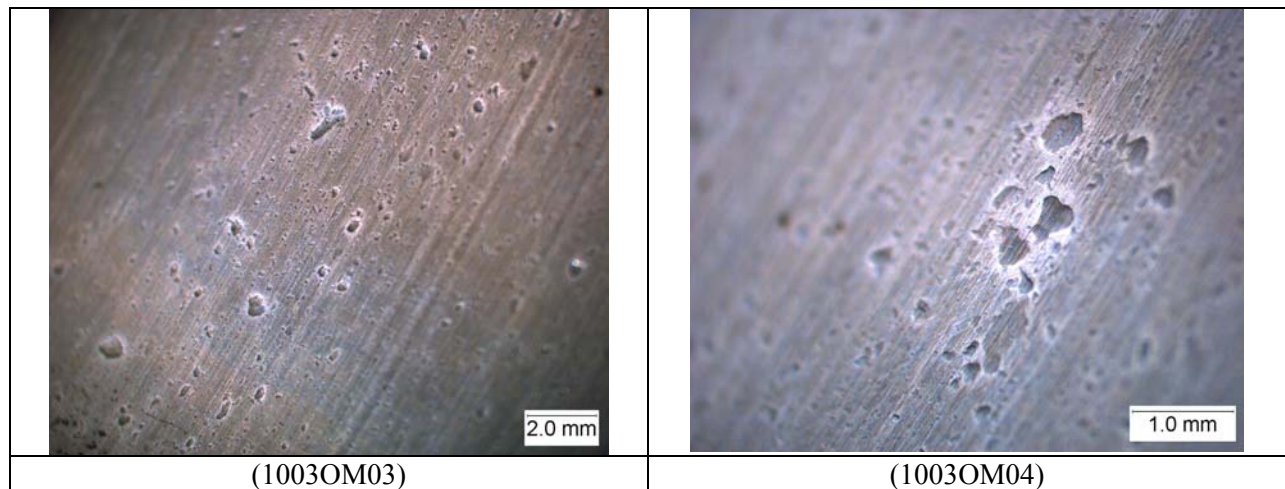
Close-up images of shallow indentations in the outer race were obtained using a Nikon macro-zoom microscope after a section of the rollers and separator ring had been removed, as shown in Section 2.5 Fig. (1003DC04). The two most prominent features were the debris dents and the fine abrasion markings in the circumferential direction. The figures below show several areas of indentations that ranged in size from less than 100  $\mu\text{m}$  to over 1 mm. High concentrations of metallic debris were confirmed by studies of the rolling elements and separator (see section 2.5). The inner race had similar features.

(1003OM03) Contact surface of the outer race showing shallow indentations from debris denting and circumferential scratches from debris that was dragged along through the interface by the rolling elements.

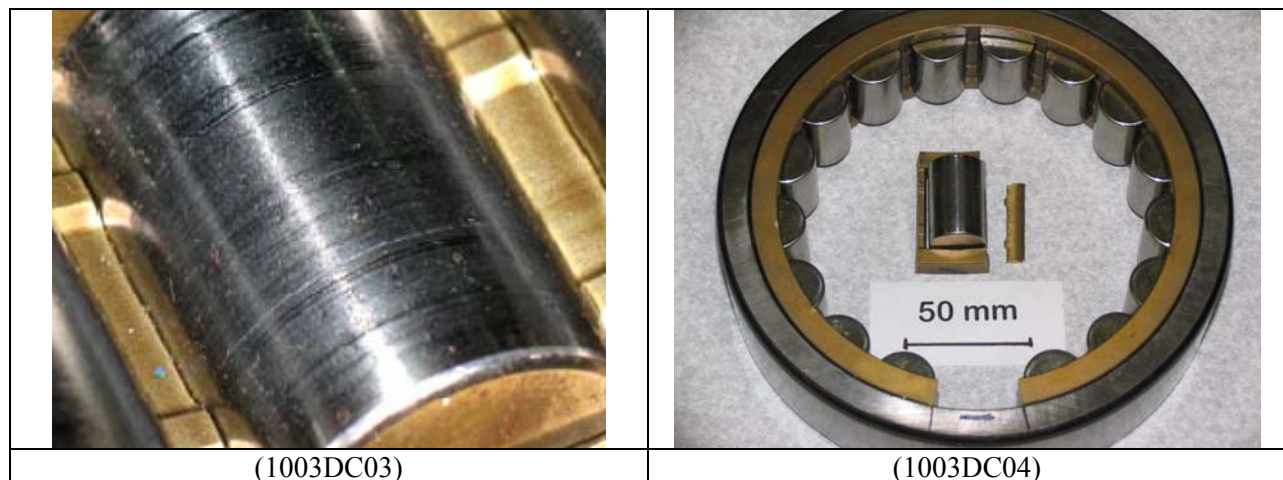
(1003DC03) Close-up of a cylindrical roller in the bronze separator.

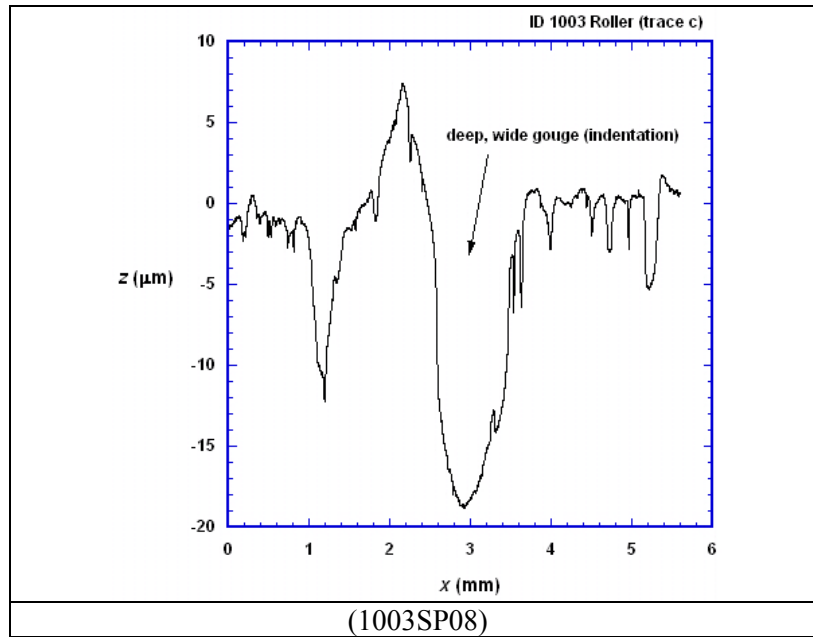
(1003SP08) Enlarged portion of a surface profile at one of the larger indentations in the surface of the roller. A three-dimensional version of the area on which this type of deep feature occurs is shown in Section 17.2.

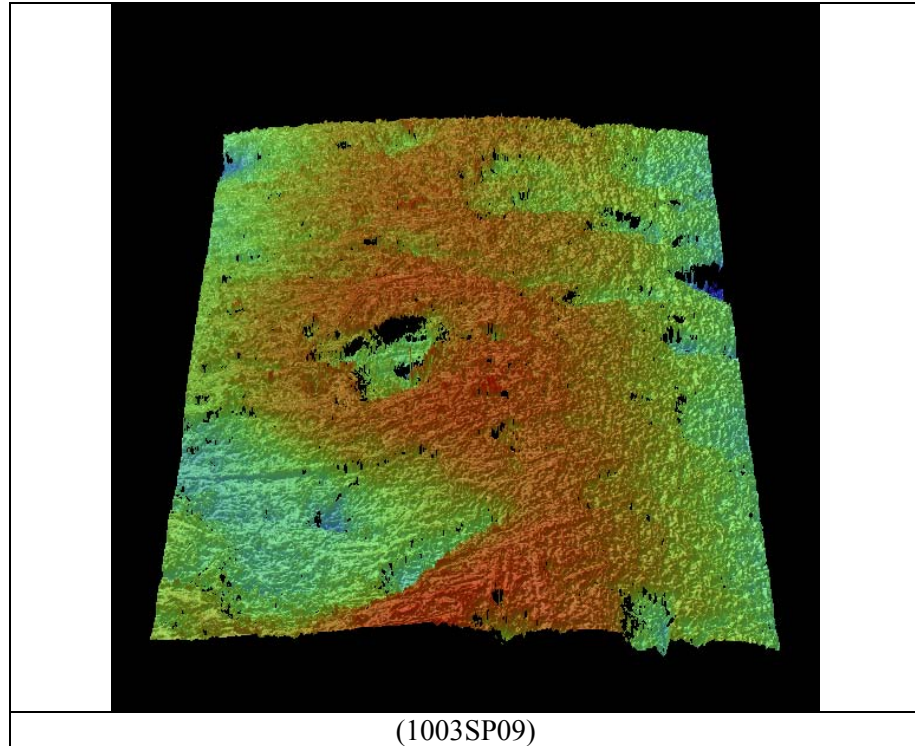
(1003SP09) 3D reconstruction of the surface of a cylindrical roller such as that profiled in 1003SP06 and 1003SP08.

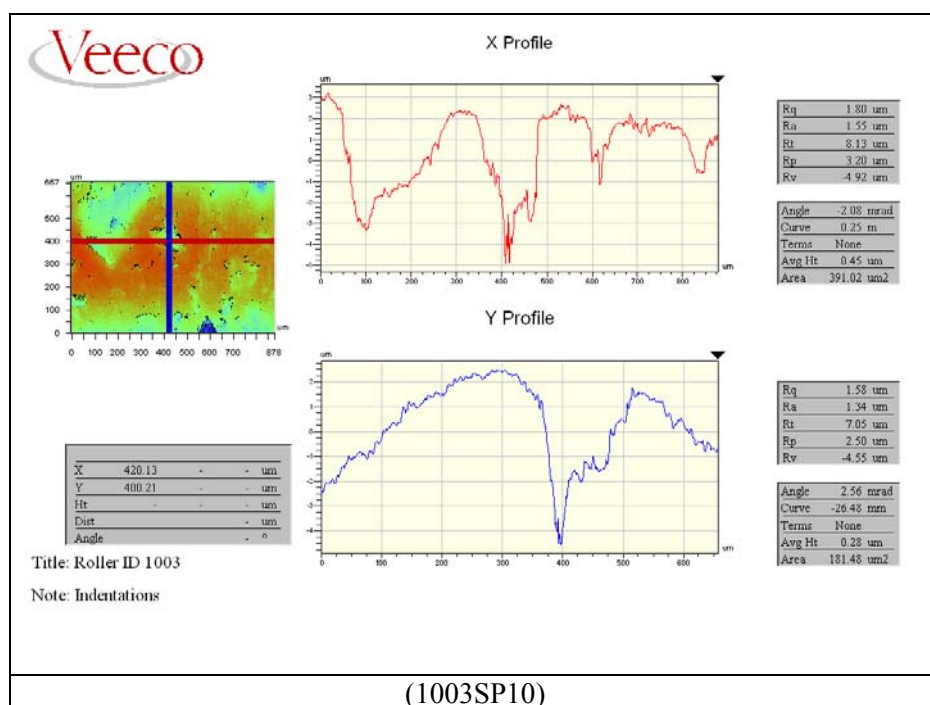
(1003SP10) 2D measurements of the cylindrical roller whose 3D image of the same area in Figure (1003SP09).

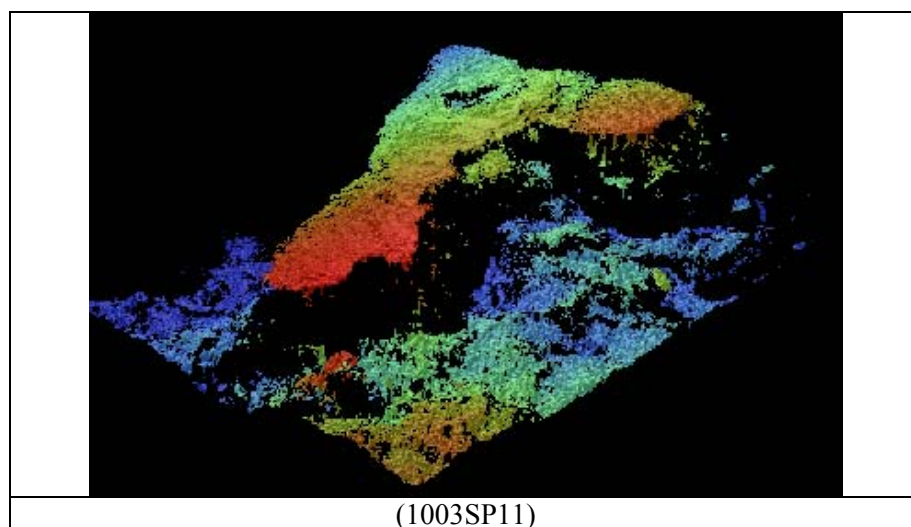
Hard debris particles were observed to be embedded on the bronze separator in bearing 1003 [see Figure (1003OM02)]. VSI images and measurements were also obtained for these features, as shown in Figures (1003SP11 and 12).

(1003SP11) 3D reconstruction of an embedded metallic particle on the surface of a separator. In terms of altitude, red color is highest, yellow is lower, then green and blue.

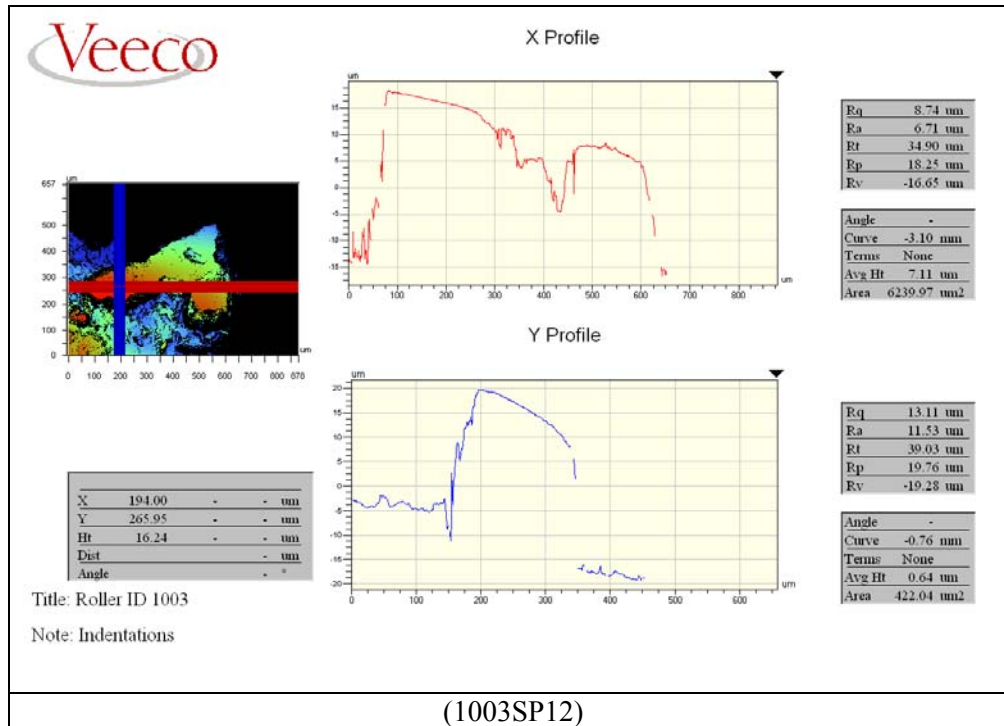
(1003SP12) 2D measurements of the embedded particle that is shown in Figure (1003SP11). The top of the embedded particle rises about 31 μm higher than the surface of the bronze separator. This can be seen from the profiles in both the X (horizontal) (red) and the Y (blue) directions.
