Spray Foam in Accessible Spaces: Best Practices and Case Studies for Retrofit in Mixed-Humid Climates

October 2011

**Prepared by
Jeffrey E. Christian
Kathy S. Gant**

Prepared by
OAK RIDGE NATIONAL LABORATORY
Oak Ridge, Tennessee 37831-6283
managed by
UT-BATTELLE, LLC
for the
U.S. DEPARTMENT OF ENERGY
under contract DE-AC05-00OR22725

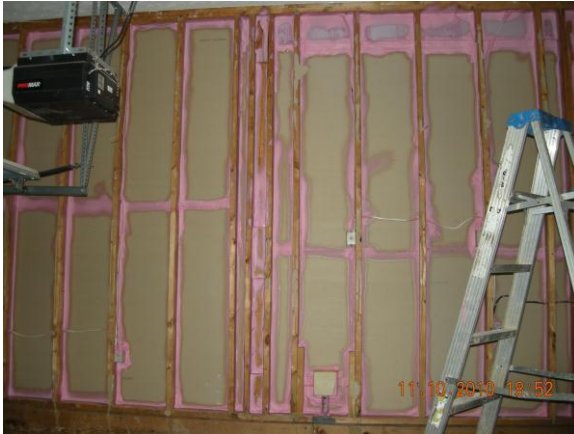
Figures 42 and 43 show the EnergyComplete[™] system applied to the floor of the attic and the wall between the conditioned space and the unconditioned garage. The installation was confirmed by the blower door tests to have been very successful in these two applications. A different crew returned and tried to seal the accessible spaces in the walkout basement with the same product. However, that crew was apparently not trained on the how to properly install the EnergyComplete[™] system. Some valuable lessons learned from this application are summarized below:

Fig. 42. Owens Corning EnergyComplete™ is used to improve the air barrier between the garage and the conditioned space.

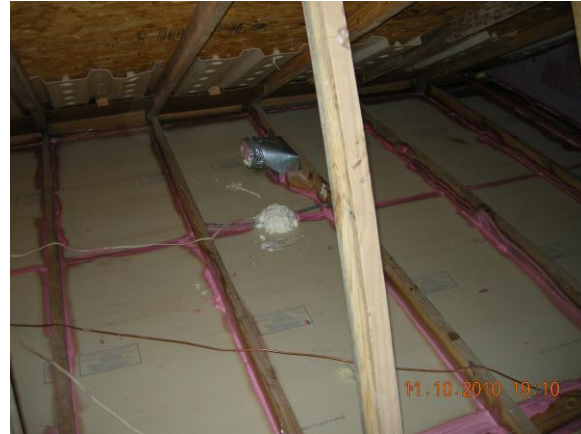
Fig. 43. Sealed and reinsulated attic. (The fiberglass batts were removed and used in the crawl space under the office. The attic was vacuumed, the electric outlets were foamed with GREAT STUFF™, and the remaining cracks sealed with the pink EnergyComplete™ latex foam.) Then new insulation was blown in to create an R-value of 60.

1. Larger cracks need to be identified, and properly sized backer rod (a flexible foam rope of varying diameter that fits snugly into cracks wider than 1/4 in.) or equivalent needs to be installed to provide foam backing.

2. The oval spray pattern needs to always be applied with the longer axis of the oval perpendicular to the crack, even in corners.
3. The homeowner removed all old attic insulation and even vacuumed the attic. The manufacturer states that vacuuming is not necessary, since the air pressure of the foam nozzle will push the loose particles away prior to the foam hitting the substrate.

5. Obviously all non-insulation-contact-rated canned down lights should be replaced, but if not, follow proper insulation damming practices of providing at least 3 inches clearance on all sides and check local codes for how much area needs to be isolated above the non-insulation-contact-rated cans. In some jurisdictions the can must remain open to the attic space. The insulation-contact-rated cans are much better because they have an on-board temperature sensor that shuts off the light when the temperature of the light fixture gets too high, avoiding the ignition of surrounding combustible materials.

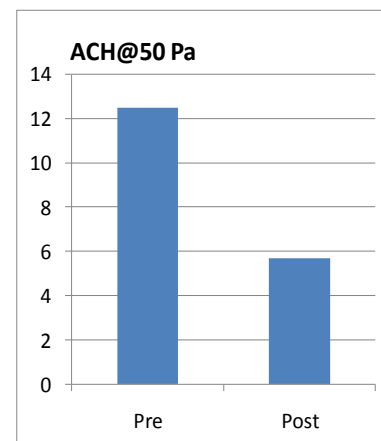
The retrofit is nearing completion. A projection based on blower door measurements suggests the final infiltration rate will fall to around 4 ACH at 50 Pa. The systematic foam air-tightening from attic, to basement, to walls (Fig. 43) has reduced the ACH at 50 Pa from 12 to 5.6, as shown in Fig. 44.

Fig. 44. Application of foam at Summit House reduced the ACH at 50 Pa from 12 to 5.6.

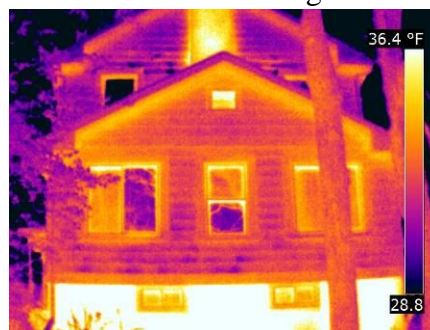
Figure 49 shows the west side of the house. The area around the gable vent in the sun room is particularly bright. Figure 50 shows a close-up of the area, which is warmer than the surrounding air. The sunroom is a converted porch, which once had an attic over it. The ceiling had been converted to a cathedral ceiling, with the insulation sprayed on the inside of the roof, and the gable vent had been covered with ½ in. plywood and foamed.

Fig. 49. Infrared image of west end of Gaiter house.

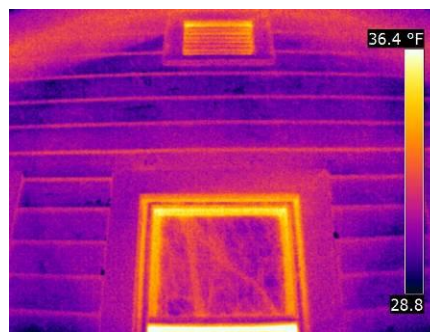
Fig. 50. Gable vent in sunroom area of the west façade.

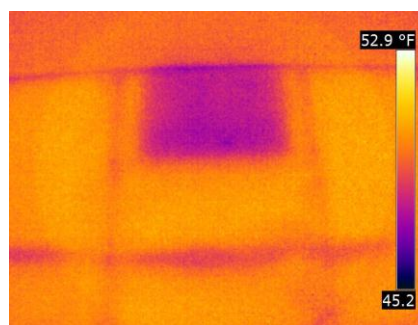
Images taken of the same area from the inside show the vent area as cooler (Fig. 51). In Fig. 52, the house was partially evacuated using the blower door set at 40 Pa. Colder air would be drawn into the house through any openings, and the purplish area is deepening and increasing in size. Notice the bulging dark area in Fig. 52, indicating that the colder air is leaking into the home from the poorly sealed gable vent.

Fig. 51. Gable vent from inside sunroom.

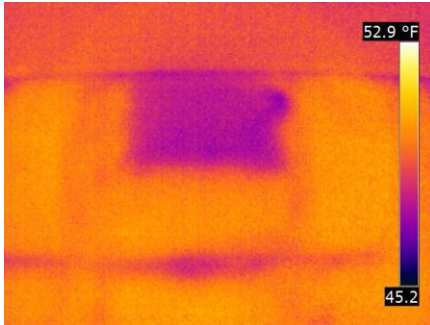
Fig. 52. Cooler air being drawn in through vent area by blower door.

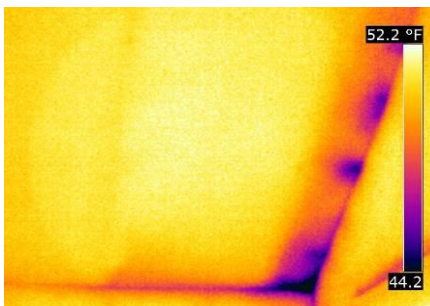
Fig. 54. Ceiling at roof line of sun room without blower door.

Figures 54 and 55 show the ceiling of the sun room at the northwest corner. There are some cooler spots along the junction in Fig. 55, and these areas expand with characteristic wispy finger-like features indicating air intrusions when the blower door is used to lower the air pressure inside the house.

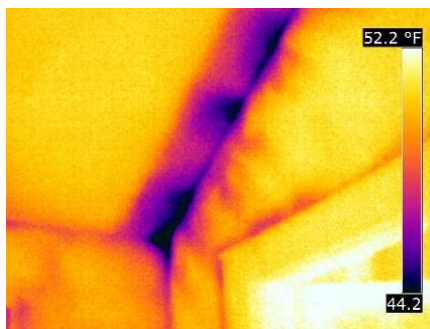
Fig. 55. Ceiling at roof line of sun room with blower door at 40 Pa.

It would be good to have the blower door and IR on site toward the end of the foam application and to agree in advance on a depth-sampling method that will be used to meet the depth specification. The IR camera identified a few spots where the insulation needed to be redone, locations that would not have been found by visual inspection. (Note that the IR camera is not very useful unless there is a large difference between the inside and outside temperatures.) Call-backs are costly because the spray rig needs to be hauled back to the site and the heated hoses dragged back into the house, all for what is generally not much added spraying.

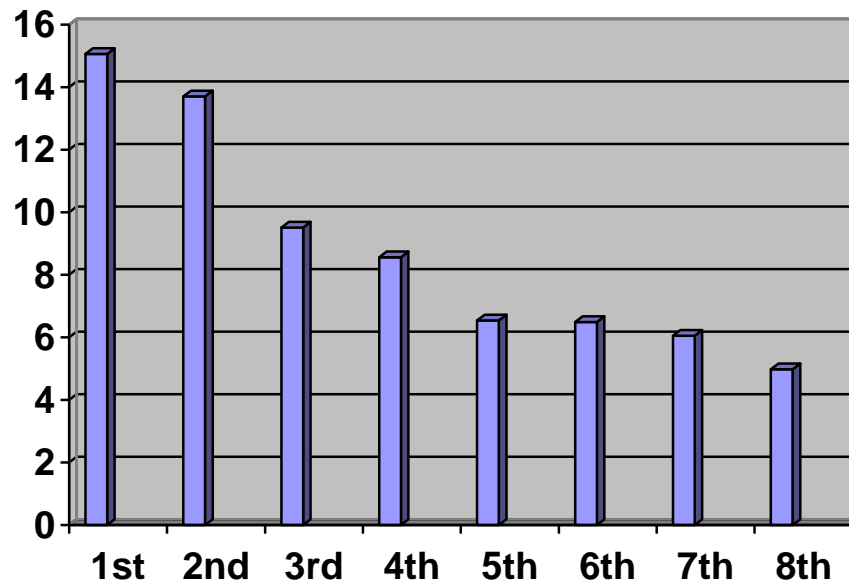
The reduction of the number of air changes per hour with successive retrofit steps is shown in Fig 58.

Fig. 58. Blower-door-directed reduction in number of air changes per hour (successive blower door tests) with additional foam retrofits at Gaiter House. (1) Baseline reading, (2) high-density foam in attic, (3) high-density foam in attic and above-grade walls, (4) high-density foam in attic, walls, and basement, (5) additional foam added to walls as result of blower door test, (6) additional foam in attic and walls after call-back, (7) after sealing 8 in. round open flue in basement, and (8) after drywall was installed.

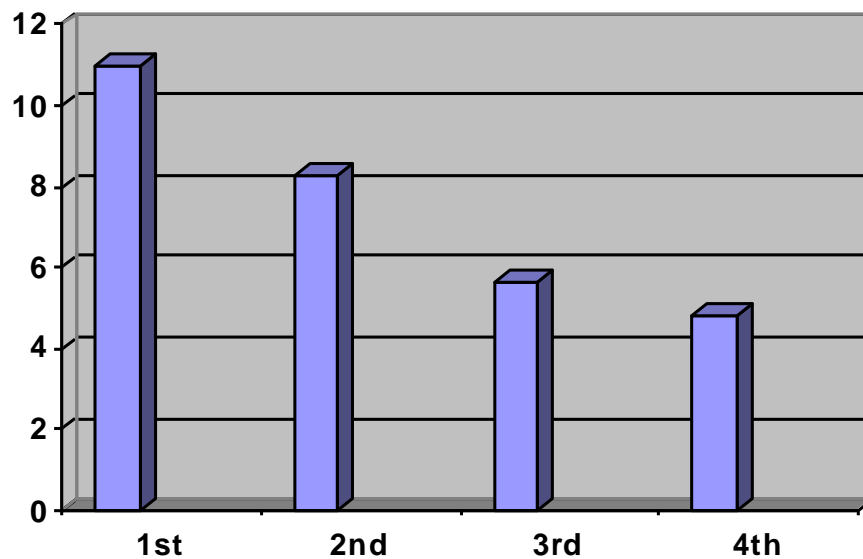
Fig. 62 shows the reduction in ACH with successive blower door tests as retrofit progressed.

Fig. 62. Reduction in ACH with additional sealing at Country House. Based on successive blower door tests: (1) Baseline reading, estimated. (2) New windows; drilled and filled above-grade walls with R-2 insulation; backed siding added. (3) Sealed basement rim joist with froth pack, sealed attic knee wall, replaced eight ceiling canned lights with air-tight recessed cans, framed-in the attic hatch, replaced the bath exhaust back-draft damper, with froth pack sealed all top plates in the attic and sealed all electrical and plumbing penetrations in the attic, sealed large attic bypass through the return duct. (4) Replaced heat pump having through-the-basement-wall unitary equipment with split system, eliminating a large leak. With insight gained from the last blower door test, crew sealed missed rim joist in the basement, fixed the leak around the main electrical power entering the basement, and sealed the crawlspace blocks where the blocks went from 10 in. to 8 in., exposing the hollow cores.

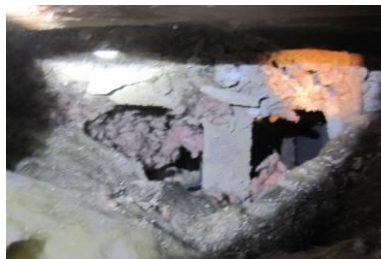
Figure 68 shows the electrical and plumbing penetrations into the house through the crawl space. In addition to providing a path for outdoor air, these openings allow the mold that tends to grow in unconditioned crawl spaces to be drawn into the house. Openings in the attic allow unconditioned air from attic into the interior walls (Fig. 69).

Fig. 69. Opening to interior walls in attic.

After sealing the electrical and plumbing penetrations and the leaks, the auditors suggested sealing and insulating the crawl space to R-15. The attic is another accessible area in which spray foam could be used for sealing and insulation. A target R-value of 50 would be appropriate for the attic floor.
