**POST-DEFORMATION EXAMINATION OF SPECIMENS SUBJECTED TO
SCC TESTING**

Prepared under the direction of the
U.S. Department of Energy
Office of Nuclear Energy
Light Water Reactor Sustainability Program
Materials Aging and Degradation Pathway

Prepared by
OAK RIDGE NATIONAL LABORATORY
Oak Ridge, TN 37831-6285
managed by
UT-BATTELLE, LLC
for the
U.S. DEPARTMENT OF ENERGY
under contract DE-AC05-00OR22725

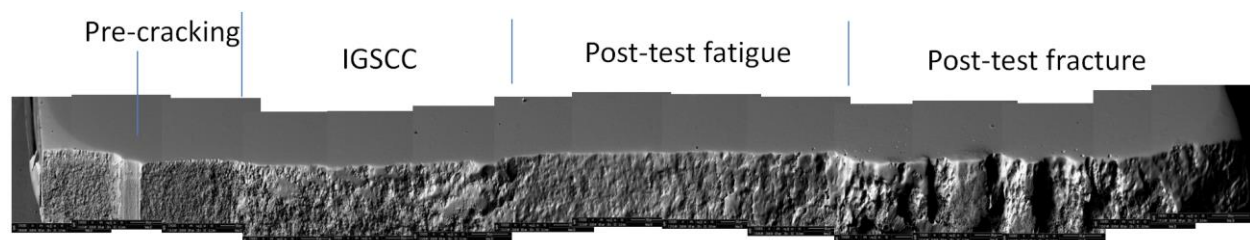
Figure 4. General view (stitched image) of the MS-01 RCT specimen cross section.

Regarding EBSD analysis of the cross-sectional specimens, it is important to underline the following. IASCC characterization was limited to the prepared cross section, so the images are essentially two-dimensional views of a complex, 3-D crack.

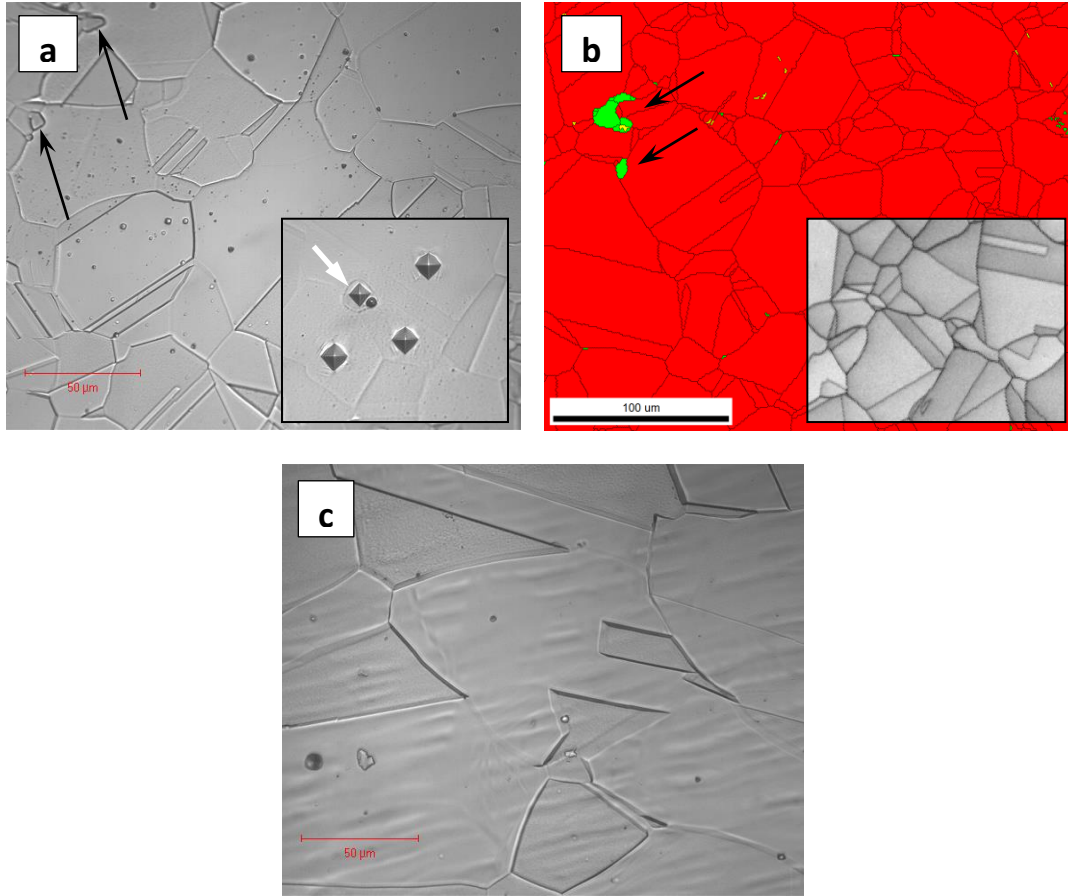
Round or irregularly shaped inclusions were observed in the structure of A-alloy and identified as δ -ferrite using EBSD phase mapping (Figure 5b). In most cases, the inclusions consisted of several δ -ferrite grains. Microhardness of δ -ferrite and the austenitic matrix at 25 g load were estimated at $\sim 560 \text{ kg/mm}^2$ and 409 kg/mm^2 , respectively. Large loads during indentation could not be used because of the small size of the δ -ferrite grains. From metallographic images, the average amount of ferrite was estimated at approximately 0.7–1%; however, ferroprobe readings showed 2.21% ferrite. The difference may be explained by the formation of fine, dispersed ferrite during irradiation. Such dispersions of α -ferrite were previously identified in the neutron-irradiated A-alloy [9]. Radiation-stimulated ferrite formation in austenitic steels is a common phenomenon and has been analyzed in detail elsewhere [9]. No coarse δ -ferrite was observed in the SW-alloy.

Figure 5. Irradiated alloy imaging showing ferrite before CERT evaluations (a) Structure of irradiated A-alloy before CERT evaluations (light microscope, 400×). Black arrows point to retained ferrite grains. The insertion shows microhardness indentations in ferrite (white arrow) and austenite grains. (b) EBSD phase map (austenite is red, ferrite is green), A-alloy. The insertion shows a fragment of EBSD image quality (IQ) map for the same area, demonstrating annealed deformation-free structure. (c) Structure of irradiated SW-alloy prior CERT test, light microscope, 400× (electrolytic etching with 10% oxalic acid at 6 V for 60–80 s for both A- and SW-alloys).

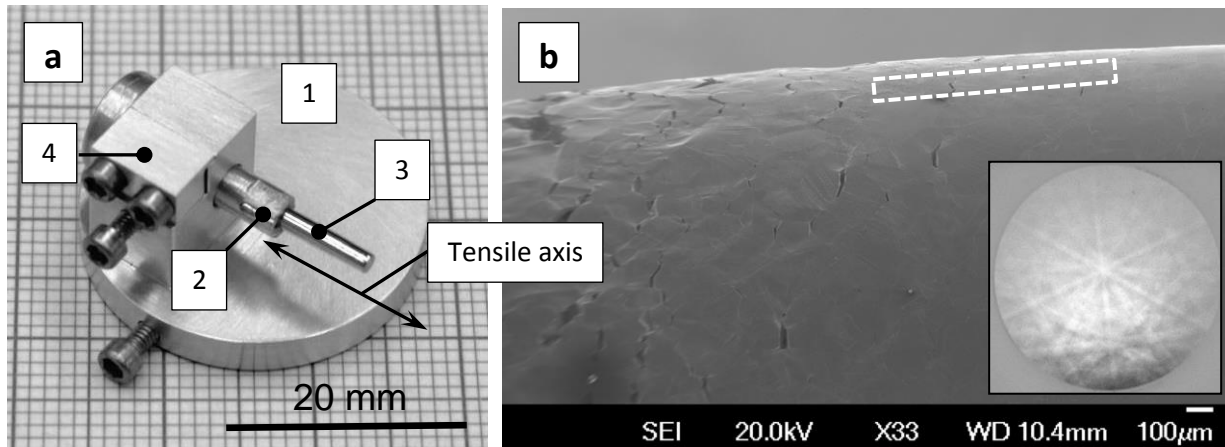
Figure 6. (a) Tensile round bar holder (1) with a tubular fixture (2) and dummy specimen (3). A small additional grip (4) may be used to hold the grids for FIB-TEM specimens. **(b) Surface of the irradiated specimen (SW-alloy) subjected to CERT test in a PW environment and cleaning;** the pronounced crack density gradient is visible (i.e., there is no crack on the right and increased crack density from the middle to the left). The white rectangle shows an area that can be EBSD scanned without specimen rotation operations; typically, these areas contained 0–5 cracks. The insert shows a typical EBSD pattern; sample curvature limited the ability to maintain a uniform background in EBSD patterns.

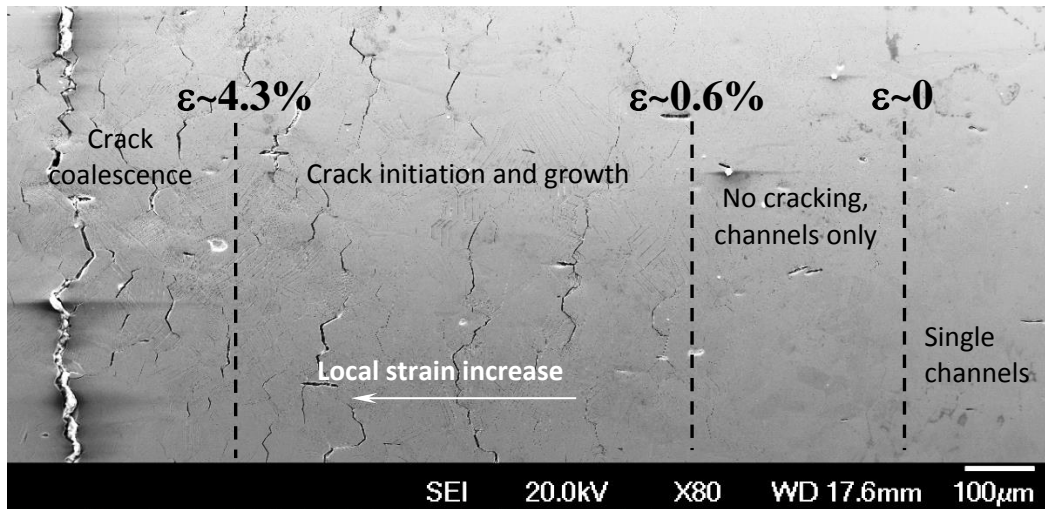
Figure 9. Surface of the deformed tensile bar with the strain levels shown (A-alloy).

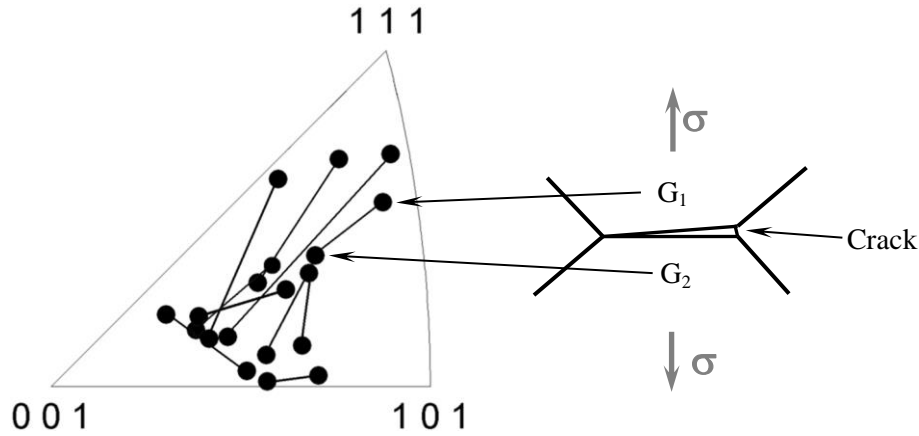
Examples of cracked GB pairs are given in Figure 14. Taking this database into account, it appears that crack initiation is not a random process. Grain orientation strongly influenced the appearance of stress corrosion cracks. In small strain areas ($\sim 1.3\%$), one or both grains adjacent to the cracked GB were oriented close to the center of the unit triangle. Such orientation corresponds to the grains with a high Schmid factor (~ 0.47 or more), which are easy to deform. In about 50% of cases, the second grain was oriented close to the [111] corner, indicating a low Schmid factor. Grains oriented close to [001]- and [101]-corners were the least involved in crack initiation at low strain levels.

Figure 14. Crystallographic orientation of cracked GB pairs relative to the tensile axis in an A-alloy specimen. The estimated strain level at the analyzed area was ~1.3%. Only short cracks (1–2 GBs) are shown.

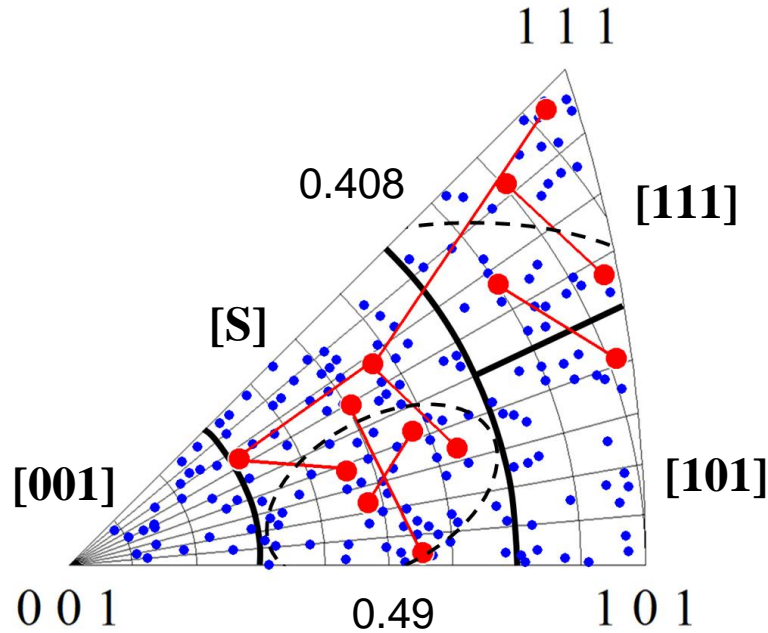
Few cracks analyzed in detail (Figure 13, Figure 15) demonstrated grain orientation patterns in the vicinity of small and long cracks. To analyze the role of grain orientation, the unit triangle was arbitrarily divided into four areas and designated as [001], [S], [111], and [101] (Figure 16). The [001]-area contained grains oriented close to the [001]-corner and with the lowest elastic stiffness [31]. Grains oriented close to the [111]-corner had the largest elastic stiffness and the lowest Schmid factor. Grains from the [S]-area were mainly the softest grains with a high Schmid factor.

Figure 16. A scheme of the unit triangle partitioning. Blue dots show average grain orientation data for one of the scans performed for the SW-alloy (~160 grains in this particular scan). Red-filled circles reproduce the orientation of grains adjacent to the cracks. Five randomly selected cracks are shown, one of which included four GB pairs. Dashed lines show the areas with high (0.49) and moderate (0.408) Schmid factor values. Grains with the exact [001]- and [101]-orientations had a Schmid factor of 0.408, and a number of grains with the close Schmid factor value belonged to [111]-area.

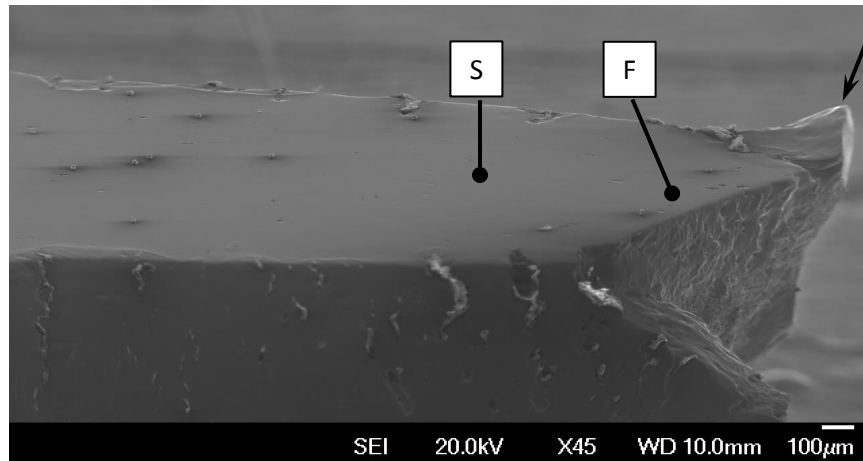
Figure 17. General view of the AS-19 specimen cross section after electropolishing. The specimen end (black arrow) was damaged by the electropolishing grips. A few dust particles are present on the surface; unfortunately, cleaning with dusters was not allowed the microscopy room, which is located outside of the standard radiological facilities. The locations designated by F and S are analyzed in detail below.

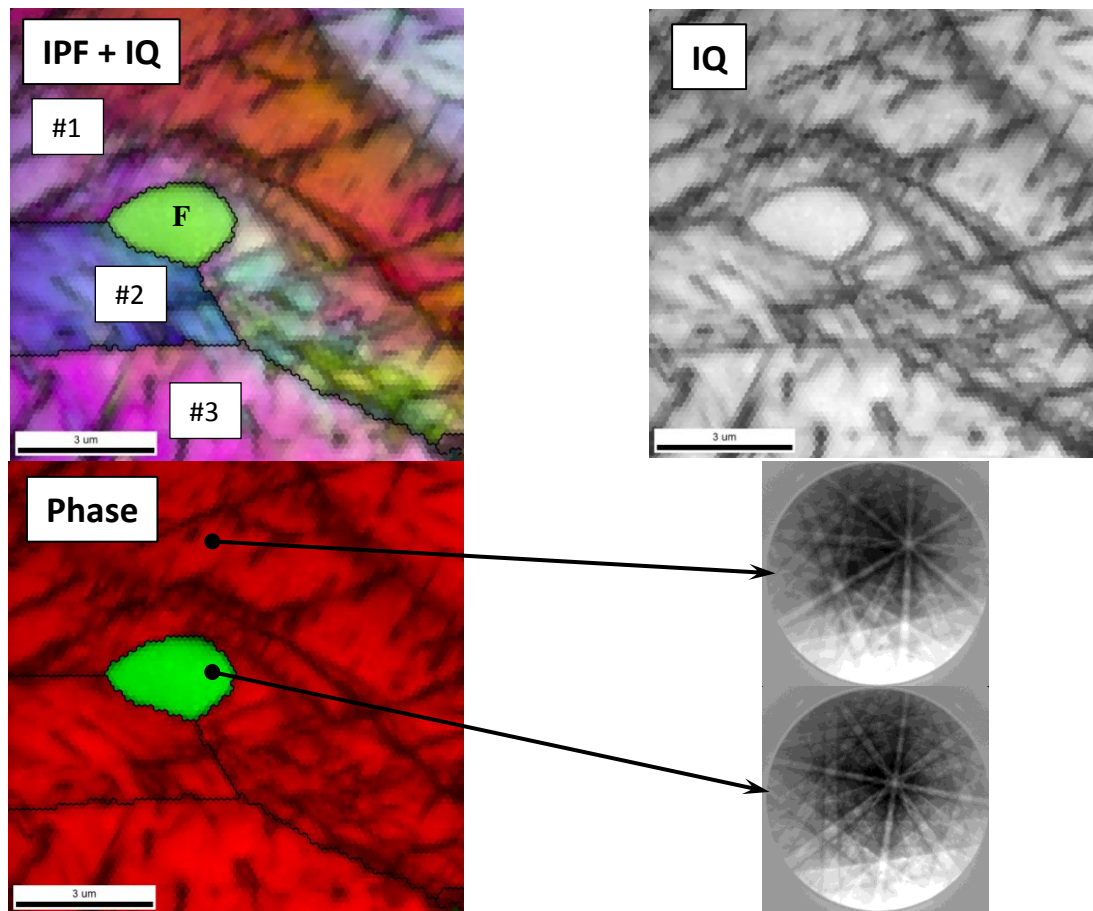
In Figure 18, three austenitic grains (#1–#3) and one small ferrite grain (F) can be seen. The austenite grains have strong internal misorientation, which is especially pronounced in grain #1. The local orientation may differ up to $\sim 20^\circ$ from the average grain misorientation. See the GROD map in Figure 19. The grain is highly fragmented and may be considered subgrains divided by dislocation boundaries, but these boundaries are, as a rule, broken and do not form an enclosed area. The kernel average misorientation (KAM) map also shows numerous points with high local misorientation relative to the matrix (the orange and red “spots” in Figure 19). Comparing IQ (Figure 18) and KAM (Figure 19) maps, it is easy to see that high local misorientation spots mainly formed at channel intersections. Dislocation channels also correspond to the sharp variations of the GROD value (compare maps in Figure 18 and Figure 19), suggesting a high local density of dislocations.

Figure 18. EBSD IPF, IQ, and Phase maps taken with 125 nm step in the deformed area. The face-centered cubic (FCC) phase is pictured in red, and the body-centered cubic (BCC) phase appears in blue. Two patterns for FCC and BCC are also shown (right bottom).

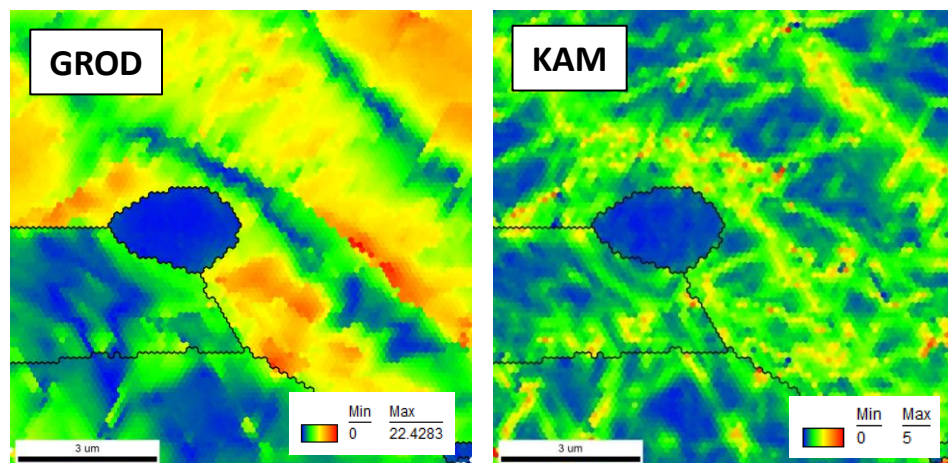
Figure 19. Grain Reference Orientation Deviation (GROD) and Kernel Average Misorientation (KAM) maps for the area depicted in Figure 18. The inserted color scales are different for each map.

no way to answer this question. Interestingly, this small ferrite grain is almost free from visible signs of plastic strain, and its GROD value (Figure 19) is much lower compared with the austenitic grains. The KAM parameter shows some weak increase. This suggests that ferrite was less involved in plastic deformation, probably due to its high strength level compared with austenite.

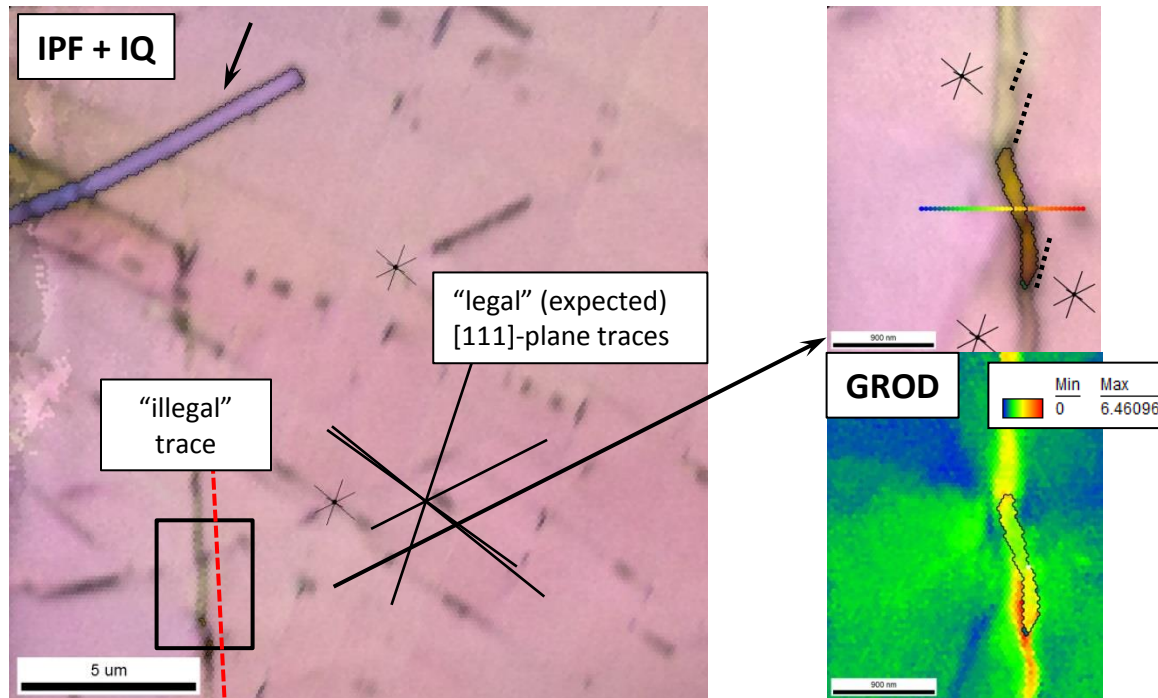
Figure 20 depicts unusual details found in one of the EBSD scans. One of the slip line channels propagated in a different direction from the $[111]$ -plane projection. This detail immediately attracted attention, and a high-resolution scan was performed at the same location. It appeared that the feature had a strain-induced nature (pronounced local misorientation gradients were observed) but was lying outside of the known $[111]$ -slip planes.

Figure 20. An unexpected channel-like structure not following the $[111]$ -plane. This feature is depicted by the dashed line in the left image. The formation the black arrow points to is believed to be an annealing twin. The black, dashed lines in the top right image show the speculated zig-zag pattern of the slip band propagation.

Due to the limited EBSD resolution, further TEM analysis may provide the exact answer. However, in the first iteration, it may be speculated that the unusual (“illegal”) slip direction is caused by a zig-zag pattern of dislocation movement. It appears that at least some segments of this specific formation followed one of the $[111]$ -planes (Figure 20, top right).

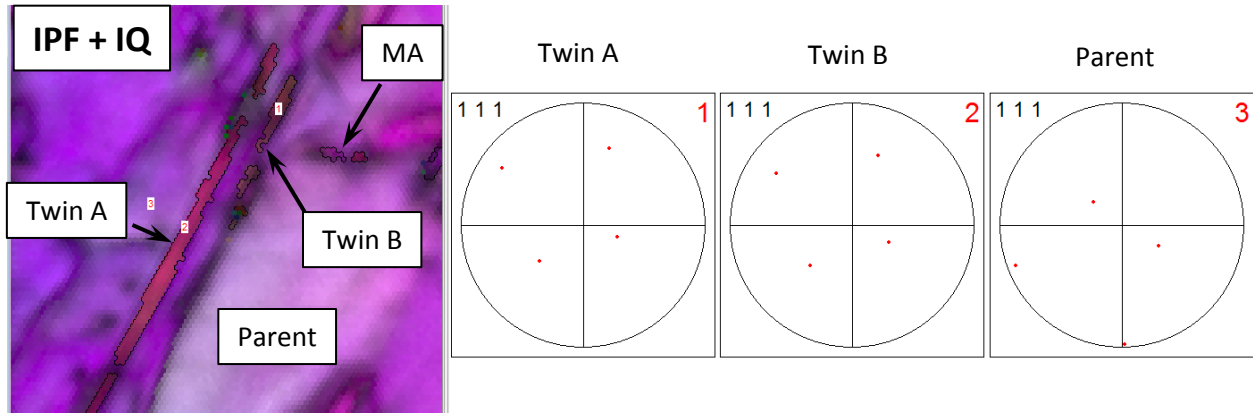
Some EBSD scans revealed wide and pronounced deformation bands with well-defined boundaries. A typical example is shown in Figure 21. The analysis of the band (channel) its orientation, and corresponding pole figures demonstrated that the observed feature is a deformation twin with specific 60° misorientation relative to the matrix. A few smaller twins were observed in the same area (for instance, twin B in Figure 21). Most likely, other channels contained twins that remained unresolved by EBSD.

Figure 21. Deformation twins in the AS-19 specimen. IPF-Map is colored in the tensile direction. Pole figures at the right show orientation of large (A) and small (B) twins relative to the parent matrix. MA is the area with some misorientation relative to the matrix.

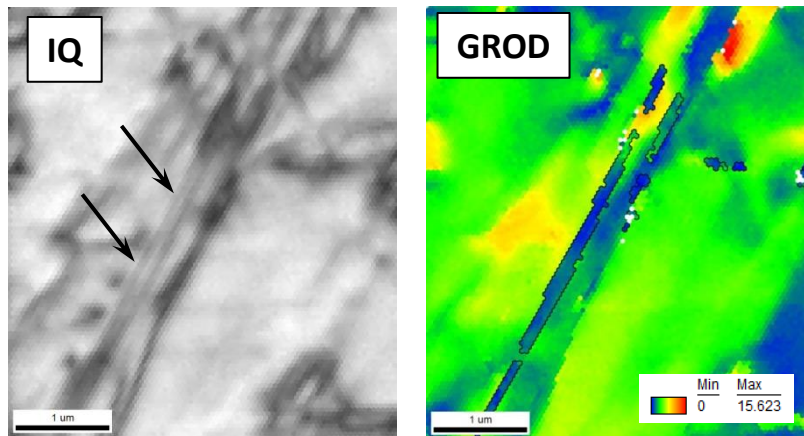
The twin boundary is also clearly visible in the IQ map (Figure 22). Instead of displaying expected deformations the twin boundaries display a weaker contrast in the IQ map compared to ordinary slip lines and channels.

Figure 22. IQ and GROD maps for the area depicted in Figure 21. Black arrows point to the contrast in the IQ map at the twin boundary.

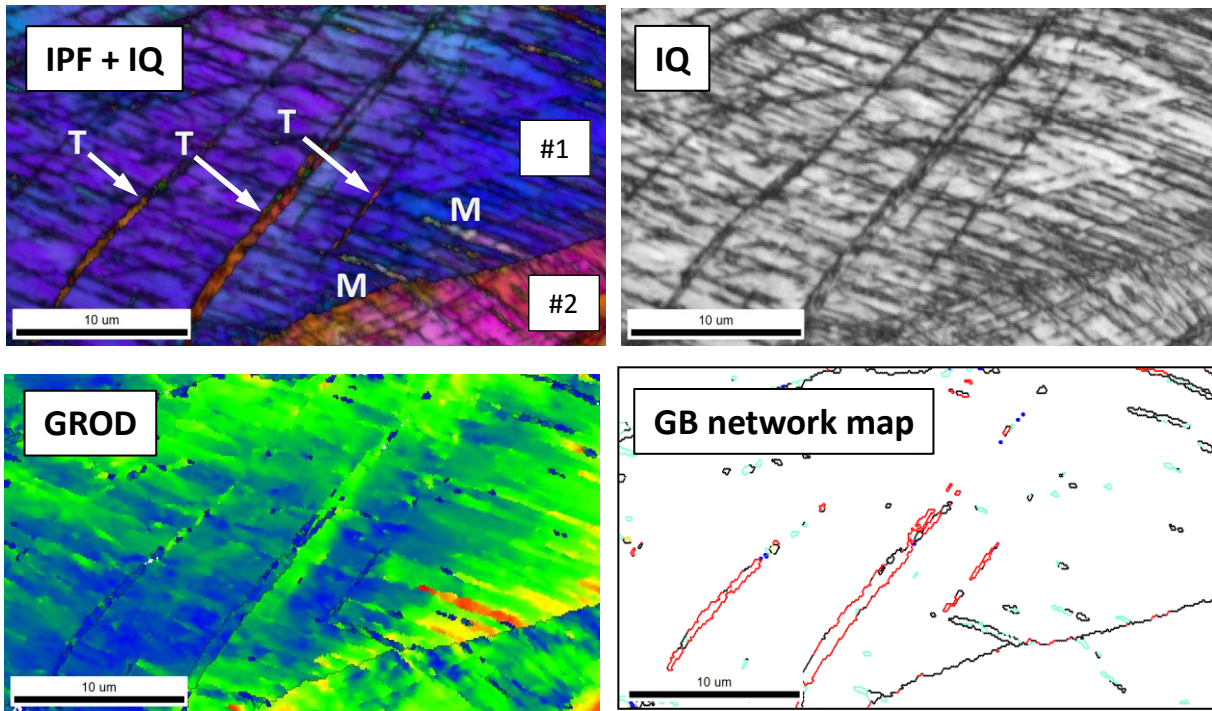
Figure 23. The structure (EBSD IPF, IQ, GROD, and grain boundary network maps) for the F-area (see Figure 17) located close to the fracture point. Deformation twins are shown by white arrows in the IPF map. M represents an area with high local misorientation (not twins). #1, #2 designate austenitic grains. In the GB map, black color represents random high-angle GBs. Twin boundaries are red, and random low-angle GB are teal.

Figure 23 shows the structure of material close to the fracture point (F in Figure 17). The IQ map demonstrates numerous dislocation channels, and the IPF map shows a number of deformation twins. In this area, twins were relatively wide, up to $\sim 0.5\text{--}0.7\text{ }\mu\text{m}$, most likely caused by high local strain levels. The width of the twins is higher compared with the width of defect-free channels observed in the structure by numerous authors (usually, $20\text{--}50\text{ nm}$). Also, twins were observed in grain #1 (Figure 23) but not in grain #2, suggesting that a strong orientation effect on twin formation still existed at the high temperature/slow strain rate conditions studied.

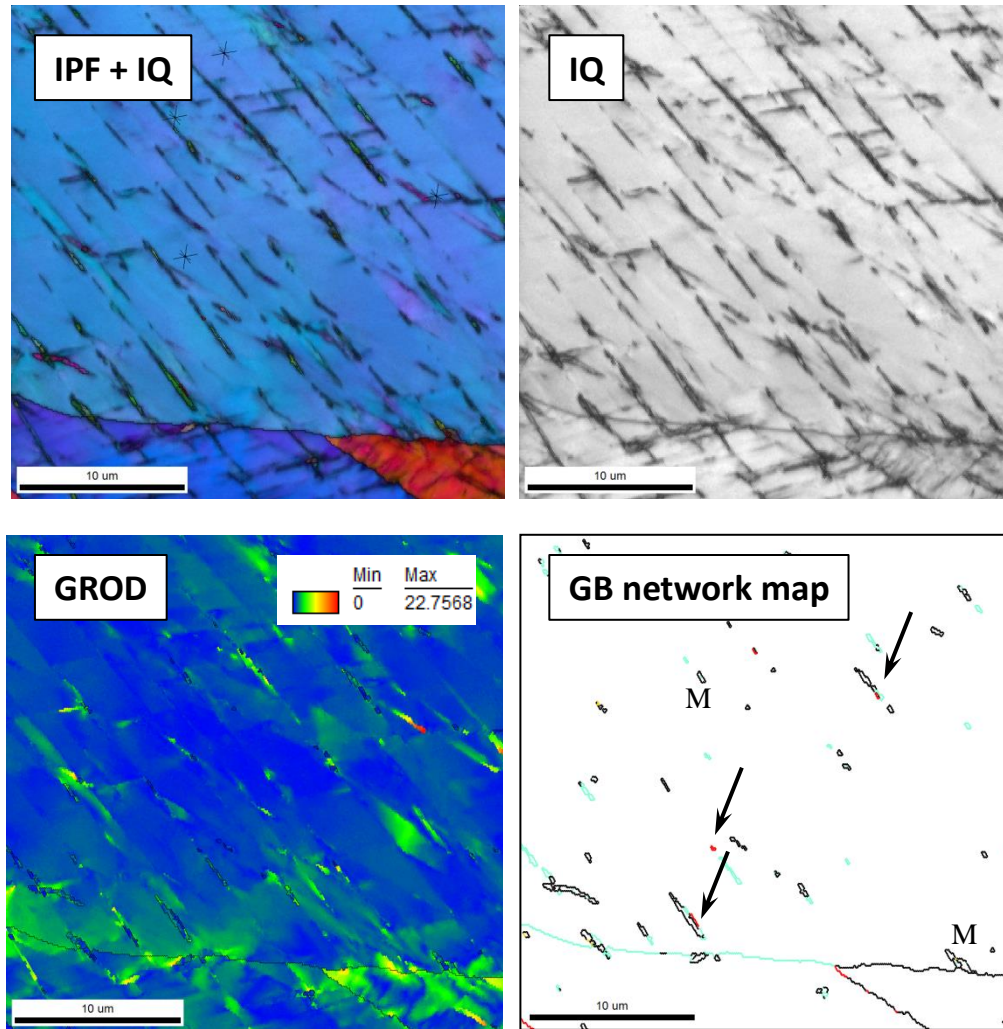
Figure 24 shows the structure of the AS-19 specimen far from the fracture point (S-location in Figure 17). The IQ map demonstrates numerous dislocation channels, and the IPF map shows a wide variation of color (orientation) within one grain. In some cases, the local in-grain misorientation may reach $\sim 22^\circ$, suggesting a high local density of dislocations. However, compared to the location F (Figure 23), the observed twins are very small, on the edge of the EBSD detection limit. The length of the twins is about $1\text{ }\mu\text{m}$ or less and the width is $\sim 200\text{--}250\text{ nm}$.

Figure 24. The structure (EBSD IPF, IQ, GROD, and grain boundary network maps) for the S-area (see Figure 17) located far from the fracture point. Deformation twins are indicated by black arrows in the IPF map. M represents an area with high local misorientation (not twins). In the GB map, black color represents random high-angle GBs, red represents twin boundaries, and teal represents random low-angle grain boundaries.

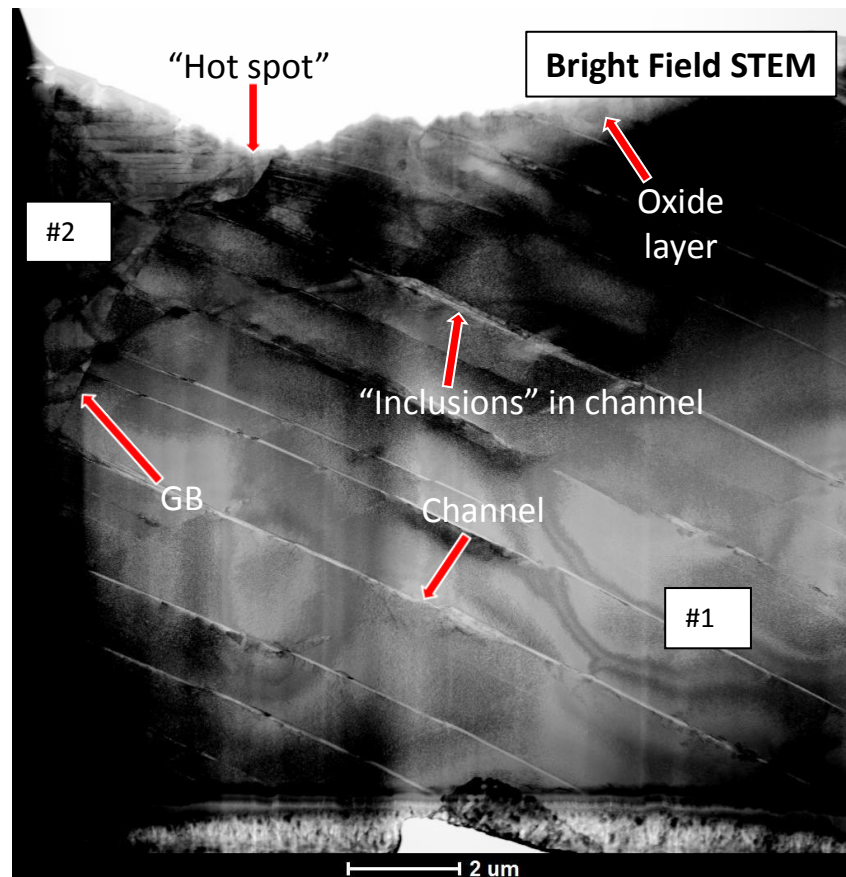
Figure 25 shows an example of the near-surface structure in the SW-36 specimen. The surface was covered with a relatively thick oxide layer (0.5–1 μm compared with 50–200 nm for the PW-tested specimen), and the layer masked many surface features, hiding the channels and possible small cracks. The sample demonstrated numerous defect-free channels in one of the grains (#1). The second grain (#2) also showed channels, but they are not visible in Figure 25 because of the grain's orientation. Some channels demonstrate specific inclusion-like elongated elements, which are likely areas fenced by dislocation boundaries from the parent grain. Further analysis using diffraction-based techniques is needed to verify the structure of these inclusions.

Figure 25. Bright field STEM image for the SW-36 specimen subjected to CERT evaluations under NWC conditions.

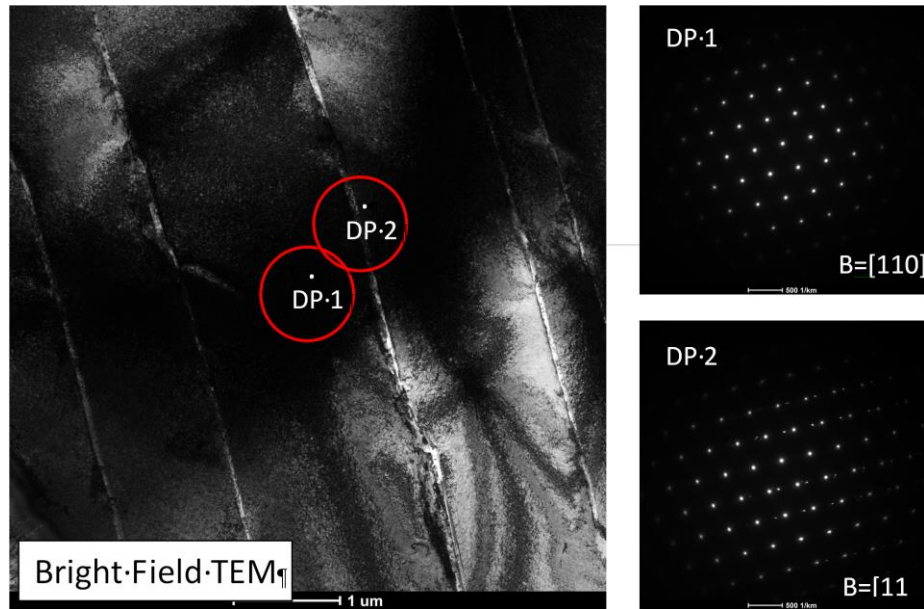
Figure 26. Bright field TEM for the area depicted in Figure 25, Grain #1. Twinning spots were observed when tilted to the $[110]$ zone axis in selected area diffraction patterns (DP2). Twinning spots were not observed in DP1 (out of the channel).

Figure 26 shows the TEM bright field image of the first grain (#1) depicted in Figure 25. A selected area diffraction (SAD) pattern obtained from the area without a channel (DP1) demonstrated a $[011]$ orientated austenite diffraction pattern. However, the diffraction pattern for the area with a channel (DP2 in Figure 26) reveals both matrix and twin reflections (small satellite reflections in DP2). This suggests that a deformation twin is present in the analyzed channel. Other channels in Figure 25 also demonstrated similar contrast and SAD pattern behavior, suggesting the twinning observed was not a singularity in the observed grain.

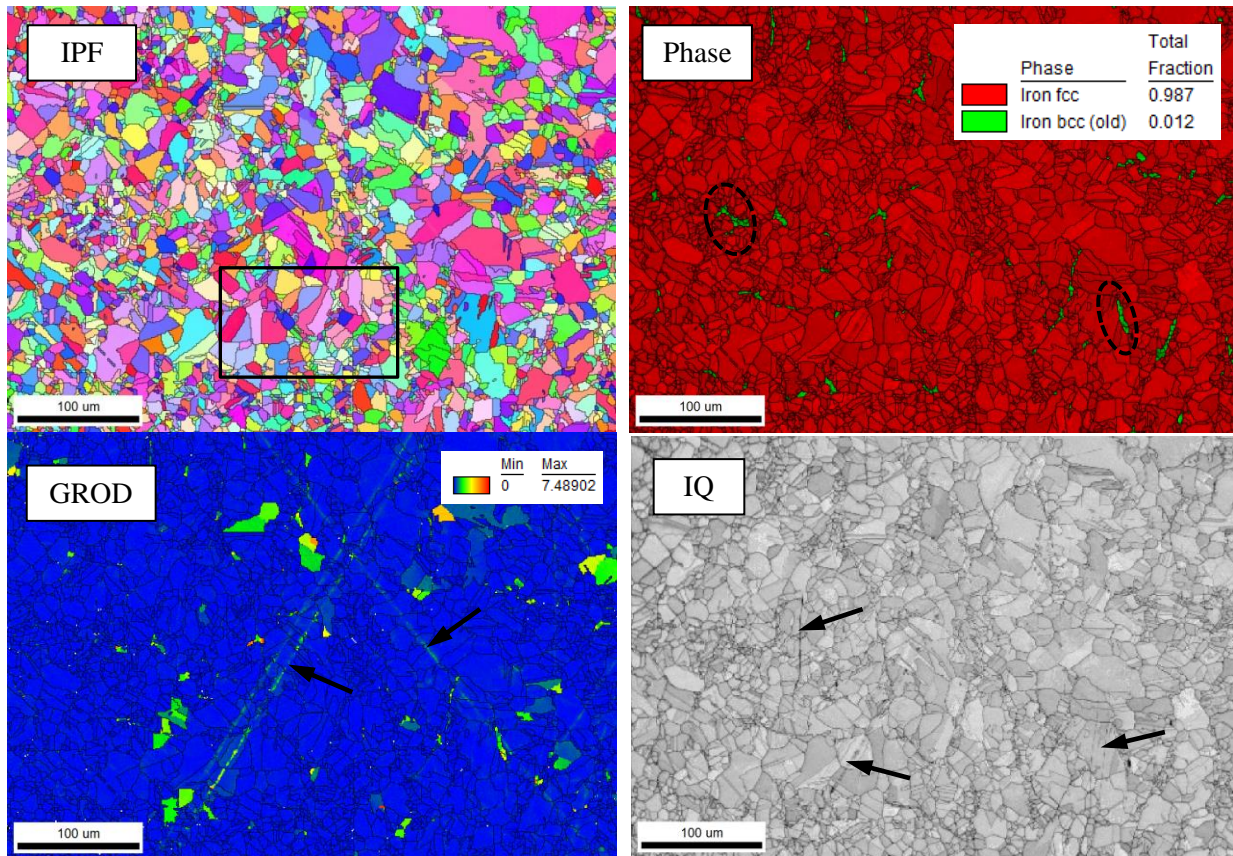
Figure 35. The grain structure of the M-alloy (MS-01 specimen). EBSD IPF, Phase (fcc: red; bcc: green), GROD, and IQ maps. Black rectangle in the IPF map shows the location of the high-resolution scan, Figure 38. Dashed black ovals in the Phase map show ferrite grain clusters. Black arrows point on the scratch traces visible in the GROD and IQ maps.

As seen in the results shown in Figure 35 and Figure 36, the irradiated M-alloy (304SS+Ti) had relatively small average grain size, about 10 μm , and a pronounced bimodal grain size distribution. Small grains formed specific clusters and bands, and large grains often grouped together. Two phases were identified:

(1) austenite, face-centered-cubic, and (2) delta-ferrite, body-centered-cubic. The amount of delta-ferrite visible for EBSD was estimated to be ~1–1.5% (Figure 35).

The structure was found to be cold-work free. No specific signs of pre- or post-irradiation cold work was observed. For most grains, the GROD, a common EBSD strain metric, showing local in-grain misorientation, were below $0.1\text{--}0.2^\circ$. Although some grains had a green or even orange color in the GROD map (Figure 35), it was caused by in-grain low-angle ($< 5^\circ$) boundaries (LAB) leading to the wrong GROD values. Figure 37 demonstrates the KAM map, with a different color scale compared to Figure 35, to illustrate specific features. In this map, the LABs are visible as local, line-like features limited by random high-angle grain boundaries. Interestingly, ferrite grains formed groups and colonies of some kind; these grains often had larger KAM values compared to the surrounding austenite grains.

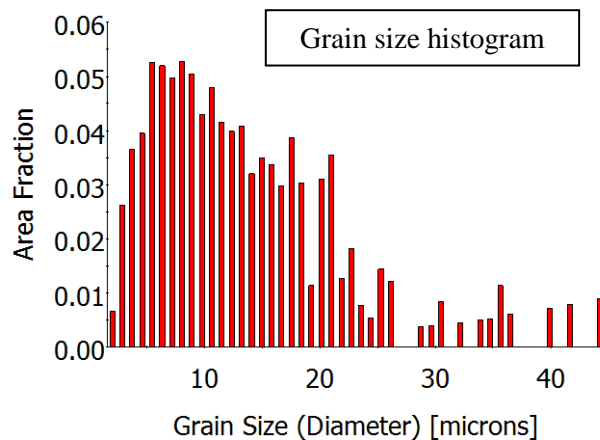
Figure 36. Grain size histogram for the scanned area shown in Figure 35.

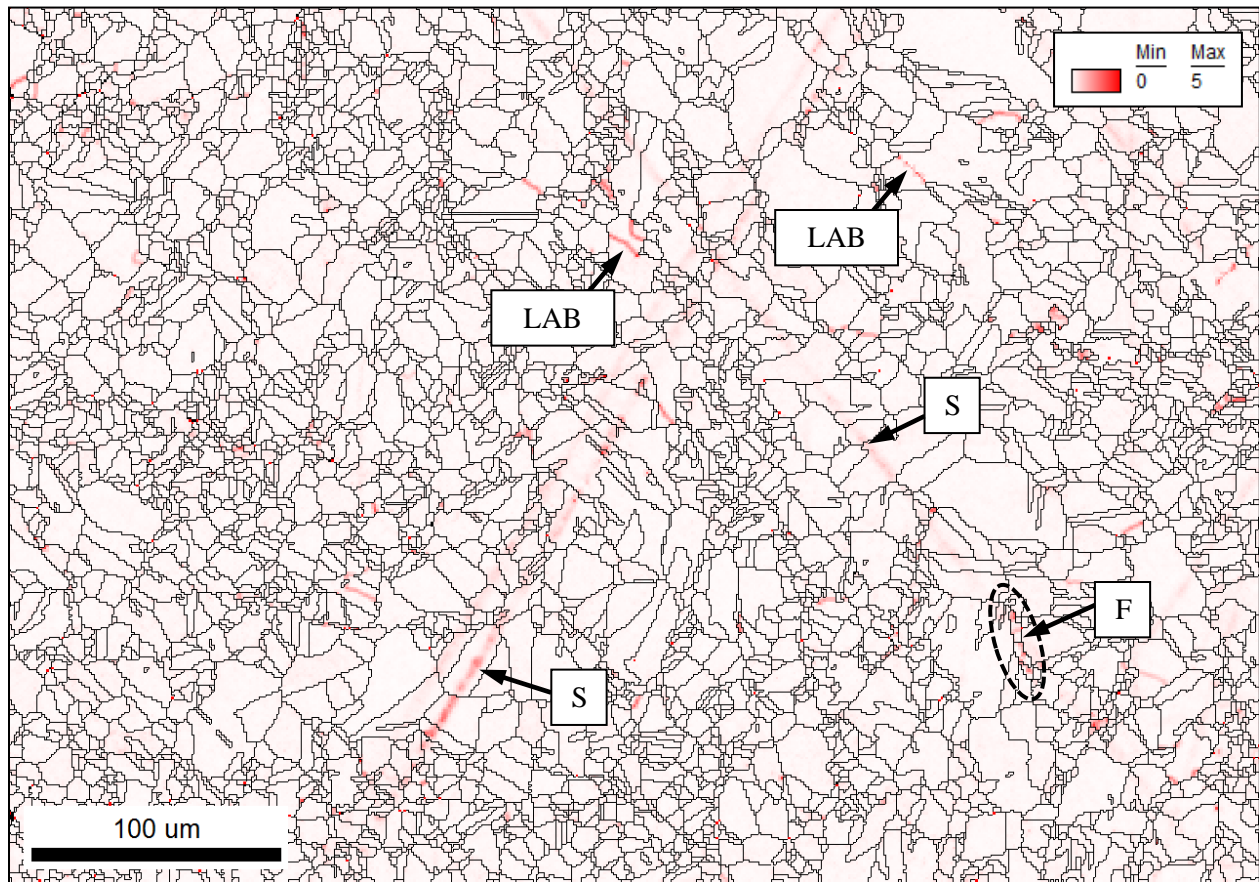
Occasional scratches, caused by abrasive particles or carbide inclusions that fell off during grinding, were clearly visible in the KAM and IQ maps, and are thus easy to avoid during further high-resolution scanning. Scratches usually intersected several grains and were easy to distinguish from features induced by plastic strain (slip lines, channels). The sample surface appeared to be scratch-free and no damage was visible with SEM, but EBSD was able to reveal scratch-related damage as a weak plastic strain in the under-surface layer. Electropolishing removed most of the damage related to the mechanical grinding, but the trace of rough scratches might have still survived. Longer electropolishing would eliminate these as well, but may lead to very smooth edges and information loss.

Figure 37. Kernel Average Misorientation (KAM) map for the area shown in Figure 35. LAB: low-angle in-grain boundaries. S: scratches. F: ferrite grain colony (compare with the Phase map in Figure 35).

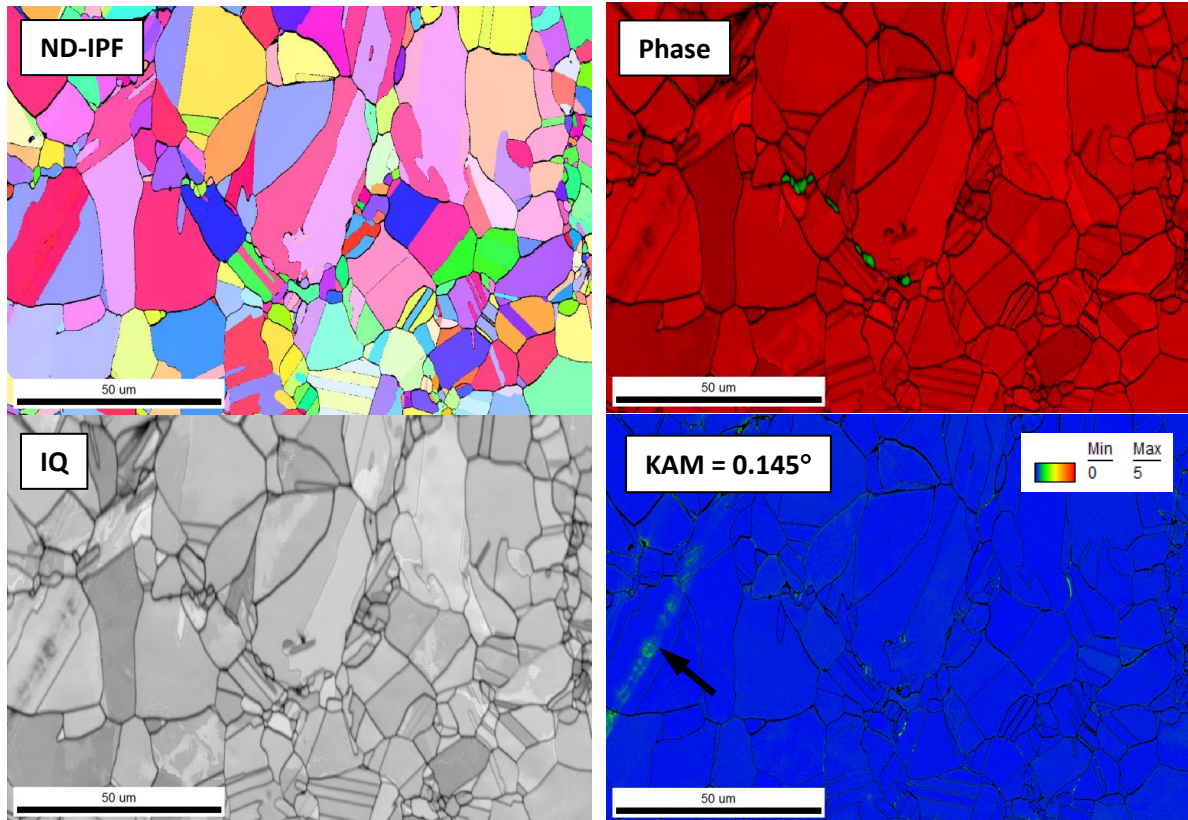
Several additional high-resolution scans (step size of 125 nm) were performed at different locations far from the surface to confirm structure homogeneity and examine different features of interest like ferrite colonies. An example of a high-resolution scan is given in Figure 38. The high-resolution scan shows the presence of very small grain (few μm) which might be missed during coarse-step scanning. Additionally, it points out the existence of very small ferrite grains in the structure.

Figure 38. High-resolution (step size 125 nm) scan of the parent material structure (far from fracture). This scan shows the subarea of a large coarse scan, Figure 35. The KAM map shows a cold-work free structure. Black arrow points to the scratch.

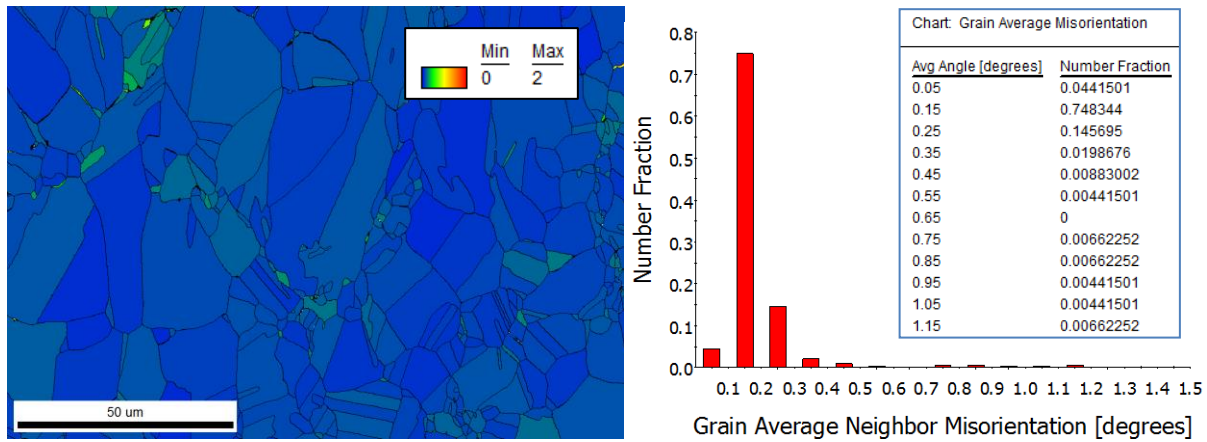
Figure 39. Grain Average Misorientation (GAM) map for the area shown in Figure 38 and GAM distribution histogram. As shown in the data, ~80% of all grains have a GAM < 0.2° and ~97% have a GAM < 0.25°. Few grains with larger GAM are present, but these are most likely artifacts (LAB inside the austenitic or ferritic grain). Typical Gam value of the non-deformed material is 0.15–0.2°. Step size is 125 nm.

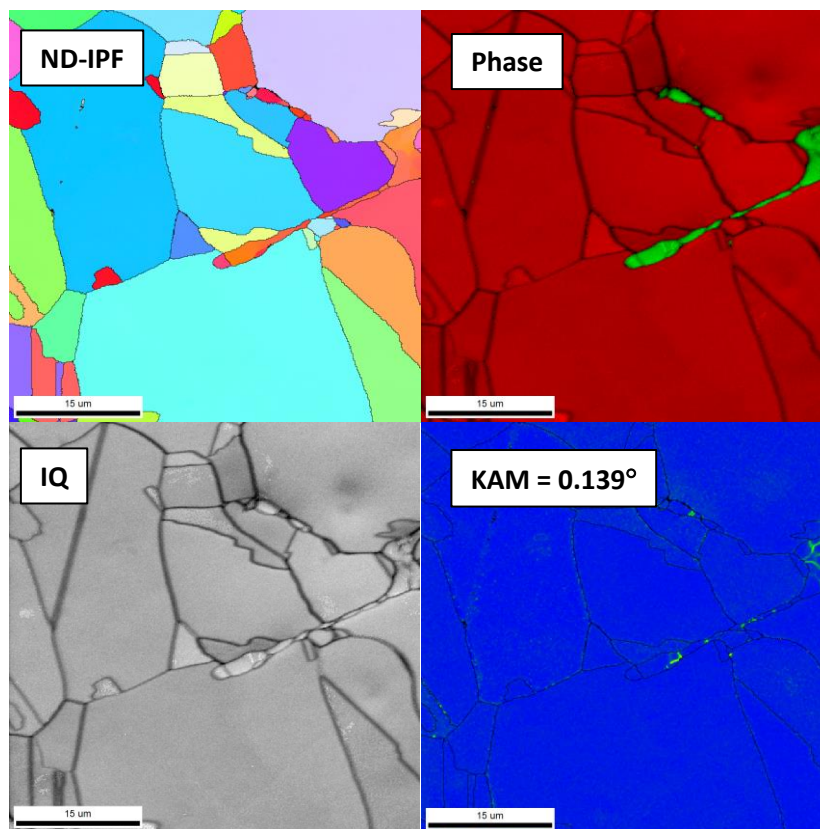
Figure 43. EBSD data for a typical non-deformed area. Scanning with 125-nm step was performed at the depth ~2 mm from the edge. In the phase map, austenite is red and ferrite is green.

Figure 43 shows a typical EBSD data set for the non-deformed area. The IPF-map demonstrates the absence of in-grain misorientation, and the IQ map is free of visible slip lines (dislocation channels). The KAM map shows weak local maximums inside the ferritic grains (also see Phase map); these local

maximums most likely correspond to low-angle ($< 5^\circ$) in-grain boundaries. The average KAM value for the non-deformed material was $\sim 0.14^\circ$ (for the step size of 125 nm).

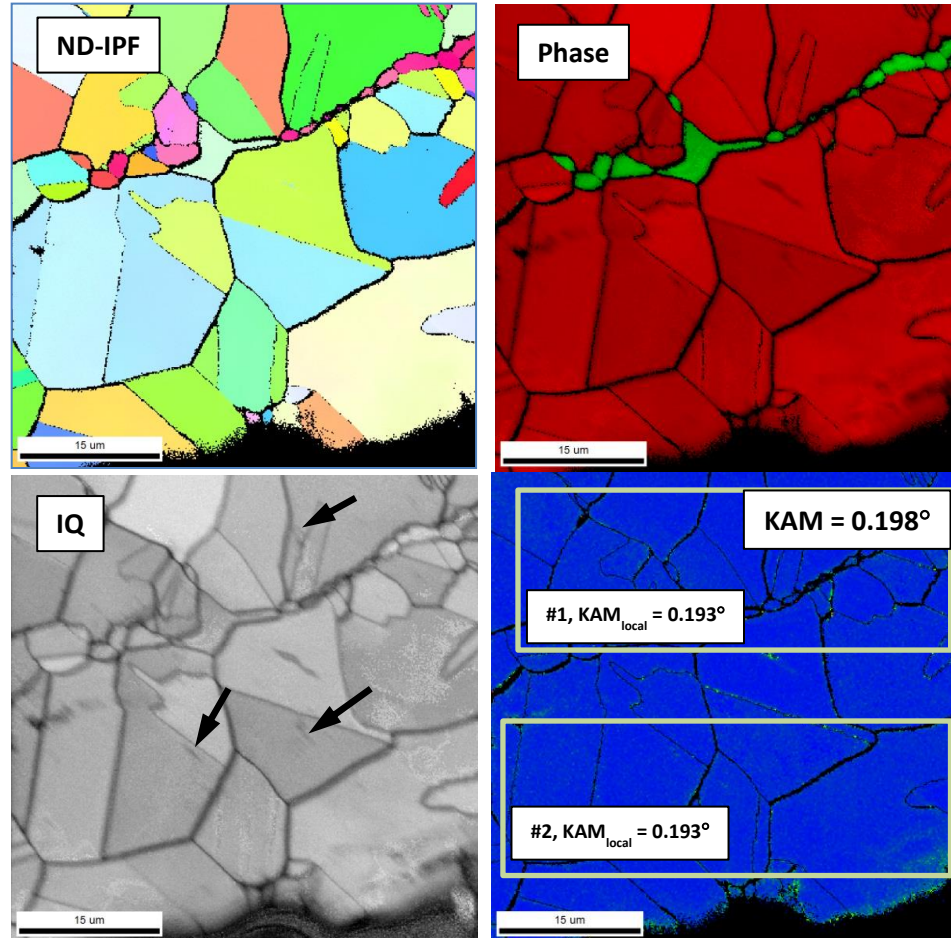
Figure 44. EBSD data for a fatigue pre-cracking area. Step size of 125 nm. The scan was taken, approximately, of the middle of this area. The specimen edge is clearly visible. The black arrow in the IQ map points to the area with a local IQ decrease due to dislocation channel formation.

Figure 44 shows the EBSD dataset for the fatigue pre-cracking area. Although strong misorientation gradients are absent in the IPF map, the IQ map reveals weak signs of slip lines, and the KAM value for this area is large compared to the bulk (0.198° and $\sim 0.14^\circ$, respectively). The difference in KAM values points out the existence of plastic strain in the material caused by fatigue deformation.

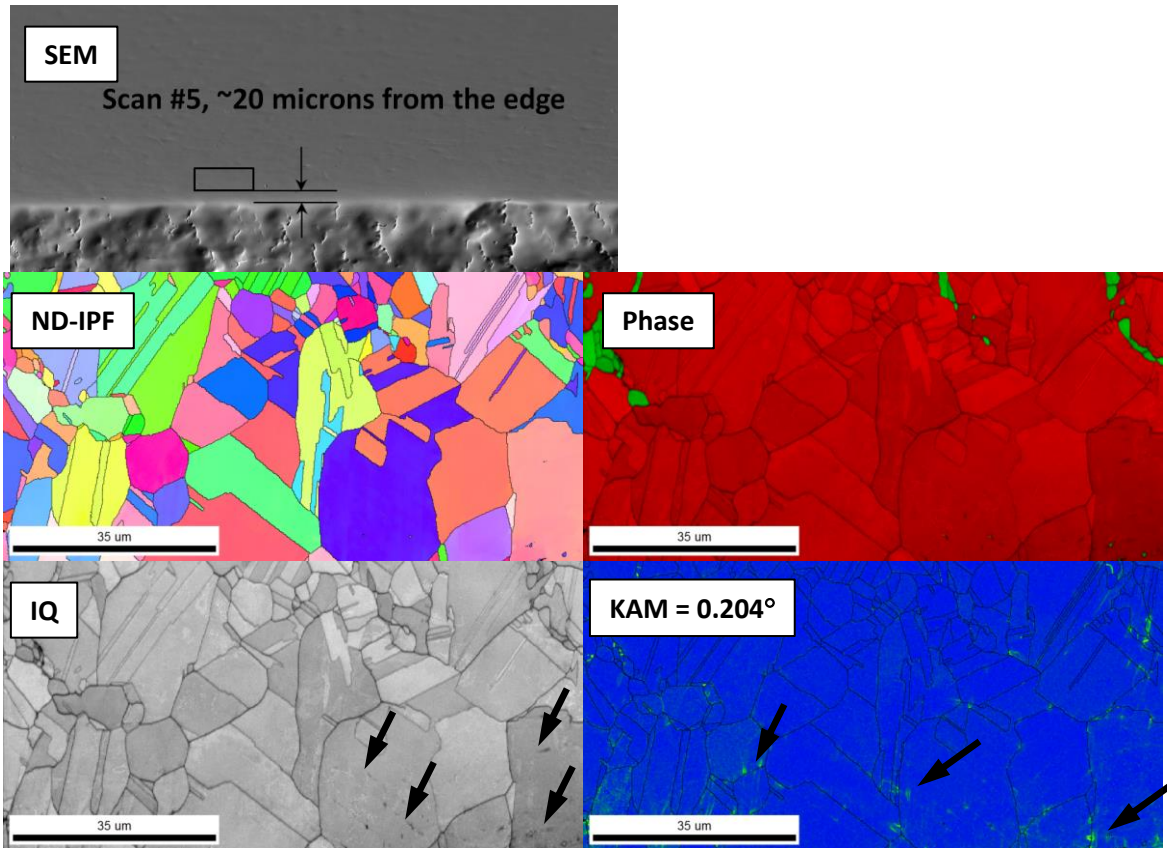
Figure 45. EBSD data set for the post-test fatigue area. Black arrows show reliable strain indications in the IQ and KAM maps. Step size is 125 nm.

Figure 45 shows the EBSD data for the post-test fatigue. The scan was taken at a depth of $\sim 20\ \mu\text{m}$, and the scan's center point is located at a depth of $\sim 50\ \mu\text{m}$ from the surface. One may see the plastic strain indications in the IQ map (as gray lines and spots inside grains) and KAM map (color variations mostly near the grain boundaries). The strain signs were most pronounced near the fracture surface (bottom edge) and decayed with the depth. The average KAM value for the scan was $\sim 0.20^\circ$.
