**POST-DEFORMATION EXAMINATION OF SPECIMENS SUBJECTED TO
SCC TESTING**

Prepared under the direction of the
U.S. Department of Energy
Office of Nuclear Energy
Light Water Reactor Sustainability Program
Materials Aging and Degradation Pathway

Prepared by
OAK RIDGE NATIONAL LABORATORY
Oak Ridge, TN 37831-6285
managed by
UT-BATTELLE, LLC
for the
U.S. DEPARTMENT OF ENERGY
under contract DE-AC05-00OR22725

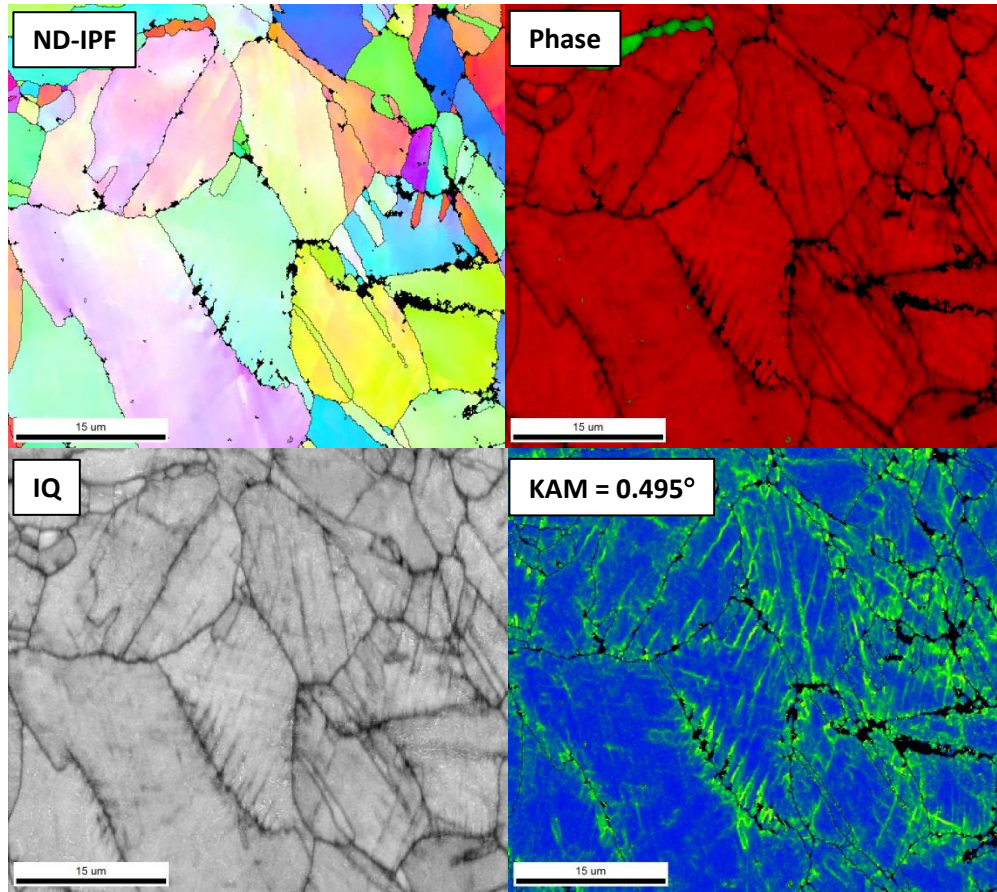
Figure 46. EBSD data for the fracture area.

Figure 46 shows the EBSD dataset for the final fracture area; the depth was $\sim 15\text{--}20\text{ }\mu\text{m}$. One may see strong misorientation (color gradients) in the IPF map, visible in-grain slip lines in the IQ map, and strong local fluctuations in the KAM map. The KAM value reached $\sim 0.49^\circ$. Final fracture led to the most pronounced plastic deformation, and the KAM increase was the largest for this area.

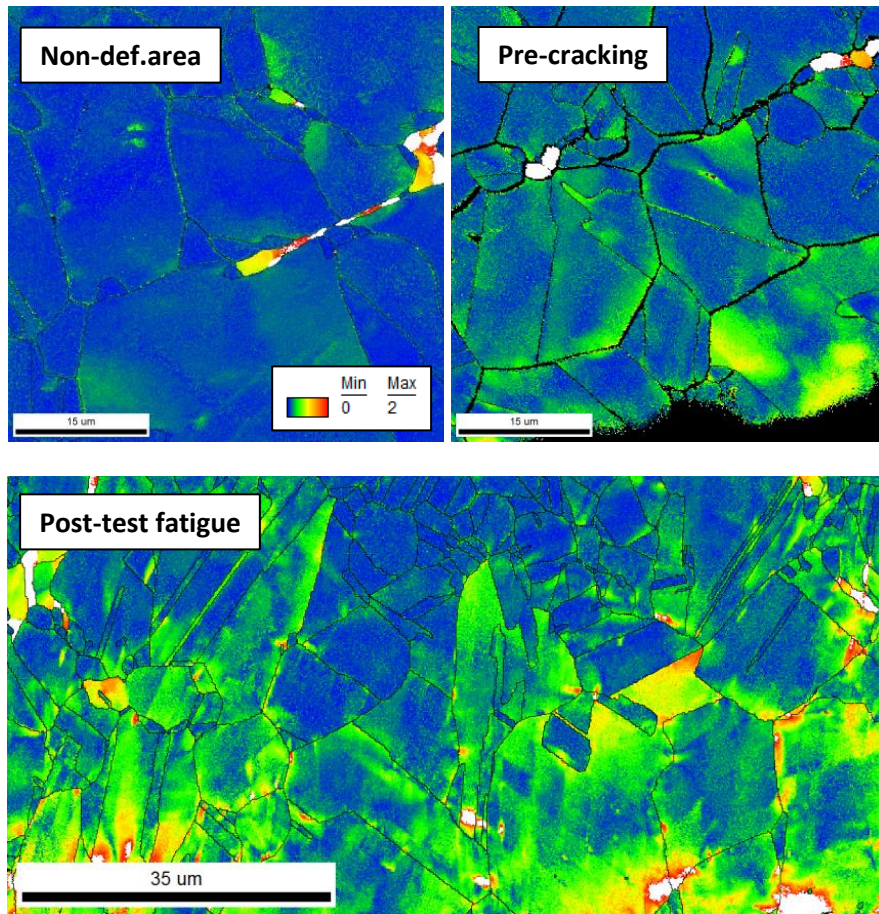
Figure 47 summarizes the plastic strain observations in the different areas. To underline the small strains, the color scale was limited to a 2° maximum misorientation. As follows from the data, the bulk non-deformed material had a very weak misorientation level with few local maximums related to the ferrite grains (see Figure 43 for the corresponding IPF and Phase maps). Pre- and post-test fatigue cracking led to some plastic strain, which was more pronounced in the post-test fatigue area. In this area, GROD values often exceeded the scale limit (2°) and appeared white in color. For both fatigue-cracked areas, the plastic strain gradient appeared to decay with the depth. For the final fracture area (not shown here), the maximum GROD reached $\sim 16.5^\circ$ (not shown here).

Figure 47. GROD maps for different areas (see above). To underline the strain, the GROD value range was limited to 2° (i.e., color scale is the same for all images in this figure).

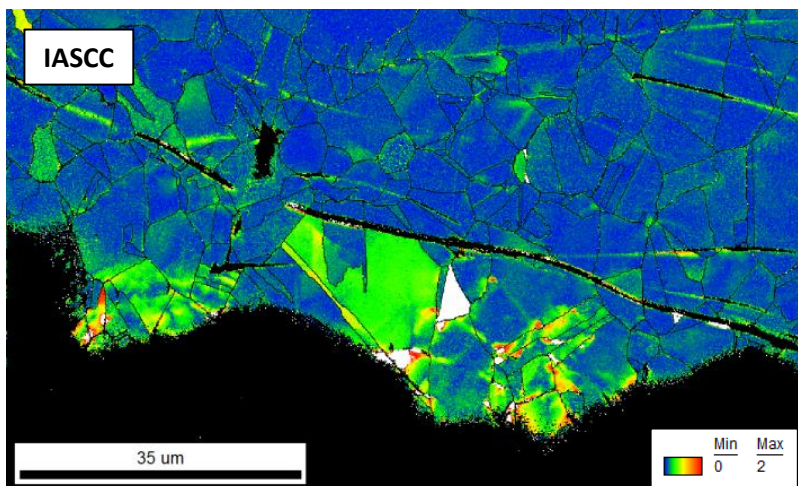
Figure 48. GROD map for the stress corrosion cracking area. To underline the strain, the GROD value range was limited to 2° .

In contrast to these areas (bulk, pre-cracking, and fatigue areas shown in Figure 47), plastic strain distribution in the IASCC area (Figure 48) appears to be different. First, only a relatively narrow area

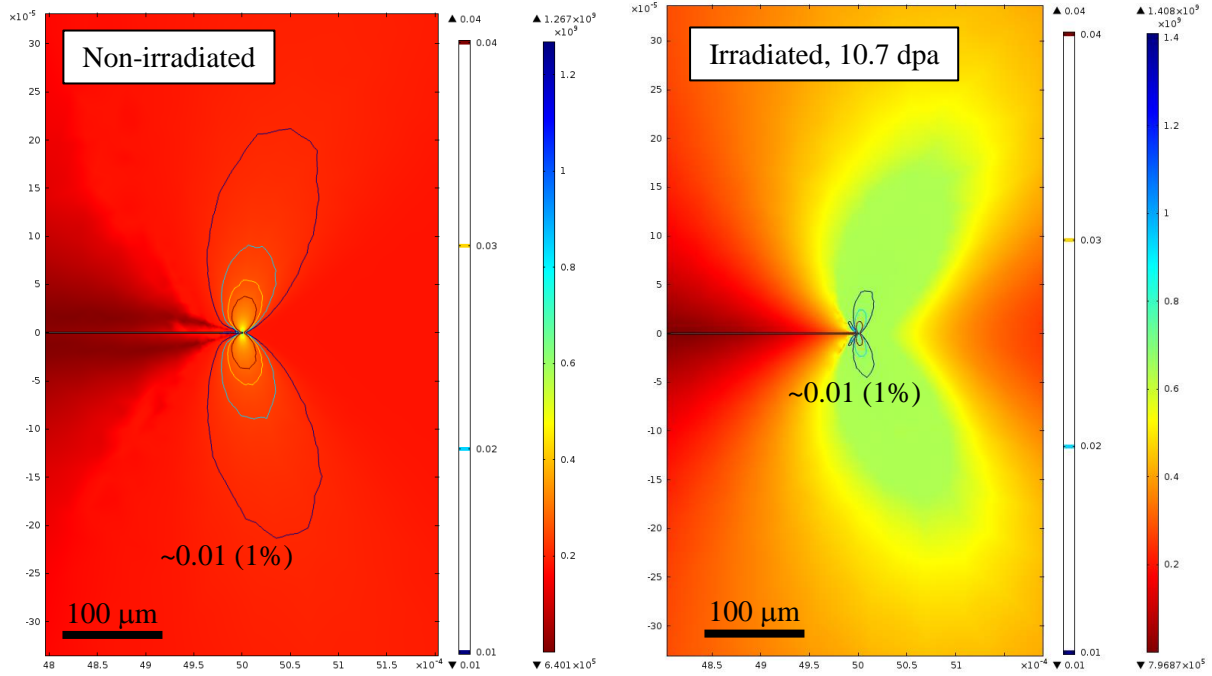
Since strong strain gradients exist in the plastic area near the crack tip, it was important to estimate the specific dimensions of the areas subjected to different strains. Figure 52 shows the expected stress and strain fields in the crack vicinity. As shown in the results, the width of area with a stress level close to the yield point is expected to be ~200 μm in the irradiated specimen. The width of the area with ~1% plastic strain will be ~40 μm and the width of the area with 2% plastic strain will be ~20- μm .

The calculated dimensions of the deformed area near the crack (~20–40 μm for 1–2% plastic strain) are obviously rough estimations considering the number of simplifications made (mentioned above) regarding plastic hardening behavior of the irradiated steel and isotropic plasticity assumption. If present, ductile ligaments should lead to crack tip shielding and a decrease in stress intensity [37]. The preliminary and qualitative character of the calculations discussed in the present section is recognized and will be addressed in more detail in future work. Nevertheless, close attention should be paid to the ~20–40 μm area along the crack in the irradiated material. At the distances of ~0.2–0.5 mm and more, material may be considered to be free of effects caused by crack propagation.

Figure 52. Calculated stress (coded by color scale) and strain (shown by contour lines with a 0.01 step increment) fields around the crack tip in the non-irradiated (left) and irradiated (right) M-alloy specimens. Note that the specific shape of the stress and strain fields. In the right image, each color line shows a 1%-strain increment. For the irradiated specimen, the width of the 1%-deformed area is ~40 μm and the ~10 μm area should have experienced ~4%-strain.

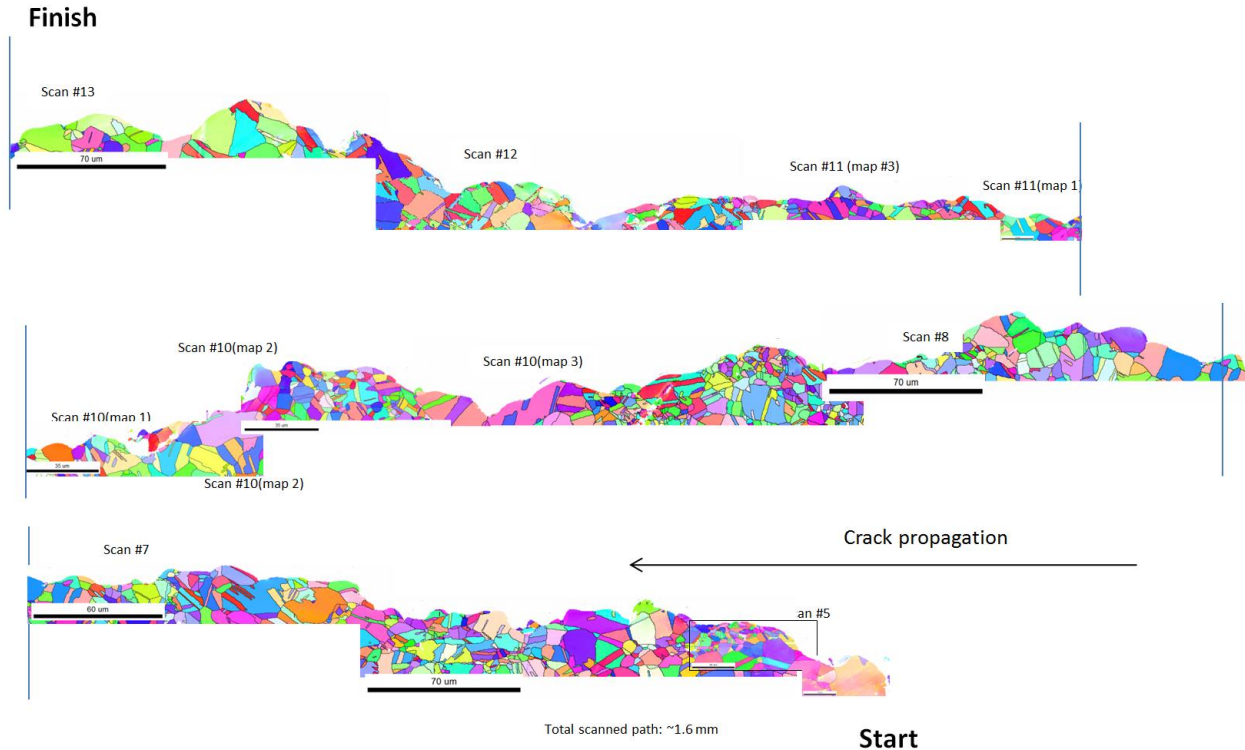
Figure 53. An example of the EBSD data set: several scans were performed along the crack path. The start location was close to the pre-cracking fatigue point (~ 0.2 mm). Unfortunately, surface quality varied along the scanned path, and some information was lost. The IPF images are colored in the vertical direction (the direction of the acting stress during crack growth testing).

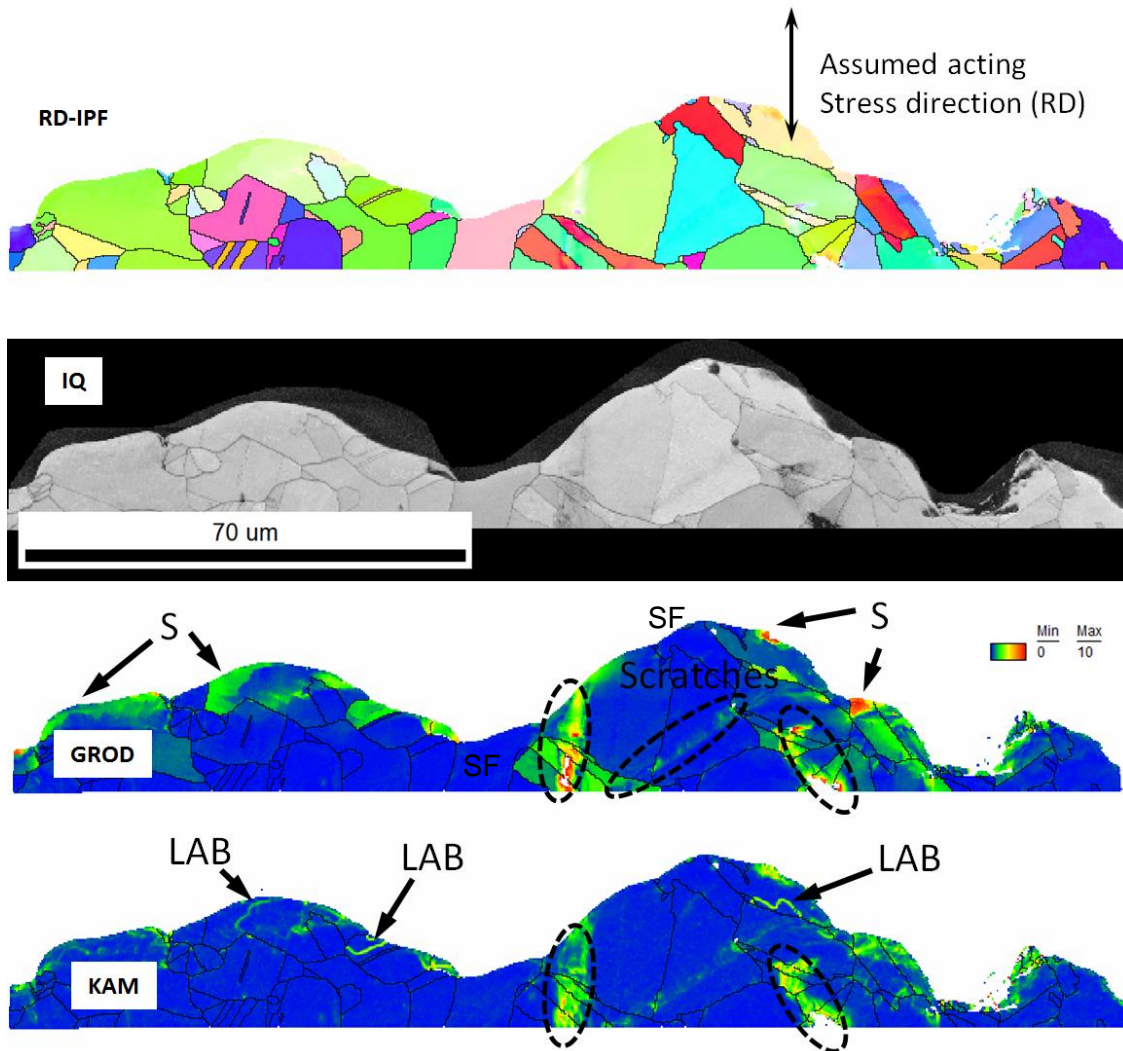
The crack-adjacent grains often have some signs of plastic strain, which are visible in the GROD and KAM maps. The width of the crack-adjacent area with signs of plastic strain (marked by “S” in Figure 54) is ~ 10 μm , and is slightly more in some cases. Local in-grain misorientation (GROD) for the crack-adjacent grains may reach $\sim 10^\circ$ for some grains. Unfortunately, it is not easy to connect the GROD value to the local strain level. To do so one needs to construct a special correlation relationship, connecting the plastic strain level and the selected EBSD strain metric (e.g., GROD, KAM, GAM, etc.). A set of specimens with a known history (strain level) is required. Such data for irradiated austenitic steels are not currently available in the literature.

Interestingly, LABs are often presented in the austenitic grains near the crack edge (Figure 54). These structure elements (LAB) might be seen as a sharp local increase in KAM, and as a rule were also visible

Figure 54. EBSD dataset for the crack-adjacent area: IPF, IQ, GROD, and KAM maps. LAB: low-angle boundaries; S: locations with high local strain level; SF: strain free grains; dashed ovals show scratches.

The most interesting aspect, observed with EBSD, is the strong inhomogeneity in the strain distribution along the crack path. Some grains (marked as SF in Figure 54 and Figure 56) have no visible signs of plastic strain, even when such grains were crack-adjacent. This result is contra-intuitive, and the finite element modeling suggested a retain plastic strain field of a more or less uniform degree.

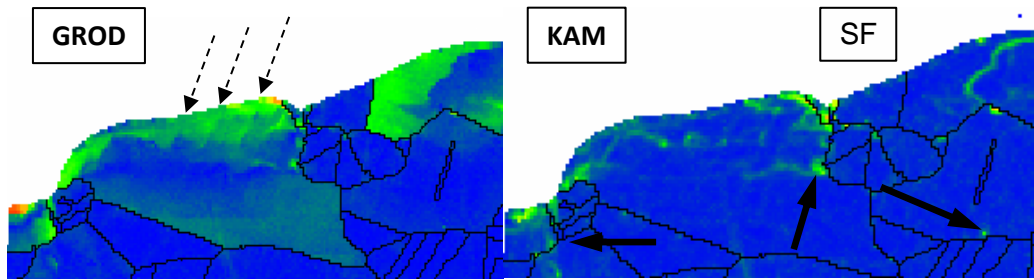
Figure 56. An enlarged portion of the GROD and KAM maps shown in Figure 54 (close to the left). Dashed arrows point to local misorientation variations that suggest the presence of defect-free channels (slip bands). KAM map highlights local strain-induced fluctuations. SF: strain free grains; solid black arrows show triple junction points with visible signs of strain.

Dislocation channels (slip bands), as a rule, did not appear in the IQ map for the stress corrosion cracking area. However, the detailed analysis of misorientation maps (Figure 56) suggests their presence in the structure. Triple junction points also often served as stain-localization locations (Figure 56). Compared to the TEM-FIB lift-outs, EBSD may cover larger areas and reveal processes acting on the meso-scale level (several to hundreds grains).

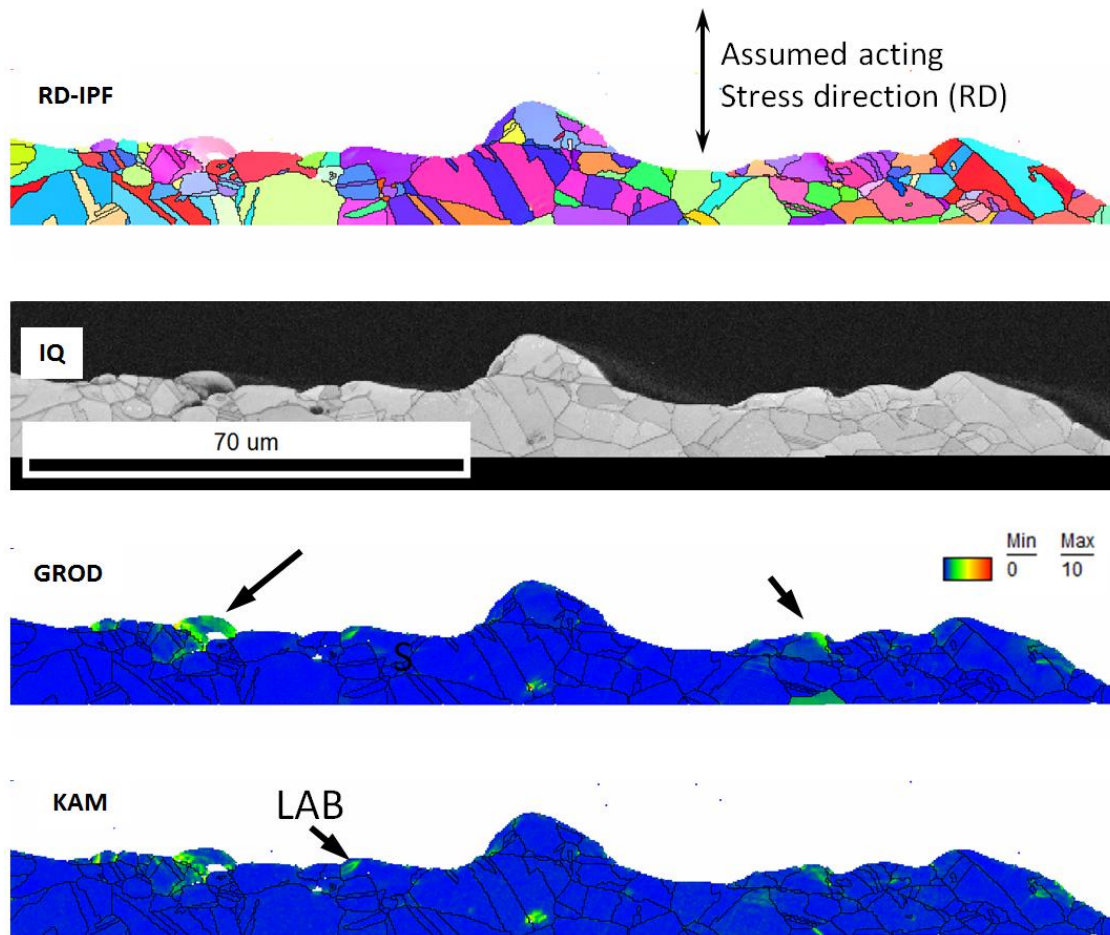
Figure 57. EBSD data set for the crack-adjacent area. LAB: low-angle boundaries; black arrows point to grains with visible plastic strain. Scanning conditions (working distance, step size) are the same as in Figure 54.

Figure 57 shows an additional data set for the crack-adjacent area. As discussed above, clear signs of plastic strain were present in some grains, a few low-angle boundaries were also visible. At the same time, the GROD map demonstrates a much smaller average misorientation for the crack-adjacent grains, compared to Figure 54. This may be caused by changes in the test conditions (temperature, environment, etc.; see [10]). Several attempts were made to establish a correlation between the test conditions—mainly stress intensity factors—and EBSD strain metrics. Unfortunately, at present no relevant solid conclusion can be drawn. It was difficult to connect any particular location and the corresponding EBSD dataset to the test history. One reason stems from the complexity of the processes during crack propagation; the crack front is often a complexly shaped line in a 3D space. Crack segments may propagate at different rates, advancing or experiencing a delay depending on local structure. Average crack length at any given time has limited value for establishing crack position at a particular cross section.

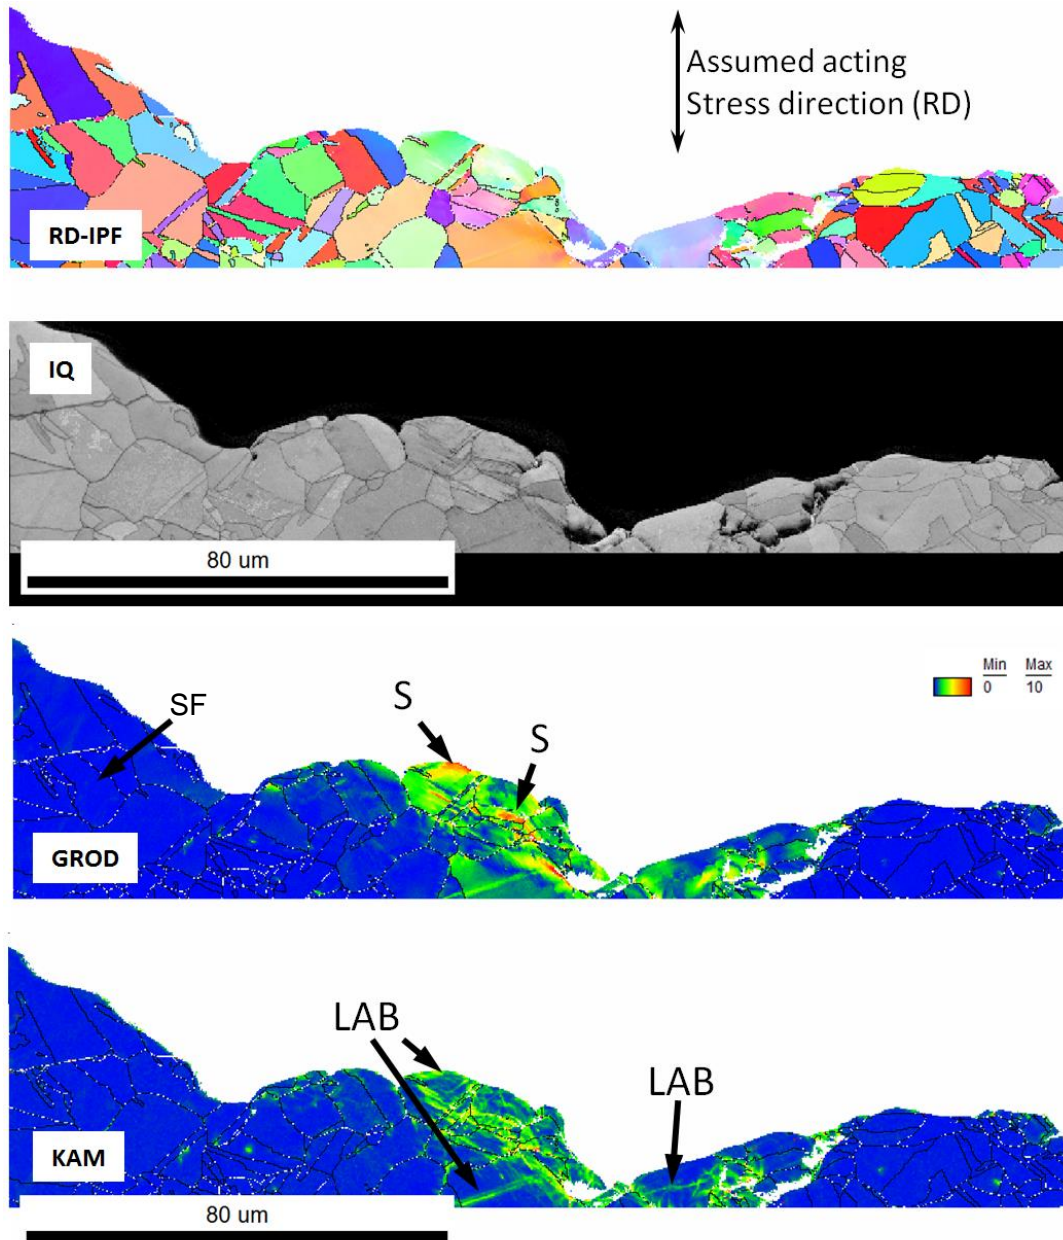
Figure 58. EBSD data for the crack-adjacent area showing a spot with high local strain level. S: areas with high local misorientation (GROD). LAB: low-angle boundaries.

The results discussed above (Figure 54, Figure 57) show inhomogeneity in strain distribution along the crack path and low (or zero) strain level in some grains. Figure 58 shows an example of different kinds regarding plastic strain distribution. Several grains experienced significant plastic strain, and the depth of the deformed area exceeded $\sim 20\text{--}25\text{ }\mu\text{m}$. GROD and KAM maps revealed complex character of strain distribution in many grains, with multiple LABs formed, most likely during deformation. Inside this specific area, the dislocation channels are clearly visible in the IQ map. This “deformation hot spot” co-existed with strain free areas (SF). Interestingly, such “hot spots” often formed if a crack changed direction.

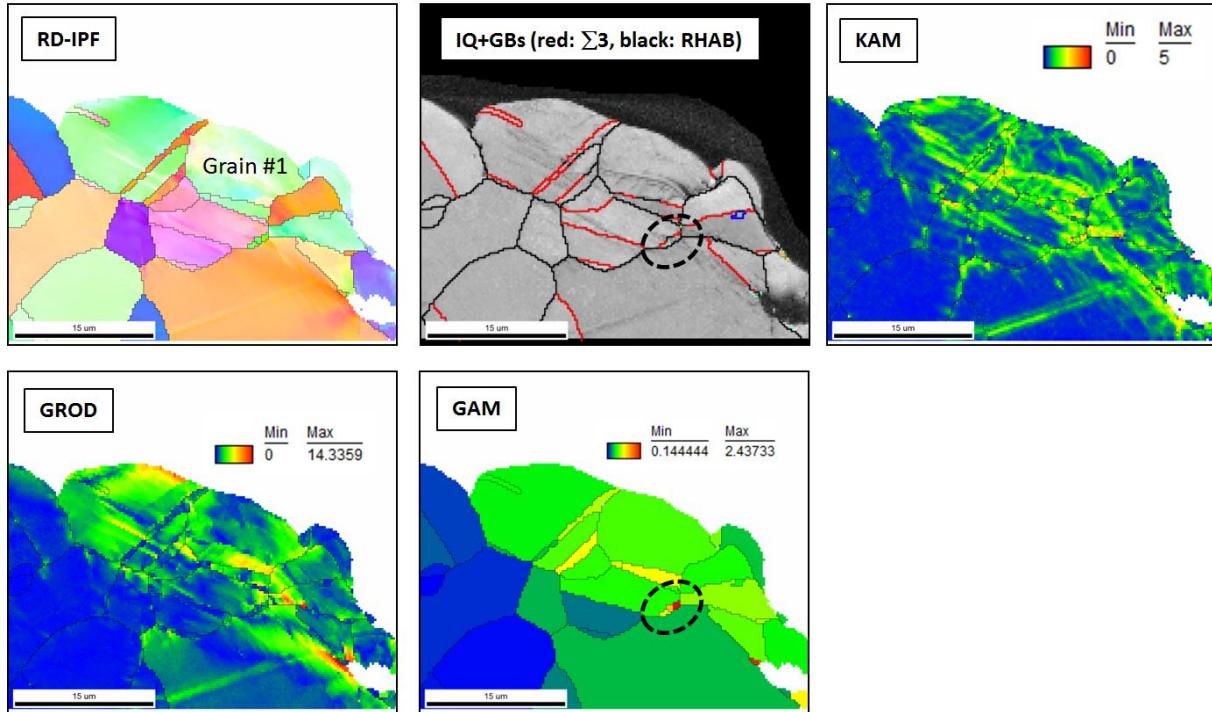
Figure 59. EBSD data set for the highly-strained area (“hot spot”) from the scan shown in Figure 58. Note the high local misorientation (color change) in Grain #1 (up to $\sim 12^\circ$). The dashed oval shows fragmentation of a small annealing twin. Grain boundary character is also shown in the IQ map.

Figure 59 demonstrates an enlarged fragment of the data maps shown in Figure 58. The GAM map was added to highlight the local strains. An interesting peculiarity seen in Figure 59 is the formation of small sub-grains (dashed oval). Most likely, the pre-existing small annealing twin experienced fragmentation during straining and was transformed for several small sub-grains separated by low-angle grain boundaries. Such structures (groups of small LAB-separated grains) are not typical for the bulk parent material.

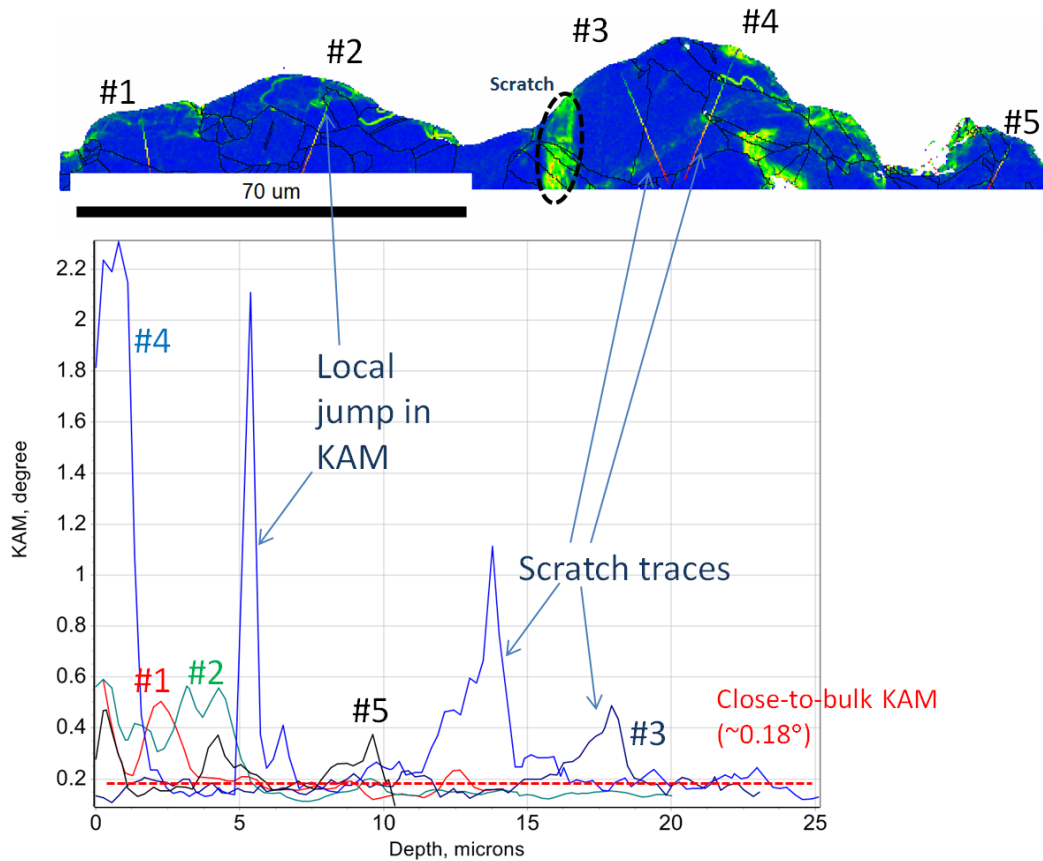
Figure 61 shows several KAM profiles for the most typical areas. Profiles #1 and #2 show deformed areas with LABs. One may see some increase in KAM (from $\sim 0.18^\circ$, i.e., bulk level, to $\sim 0.4\text{--}0.5^\circ$) at the depth of $\sim 5\text{ }\mu\text{m}$. Below $\sim 5\text{ }\mu\text{m}$ the material appeared to be unstrained, and the KAM profile curve was close to the bulk.

Profiles #3 and #5 were taken in the grains without visible plastic strain. Indeed, regardless of the depth, the KAM value was close to the bulk ($\sim 0.18^\circ$). Material at these locations did not reveal plastic strains even in the crack vicinity. The local fluctuation in profile #3 at 10–15 μm of depth was caused by a scratch.

Profile #4 has few maximums, related to both cracking and scratches. The first maximum, at the crack edge, was most likely induced by plastic strain. The second, at $\sim 5\text{--}6\text{ }\mu\text{m}$ depth, corresponded to the LAB.

Figure 61. KAM profiles (#1–5) for the EBSD scan shown in Figure 54. Average width of 10 data points.

It appears that most plastic strain, if it appeared during crack propagation, was localized in the $\sim 5\text{--}10\text{ }\mu\text{m}$ layer. The strain tended to be localized to some grains, whereas other grains near the crack edge remained un-deformed.

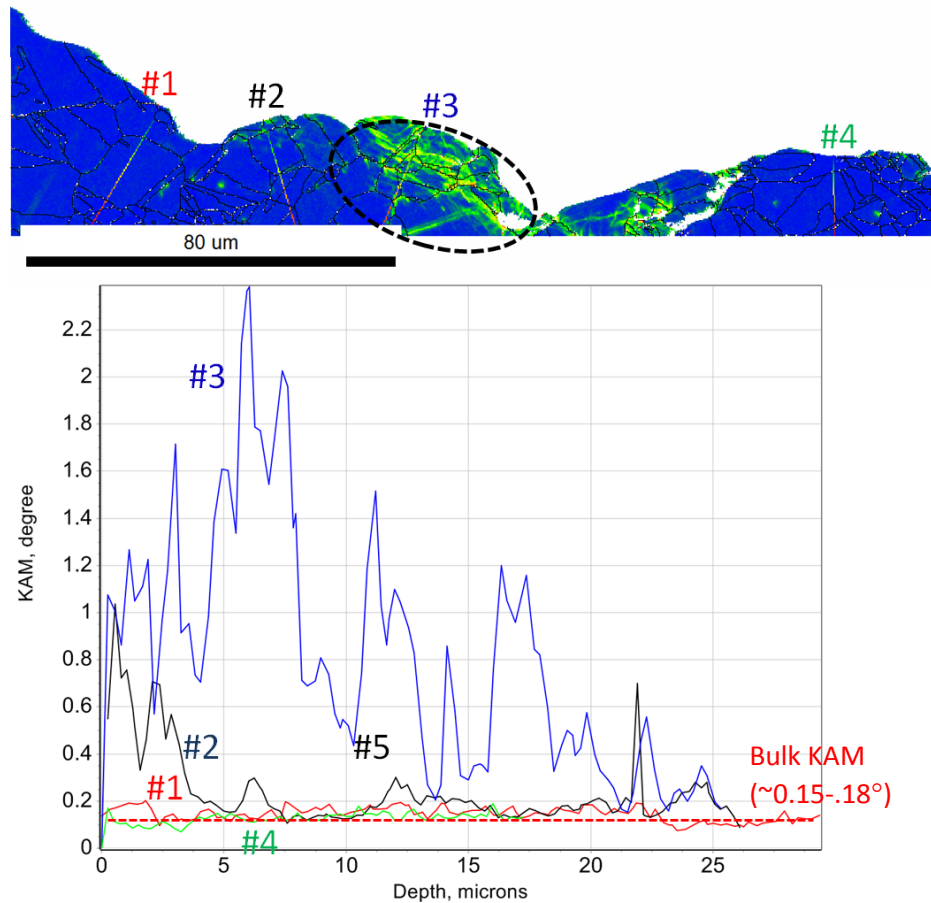
Figure 62. KAM profiles for the EBSD dataset shown in Figure 58.

Figure 62 provides some additional statistics and shows the KAM profiles for the highly deformed area (Profile #3) in contrast to the neighboring grains. Along profile #3, KAM reached $\sim 3^\circ$ and the depth of the deformed area was up to 20 μm . Curves #1 and #4 demonstrated zero strain even at the crack edge, and profile #2 had a $\sim 4\text{--}5\text{ }\mu\text{m}$ deformed layer.

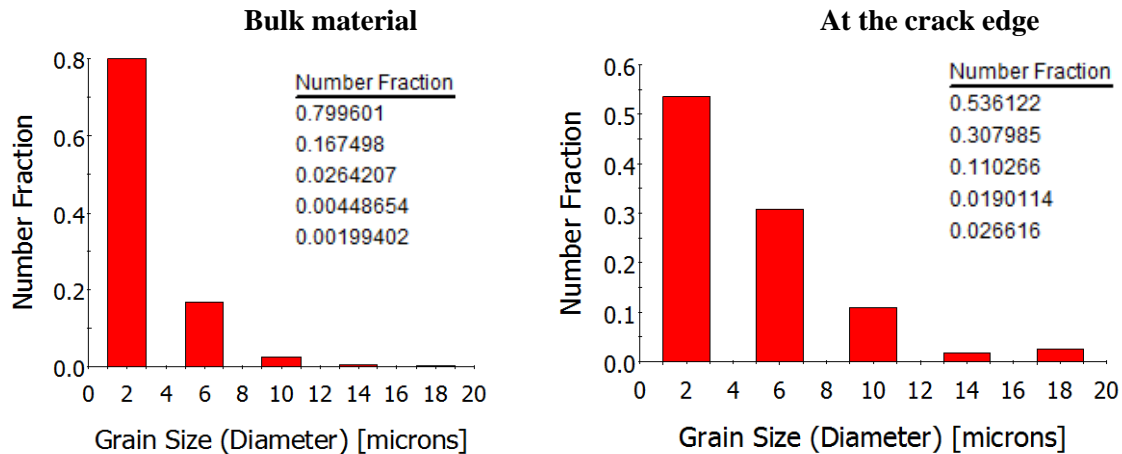
Figure 65. Grain size histograms for bulk material (left) and crack-adjacent grains (right).

As shown in the image, the probabilities of finding a grain of the given size near the crack and in the bulk material are not the same. The fraction of the smallest grains (< 4 μm) is slightly higher in the bulk (factor of ~ 1.5), but it may be just an artifact induced by the specimen preparation method. Electropolishing might destroy small grains at the edge.

However, as grain size increases, the probability of finding a given size grain at the crack edge increases drastically. The largest grains (16 – 20 μm grain size range) presented at the crack edge with ~ 13 times larger probability compared to the bulk, and grains with moderate size (8 – 12 μm) presented at the crack

Nevertheless, it appears that larger grains may be involved more often in the crack propagation compared to the small grains. In the first iteration, it may be explained by the well-known Hall-Petch law (reducing the grain size will lead to strength level increase). Smaller grains will have larger yield stress compared to the larger grains, and plastic deformation will first develop in the larger grains.

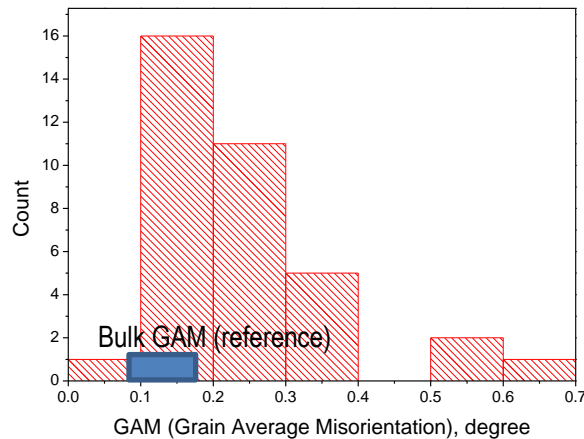
Figure 66. GAM (Grain average misorientation) value histogram for one of the EBSD scans (M-alloy, MS-01 specimen). Only crack-adjacent grains are shown. The typical GAM value for non-deformed material is $0.13 \pm 0.05^\circ$.

Figure 66 shows a typical GAM value histogram for the crack-adjacent grains. The GAM value of ~ 0.13 – 0.15° was obtained for the bulk austenitic grains (non-deformed material far from the crack). As shown in the image, ~50% of grains along the crack path had the GAM values close to the bulk (i.e., these grains did not experience visible plastic strain). Some grains demonstrated weak signs of plastic deformation with the GAM values within a 0.2 – 0.4° range, and 3 grains in the analyzed scan showed an unexpectedly high GAM value ($> 0.5^\circ$).

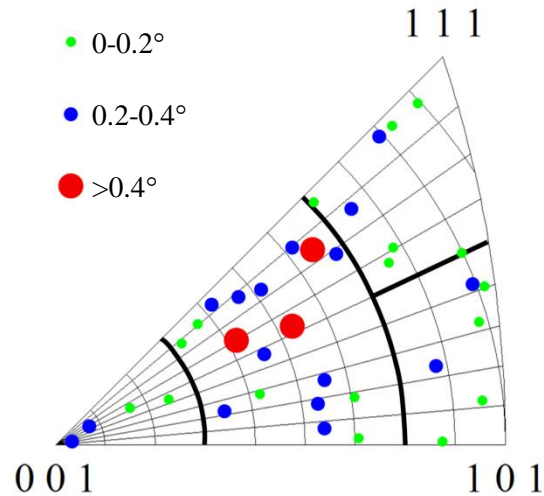
Figure 67 shows the orientation of crack-adjacent grains with respect to the externally applied stress. The marker size corresponds to the GAM value for each particular grain. One can see that there is a tendency for the GAM value to correlate with the grain orientation. It appears that slightly deformed grains (GAM range of 0.2 – 0.4°) are grouped near the center of the unit triangle (near the Schmid factor maximum). All heavily deformed grains ($\text{GAM} > 0.4^\circ$) appeared in the middle area of the unit triangle.

Figure 67. The orientation of the grains from the Figure 66, with respect to the applied stress direction. The size and color of the markers correspond to the GAM value range. For each grain, an average orientation is given.

Thus, for the crack-adjacent grains, there may be a strong connection between grain orientation and its GAM value (internal misorientation or strain level). The largest plastic strain was observed in the softest grains with the highest Schmid factor. At the same time, there were significant variations in the internal misorientation level between the grains of the same or similar orientation. This suggests that there may be an additional factor(s) influencing the appearance and amplitude of plastic strain during stress corrosion crack propagation. Such a factor may be a grain boundary type.

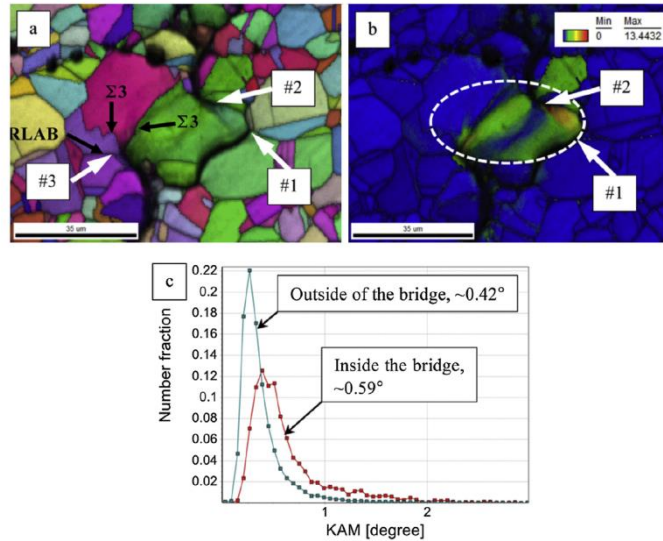
Figure 68. EBSD scan for the stress-corrosion crack in the neutron-irradiated 718-alloy (after [38]).

Analyzing the crack trajectory, authors observed specific, highly-deformed areas in the 718-alloy specimen with stress-corrosion cracks [38] (Figure 68). These areas (often termed “plastic bridges” or “ductile ligaments”) were attributed to the $\Sigma 3$ -grain boundaries (or twin boundaries), which are usually more resistant to cracking compared to the conventional random high-angle boundaries.

Thus, the highly-deformed areas might be the result of appearance and evolution of “plastic bridges.” Unfortunately, there was no way to analyze the corresponding grains/areas on the second half of the specimen or exactly define the grain boundary type.

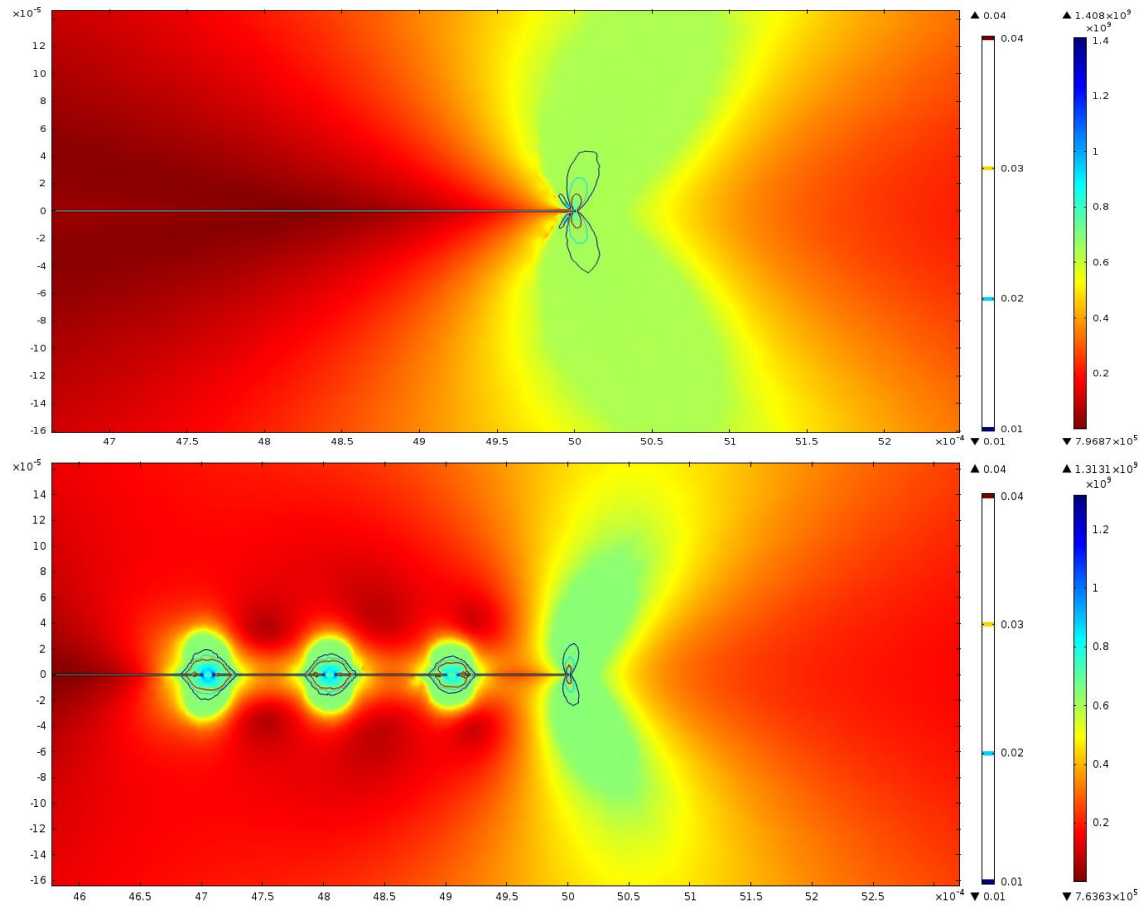
Figure 69. Ductile ligament-free crack (top) in contrast with crack with 3 “bridges” (ductile ligaments). The loading conditions are the same.

The FEA model introduced above was modified to introduce several “plastic bridges” (or ductile ligaments); the external loading conditions were kept the same. Figure 69 shows the stress and strain distributions around the crack without, and with a few, simulated ductile ligaments (“plastic bridges”). One may see some decrease in the plastic area size (from $\sim 50 \mu\text{m}$ for the 1%-strain level to $\sim 30 \mu\text{m}$) if the ligaments are present in the structure. Interestingly, there are strong stress and plastic strain gradients inside the “bridges” (i.e., ductile ligaments are spatially limited objects); strain level inside the bridges reached $\sim 0.1\text{--}0.15$ ($\sim 10\text{--}15\%$). Thus, the presence of ductile ligaments may explain, at least qualitatively, the reduction in the plastic area size and the smaller than expected degree of plastic strain.

Thus, the final plastic strain distribution of the structure will be a result of overlapping from strains induced by the main crack and strains produced by the ductile ligaments. Stress shielding due to ligament formation should reduce the actual stress intensity factor.
