Cracking and Corrosion of Composite Tubes in Black Liquor Recovery Boiler Primary Air Ports

October 2006

Materials Science and Technology Division

**CRACKING AND CORROSION OF COMPOSITE TUBES
IN BLACK LIQUOR RECOVERY BOILER
PRIMARY AIR PORTS**

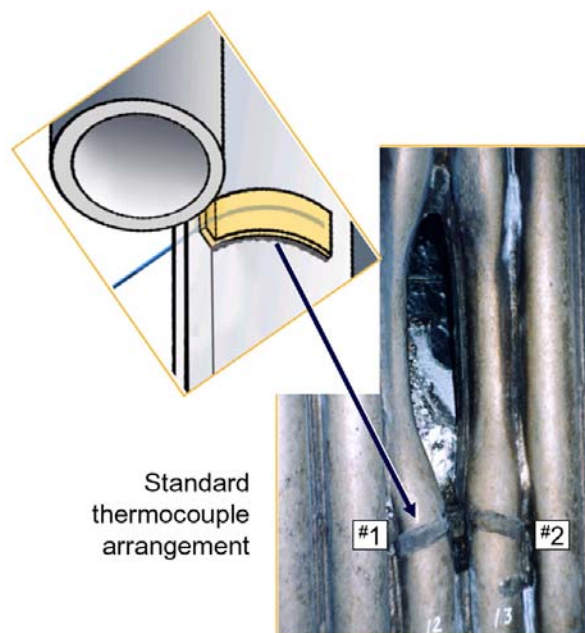
In the thermocouple installations on the first two boilers, thermocouples were mounted in the lower portion of an air port on the bent portion of the tubes in the general area where cracking was most often seen. The most frequently used installation arrangement is shown in Fig. 8 while several examples of typical thermocouple installations are shown in Fig. 9. In addition to the original three

Fig. 8. Thermocouples were mounted on the portion of air port opening tubes in the area where cracking was frequently observed.

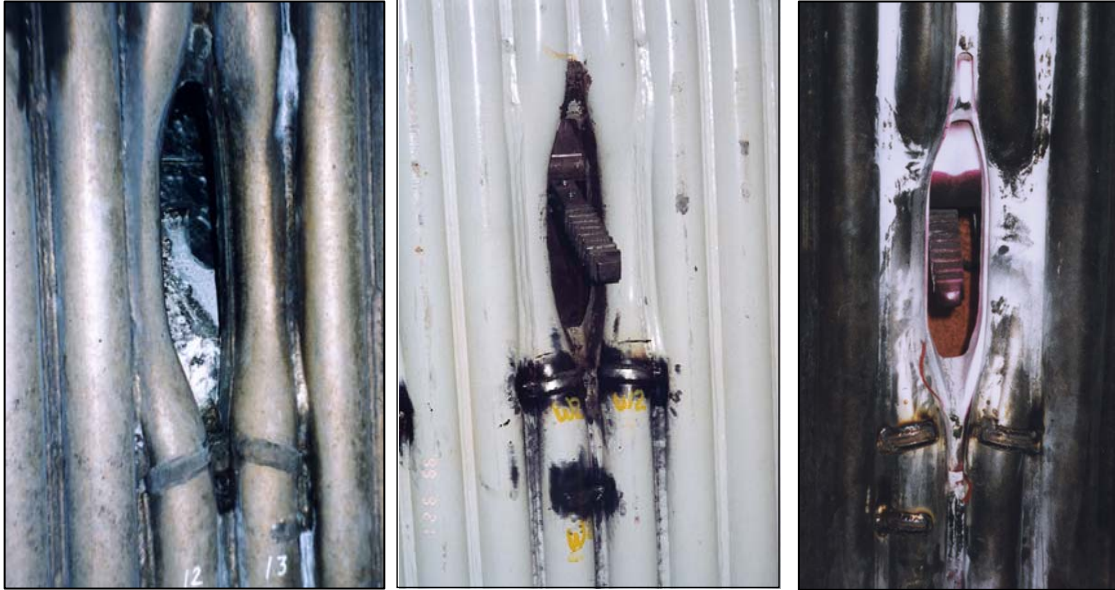
Fig. 9. Examples of the thermocouple installations used in the first three boilers equipped with thermocouples on the primary air port tubes.

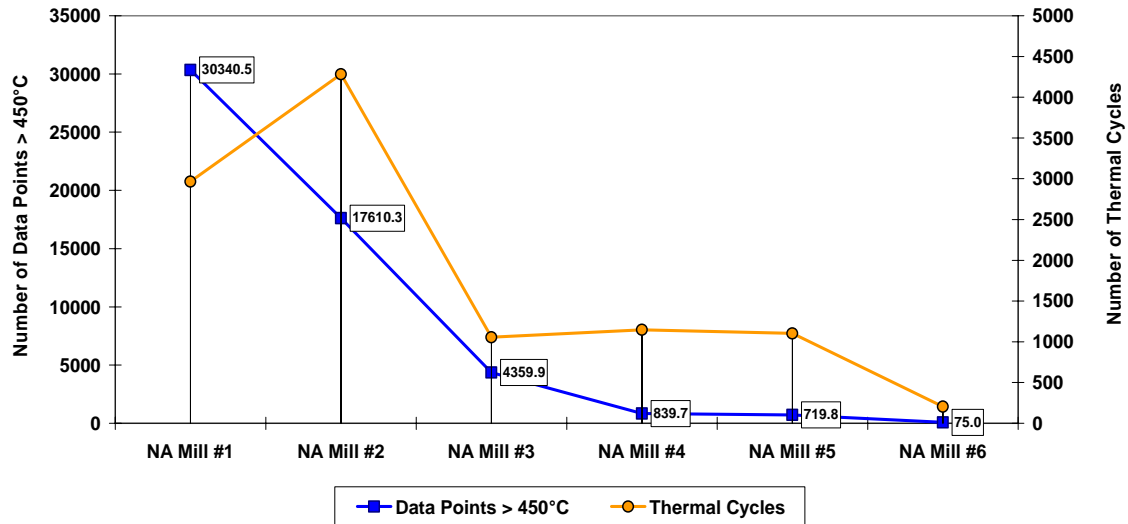
An example of the use of cycles and deviations to $\geq 450^\circ\text{C}$ is shown in Fig. 13 where both of these parameters are plotted for six North American recovery boilers. This figure shows two of the boilers experienced considerably greater activity than the others, and one has much less than the others. It is probably not a coincidence that the first three boilers have experienced significant amounts of primary air port cracking while the sixth has experienced no cracking of primary air port tubes.

Fig. 13. Plot of cycles and data points >450°C for six North American recovery boilers for one year period.

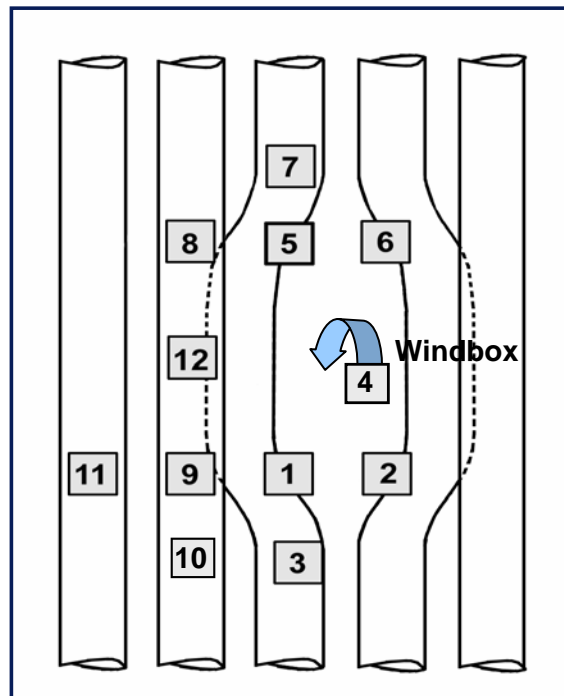
Originally, only two thermocouples were placed on the bottom fireside portion of cracking primary air ports at positions identified as #1 and #2 in Fig. 14. The thermocouples were mounted in the area of the lower tube bend where cracking was seen most frequently. Positions #1 and #2 were the most common positions installed in the monitored boilers. These two thermocouple positions,

Fig. 14. The numbered thermocouple positions shown above were used to observe temperature variations around the air ports in one mill. Positions #1 and #2 were used in all boilers in this study. No single air port was instrumented with all available positions.

along with #3 (directly below #1), saw the greatest amplitude of spikes and the highest temperatures recorded at any of the thermocouple positions. Figure 15 shows an example of severe thermal cycling.

Thermocouples mounted in positions #5–#8, shown in Fig. 14, at the top of a few primary air ports, consistently recorded temperatures ~50C° higher but with considerably fewer cycles and fluctuations than thermocouples located at the bottom of the air ports. This was a consistent finding not only from air port to air port within the same boiler but also for different boilers. Unfortunately the two thermocouples placed at position #6 never recorded accurate readings; it is expected that position #6 would have produced temperatures very similar to those read by positions #5, #7, and #8.

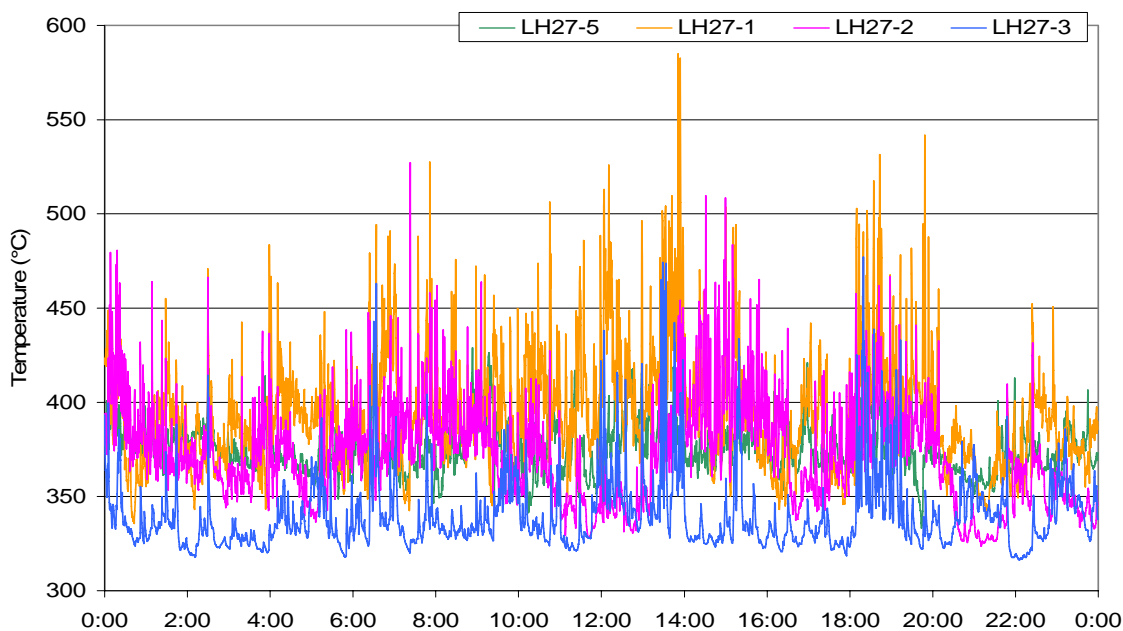
Fig. 15. Thermocouples record severe thermal activity on left hand side wall of a North American black liquor recovery boiler.

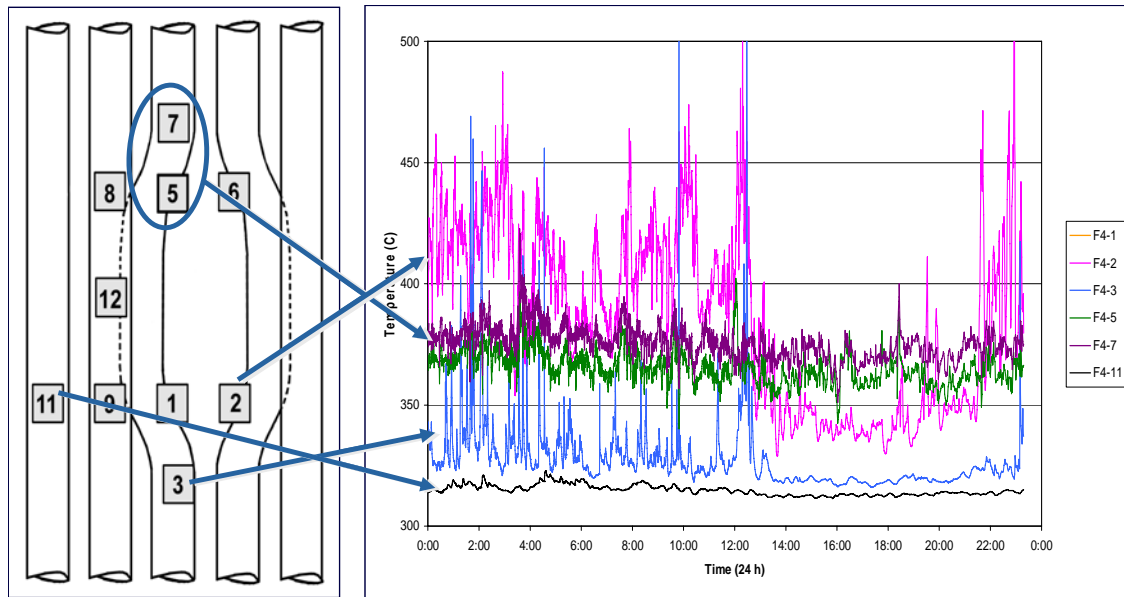
Adjacent straight tubes were fitted with thermocouples mounted at 90° from the membrane. Thermocouples in positions #9, #11, and #12 revealed fluctuations fewer in number and lower in magnitude than those seen by the lower portion of the air port. Shown in Fig. 16, the thermocouple placed approximately midway between the top and the bottom of the air port, position #12, showed large fluctuations at times, similar to those in positions #1 and #2; at other times it would record data points similar to those at the top of the air port with higher temperatures but fewer oscillations.

Position #11 in Fig. 16, located two full tubes away from the bottom of the air port opening, recorded the fewest fluctuations and lowest temperatures measured for any of the thermocouple

Fig. 16. Sketch showing the locations at which thermocouples were installed in one boiler to determine the variation in temperature patterns around the air port. Note that no air port had thermocouples installed at all the locations indicated. The plot on the right shows typical temperature patterns measured for the locations indicated.

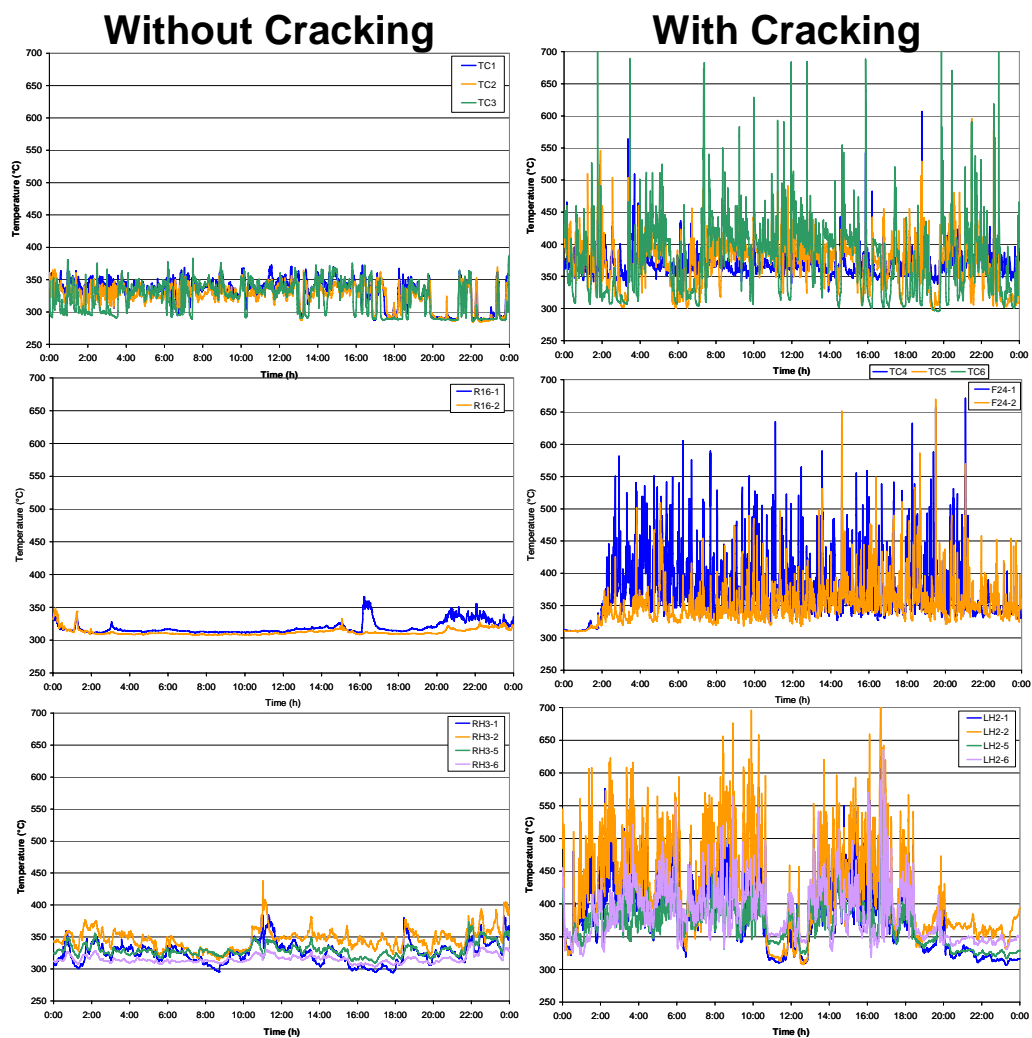
Several air port openings with no history of cracking were instrumented in different mills to serve as a reference for data comparison. As shown in Fig. 19, air ports with no history of cracking revealed minimal temperature spiking compared to the severe thermal fluctuations seen on the primary air ports with a history of cracking. The extreme temperatures seen by the tubes with a history of cracking indicate an intense heat source. Figure 20 demonstrated the intensity and frequency of amplitude one cracking air port saw over a five day period compared to another non-cracking air port within the same mill. Although it was determined that thermal fluctuations did not have a role in initiating air port tube cracking, it is thought the thermal cycles likely play an important role in the propagation of cracks. Further observations, as will be described in more detail, led to the conclusion that boiler operating parameters play a significant roll in producing the thermal fluctuations seen by the primary air ports.

Fig. 19. Data from three different mills show the difference in thermal fluctuations between air ports with and without a history of cracking.

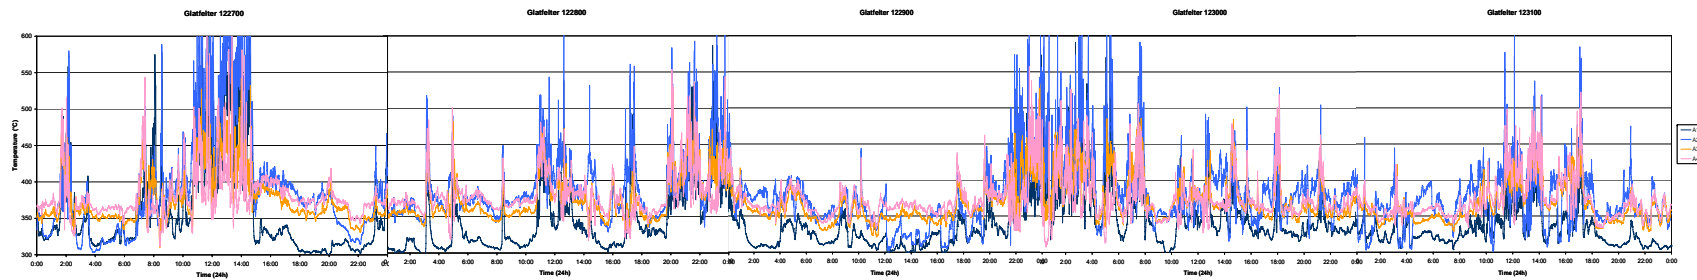
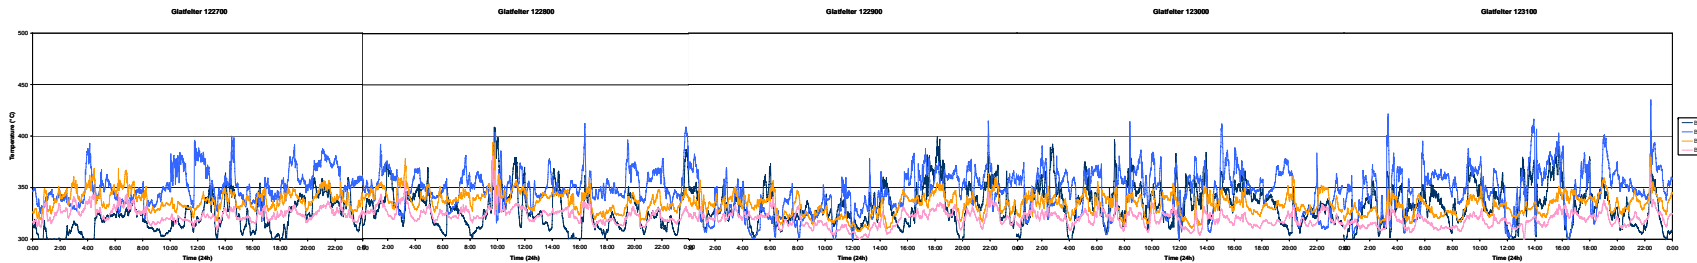
PAP LW#2 has previously exhibited cracking.

PAP RW#3 has exhibited no cracking.

Fig. 20. Activity from two different air ports compared over a five day period. The primary air port with no history of cracking exhibits much less thermal activity over the extended period of time.

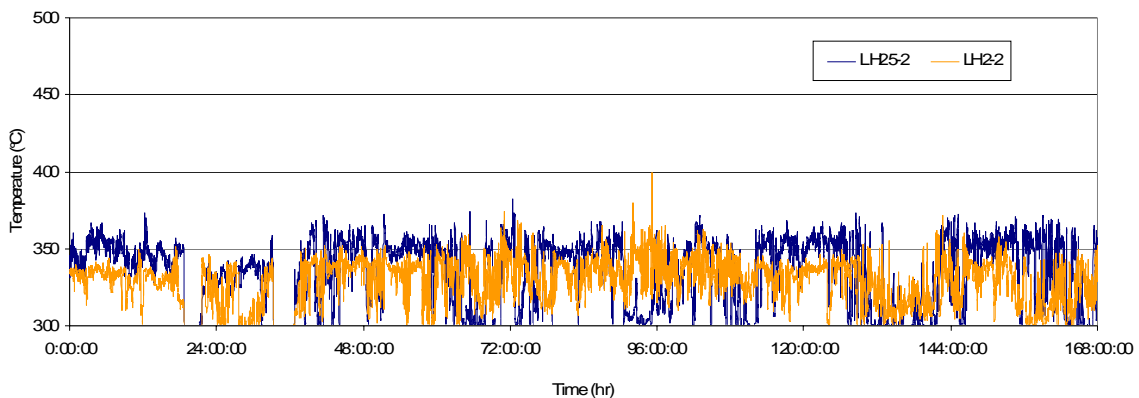
A limited study was conducted in one boiler of a design in which there had been no reports of air port tube cracking in any North American boiler. This boiler design employs primary air ports that are longer and narrower than most of those found in North America, so there was a question as to whether this design might offer some advantage for preventing air port cracking. This boiler design has a number of other differences from the majority of boilers in North America in that it uses a four wall non-interlaced secondary air system as well as some other features that make the design unique. Thermocouples were mounted on single tubes of several primary air ports in this particular boiler, and the temperature behavior was monitored. Figure 21 shows a plot of the temperature data collected, and it is apparent that essentially no temperature excursions occurred during the time period monitored. Because of the lack of temperature fluctuations observed, the option of air port design was added to the list of possible means to prevent cracking of primary air port tubes.

Fig. 21. Plot of temperature versus time for two thermocouples on primary air port opening tubes in a boiler originally equipped with the longer, narrower air port design.

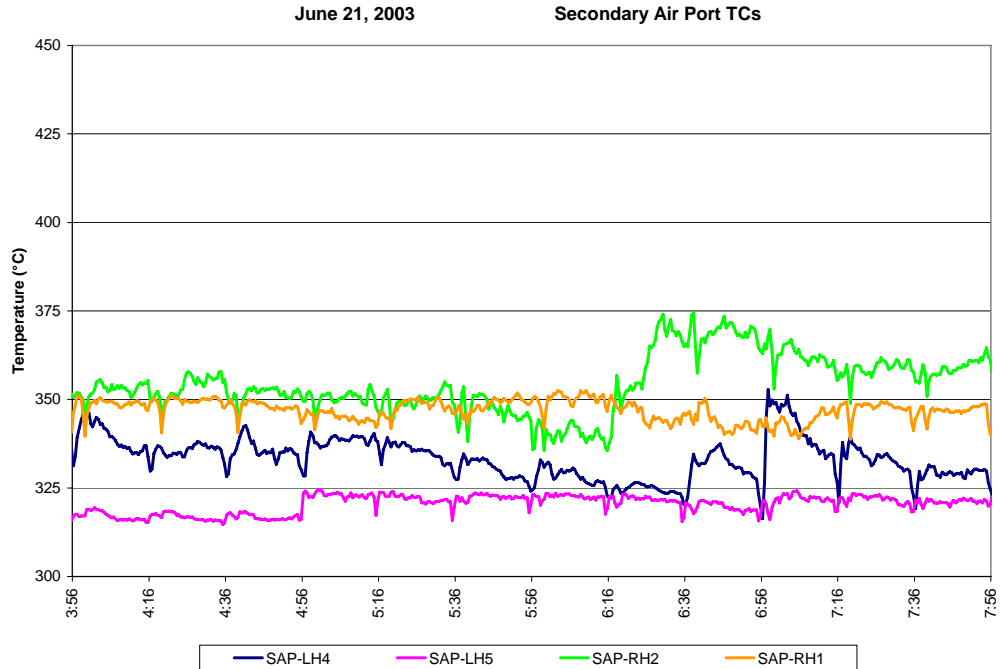
and these show minimal cycles and excursions. The cyclic pattern, shown clearly in Fig. 28, is associated with the automatic air port rodders. Figure 29 shows no significant difference in temperatures measured on the straight tube and the bent tube of a primary air port suggesting tube shape has no effect on the likelihood of temperature fluctuations.

Fig. 28. Plot of temperature vs time showing apparent effect on secondary air port thermocouples of automatic secondary air port rodder operation at 20 minute intervals.

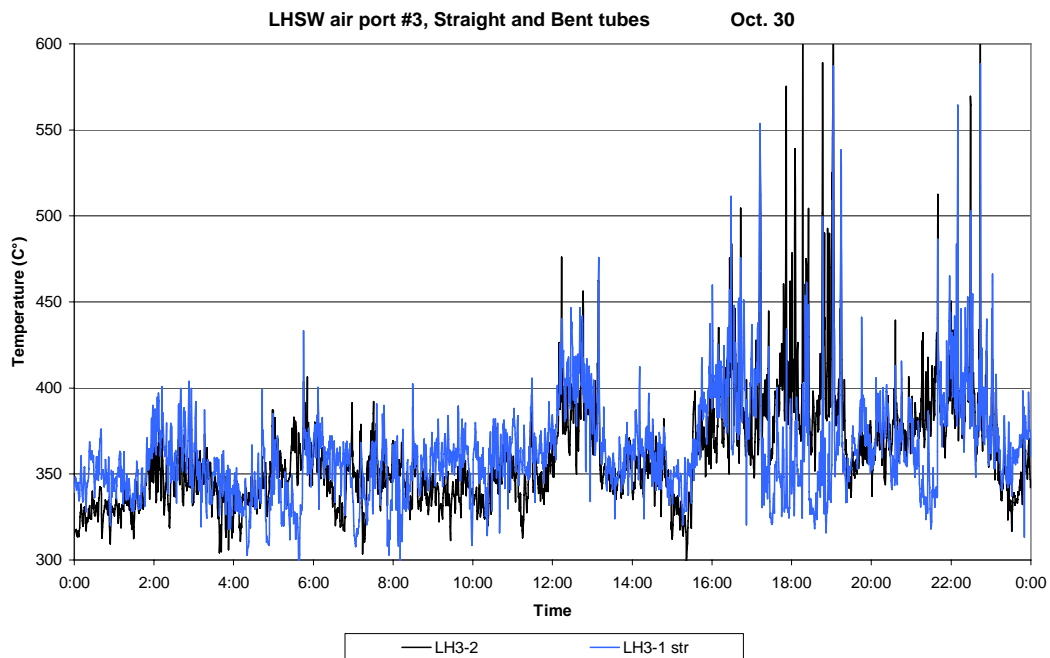
Fig. 29. Thermocouple measurements for thermocouples on the straight and bent tubes of a “D” shaped primary air port opening on a boiler with 7.6 cm (3 in.) OD tubes on 10.2 cm (4 in.) centers.

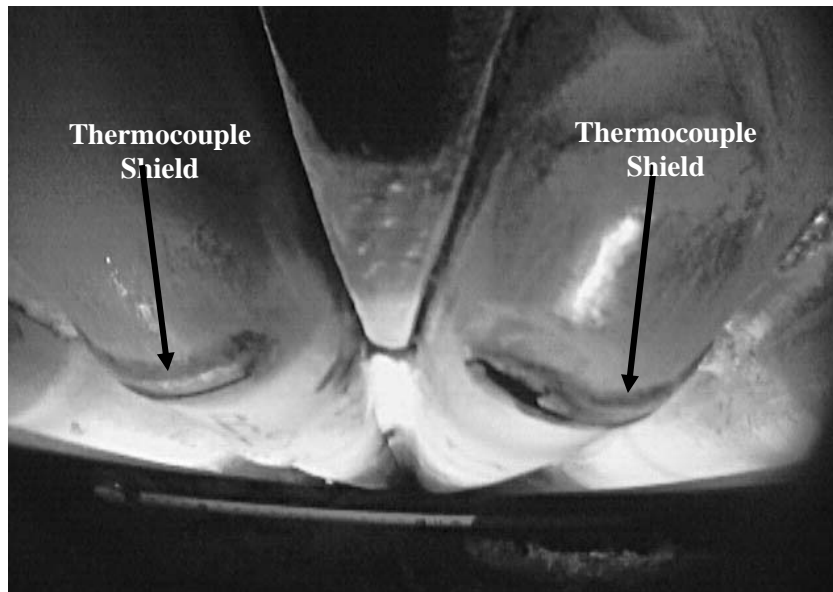
Fig. 31. Primary air port during shutdown; view gained looking down towards boiler floor with the boiler-view camera. A thermocouple shield can be seen on each of the tubes forming the air port opening, and a tape measure is visible on the boiler floor under the opening.

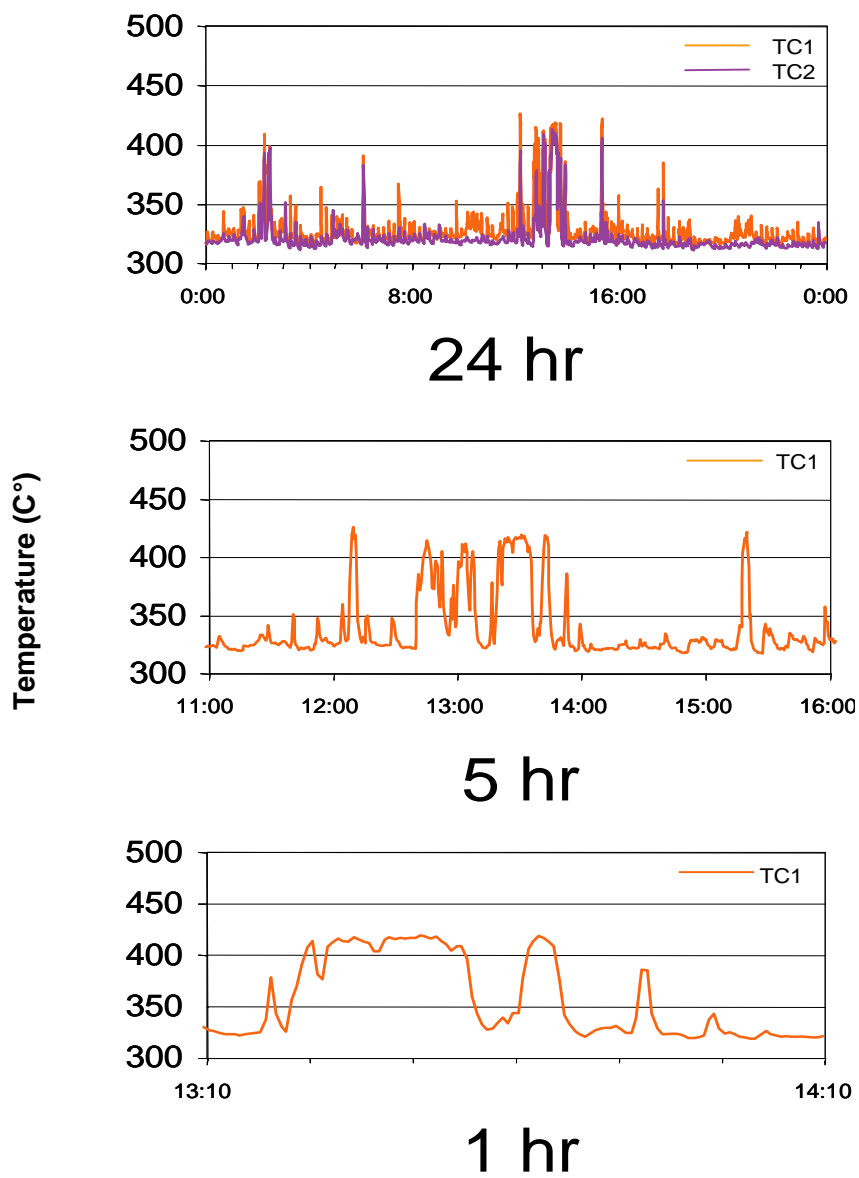
Careful examination of thermocouple data over short time intervals revealed two dominant temperature bands (Fig. 32). Further examination of the corresponding video, during the longest and most stable of these temperature events, revealed two extremes in the density of accumulated char particles.

Upper temperature band—The thermocouple shields were exposed, except for the usual white coating on the surface. No particulate was landing on the surface of the thermocouple shields, the char bed was more than roughly 30 cm (1 foot) from the bottom of the primary air port, and very steady temperatures ($\pm 5^\circ\text{C}$) were recorded, typically for periods of about 15 minutes (Fig. 33a). The actual temperature measured within the upper band appeared to vary with location of the thermocouple relative to the port and the port's location around the boiler. For Mill C's boiler, the temperature band was generally 380 to 420°C.

Fig. 32. Temperature measurements from thermocouples installed on tube bends at the bottom of a primary air port; expansion of data time scale assisted in the recognition of two dominant temperature bands.

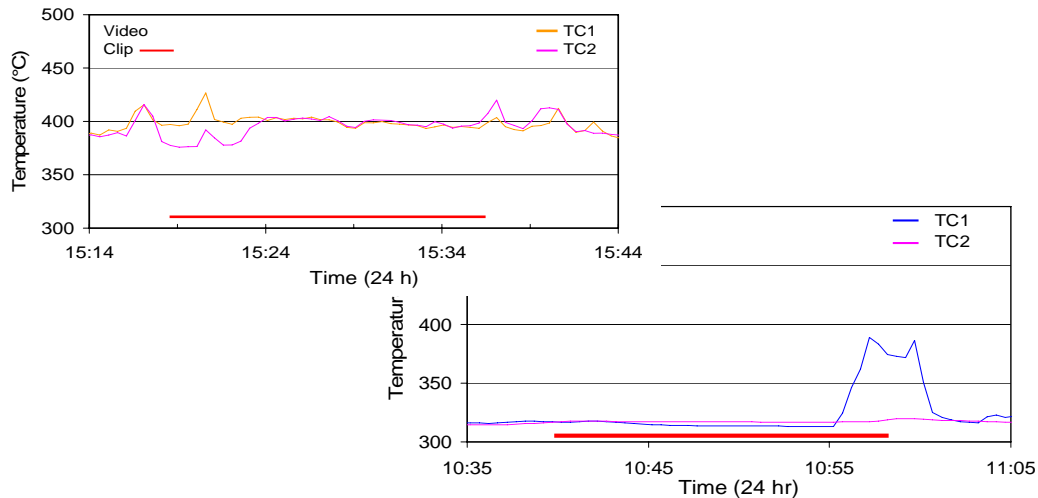
Fig. 33. Temperature measurements from thermocouples installed on tube bends at the bottom of a primary air port (a-upper left) example of characteristic temperatures in the upper temperature band and (b-lower right) example of characteristic temperatures in the lower temperature band.

Lower temperature band—A high char bed at the tube walls submerged the coated thermocouple shields beneath a compact layer of medium sized white or grey char particles. This results in very steady temperatures close to that of the water in the wall tubes, and can last for several hours at a time. The char bed over the tubes was continuously renewed by light particle deposition as combustion occurred, and appeared stable and dense enough to protect the coated thermocouple shields from exposure to radiation, hot combustion gas or air interaction. Exclusion of oxygen would allow endothermic reduction reactions to dominate [17]. It's possible that such a cooling effect could contribute to the stability of the temperature on tube surfaces submerged under the char bed. The temperature measured at the bottom of the primary air ports under this condition in Mill C's boiler was typically $320 \pm 5^\circ\text{C}$ (Fig. 33b).

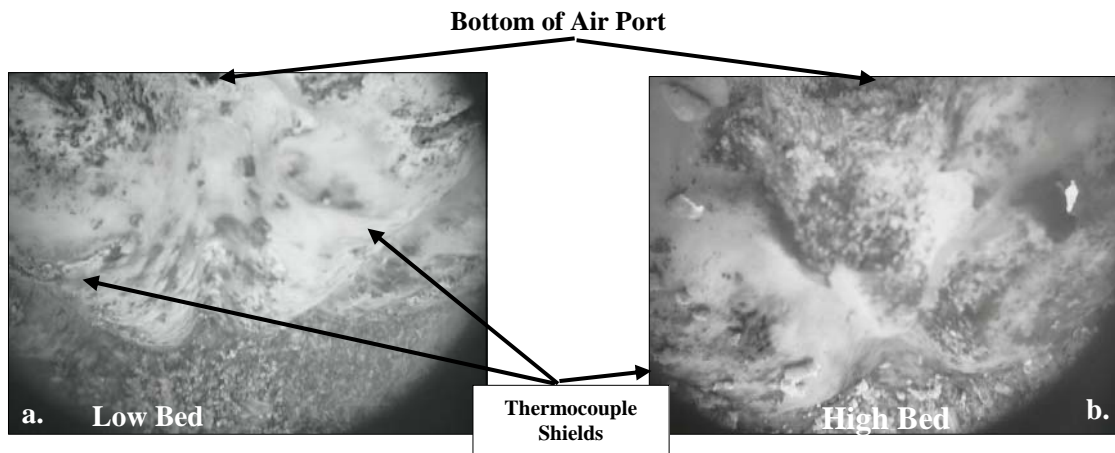
Examples of what is seen with the video camera are shown in Fig. 34. Figure 34 shows photos taken by the camera when a) the bed is low and when b) the bed is high.

Fig. 34. View of the air port opening tubes as seen by the boiler camera probe taken while boiler was in operation. (a) The bed is low, and can be seen at the base of the tubes. Thermocouple shields are barely visible on both the left and right hand tubes, and (b) similar camera view of the air port. The bed at this point is much higher and may be obscuring view of the thermocouple shields. While not obvious in this still photograph, streams of transparent liquid are flowing down the smooth light gray surface on either tube.

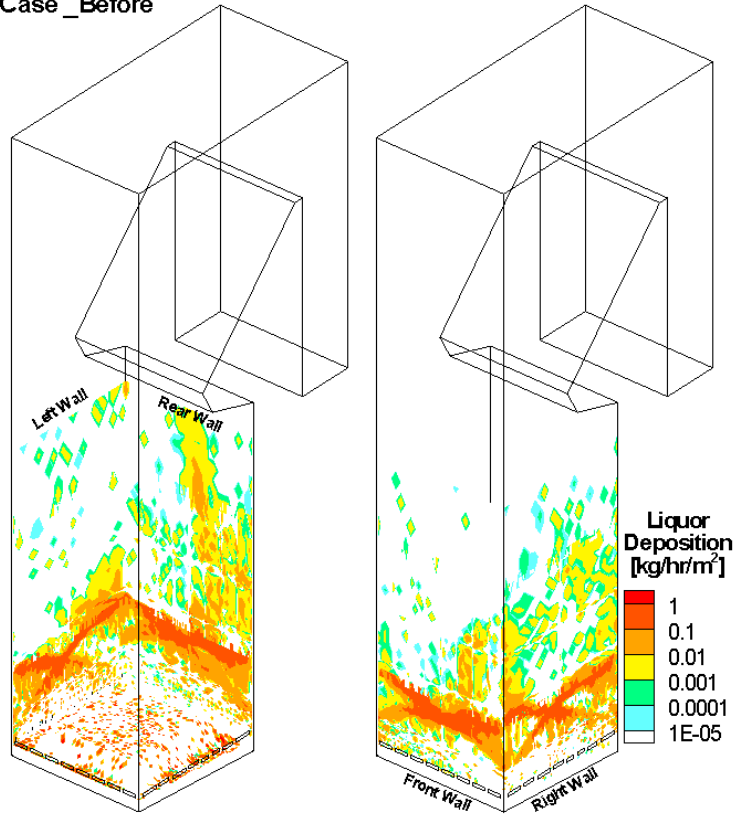
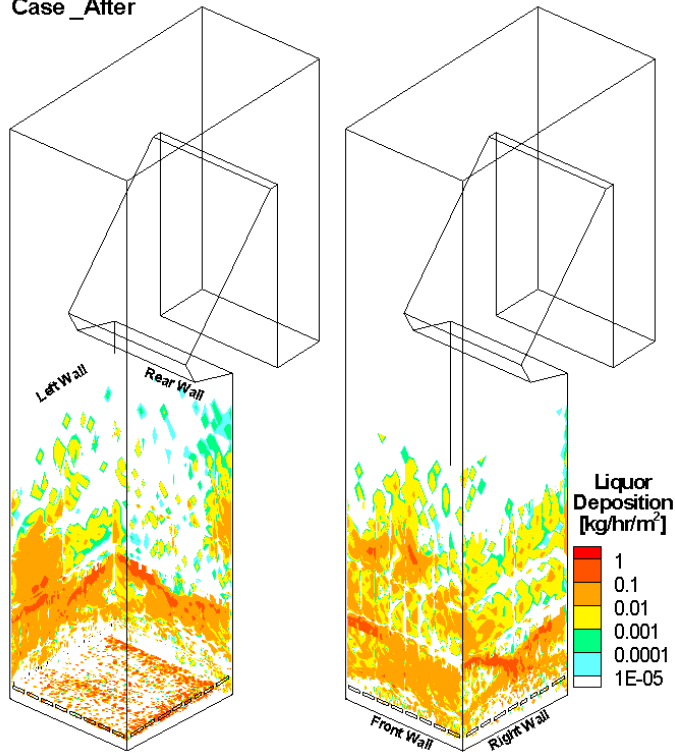
The modeling of the two cases has shown some differences in the boiler performance, which are believed to be associated with tube temperature excursions. The liquor deposition on the walls is one of the major differences. As shown in Fig. 41 and listed in Table 8, the total liquor deposition on the walls decreases from 65.2% to 45.5% after the changes. Moreover, the volatiles remaining in the liquor when it sticks on the walls decrease by about half and the moisture remains more than half. It means that in “Case Before” there are twice as many liquor droplets burning on the walls comparing to “Case After”. As discussed above, burning droplets on the walls could provide heat sources for tube temperature excursions. The decrease of wall deposition in “Case After” is considered a result of liquor nozzle change. A wedge nozzle spreads more liquor towards edges than a splash plate nozzle does. Finer droplets in “Case After” are more easily burned in flight; therefore fewer burning droplets hit the walls.

Fig. 41. Predicted wall deposition in Case Before and Case After of Boiler-Q.

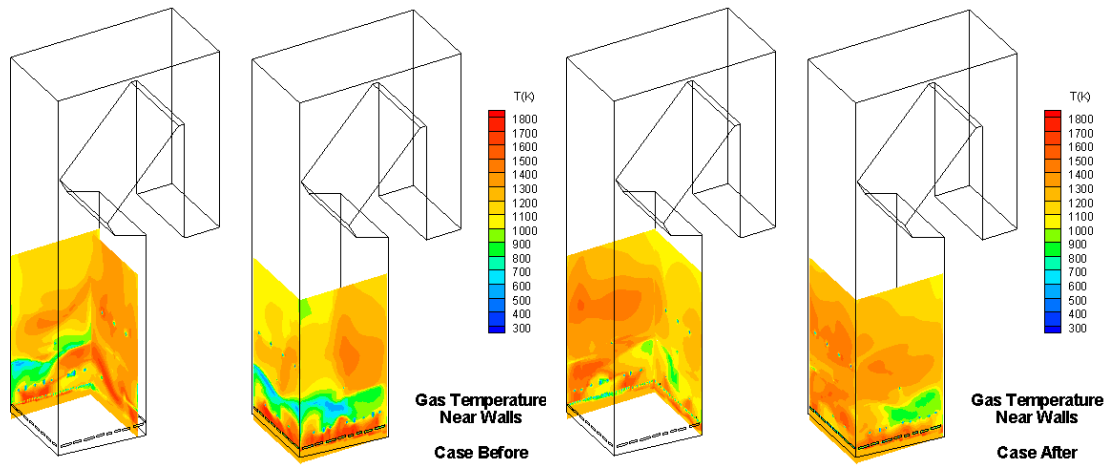
The heat fluxes to the walls and the gas temperatures near the walls show differences between the two cases. Figure 42 presents the gas temperature near the walls in the lower and mid furnace. In “Case Before,” the gas temperature around primary air ports on the front and the right walls is higher than that in “Case After”. Higher gas temperature reveals stronger combustion and contributes higher radiation heat to the walls around primary air ports. As shown in Fig. 43, the heat fluxes on the front and the right walls are higher in “Case Before” than in “Case After.”

Fig. 42. Predicted gas temperature near the walls in Boiler-Q.

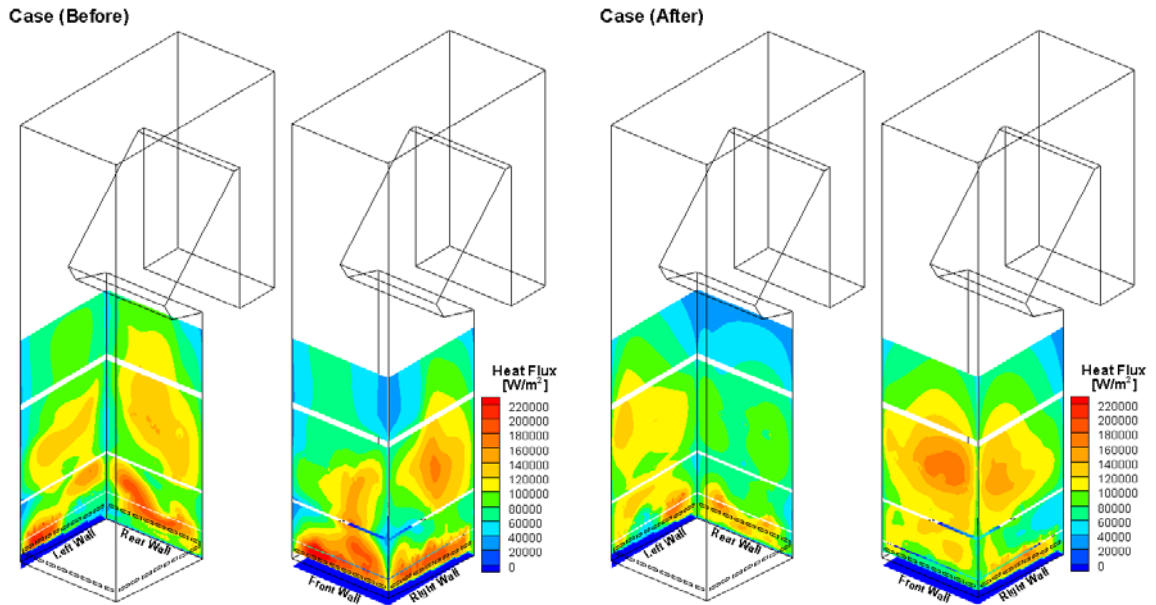
Fig. 43. Predicted heat flux to the walls in Boiler-Q.

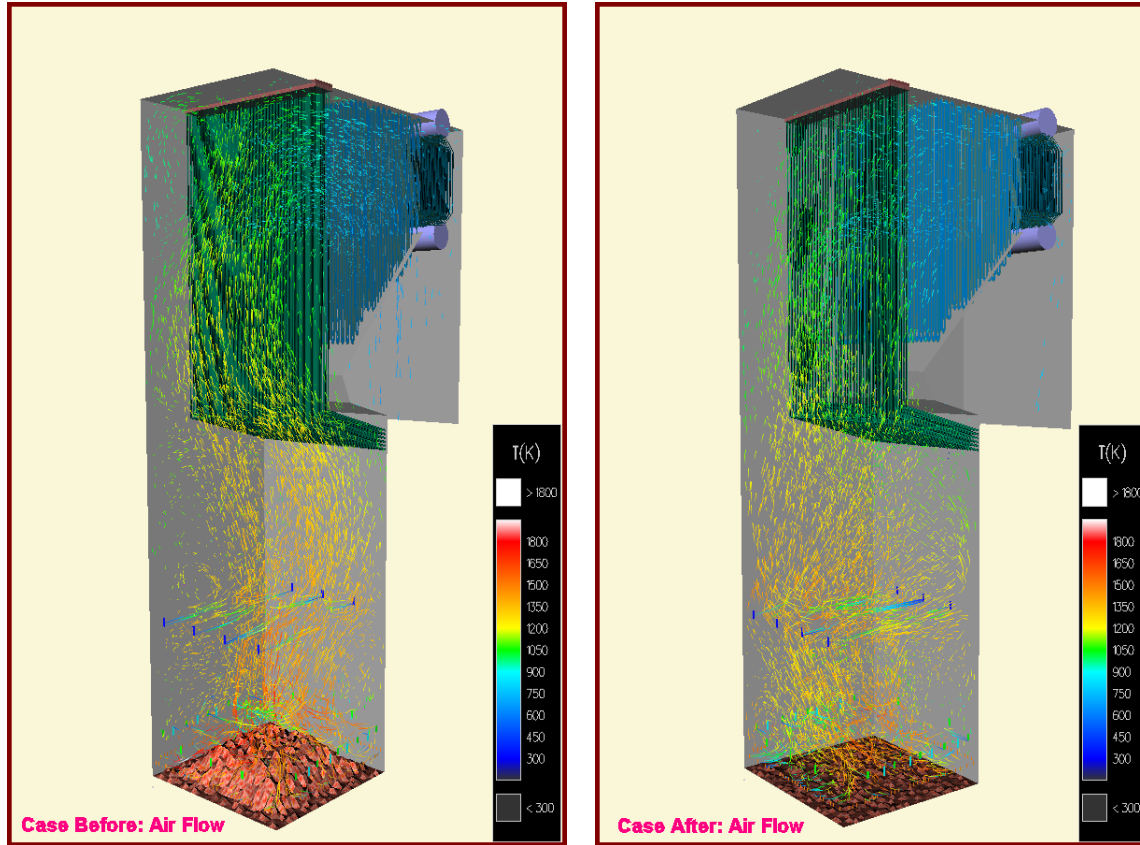
The flow pattern in the boiler shows a significant difference between the two cases. Figure 44 shows a picture of the flow animation of each case. In “Case Before,” secondary air jets have strong collisions in the boiler center and form a strong upward flow in a limited area. A strong recirculation is formed above the secondary air. Although the modeling could not predict the flow instability quantitatively, the predicted flow pattern is believed highly unstable. Any disturbance in the operational conditions could change the pressure differences between the upward flow and the recirculating flow and promote upward flow in the furnace. The tube temperature excursion is believed to be strongly associated with the flow instability in the furnace. In comparison, the flow

Fig. 44. Predicted air flow in Boiler-Q.

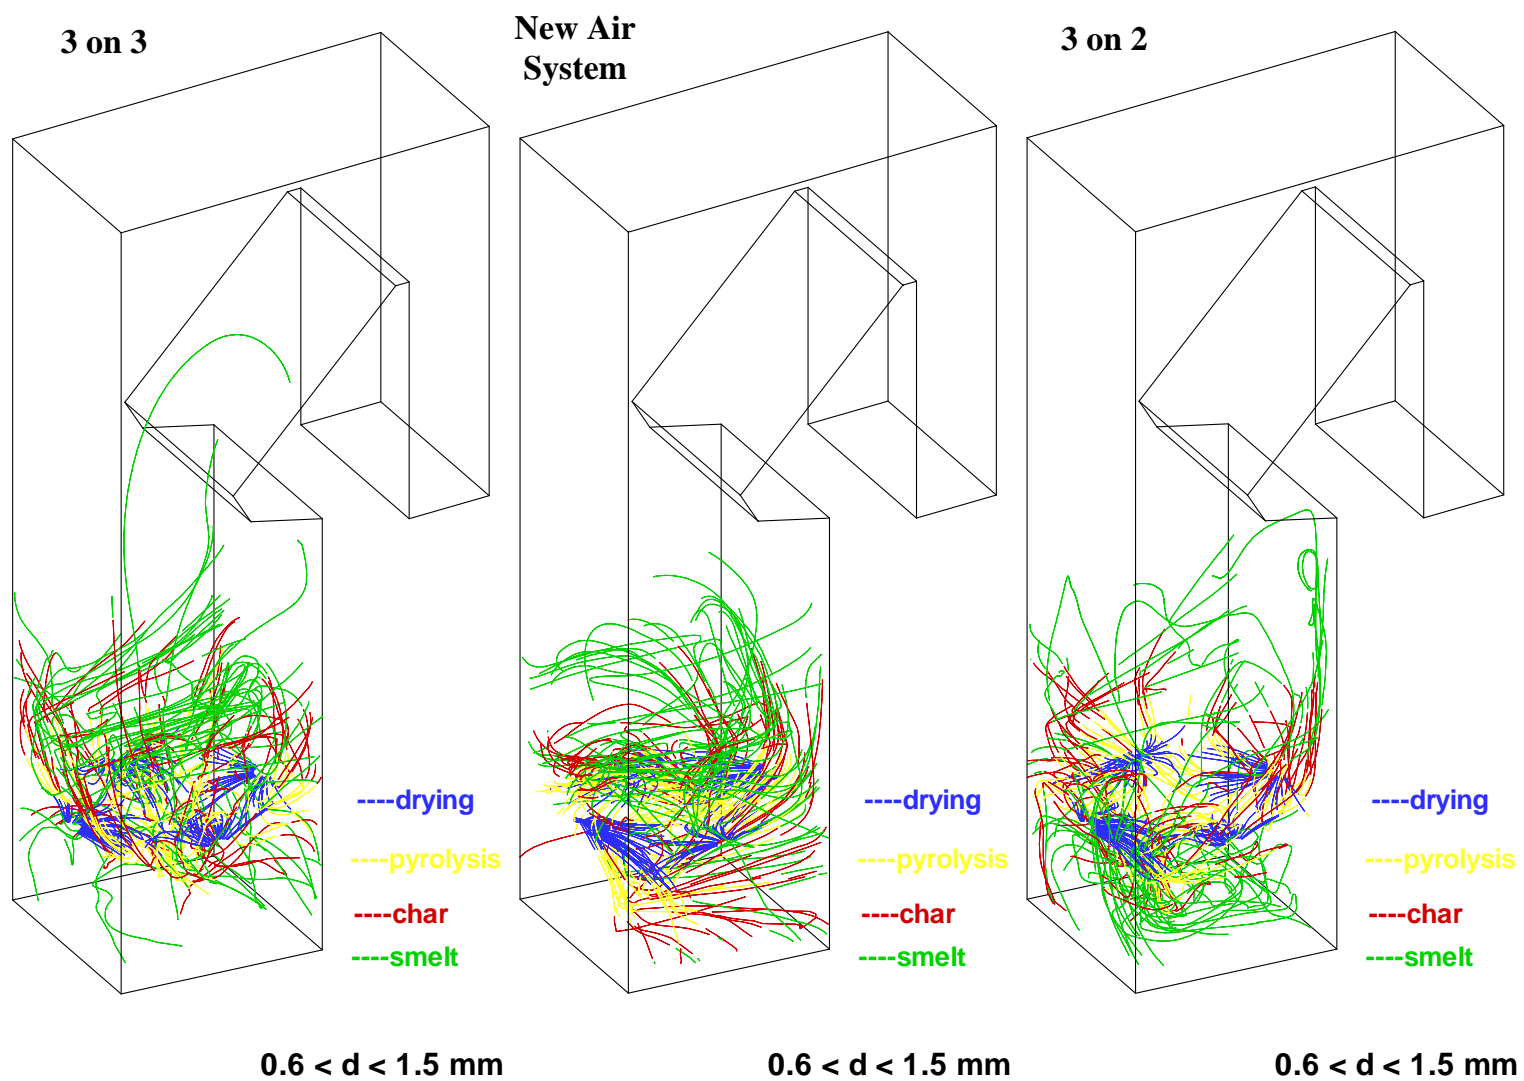
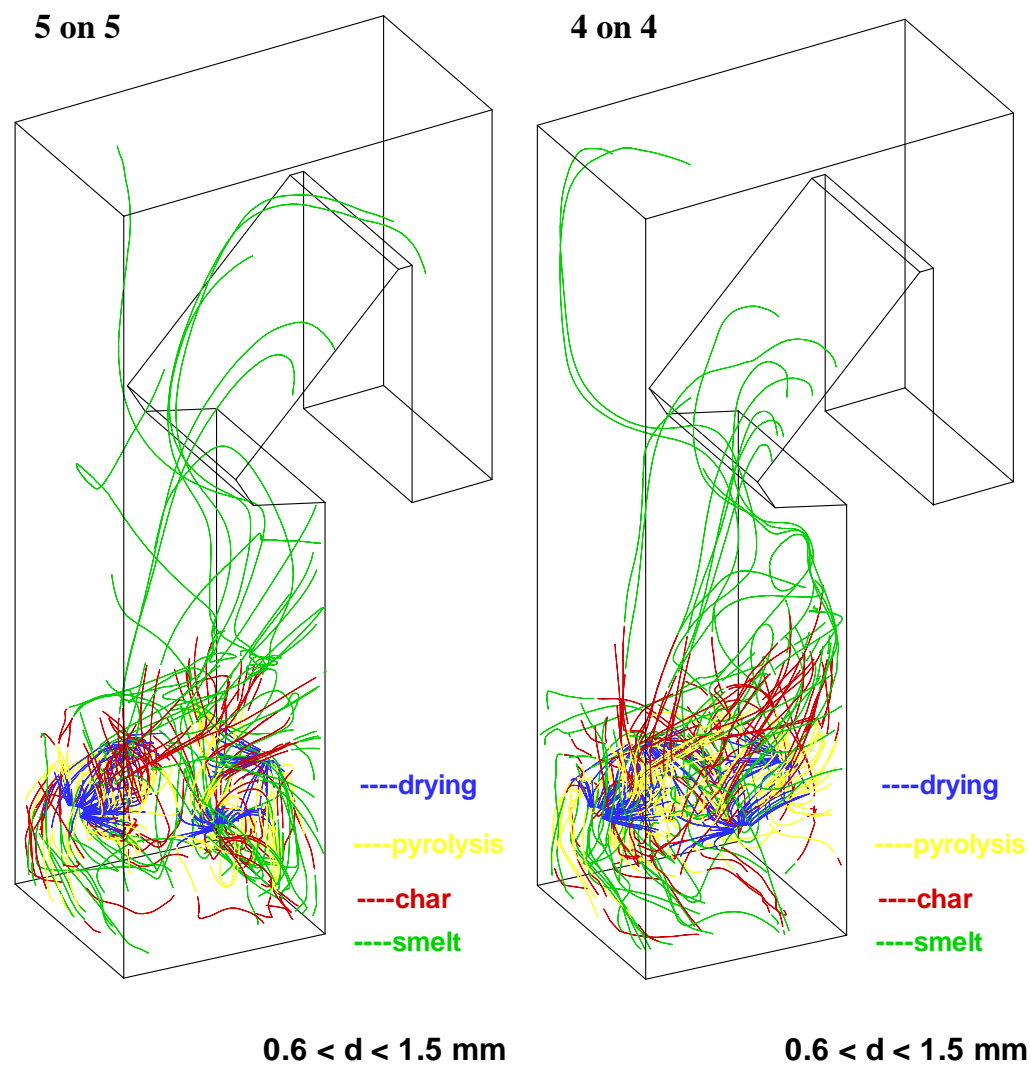
Fig. 53(a). Trajectories of medium droplets under different secondary air distribution modes in Boiler-Q.

Fig. 53(b). Trajectories of medium droplets under different secondary air distribution modes in Boiler-Q.

None of the changes in air distribution or port geometry had a big effect on the distribution of liquor deposition on the walls. There were however, as shown in Fig. 53, some differences in the droplet trajectories. In mode 5 on 5 and 4 on 4, there are many small and medium droplets being entrained by downward flow along the front and the rear walls and reaching the areas around the primary air ports. In mode 3 on 3, very few small and medium droplets reach the primary air port.

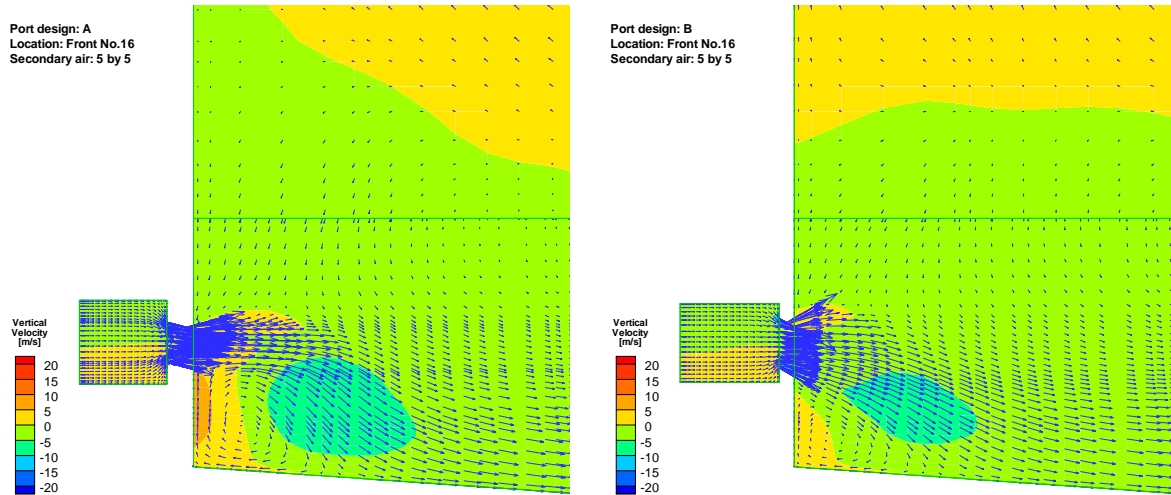
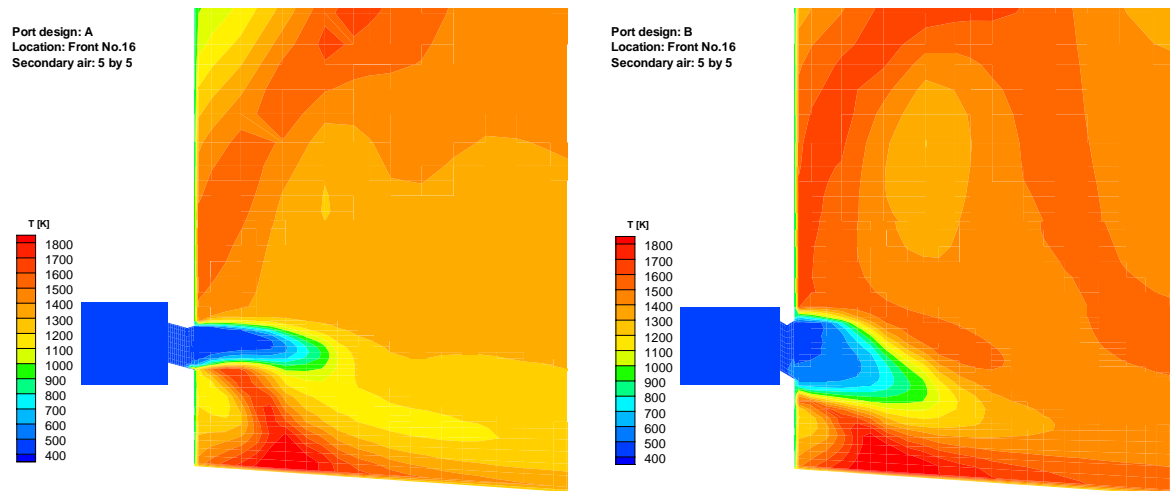
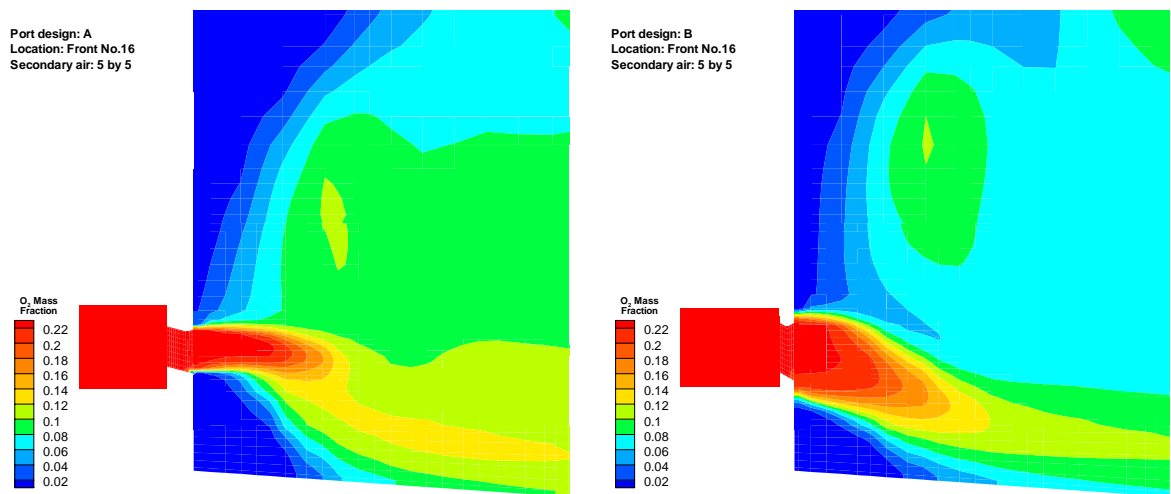
Fig. 70. Comparison between Design A and Design B at same location.

The single air port model is coupled with the global boiler model at the same location on the front wall for Design A and Design B, respectively. The modeling results, illustrated in Fig. 70, indicate that Design A has a strong recirculation below the air jet, which brings high temperature gas back to the bottom of the port. The strong recirculation favors a build up of the char bed below the air port, which is linked with temperature fluctuation. The predicted oxygen distribution reveals possible combustion in the bottom area of the port.

As seen in Figs. 70 and 71, Design A has a strong recirculation at the two locations on the front wall and the right wall. One more location on the right wall is also modeled, and the modeling shows a similar strong recirculation. The difference between different locations is the maximum temperature at the bottom to the port. The temperature inside the port reaches 1780°K at the location of front wall, and 1490°K and 1120°K , respectively, at the two locations of right wall.
