Cracking and Corrosion of Composite Tubes in Black Liquor Recovery Boiler Primary Air Ports

October 2006

Materials Science and Technology Division

**CRACKING AND CORROSION OF COMPOSITE TUBES
IN BLACK LIQUOR RECOVERY BOILER
PRIMARY AIR PORTS**

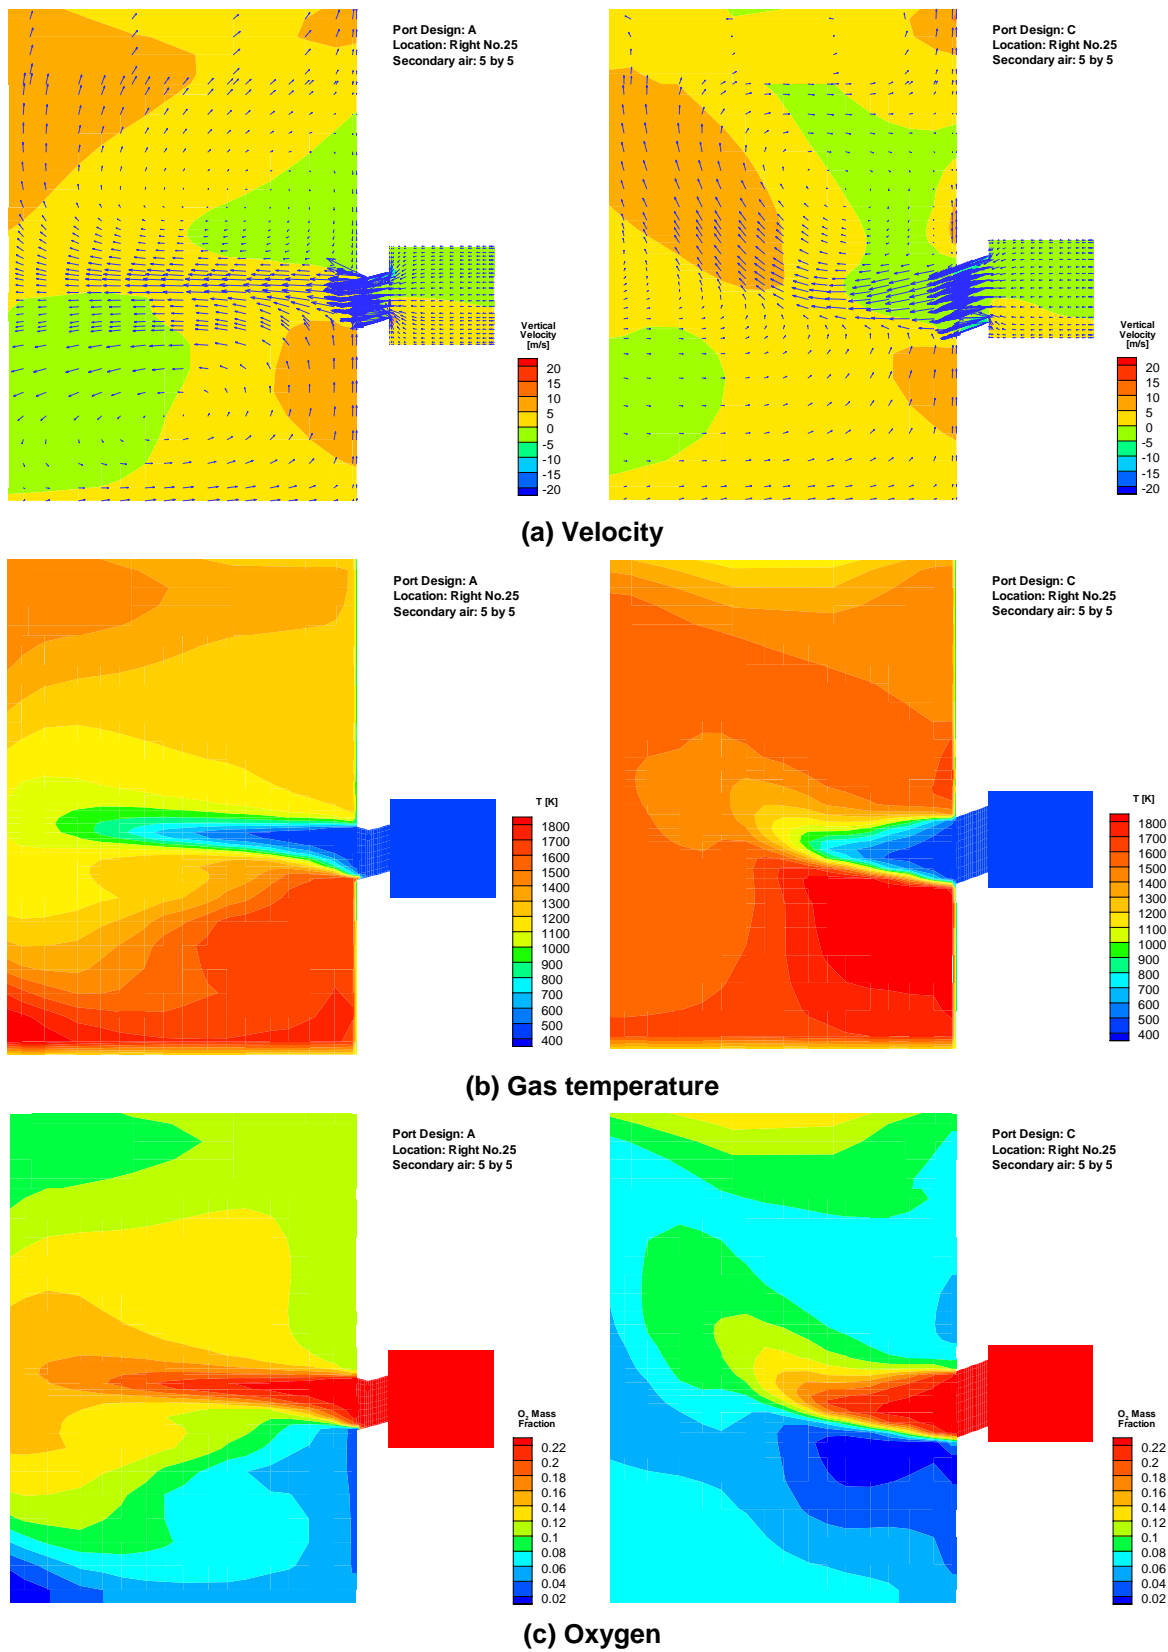
Fig. 71. Comparison between Design A and Design C at same location.

Design A and Design C were modeled at the same location on the right wall. Fig. 71 shows the local flow field and environment around the air port. Comparing both designs, Design C has less recirculation and therefore less high-temperature gas going back toward the bottom of the port.

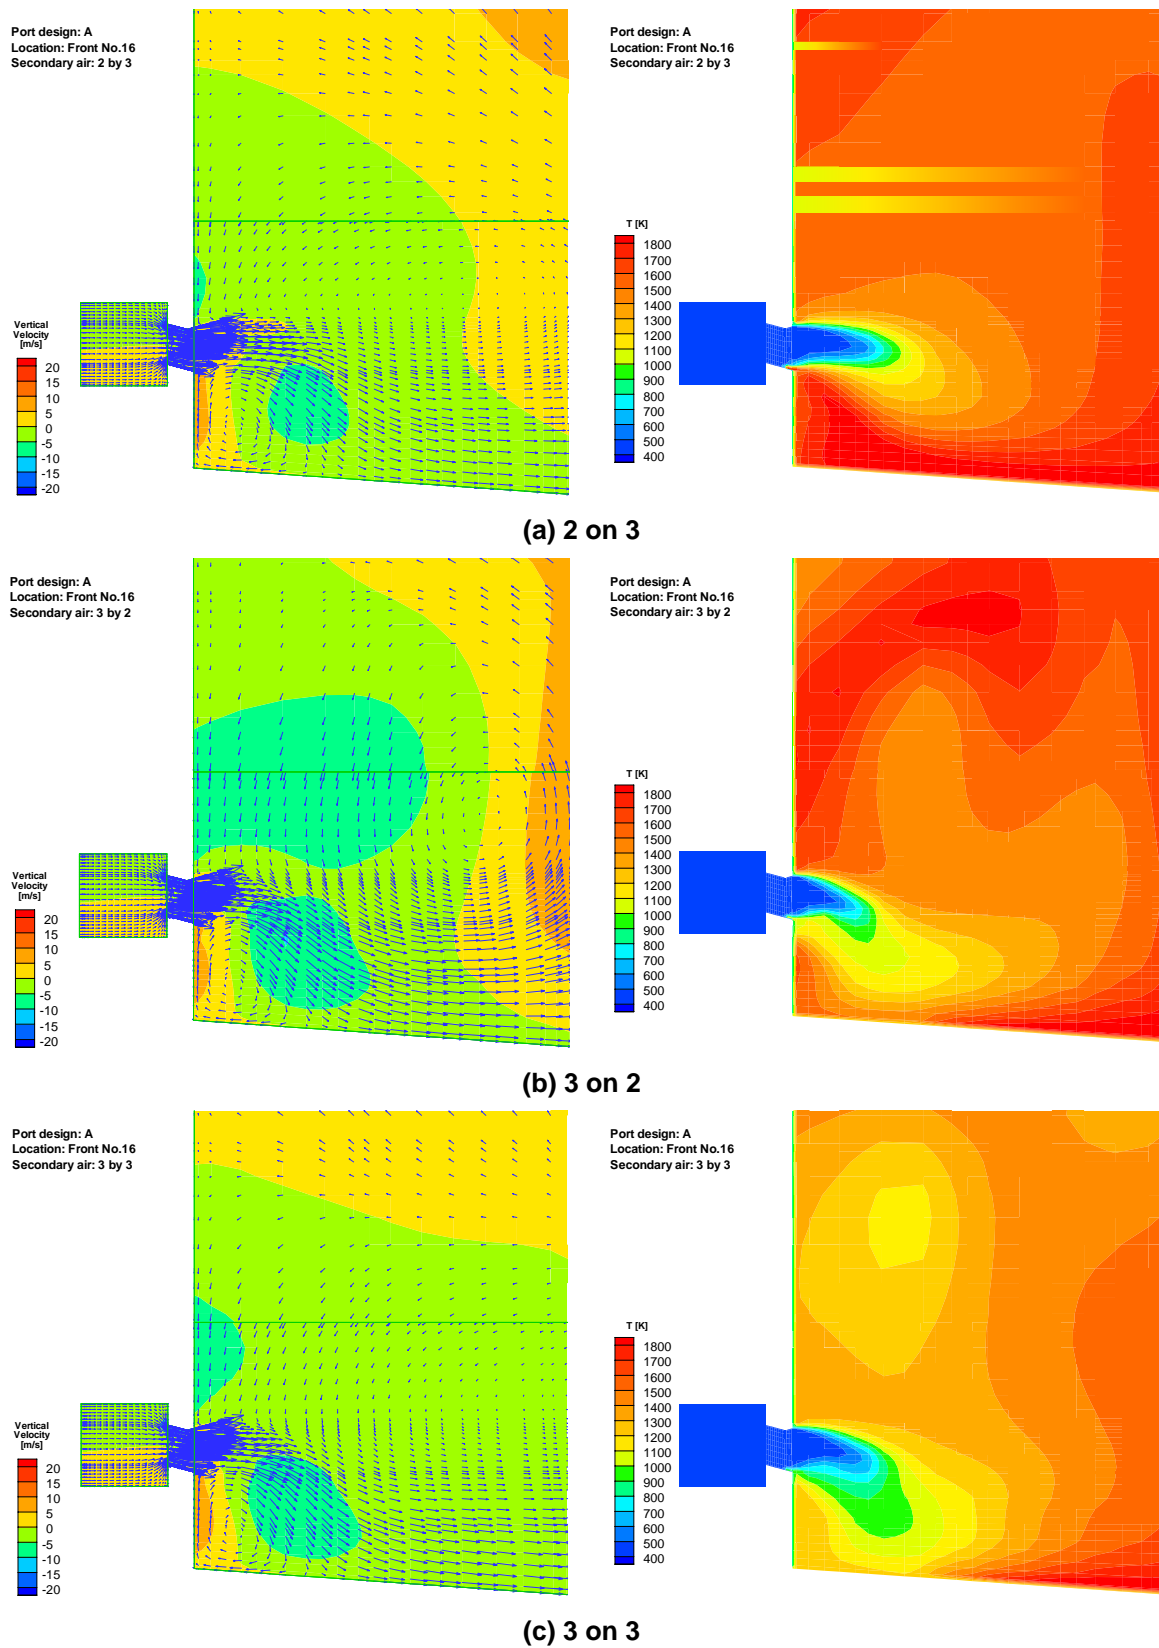
Fig. 72. Comparison of same design under different operation conditions.

As revealed by the global boiler modeling, secondary air distribution has a significant influence on the boiler performance. It can be speculated that the secondary air distribution should also have an influence on the local environment around primary air ports. A primary air port of Design A at location No.16 on the front wall was modeled in coupling with the whole boiler operated under different modes of secondary air distribution. Four modes were modeled: 5 on 5, 3 on 3, 2 on 3, and 3 on 2. The local flow field and gas temperature around the air port is shown in Fig. 72 for different operation conditions. The common feature in the flow patterns is that a recirculation zone is always formed under the primary jet, regardless of secondary air distribution. While always being present, the level of recirculation is stronger in some cases and weaker in others. As a result of the recirculation, the gas temperatures in the port bottom area are different. The maximum calculated gas temperature inside the port are, in decreasing temperature, 1658°C for Case 2 on 3, 1507°C for Case 5 on 5, 1321°C for Case 3 on 2, and 915°C for Case 3 on 3. The data is also shown in Table 12. Figure 73 shows the gas velocity, gas temperature and oxygen content for two air port designs. The maps in the left hand column show the pattern for the conventional, wide, short primary air port while the maps on the right show the patterns for the longer, narrower primary air port.

The modeling of single air port designs within the whole recovery boiler shows that different air port designs behavior differently, interestingly, the same port design can behave differently at different locations under similar operating conditions. Among three air port designs modeled, Design A creates the strongest level of recirculation below the primary jet. The strong recirculation can bring hot gas, hot smelt, and/or burning droplets back to the bottom of the port, which could cause the temperature fluctuation on the tube surface. Also, the recirculation varies as a function of location and operating conditions.

To prevent cracking in primary air port tubes, the CFD modeling study indicates the flow and combustion in the furnace needs to be stabilized by either adjusting the air split and/or air distribution among ports or updating air system design. Computer modeling can help to optimize the operation and design and to evaluate the stability of the flow and combustion. Avoiding strong recirculating gas flows below primary air jets can be achieved with an air port that is designed to remove burning droplets and local gas combustion from tube surface. It is also important to minimize the number of liquor droplets hitting the walls, which could be achieved by choosing different nozzle designs, or changing liquor properties such as temperature and solid content. Computer modeling can also help to evaluate the liquor combustion process in recovery boilers.

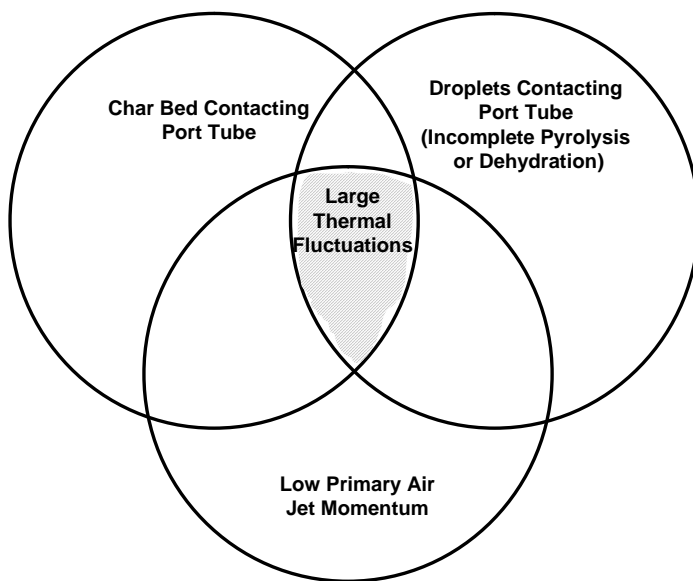
Observations during these trials, which include observations from *in situ* video imaging described in section 6 and reported separately [53], suggest there may be three critical conditions that must be present simultaneously to produce large thermal fluctuations: char bed contacting the port tube, high flux of black liquor droplets contacting the port tube while pyrolysis and possibly dehydration is incomplete, and low primary air jet momentum (Fig. 81). Two of those critical conditions (char bed contacting the port tube and low primary air jet momentum) are derived mainly from observations and measurements reported here. The third critical condition (high flux of black liquor droplets contacting port tubes while pyrolysis and possibly dehydration is incomplete) is derived mainly from observations made from *in situ* video imaging covered in section 6 [53]. Arguments in support of those critical conditions are made by answering the question: how do these global changes in operation, namely burning of soap in combination with black liquor, nozzle type, and high primary air jet momentum change the local conditions in and around primary air ports?

Fig. 81. The three critical conditions required for the large thermal fluctuations associated with primary air port cracking: simultaneous char bed contacting the port tubes, a high flux of droplets contacting the port tube while pyrolysis and possibly dehydration is incomplete, and low primary air jet momentum.

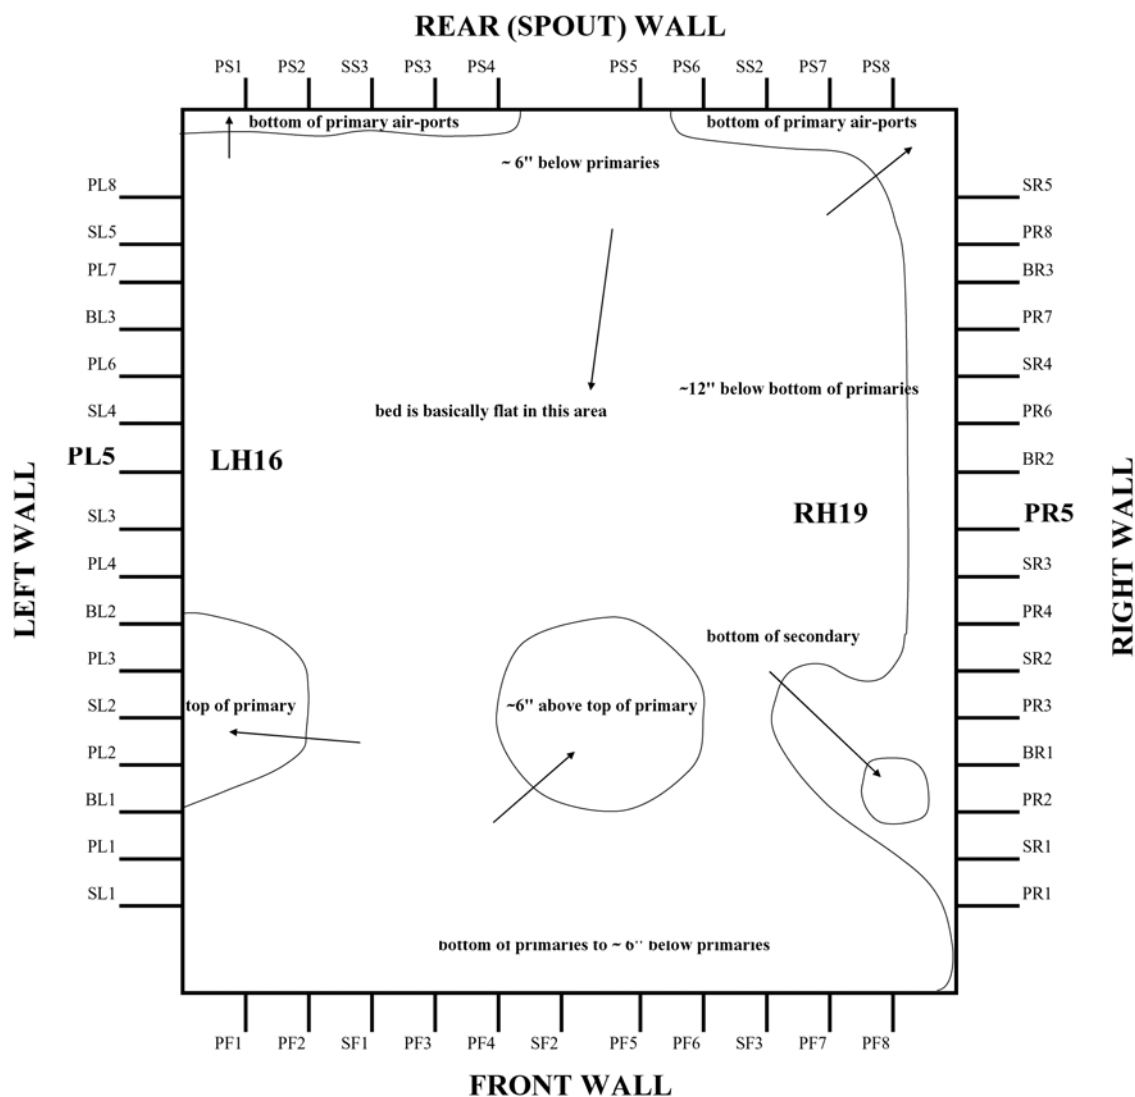
Figure 82 schematically illustrates a contour map of the char bed height made during Trial IV. As the map shows, the critical condition of a high char bed located adjacent to the primary air port is met for ports on the right wall, but it is not met for ports on the left wall. This situation provided an opportunity to test the hypothesis that three critical conditions must be present simultaneously for large thermal fluctuations. The test involved producing the two remaining critical conditions simultaneously at an instrumented air port located on each of the side walls (RH19 and LH16) and then observing the temperature response. Closing the damper of the windbox containing the instrumented port attained the critical condition of low primary air jet momentum. The remaining critical condition of droplets contacting the port bottom while pyrolysis and possibly dehydration is incomplete was attempted by closing the damper of the secondary air port located nearest to the instrumented port. *In situ* video imaging conducted during the experiment, the results of which are reported elsewhere [6], provide strong evidence that this was indeed achieved.

Fig. 82. Schematic contour map of char bed shape and height around the time of the verification experiments. Note that the height of the char bed is at the bottom of the primary air ports on the right wall and is about 6 inches below the primary air ports on the left wall along the majority of the wall. Arrows indicate direction of increasing char bed height.

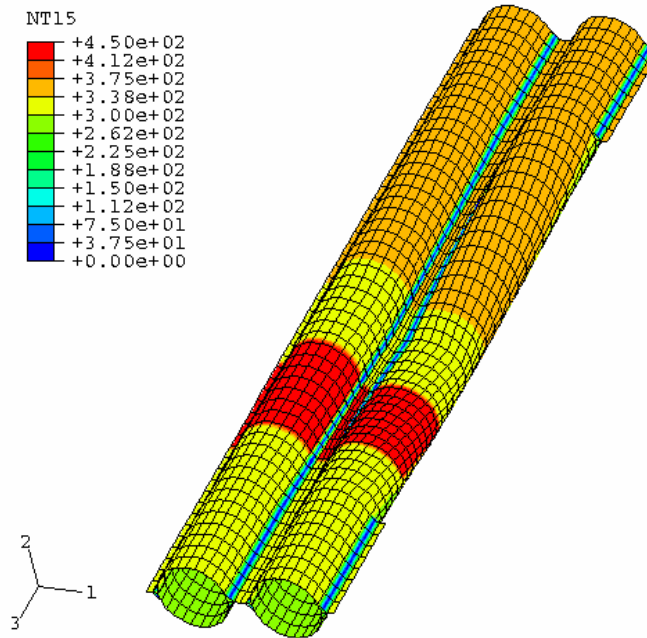
The thermocouple data being collected from several mills indicate that essentially all primary air ports experience fluctuations in temperature, and, in some cases, the fluctuations reach fairly high magnitudes. These severe fluctuations are often limited to the lower portions of the air port opening. The effects of these localized temperature excursions were investigated through finite element modeling. The temperature rise was limited to a small region on the lower portion of the primary air port, while the balance of the tube remained under normal operating conditions. Figure 87 shows the temperature contours assumed for this model during the localized heating. The results of the modeling effort are presented at the surface of the clad layer and at two locations in the carbon steel layer—at the interface on the SA210 side and the inside surface of the tube at the crown of the tube on the fireside, since the interest is mainly in checking for development of tensile stresses in the carbon steel.

Fig. 87. Temperature [°C] contours at the fireside surface of primary air port during localized heating.

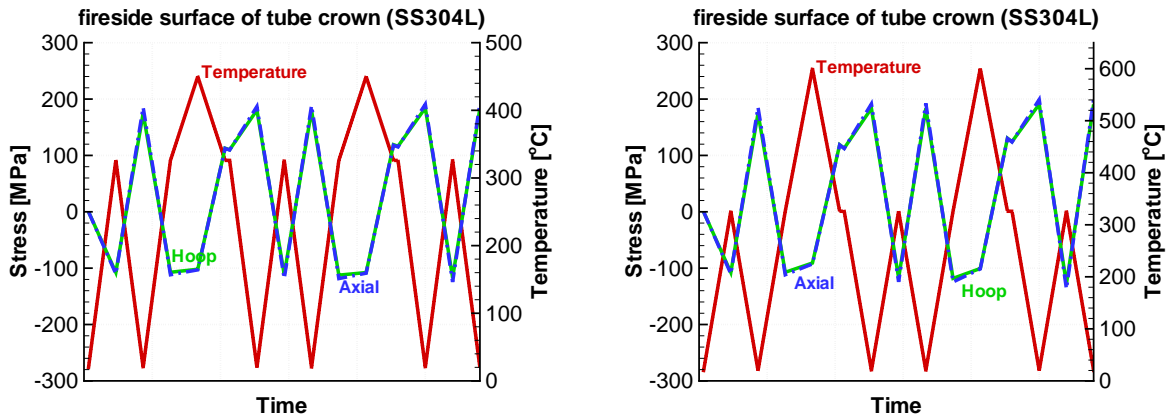
Figure 88 shows the changes in temperature and stress values at the fireside surface for 304L stainless steel clad tube. The operating cycles analyzed consisted of heating to normal operating temperature as well as localized heating to two different temperatures, 450°C and to 600°C. Due to the large thermal expansion mismatch between stainless steel and carbon steel, the stresses in the clad layer become compressive during heating to operating temperature. Upon cooling back to room temperature, the stresses become highly tensile at the surface. Upon reheating to operating temperature the stresses again are compressive. When the temperature increases further during localized heating, the stresses continue to remain at compressive yield. This is because of the large increase in the temperature gradient through the tube wall, since the inside surface of the tube is assumed to be in contact with water at 295°C. Removal of localized heating causes stresses to

Fig. 88. Stress variation at the fireside surface of the 304L clad composite tube during normal operating cycle and during localized heating to 450°C (left) and 600°C (right).

become highly tensile upon returning to operating temperature, and cooling to room temperature further increases their magnitude. A second cycle of localized heating and normal operation shows stress values similar to the first cycle. The results for temperature excursions to 450°C and 600°C are very similar at the tube surface, since both temperatures exceed the value required to cause yielding in the stainless steel layer. These results are significant, since they show that while stresses are expected to be compressive under normal operating conditions at the fireside surface of the 304L clad layer in primary air port composite tubes, localized temperature excursions can lead to tensile stresses even at normal operating temperature.

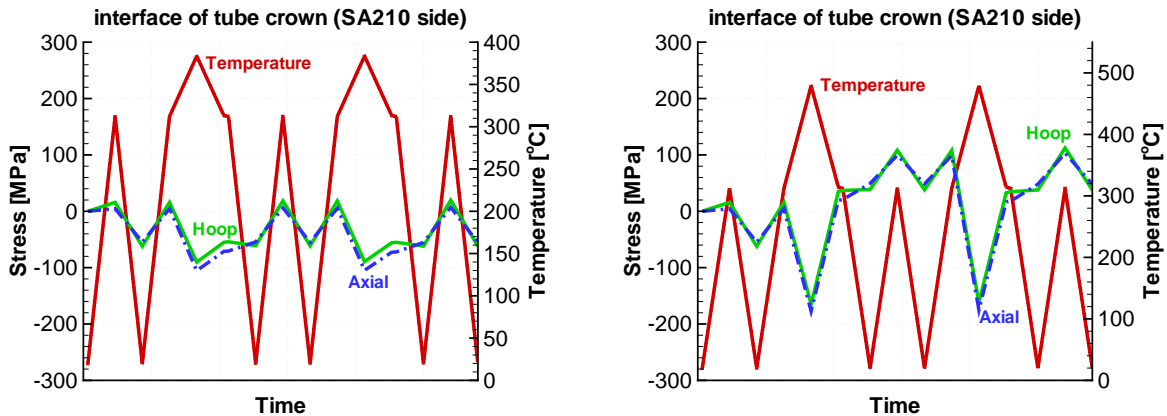
Figure 89 shows the temperature and stress variation on the carbon steel side at the interface with the clad layer during normal operation and for the 450°C and 600°C temperature fluctuations. Heating to operating temperature and cooling to room temperature during a normal operating cycle causes stresses to become slightly compressive. During localized heating to 450°C, the interface on the SA210 side develops compressive stresses due to the constraint from the region closer to the inside surface which is at lower temperature. When the localized heating is removed, the stresses are less compressive at operating temperature and after cooling to room temperature. The stresses become slightly tensile upon subsequent heating back to operating temperature. When the localized fluctuation temperature is increased to 600°C, the stresses during localized heating are even more compressive, and the stresses upon returning to operating temperature are now slightly tensile. What is of significance is that due to the plastic deformation resulting from the localized heating, the stresses at operating temperature and at room temperature are now slightly tensile instead of being compressive. Subsequent heating to normal operating temperature now causes tensile stresses of even higher magnitude in the SA210 at the interface, potentially aiding the propagation into the carbon steel layer of cracks that originate in the clad layer. A second cycle of localized heating and normal operation shows variation of stresses which is similar to the first cycle.

Fig. 89. Stress variation at the interface on the carbon steel side of the 304L clad composite tube during normal operating cycle and during localized heating to 450°C (left) and 600°C (right).

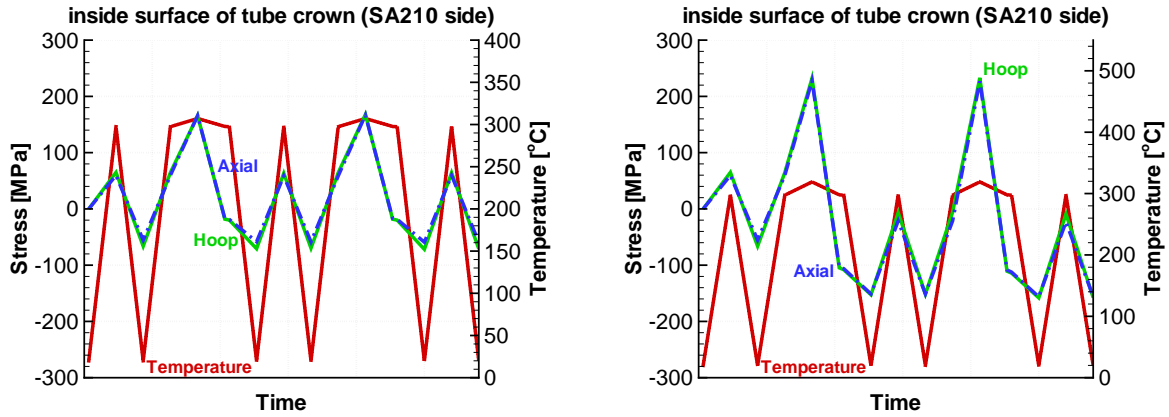
The temperature and stress variations at the inside surface of the tube are shown in Fig. 90. The stresses become tensile during heating to normal operation and compressive upon cooling to room temperature. The tensile stresses increase in magnitude during localized heating due to the increased temperature gradient through the wall. Cooling to operating temperature causes stresses to become compressive, and cooling to room temperature causes further increase in their magnitude. The stress variation at the inside surface is qualitatively similar for localized fluctuations to 450°C and 600°C, with some differences in the magnitudes. The higher temperature leads to a higher magnitude for the

Fig. 90. Stress variation at the inside surface of the 304L clad composite tube during normal operating cycle and during localized heating to 450°C (left) and 600°C (right).

compressive stresses at the end of the localized heating cycle, which would be beneficial in preventing cracks from progressing through the carbon steel layer all the way to the inside surface of the tube. A second cycle of localized heating and normal operation shows results very similar to the first cycle.

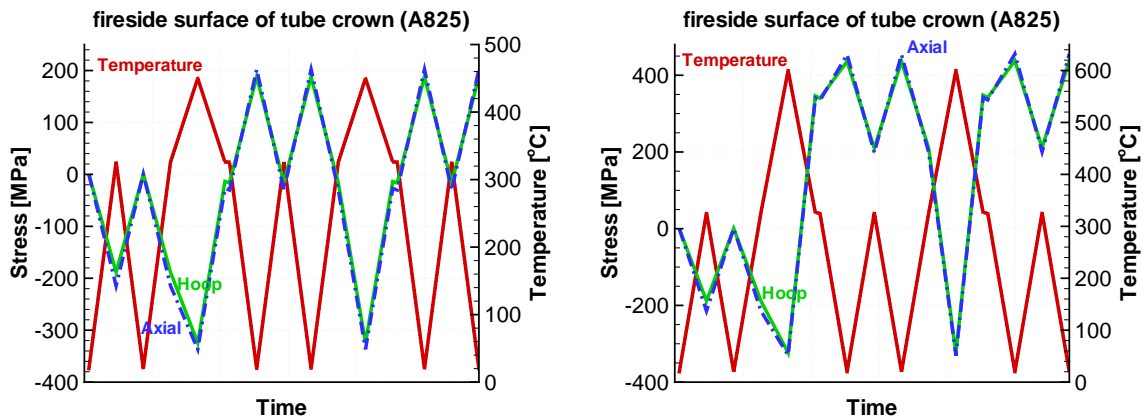
Since 304L stainless steel has low yield properties and high thermal expansion mismatch with carbon steel, alternate nickel-based alloys such as alloy 825 are being considered as potential replacements to form the clad layer of composite tubes in primary air ports. The modeling work to determine the stresses in the tubes, both under normal operation and during localized heating, was extended to alloy 825 clad composite tubes. Figure 91 shows the changes in temperature and stress values at the fireside surface for an alloy 825 clad tube. Due to the thermal expansion mismatch between alloy 825 and carbon steel, the stresses in the clad layer become compressive during heating to operating temperature. Upon cooling back to room temperature, the stresses return to their initial values. Upon reheating to operating temperature, the stresses again are compressive. When the temperature increases further during localized heating, the stresses become even more compressive at the surface of the clad layer, because of the large increase in the temperature gradient through the tube wall. Due to plastic deformation, removal of localized heating causes stresses to become much less compressive (almost zero) for the 450°C case, while they become highly tensile for the 600°C case. Subsequent cooling to room temperature further increases the magnitude of tensile stresses.

Fig. 91. Stress variation at the fireside surface of the alloy 825 clad composite tube during normal operating cycle and during localized heating to 450°C (left) and 600°C (right).

A second cycle of localized heating and normal operation shows stress values remain in the tensile regime during normal operation, indicating that sufficiently large localized temperature excursions can lead to tensile stresses at the fireside surface of the alloy 825 cladding in primary air port composite tubes.

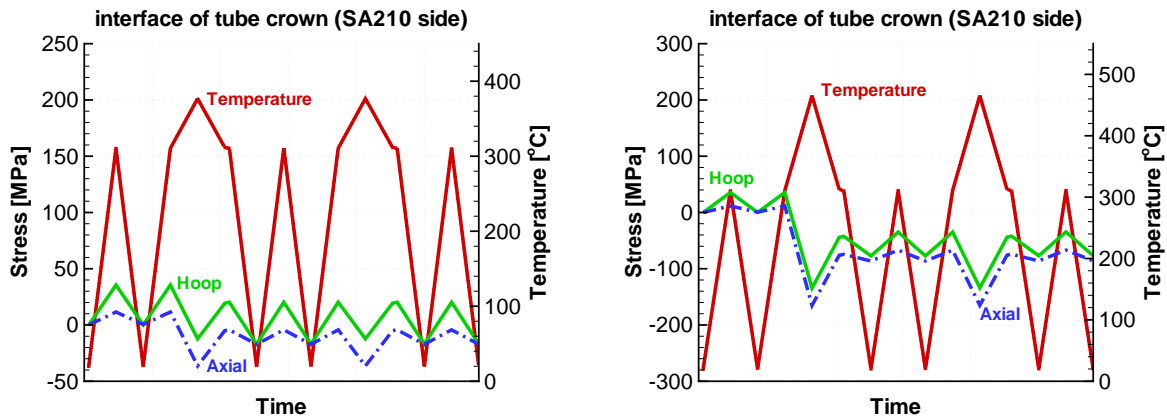
Figure 92 shows the temperature and stress variation on the carbon steel side of the interface with the clad layer during normal operation and for the 450°C and 600°C thermal excursions. During localized heating, the interface on the SA210 side develops compressive stresses due to the constraint from the region closer to the inside surface which is at lower temperature. When the localized heating is removed, the hoop stress is slightly tensile and axial stress is close to zero at operating temperature for the 450°C case. The stresses become compressive upon cooling to room temperature. During subsequent heating and cooling, the hoop stress changes between slightly tensile and slightly compressive values while the axial stress remains compressive. For the 600°C temperature fluctuation, both hoop and axial stresses become compressive during localized heating and remain compressive upon returning to operating temperature. The stresses remain compressive during subsequent normal operating cycle and localized heating and cooling. Unlike the stresses at the surface, the changes in stress values are not that large at the interface on the carbon steel side, and therefore effects of initial stress values would be significant in this case.

Fig. 92. Stress variation at the interface on the carbon steel side of the alloy 825 clad composite tube during normal operating cycle and during localized heating to 450°C (left) and 600°C (right).

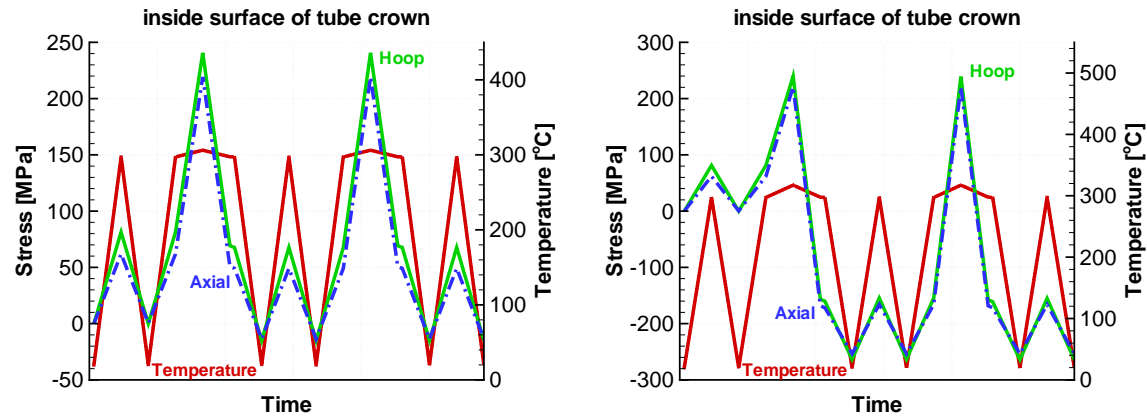
The temperature and stress variations at the inside surface of alloy 825/SA210 air port tubes are shown in Fig. 93. The stresses become tensile during heating to normal operation, and

Fig. 93. Stress variation at the inside surface of the alloy 825 clad composite tube during normal operating cycle and during localized heating to 450°C (left) and 600°C (right).

increase in magnitude during localized heating due to the increased temperature gradient through the tube wall. For the 450°C temperature excursion, cooling to operating temperature causes stresses to return close to values before the localized heating, and subsequent cycles show similar behavior. For the 600°C temperature excursion, cooling to operating temperature causes stresses to become compressive, and cooling to room temperature causes further increase in their magnitude. The stresses remain compressive during subsequent normal operation.

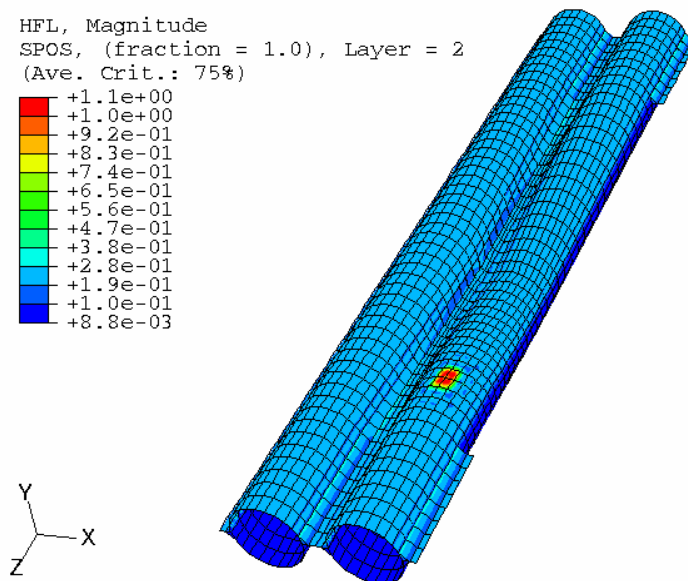
For both cases, the model used the assumption that the inside surface of the tube was in contact with water at 295°C , and the increase in heat flux was assumed to occur over a 2×2 element region of approximately 375 mm^2 (0.6 in^2) area on the lower portion of the bent tube, as shown in Fig. 94. Furthermore, it was assumed that all of the heat generated by the combustion or oxidation is directly felt by the tube surface, whereas, in practice, the tube fireside surface is often covered by a thin layer of frozen smelt—as has been documented by the video camera. The duration of the heat pulse modeled was assumed to be the result of a single event, even though the video camera work and personal observations indicated that both the liquor droplet deposition and the flow of molten smelt usually continued for a longer time.

Fig. 94. Heat flux [W/mm^2] contours on the outside surface of primary air port showing region of increased heat flux on the lower portion of the bent tube.

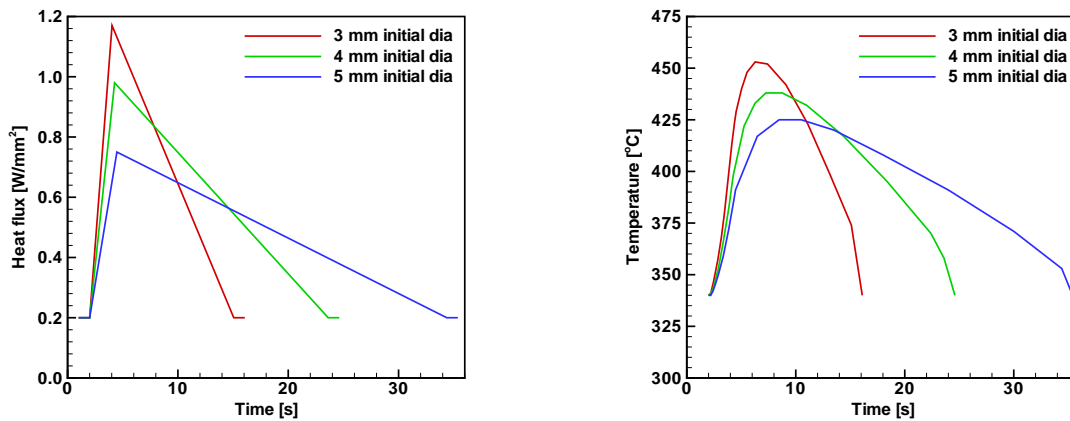
For the case of heat release from the combustion of black liquor droplets on the tube surface, the contributions from the volatile combustion (pyrolysis) and the char burning stages were considered. It was assumed that the total heat generated can be approximated by a heat flux profile which increases linearly over a fairly short period of time (1.5–2.5 s), before decreasing more gradually to the initial value. It was also assumed that the entire 2×2 element region of the tube surface was simultaneously under the influence of liquor droplets undergoing combustion. The variation in heat flux and the resulting temperature at the tube surface due to the combustion of liquor droplets is shown in Fig. 95 for three different droplet sizes. The smaller the droplet size, the higher is the peak heat flux and the temperature increase, and also the faster is the drop in temperature to its initial value. Since the heat flux is computed using an area measure based on the initial diameter of the droplet, the smaller droplet leads to a greater heat flux. It should be noted that the smaller droplet size causes a larger increase in temperature, but for a smaller duration.

Fig. 95. Variation of heat flux (left) and corresponding temperature (right) during localized heating due to combustion of black liquor droplets on the primary air port tube surface.

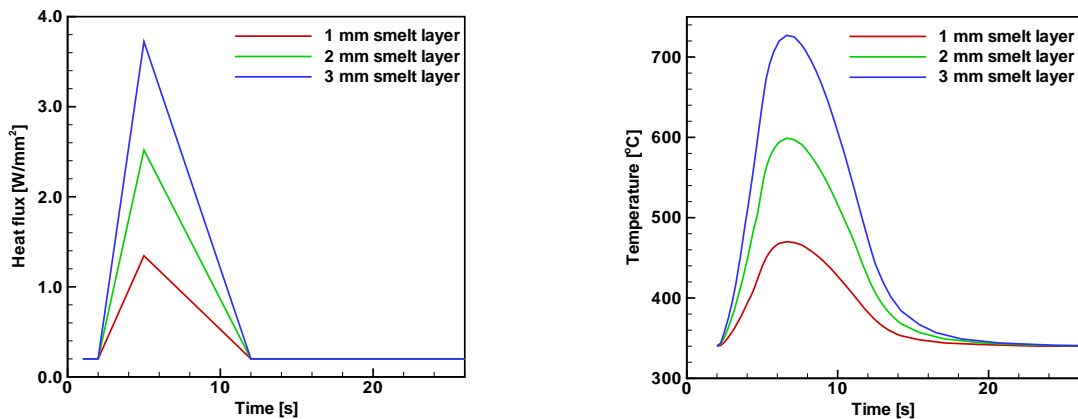
The other source of heat for a localized increase in temperature considered in the analyses was the exothermic reaction of smelt oxidation, which converts Na_2S to Na_2SO_4 . The maximum heat generated by the oxidation of a smelt layer on the tube surface was estimated, based on the assumption that sufficient oxygen was available to oxidize all the Na_2S in the smelt. In this case, the heat release was assumed to occur over a fixed period of 10 seconds, with a linear increase in heat flux over 3 seconds, followed by a linear decrease over the next 7 seconds. The heat flux increases with the thickness of the smelt layer, as does the maximum temperature at the center of the heated region (Fig. 96). Similar to the previous case, all of the heat from the smelt oxidation is assumed to go into heating the tube surface.

Fig. 96. Variation of heat flux (left) and corresponding temperature (right) during localized heating due to oxidation of Na_2S in the smelt on the primary air port tube surface.

The analyses described show that smelt oxidation is capable of causing a fairly large increase in temperature, although it should be mentioned that the magnitudes shown are based on calculations with several simplifying assumptions. The possible insulation offered by the frozen smelt layer has not been included in the analyses, and this could lower the maximum temperature during the localized heating. Nevertheless, the modeling results show smelt oxidation can lead to a fairly high heat flux and a significant increase in temperature, while the combustion of black liquor droplets leads to a comparatively smaller temperature rise. Thermocouple data recorded at 10 second intervals show, in

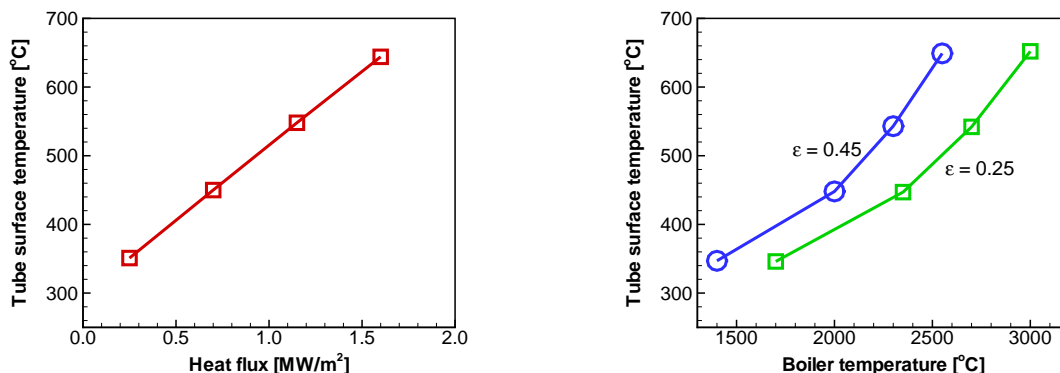
Calculations were also performed using a simple one-dimensional heat transfer model to estimate both the heat flux and the temperature of the boiler environment that could lead to an increase in the temperature of the fireside tube surface. Figure 97 shows the tube surface temperature as a function of the heat flux and the boiler temperature. A heat flux value of 0.25 MW/m^2 leads to a tube fireside temperature of 351°C , which corresponds to normal operating conditions. A heat flux of 1.6 MW/m^2 is required to increase the tube fireside temperature to 644°C . For the analyses of the temperature rise due to increase in the boiler temperature, two values of emissivity of the tube surface were considered—one corresponding to the value for 304L stainless steel and a higher value corresponding to a layer of frozen smelt on the tube surface. For the lower emissivity, a boiler temperature of 3000°C is required to cause the tube surface temperature to reach 650°C . Even with the higher emissivity, the boiler temperature needs to be 2550°C to cause the thermal excursion to 650°C , which is unlikely to occur with the frequency that is observed for the thermal fluctuations. Therefore, it is concluded the thermal fluctuations are caused by an increase in heat flux.

Fig. 97. Change in temperature at the fireside surface of primary air port tubes due to increase in heat flux (left) and due to increase in the boiler temperature (right).

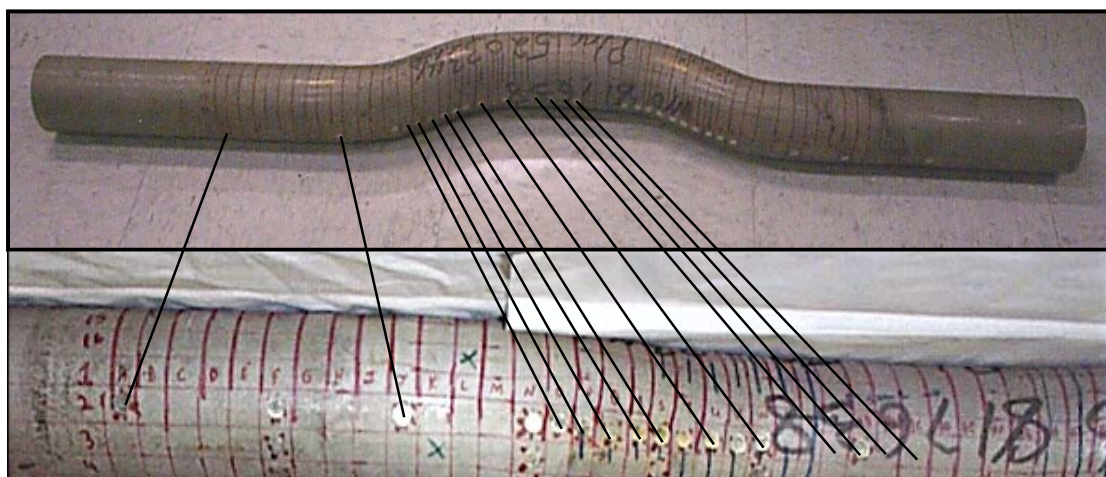
X-ray diffraction was used to measure the surface stresses in the single, unexposed, bent tube shown in Fig. 98. To avoid most effects of surface cold-work, the surface was electropolished to remove about 0.04 mm (0.0015 inch) in the areas where measurements were to be made. The bright circles on the side of the tube in Fig. 98 are the areas that were electropolished and used for surface stress measurements. Figure 99a shows the variation in axial residual stress measured along the length

Fig. 98. Photo of a 304L stainless steel clad tube bent in the shape required for the most common air port design used in North American boilers. The shiny circles are the electropolished areas where X-ray diffraction residual stress measurements were made.

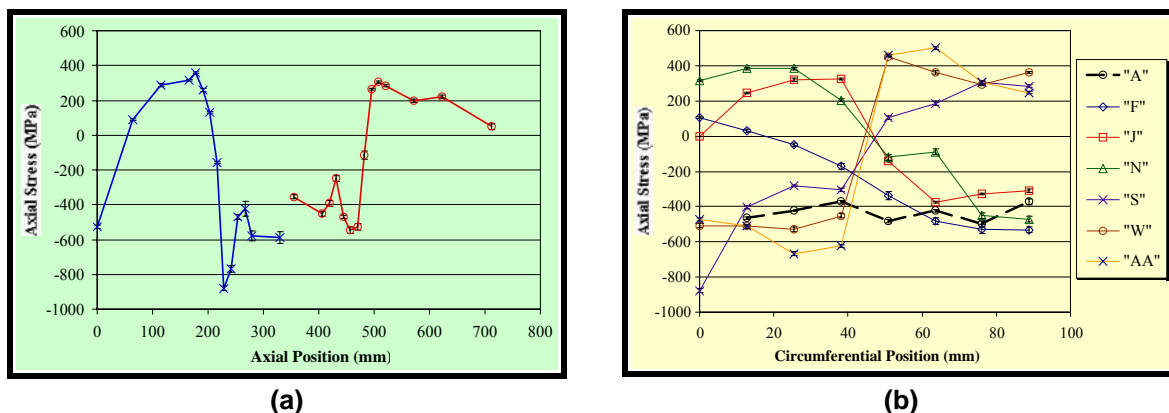
Fig. 99. Surface residual axial stresses measured (a) at selected locations along the tube and (b) at selected locations around the circumference of the tube.

of the tube in the locations indicated. In the unbent portion of the tube, the axial stress is compressive, but as the measuring location moves around the “stretched” portion of the tube, the stresses become tensile. As the measuring location moves on to the “compressed” area of the tube, the stresses become highly compressive then the sequence is reversed as the measuring location moves on to the second half of the tube.

Figure 99(b) shows the variation in axial stress at selected locations around the circumference of the tube. At section A in the unbent portion of the tubing, the axial stresses are compressive all the way around the tube. In the first portion of the bent tube, sections F, J and N, the stresses are generally tensile during the first half of the measurements, then they become compressive. In sections S, W and AA, the stresses are compressive during the initial measurements, then become tensile during the latter measurements. Clearly, in the unexposed tube at room temperature, there are regions in the bent portion of the tube where the surface stresses are highly tensile.

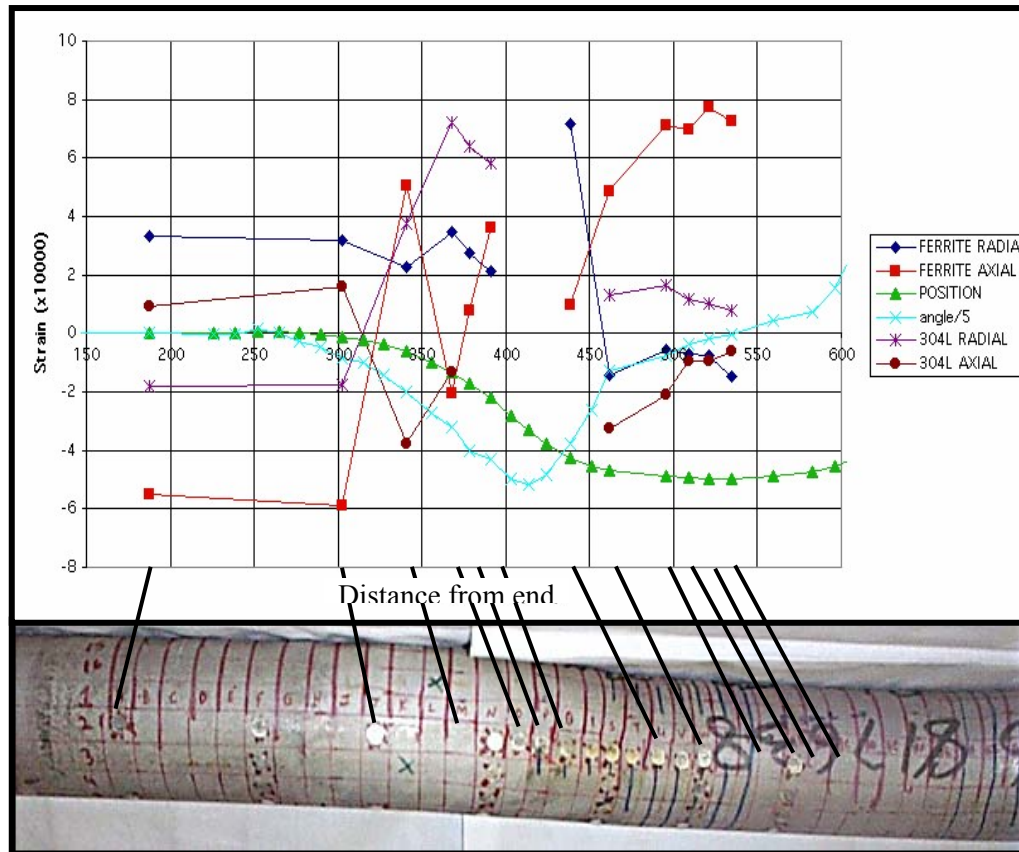
Neutron diffraction measurements have also been made to determine the stresses within the stainless steel clad layer and within the ferritic carbon steel material. These measurements were made below the surface at approximately the same locations where the surface residual stress measurements were made. Fig. 100 shows the result of the neutron diffraction residual stress measurements. These indicate that the axial strains in the carbon steel are compressive in the straight portion of the tube, but they become tensile in some of the bent regions of the tube. It has to be noted that these measurements are made at room temperature in unwelded tubing and represent an average over the thickness of the carbon steel shell. Nevertheless, there is a clear indication that significant changes occur in the strains (and stresses) when the tubes are bent at this radius. Figure 101 shows the stresses measured at several points through the wall thickness of an exposed tube. These results show the stresses in the carbon steel near the interface in the bent portion of the tube are near neutral while stresses measured in comparable locations at the top of the air port were more compressive.

Fig. 100. Results of neutron diffraction residual stress measurements showing stresses in both the 304L stainless steel and the carbon steel (ferrite) as a function of position along the tube.

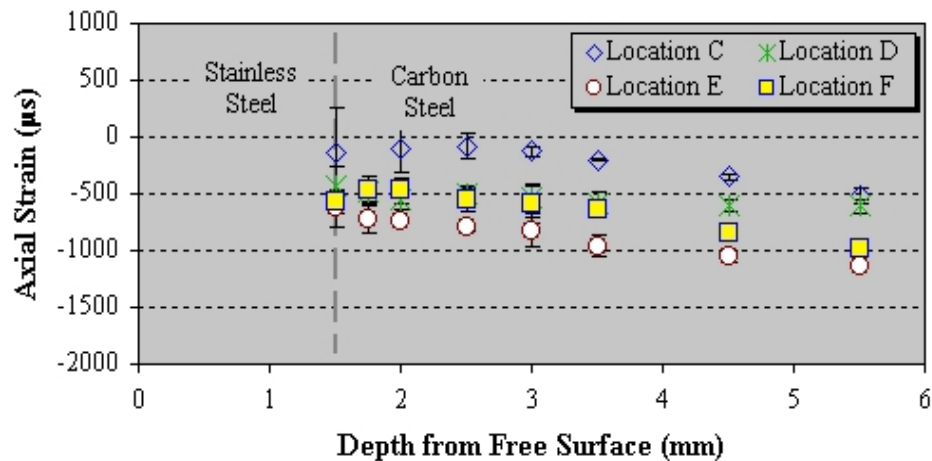
Fig. 101. Axial strain measured at several points through the wall thickness of a previously exposed 304L stainless steel/carbon steel tube. The locations shown are near the bottom of the air port and the strains are near neutral near the interface. The strains measured at the top of the air port were more compressive.

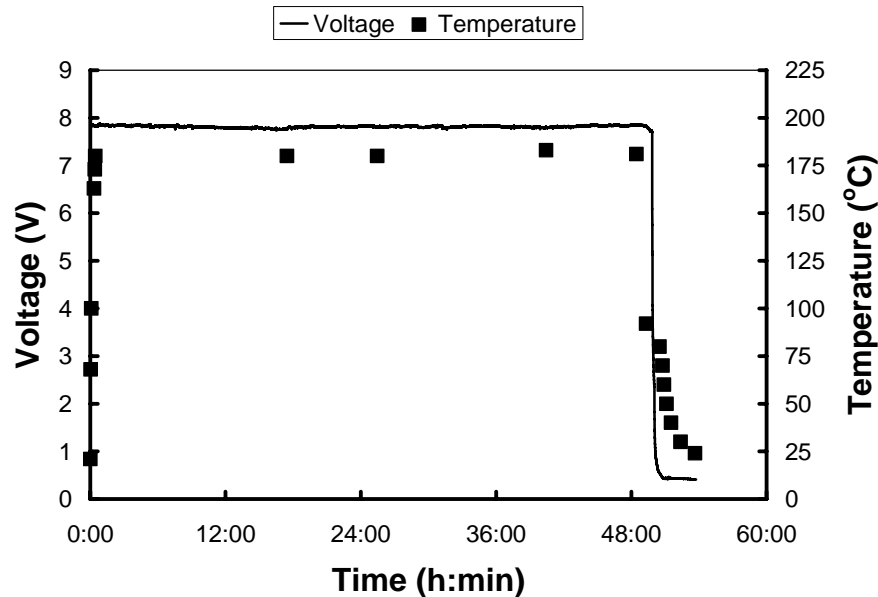
Figure 103 shows the change in conductivity (voltage) of the hydrate mixture as a function of time as the mixture is heated from room temperature to 180°C, held at 180°C for 48 hours, then cooled back to room temperature. As Fig. 103 shows, prior to heating the conductivity (voltage) is low when the hydrate mixture is at room temperature. The low conductivity indicates the absence of a molten phase. However, the conductivity rises rapidly from almost zero to about 8 V as the temperature of the mixture approaches the set point of 180°C, indicating the formation of a molten state. Once at the set temperature the conductivity remained stable at about 8 V for the entire 48 hour test period, indicating the mixture remained molten. The conductivity then decreased rapidly from the stable value of 8 V to almost zero as the mixture temperature cools from the set point back to room temperature, indicating the mixture solidified. It can be concluded with good confidence that the hydrate mixture under study remained molten for the entire 48 hour exposure of the various U-bends.

Fig. 103. Change in voltage across a fixed resistor in the apparatus circuit and temperature of 75%/25% Na₂S/NaOH molten hydrate mixture.

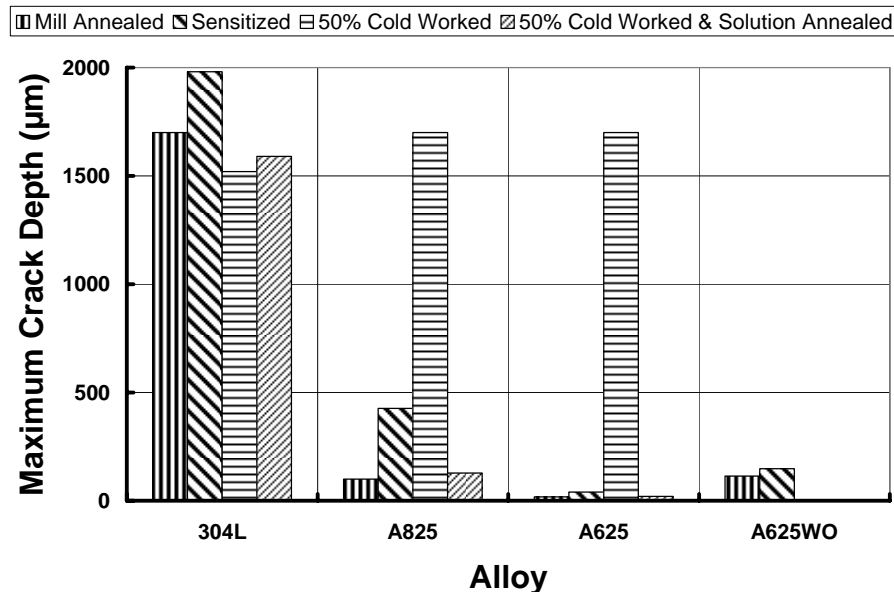
attempt was made to compare the relative cracking resistance using the maximum crack depth observed in cross-section as a comparative basis, Fig. 105. Several interesting observations can be extracted from that comparison regarding the relative SCC resistance in molten 75%/25% Na₂S/NaOH hydrate mixture at 180°C. It is clear that, of the set of alloys tested, 304L stainless steel exhibited the lowest relative SCC resistance, regardless of its metallurgical condition. The alloy type with the highest relative SCC resistance depended on the metallurgical condition. In both the mill annealed and sensitized condition, Alloy 625 exhibited the highest relative resistance. However, this improved relative SCC resistance exhibited by Alloy 625 is clearly lost in the 50% cold worked condition. In that case, all three wrought alloys exhibited a low SCC resistance. Of the two metallurgical conditions that decreased the relative SCC resistance, the cold-worked condition (CW) has a significantly stronger influence on SCC resistance than did the sensitized condition (S). The solution annealing treatment (SA) was successful in restoring the level of SCC resistance found with the mill-annealed condition (MA). Regarding Alloy 625, the wrought specimen appears to exhibit a somewhat higher SCC resistance than the weld-overlaid specimen. However, the apparent lower SCC resistance exhibited by the weld-overlaid specimen may be related in part to residual weld stresses inherent to the as-welded condition.

Fig. 105. Bar chart comparing influence of metallurgical condition on the maximum crack depth recorded in U-bends after exposure in to 75%/25% Na₂S/NaOH molten hydrate mixture at 180°C for 48 hours.

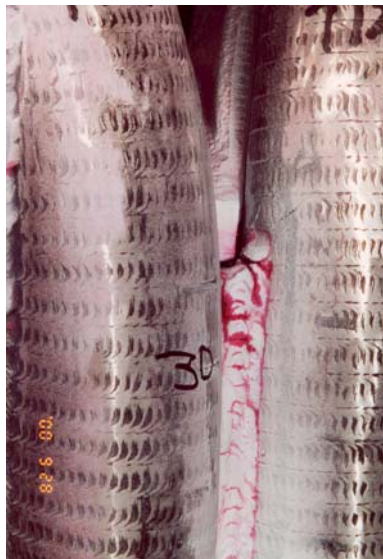
Fig. 113. Photograph showing membrane-type cracking in primary air port comprised of weld-overlaid UNI625/CS composite opening tubes installed in Boiler 8 after 12 months of service.
