Cracking and Corrosion of Composite Tubes in Black Liquor Recovery Boiler Primary Air Ports

October 2006

Materials Science and Technology Division

**CRACKING AND CORROSION OF COMPOSITE TUBES
IN BLACK LIQUOR RECOVERY BOILER
PRIMARY AIR PORTS**

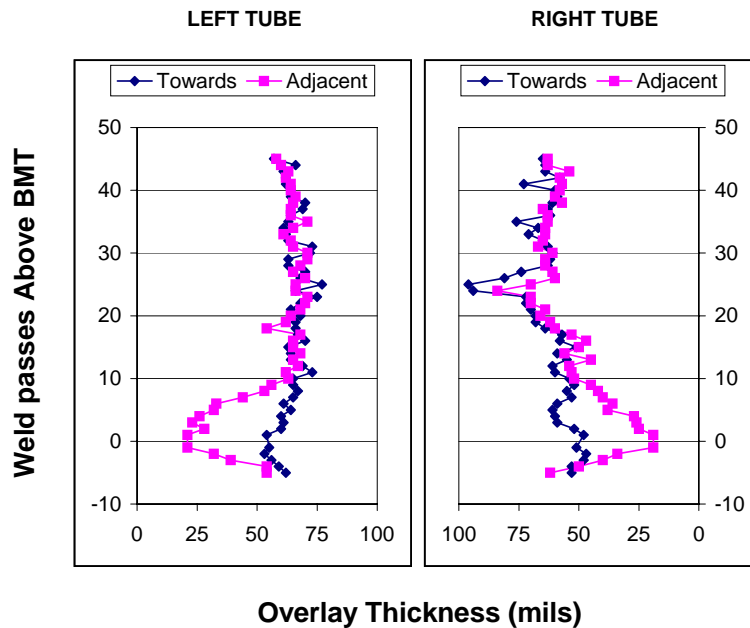
Fig. 114. Overlay thickness of UNI625/CS composite tubes fabricated into Port B installed in Boiler 10 after one year service. (BMT = bottom membrane termination, adjacent and towards = measurements made adjacent to membrane/casting, and towards fireside crown, respectively) (1 mils = 0.001 in = 0.0254 mm).

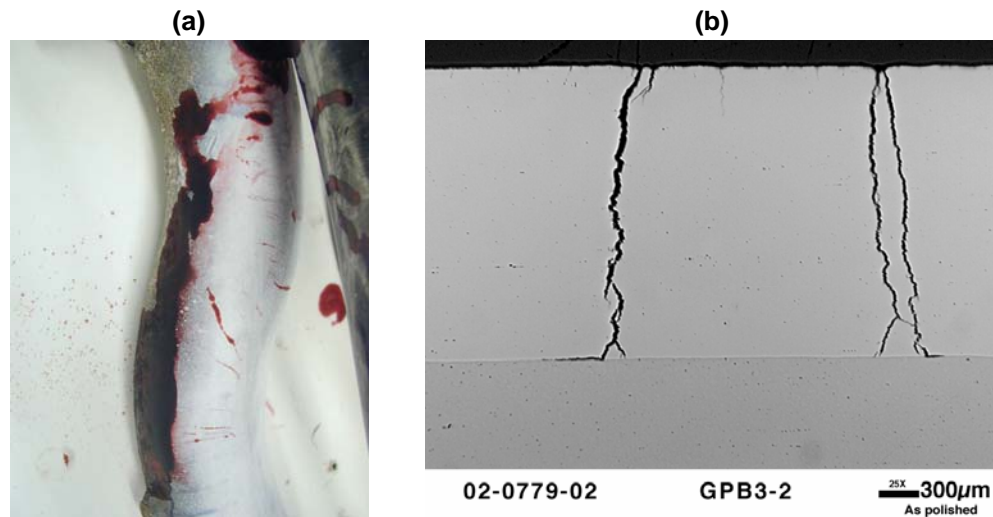
Primary air ports comprised of SAN63 (modified alloy 625)/CS opening tubes were installed in two recovery boilers, each with a different port design. In Boiler 8, with Port F, cracks were found in the SAN63/CS opening tubes after 12 months of service. Similarly, extensive tube cracking was found on those tubes opening installed in Boiler 20, with Port H. Several of the ports in this boiler were removed for a metallographic examination. Cracks propagated through the cladding, by an intergranular mode and either terminated at the (carbon steel) interface or continued to propagate along the interface, Fig. 116. Neither membrane cracks nor corrosion was found in this boiler.

Fig. 116. Cracks found in SAN63/CS composite tubes fabricated into Port H installed in Boiler 20 after 12 months of service. (a) Crack indications as revealed by liquid dye penatrant inspection of the tube surface. (b) Micrograph of polished cross-section showing cracks, which have propagated through cladding, by an intergranular mode, and have either terminated at the carbon steel interface or continued to propagate along the interface.

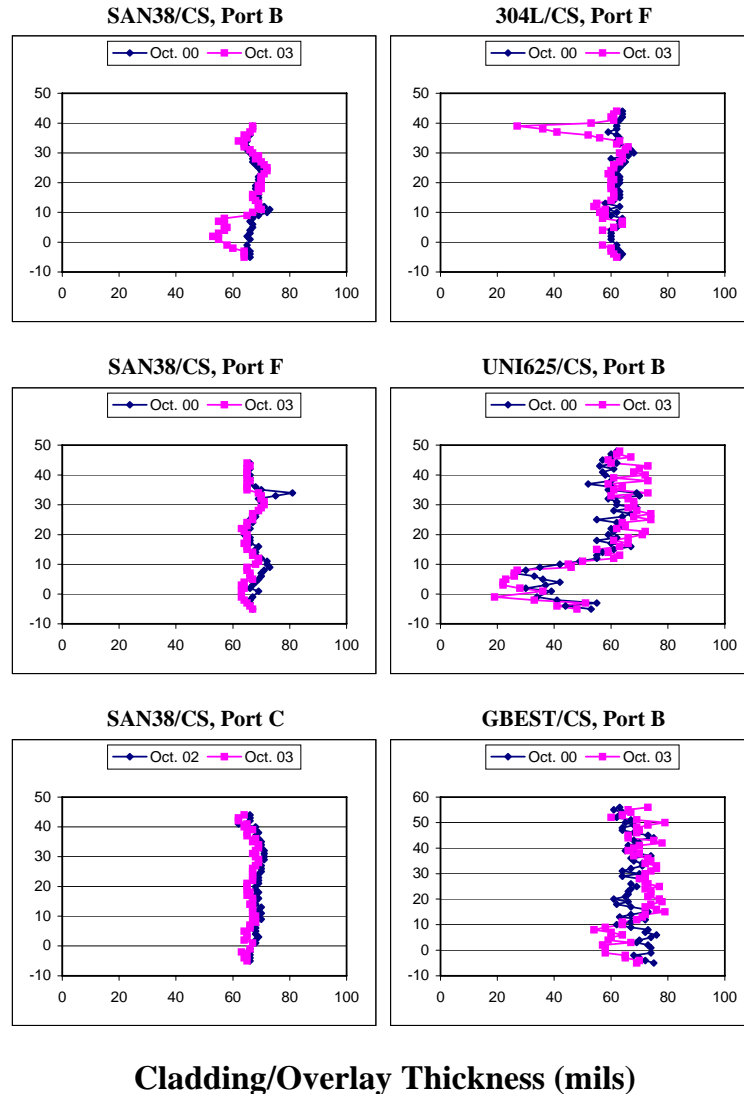
The thickness distribution, as measured adjacent to the casting/membrane, of the “worst case” port tube from each test panel is plotted, as function of elevation and time, in Fig.117.

Measurements at locations where surface grinding was conducted to remove a crack indication were omitted from the plots. Thickness losses were influenced by both metallurgy and the port design. The extent of thinning was lowest for the SAN38/CS opening tubes. Of the three test ports fabricated using SAN38/CS port tubes, a loss in cladding thickness was only observed on the tubes fabricated into Port B, and it occurred in a range from the BMT to an elevation corresponding to the bottom of the casting opening (BCO). In contrast, thinning of 304L/CS tubes did not depend on port design. A significant thickness loss occurred on the 304L/CS tubes fabricated into Port F over a range from, and to, an elevation corresponding to the top of the casting opening (TCO) to the top membrane termination (TMT). A similar rate of thinning was found on the original 304L/CS tubes fabricated into Port B. Unlike the case for SAN38/CS and UNI625/CS port tubes, thinning of the 304L/CS tubes coincided with a degraded seal between the casting insert and the port tube, regardless of port design. A loss in overlay thickness was found on both weld-overlaid composite tubes, A625WO/CS and GBEST/CS, fabricated into Port B. The corroded area (elevation) is similar to that found on the SAN38/CS tubes fabricated into the same port design. The A625WO/CS tubes had the greater cladding/overlay thickness loss of all alternative composite tube-port design combinations. The majority of this loss occurred during the first 12 months of service. Significant changes were made to the liquor delivery system and the combustion air system during this time. Interestingly, similar losses in cladding thickness were not observed for any of the 304L/CS opening tubes fabricated into Port F during this time period.

Fig. 117. Cladding/Overlay thickness of “worse case” port tube from test panels installed in Boiler A. (BMT = bottom membrane termination, adjacent and towards = measurements made adjacent to membrane/casting, and towards fireside crown, respectively) (1 mils = 0.001 in = 0.0254 mm).
