Furnace and Water Heater Venting Field Demonstration

May 2019

FURNACE AND WATER HEATER VENTING FIELD DEMONSTRATION

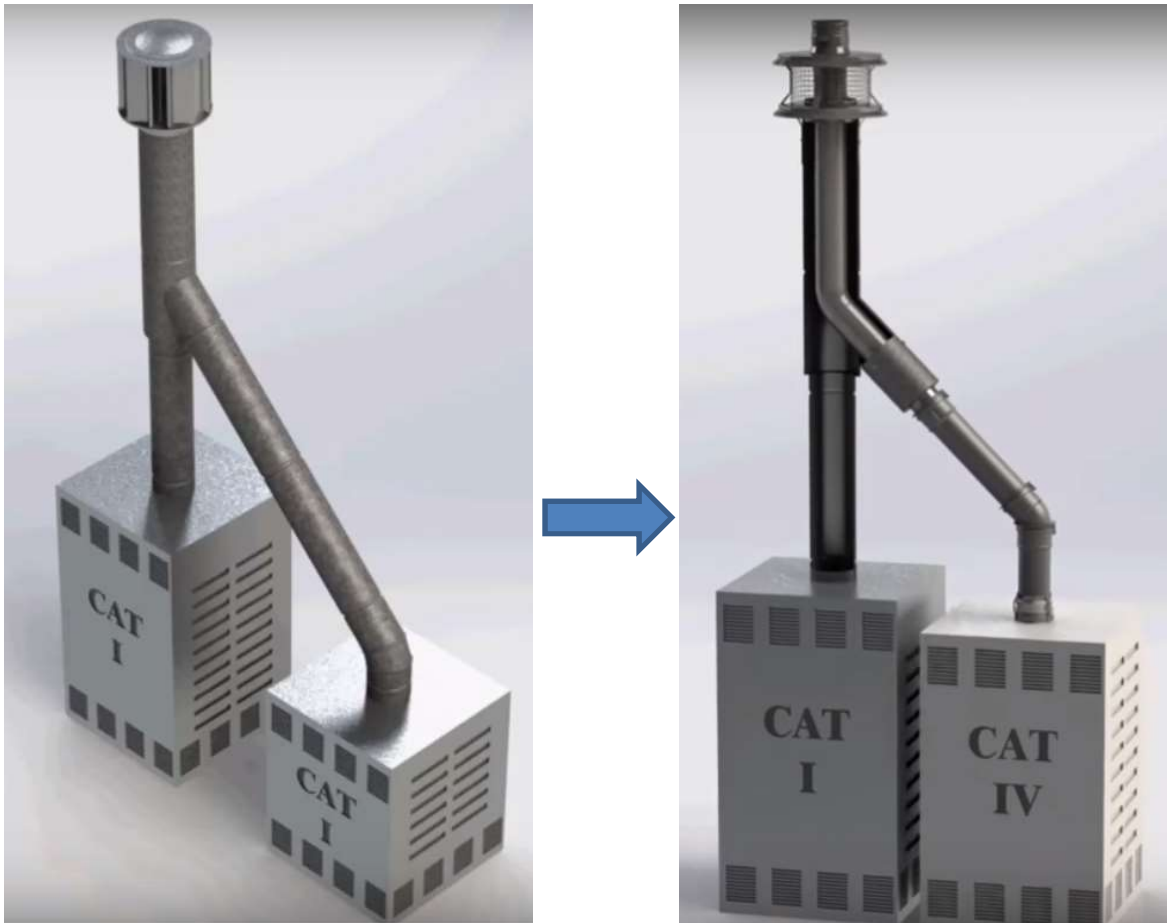
Figure 2.1. DuraVent FasNSeal 80/90 venting system before and after installation diagrams.
(M&G DuraVent 2015)

¹ Figure 2.1 shows the stainless steel liner inserted down the existing B Vent and exiting at a 45° angle to the Category IV condensing furnace. The contractors for the field demonstration found that it was generally easier to exit the B Vent at the bottom and to connect the water heater to the B Vent at a 45° or 90° angle.

For an existing home, the DuraVent FasNSeal 80/90 venting system is applicable if the existing chimney venting both the natural-draft water heater and non-condensing furnace is a metal, double-wall B Vent. As depicted in Figure 2.1, the existing Category 1 water heater (i.e., natural-draft) and Category 1 furnace (e.g., natural-draft furnace, fan-assisted non-condensing furnace) are vented vertically through a common flue. The FasNSeal 80/90 venting system involves replacing the existing vent cap with a new one that supports a flexible stainless steel inner liner inserted down the existing B Vent to serve as the flue for the new Category IV condensing furnace.¹ The annular space between the flexible liner and the wall of the original B Vent serves as the flue for the natural-draft water heater. The two flue streams remain separated and are exhausted individually to the atmosphere. The new vent cap is used to keep the flue gases separate at the vent termination. An animated video is available that demonstrates the installation and operation of the system (<http://duravent.com/Product.aspx?hProduct=49>).

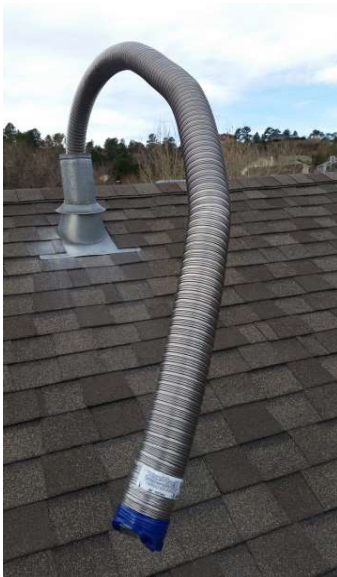
(a)

1. The flexible stainless steel liner is pre-cut to its approximate length (leaving excess to be trimmed more precisely later) and then inserted down the existing B Vent (see Figure 2.2a). Arrows stamped on the flexible liner (not shown) indicate the correct orientation of the liner (arrows point in the direction of the exhaust flow). DuraVent installation instructions discuss the process for selecting the correct diameter of the liner given the diameter of the existing B Vent to ensure proper venting for both the condensing furnace through the liner and the natural-draft water heater through the annular space.

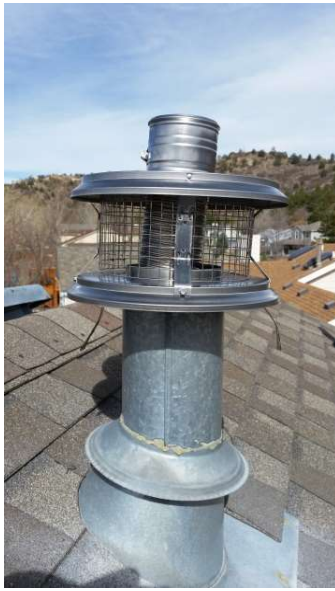
(b)

2. A vent cap is installed to support the flexible liner and keep the water heater and condensing furnace flue gases separate at the vent termination (see Figure 2.2b). The flue gases from the condensing furnace travel through the liner and exit the vent cap at the top (i.e., the termination cap). The water heater flue gases travel between the annular space formed by the liner and the existing B Vent and exit between the two round horizontal plates of the vent cap. A worm-drive hose clamp secures the liner to the termination cap, high-temperature silicone seals the liner to the termination cap, and a screen is installed at the top of the termination cap for bird and rodent protection (these are not shown in Figure 2.2b). As shown in Figure 2.2b, a screen between the two round horizontal plates provides bird and rodent protection for the annular space.

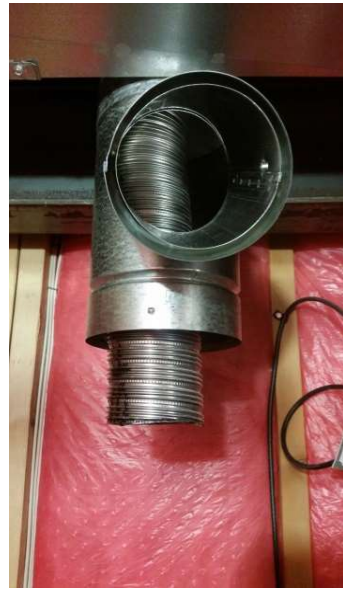
(c)

3. As shown in Figure 2.2c, a double-wall wye or tee (a wye is shown) is attached to the end of the existing B Vent, the flexible liner is brought out the bottom of the wye or tee (the water heater flue will be connected to the other opening), and the liner is cut to size if it was not already done so before being inserted down the existing B Vent. The liner could be brought out the wye's 45° opening, although contractors used in the field demonstration generally found it easier to bring the liner out at the bottom of the wye. If a tee is used, the liner must be brought out the bottom of the tee to ensure that at least a 45° downward slope is maintained to drain condensate back to the furnace. Although the existing wye or tee could be used, in the field test demonstration houses it was always replaced. In this case, an adaptor may be needed, depending on the brand of existing B Vent and the brand of wye or tee being purchased.

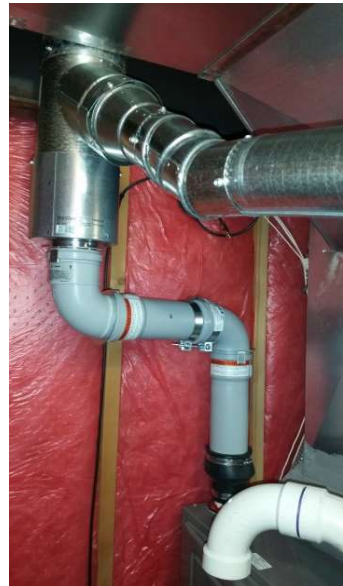
(f)

7. The water heater vent is connected to the wye or tee using standard venting materials (Figure 2.2f).

used with condensing furnaces and is an engineered alternative to polyvinyl chloride (PVC) pipe. Locking bands are used at all joint connections. An appliance adapter and an adapter connector are used to connect the PolyPro to the furnace vent connection (not shown; an alternative connection is shown in Figure 2.2f).

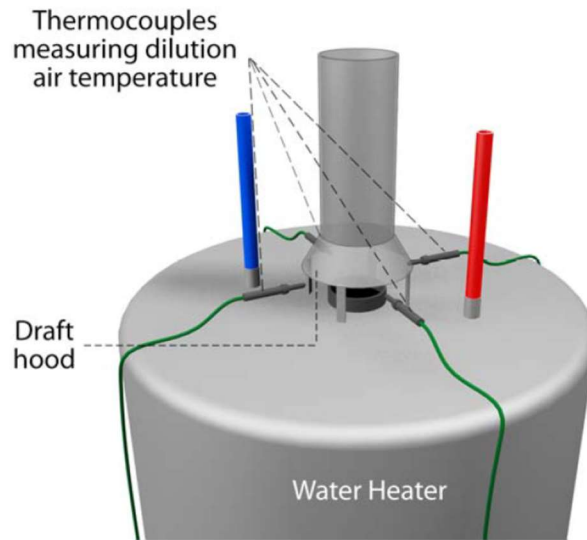
Figure 3.3. Thermocouple array to measure the dilution air temperature surrounding the water heater draft hood.

A second method used to detect the presence and duration of spillage was to measure the difference between the ambient temperature surrounding the water heater (i.e., the temperature of the CAZ) and the dilution air temperature surrounding the draft hood of the water heater. This method is referred to as the differential temperature or DT method. The dilution air temperature was monitored by averaging the temperatures from four thermocouples equally spaced around the circumference of the water heater draft hood (Figure 3.3), while the CAZ temperature was monitored using a fifth thermocouple. In general, the dilution air temperature is very close to that of the ambient air under normal draft conditions and much greater than the ambient air temperature when spillage occurs because of the hot flue gases passing the outer perimeter of the draft hood. A sharp increase in the temperature differential between the dilution and ambient air when the water heater was on indicated the start of spillage of flue gases into the CAZ. A

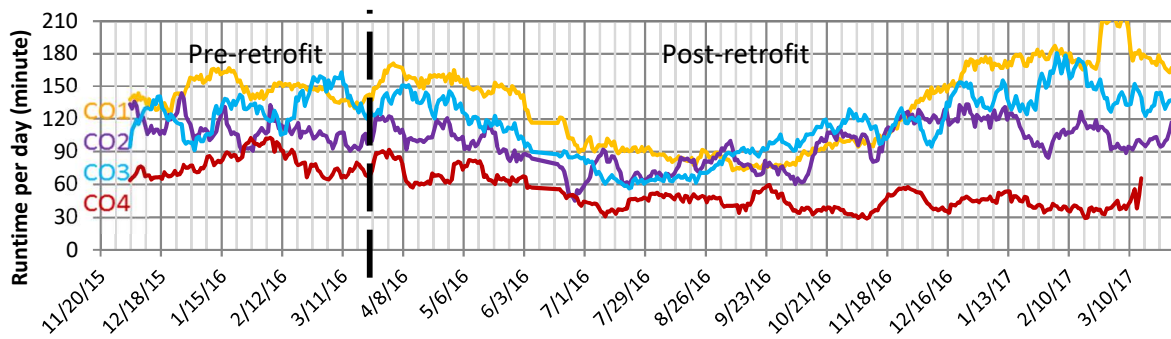
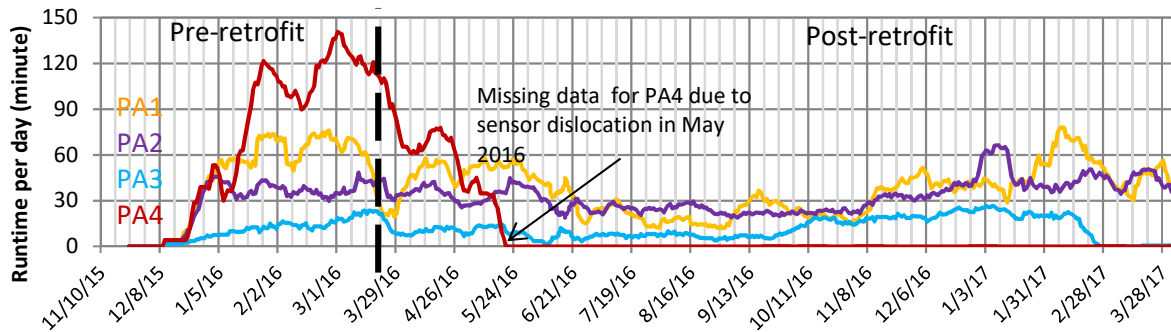
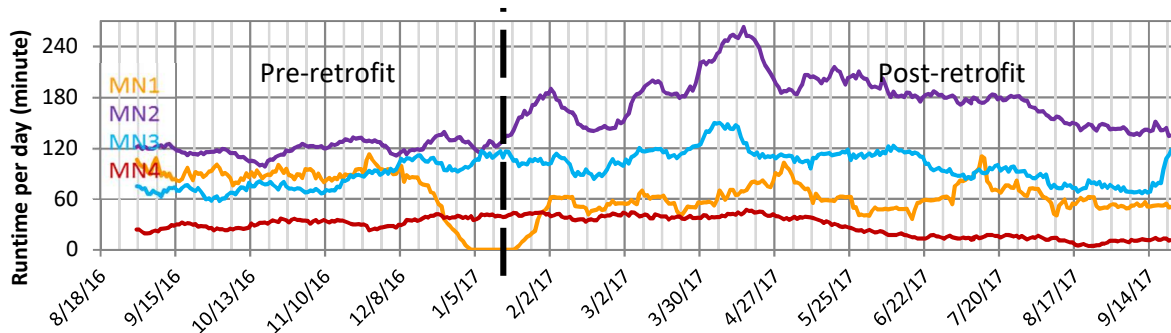
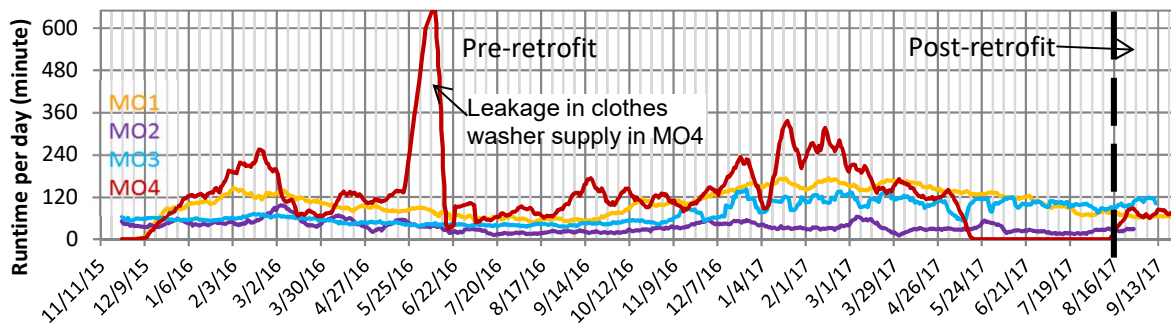
Figure 5.1. Trend of water heater runtime per day during the monitoring period.

Figure 5.1(a) through (d) show the trend of water heater runtime per day during the monitoring period for each house in the four cities. The water heater runtimes per day were determined from 1 second data of the water heater flue outlet temperature. The lines showing the trends in these figures are 14 day moving averages of water heater runtime per day; 14 day moving averages were used to avoid the high variability

These figures, and especially Figure 5.1(a) and (b) for the Colorado Springs and Philadelphia houses, respectively, show the seasonal fluctuation that can occur in the average daily runtime of water heaters due to seasonal variations in inlet cold water temperature, seasonal variations in water use due to occupant behavior, and other factors. Considering the seasonal variation in runtime, the pre- and post-retrofit runtime patterns were similar in most of the houses because the water heaters were not replaced during the monitoring periods (only the furnaces were replaced) and the same occupants lived in the houses.²

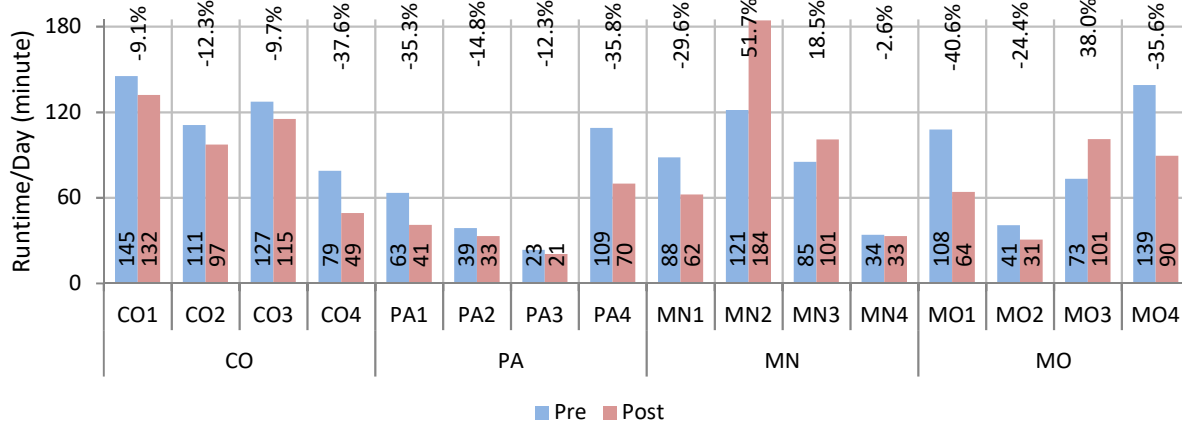
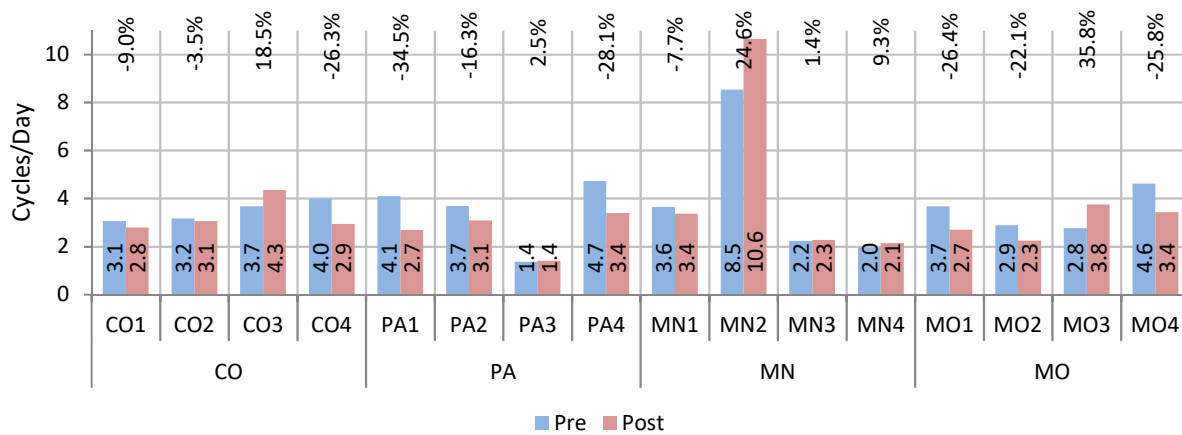
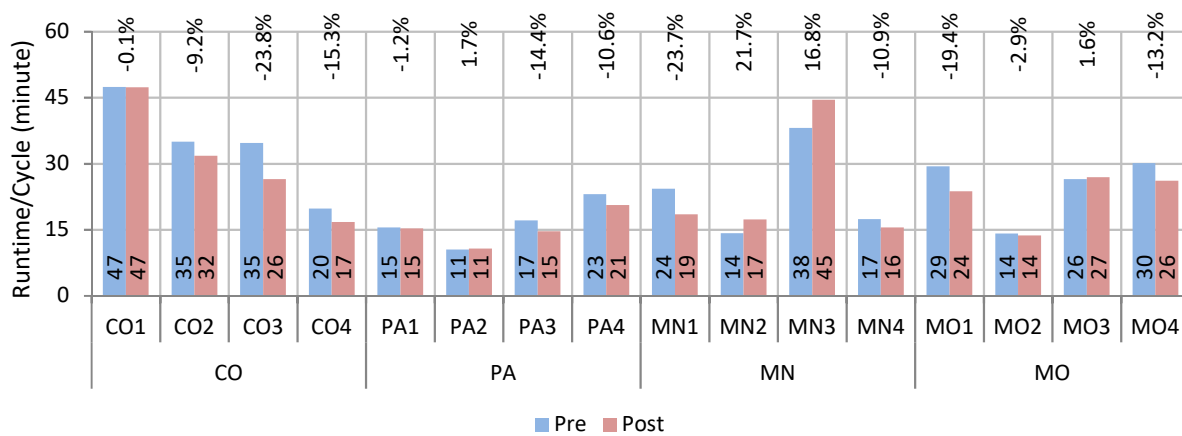
Figure 5.2. Comparison of water heater operation during the pre- and post-retrofit periods.

Figure 5.2(a) through (c) show the average runtime per day, average number of cycles per day, and average runtime per cycle, respectively, for the pre- and post-retrofit periods for each house. The water heater runtime per day and number of water heater cycles per day were determined for each house from 1 second data of the water heater flue outlet temperature and averaged over days when water heater operation was detected. The average runtime per cycle was calculated as the ratio of total runtime and total number of cycles. In all three figures, the two columns for each house represent the pre- and post-retrofit periods. The percent change in these averages after retrofit is also indicated on these figures.

Figure 5.2(b) shows that the water heaters fired, on average, 2–5 times per day in all the houses during both the pre- and post-retrofit periods with the exceptions of Houses PA3 and MN2. Figure 5.2(c) shows that the average duration of each firing cycle in both the pre- and post-retrofit periods was commonly about 15–30 minutes.

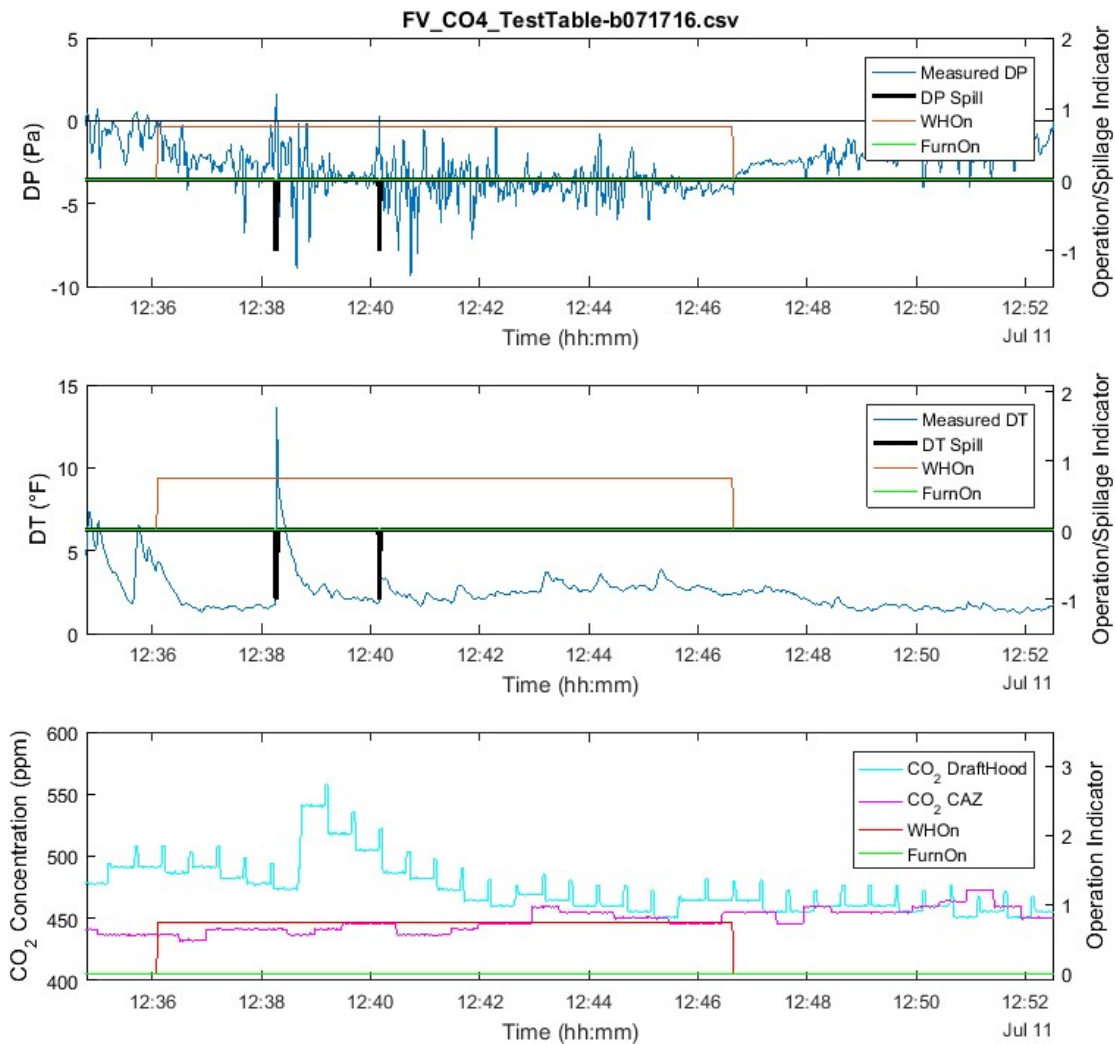
Spillage does not necessarily occur just at the beginning of a water heater cycle. Although it may occur most frequently at the start of a water heater cycle, spillage can occur at any time during a cycle. As shown in Figure 5.4, spillage occurred twice during this ~11 minute water heater cycle (from ~12.36 to ~12.47) in the middle of the cycle rather than at the start, with each spillage event occurring for just a few seconds. The DP and DT methods both detected these events and detected the same duration for the events (see the black lines generated by the analysis software in the top and middle plots that indicate that these spillage events occurred at ~12.38 and ~12.40). The CO₂ measurement confirmed the occurrence of the first spillage event.

Figure 5.4. Two spillage events detected by DP, DT, and CO₂ in the middle of a 10 minute water heater cycle.

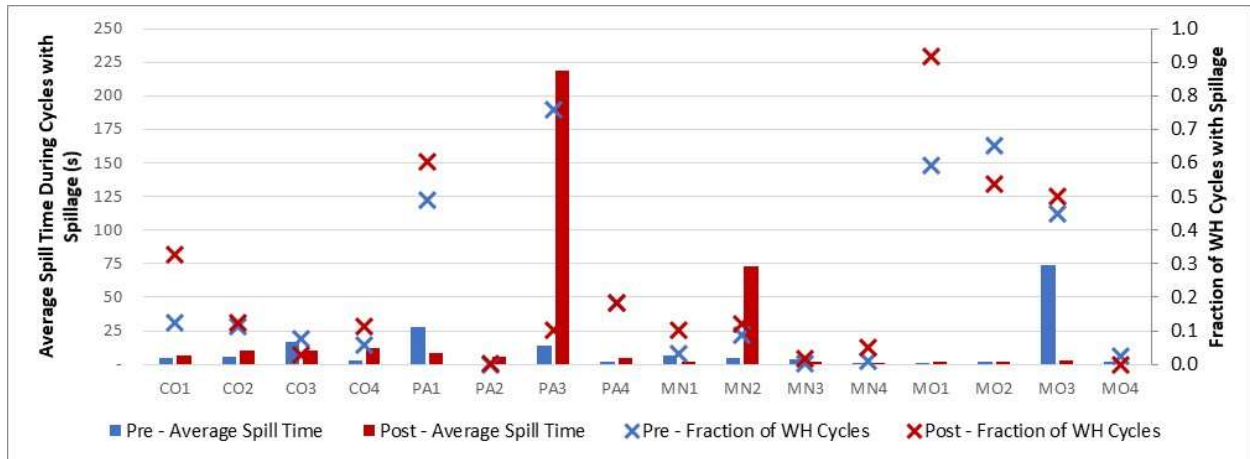
To facilitate a comparison of the frequency of spillage and average spillage time with non-zero spillage between the pre- and post-retrofit periods in each a house, a single value was calculated for these for each house (Figure 5.12). These values were calculated using only those water heater cycles that occurred within an outdoor temperature range unique to each house. The outdoor temperature range was selected such that 20 or more water heater cycles occurred in each of the pre- and post-retrofit temperature bins within the selected range. This was done to make sure there were enough pre- and post-retrofit data to

Figure 5.12. Average spillage for all houses.

Figure 5.12 shows that the pre-and post-retrofit values calculated for the frequency of spillage and average spillage time with non-zero spillage were the same before and after retrofit for nine houses: CO2, CO3, CO4, PA2, PA4, MN1, MN3, MN4, and MO4. For these houses, the fractions of water heater cycles with spillage were less than 0.1 with one exception (the pre- and post-retrofit fractions were both just less than 0.2 for House PA4) and the average spillage times with non-zero spillage were less than 25 seconds (with the BPI 2015 spillage limit being 120 seconds as a source of reference).

It can also be concluded that the pre- and post-retrofit performance of the conventional and FasNSeal venting systems are the same in Houses MO1 and MO2. The fraction of water heater cycles with spillage was high for both houses both before and after retrofit (the post-retrofit value was higher than the pre-retrofit value for House MO1 while this was reversed for House MO2); however, the average spillage times for these houses were extremely short (on the order of 1 second). This can be seen in the scatter plots for these two houses provided in Figure 5.11, where many spillage cycles of short duration are shown as evidenced by the number of data points just above the x-axis. One possible explanation for the frequent spillage could be that the outdoor temperature range used for both houses was restricted to higher outdoor temperatures when it is more difficult to establish a draft; a similar high spillage frequency was measured in House MO3, but not MO4, under the same outdoor temperature conditions.

For the remaining five houses shown in Figure 5.12 (Houses CO1, PA1, PA3, MN2, and MO3) differences in the pre- and post-retrofit performance of the venting system is evident in individual houses and/or data indicating frequent spillage or long spillage times are observed. The anomalies with these five houses are discussed in Sect. 5.5.

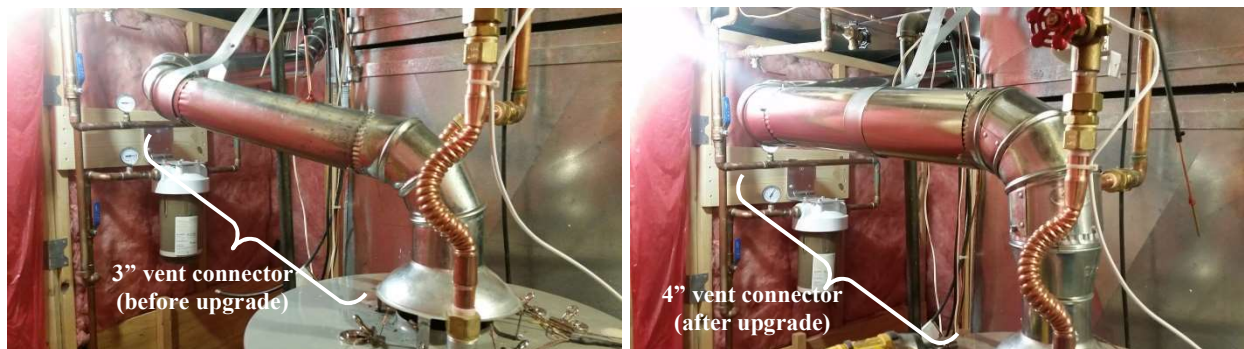
The combination of a reduced venting area due to the inner liner in the vertical chimney and the long vertical rise put this installation near the limit of acceptable performance in the NFPA 54 vent tables and is likely why it is experiencing frequent spillage events following the installation of the FasNSeal 80/90 venting system. Significant spillage was seen after the initial installation of the FasNSeal system. For this reason, the interconnecting vent between the water heater and the vertical vent pipe was increased from a 3 in. to a 4 in. diameter, as shown in Figure 5.13, approximately one month after the FasNSeal system was installed. This improved the drafting based on spillage tests performed with a smoke stick. The continuous data monitoring still showed frequent spillage events, but of much shorter durations.

Figure 5.13. Three inch vent connector (left) upgraded to a 4 inch vent connector (right) in House CO1.

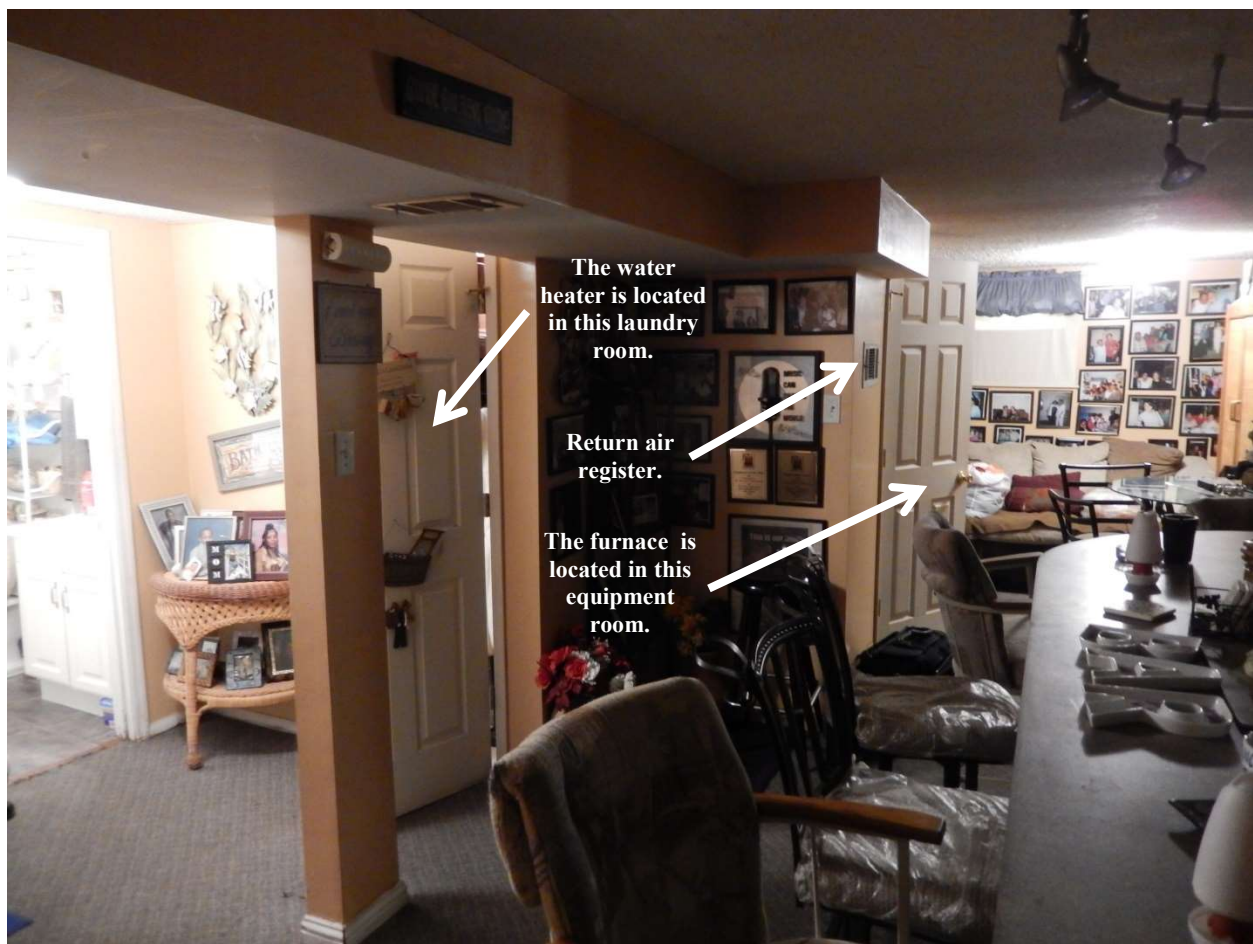
The water heater and furnace are installed in separate but adjacent equipment rooms located in the conditioned basement of House MO3. As shown in Figure 5.18, the white paneled door on the right opens into the furnace room, while the paneled door on the left opens into a large storage/laundry room where the water heater is installed.

Figure 5.18. Basement equipment rooms in House MO3.

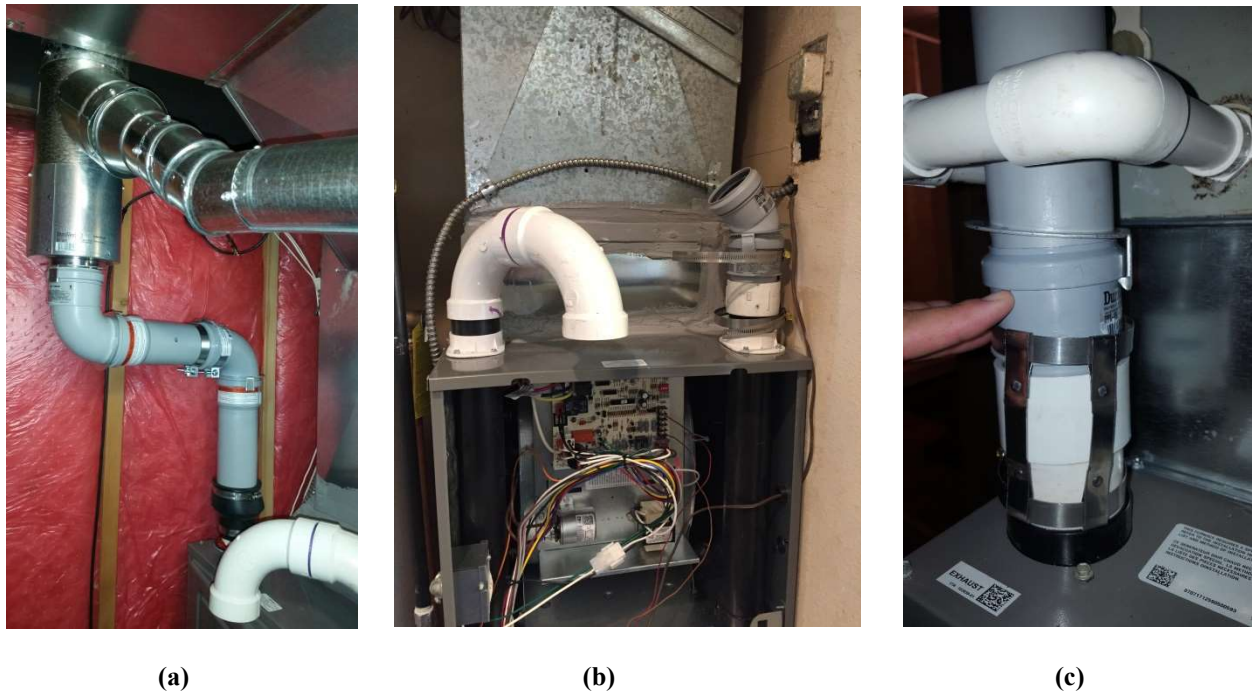
An important issue that arose at every agency was the connection of the PolyPro to the condensing furnace. The DuraVent literature available at the time two agencies ordered material for the March 2016 installations did not identify the availability and use of a “PolyPro Appliance Adapter for PVC Coupler.” At one agency, the proper connector was provided by a DuraVent representative present at the first installation and used in three houses, while in the other house the PolyPro was run directly to the furnace blower inside the furnace cabinet. At the other agency, a rubber reducer was used to make the connection at three houses (see Figure 6.1a) and an alternative method was used at a fourth house (see Figure 6.1b). The remaining two agencies also had issues even though the adaptors were ordered based on updated DuraVent literature. One agency prematurely converted from PolyPro to PVC before reaching the condensing furnace because of their unfamiliarity with PolyPro. The other agency encountered an issue with the length of the adaptor and the clamp provided to secure the assembly. This agency used a small length of PVC to complete the installation (Figure 6.1c).

Figure 6.1. Alternative methods of connecting the PolyPro to the furnace.
