ORNL/TM-2019/1071
CRADA/NFE-17-06791

Repairing polycrystalline Inconel 100 using additive manufacturing

CRADA FINAL REPORT
NFE-17-06791

**REPAIRING POLYCRYSTALLINE IN 100 USING LASER BLOWN
POWDER ADDITIVE MANUFACTURING**

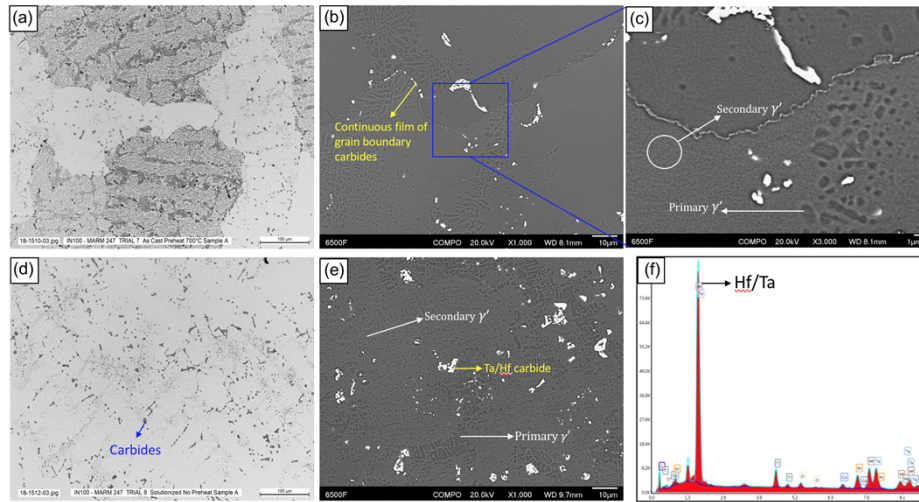
Figure 1: Microstructure of the substrate (a)-(c) in the as received condition showing the presence of γ' and Hf/Ta rich grain boundary carbides (d)-(f) in the solution annealed condition showing that the treatment dissolved the grain boundary carbides and also modified the γ' morphology

The substrate was characterized using optical microscopy and scanning electron microscopy. Samples were mounted and polished using regular metallographic methods and etched using Kallings reagent to reveal the microstructure. Results are shown in figure 1. Figure 1 (a)-(c) show the optical and SEM micrographs of the substrate samples in the as received conditions. The microstructure clearly shows a bi modal distribution of γ' with Hf/Ta rich carbides along the grain boundaries. Such continuous network of carbides acts as potential sites for liquation cracking during repair. Therefore to eliminate the carbides and coarsen the γ' a subsolvus solution annealing treatment was given to the substrates. The as received coupons were solution annealed at 1093°C for 2 hours in a vacuum furnace. The solution annealing treatment was a sub solvus treatment. The solution annealed substrates are also shown in figure 1(d)-(f). Solution annealing led to the dissolution of the continuous network of carbides along the grain boundary. While the grain boundary carbides dissolved, energy-dispersive spectroscopy (EDS) showed that the actual composition of the carbides did not change. In addition the procedure coarsened the secondary γ' precipitates, and caused the dissolution of the continuous network of grain boundary carbides.

Previous reports have shown that solution annealing the substrates before repairing resulted in improved resistance to cracking. Figure 1 clearly shows that solution annealing plates eliminated the continuous grain boundary carbides and also coarsened the fine secondary γ' precipitates in the as received material. The post deposit optical micrographs are shown in figure 6.

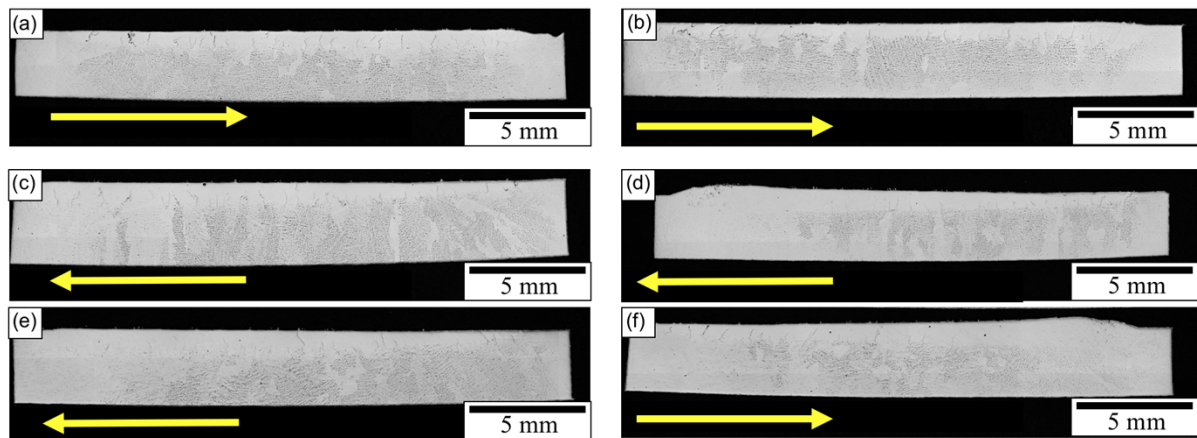
Figure 2: Micrographs of the coupons on which the deposits were fabricated. The arrow indicates the direction of laser travel where the head points towards the end of the build. Samples (a)-(f) correspond to samples fabricated using trial-1 thru' 6. Note that the samples fabricated with a tighter hatch spacing and lower speeds reduced the cracking tendency.

The results of the deposition trials are shown in figure 2. Figure 2 shows that the best results were obtained for deposits fabricated using a tighter hatch spacing. In addition, figure 3 shows the deposit substrate interface at higher magnification. The micrographs clearly shows that most of the cracking occurred at the heat affected zone. The cracks then propagated to the deposited material.

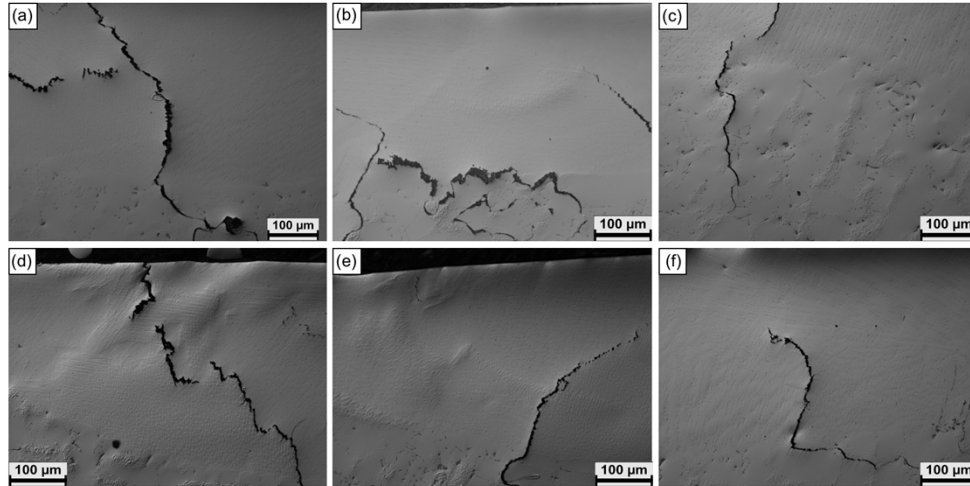
Figure 3: Micrographs showing the cracking at the heat affected zone and the substrate. (a)-(f) corresponding to the various trials

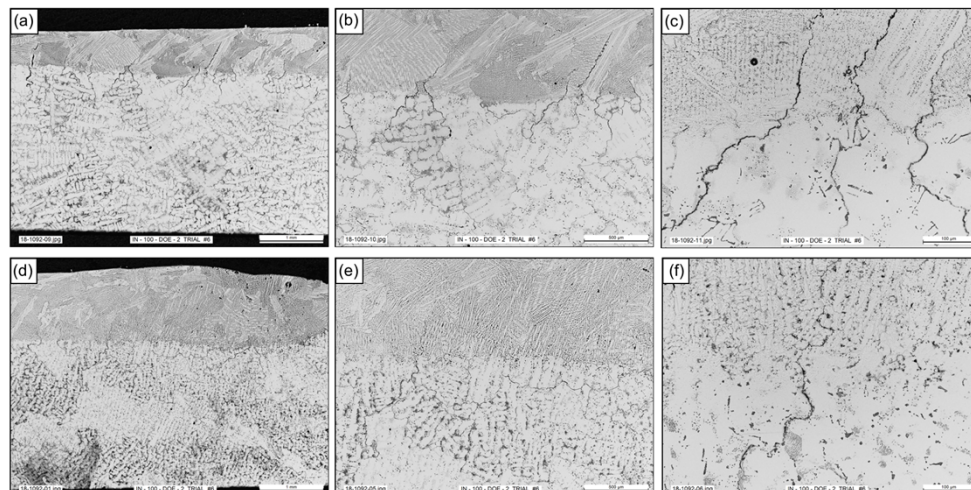
Figure 4: Micrographs (a)-(c) showing the presence of cracking in the beginning of the deposit only at the start of the build (d)-(f) showing the presence of cracking at the heat affected zone at the end of the deposit. Note that this section does not have any cracks in the deposits.

Figures 4 and 5 show the interface structure of the deposits fabricated on the as cast substrate. The optical micrograph clearly shows that the cracking predominantly occurs in the heat affected zone. This mechanism of cracking could be attributed to heat affected zone liquation cracking. To conduct a more detailed investigation of the cracking mechanism detailed Scanning Electron Microscopy (SEM) microscopy was performed. The SEM microscopy clearly shows the presence of liquid films along the carbides. This mechanism is well known and has been documented in the existing literature [7]. The carbides were identified to be rich in Hf and Ti, as shown in the EDS spot analysis. Note that the cracks initiate in the heat affected zone and propagate into the deposit. However the cracking in the deposit is attributed to solidification cracking, which is evident from the formation of eutectic films at the interface [4], [5]. In addition to this characterization of the as deposited structure shows the presence of carbides in the interdendritic region due to the $L \rightarrow MC (Hf/Ta) + \gamma$ eutectic reaction during the solidification. However, no evidence was observed for the constitutive liquation in the deposit. Nearly all the cracks in the deposit were solidification cracks.

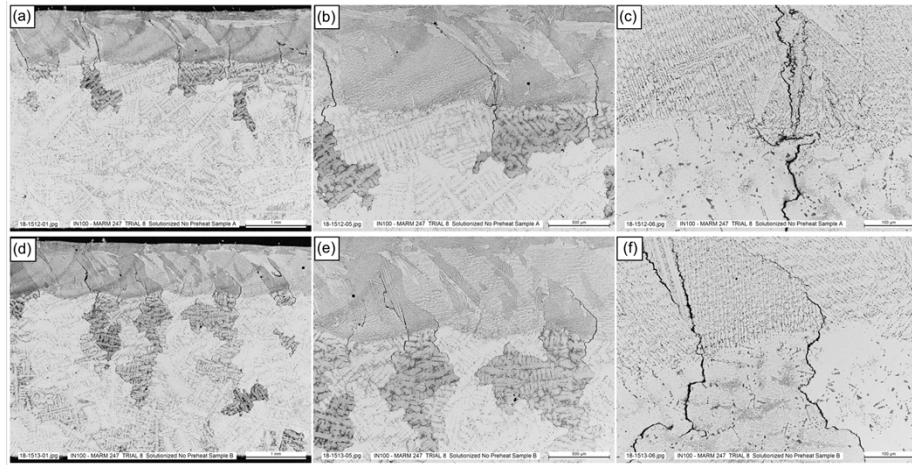
Figure 6: Deposits fabricated in solution annealed plates. The while the total number of micro cracks are reduced the samples did show cracking in the heat affected zone of the substrate as shown in the micrographs (a)-(f)

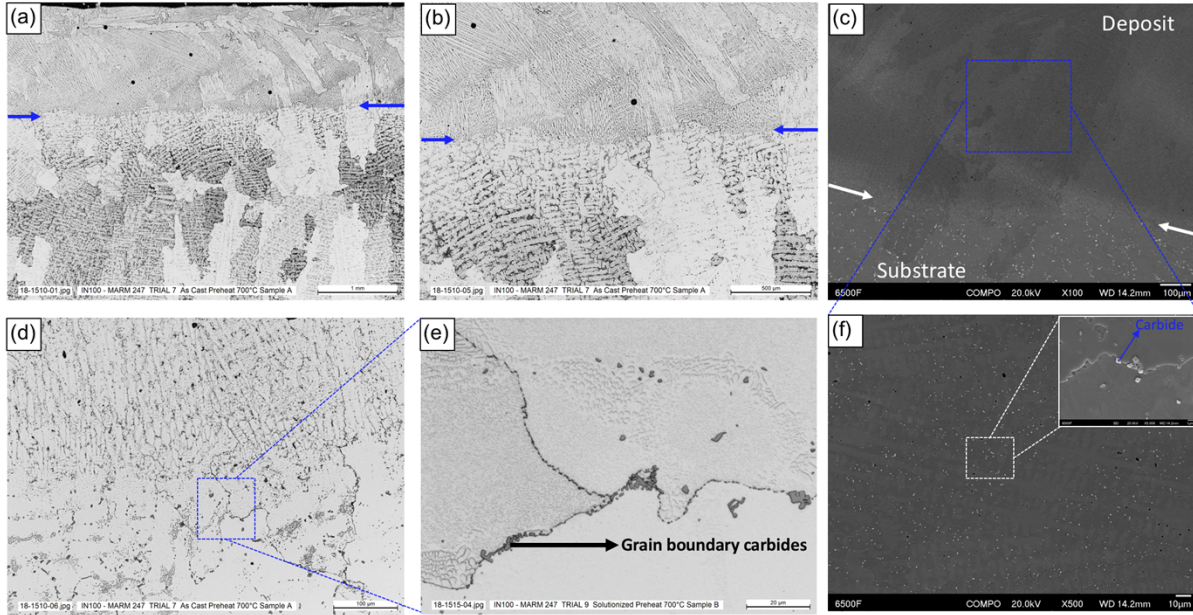
Figure 9: Micrographs showing the absence of liquation cracking and solidification cracking in the deposits fabricated with a preheat of 750°C. Note the absence of cracks despite the continuous network of grain boundary carbides in the heat affected zone

Figures 9(a)&(b) show the deposit substrate interface without any cracks. Figure 9(c)-(e) show the same interface at higher magnification showing that despite the presence of significant grain boundary carbide phases similar to the as received material, cracking did not occur. This would have been due to the shallower thermal gradients experienced by the material, which could have suppressed the liquation of these grain boundary carbide phases. Figure 9(f) shows the micrograph of the deposit. No γ' was observed in the deposit, however the inset shows the deposit at higher magnification showing the presence of carbides present in the interdendritic region. Based on the extent of characterization performed within phase 1 it is clear that the deposit fabricated by pre heating the substrate did not show any major difference with those fabricated without any preheat. However the role of strain age cracking during post weld heat treatment of the deposits were not evaluated. This will be performed in phase 2 of this work.
