ORNL/TM-2019/2117
CRADA/NFE-17-06604

Comparison of Electron Beam and Laser Beam Powder Bed Fusion Additive Manufacturing Process for High Temperature Turbine Component Materials, Phase II

**CRADA FINAL REPORT
NFE-17-06604**

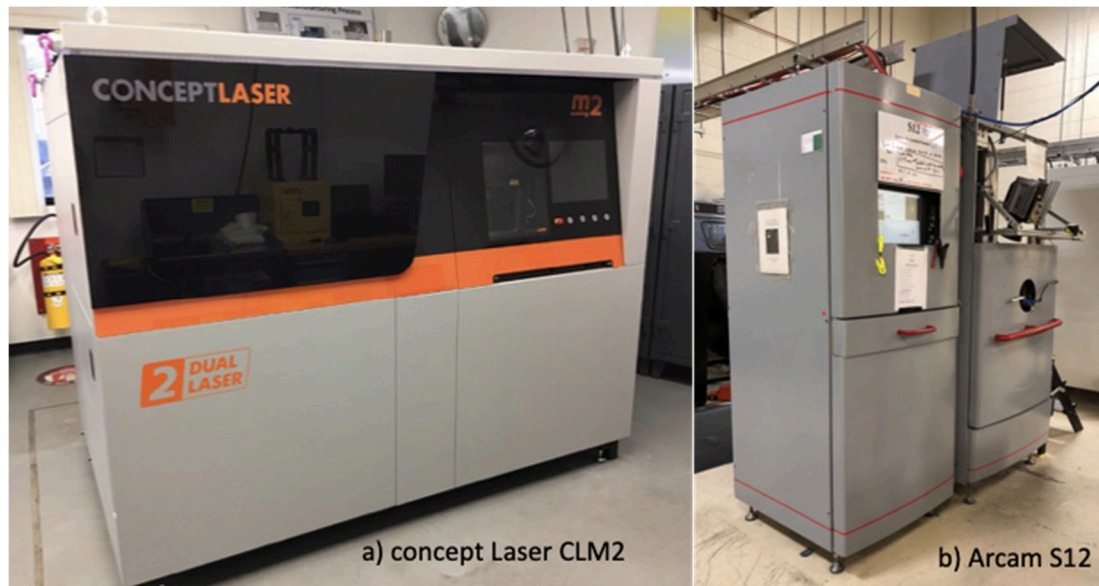
Figure 2: a) LB-PBF Concept Laser M2 machine, b) EB-PBF Arcam S12 machine

AM Machines: A Concept Laser M2 machine was used for the LB-PBF fabrication at Solar Turbines, while an Arcam S12 machine was used at ORNL for the EB-PBF specimens and artifacts (Figure 2). It is worth noting that a LB-PBF 3D Systems ProX300 machine was used for the phase I of the project, so new M2 specific fabrication parameters were used for phase II. For the EB-PBF process, the fabrication parameters optimized during the phase I were used for all the builds fabricated during phase II.
