Oak Ridge National Laboratory NERC MISOPS

December 2021

Investigation of Misoperations on the North American BPS

Christopher Sticht

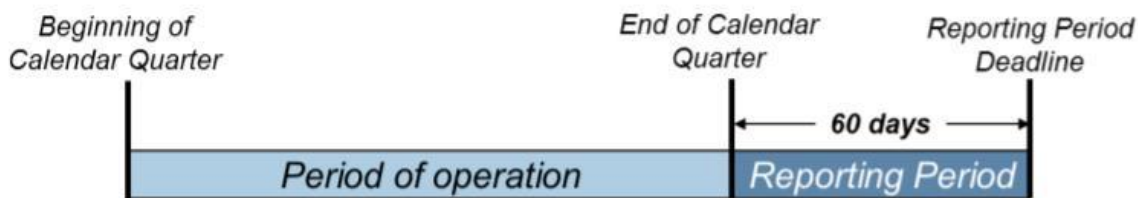
Figure 3 Reporting Period

Transmission Owners, Generator Owners, and Distribution Providers report Protection System Operations and Misoperations to NERC via the Misoperation Information Data Analysis System (MIDAS) on a quarterly basis, within 60 days of the end of each quarter. MIDAS is the database system maintained by NERC to collect and store the misoperations under NERC jurisdiction.
