# STEM imaging of irradiation induced defects in Eurofer97 steel variants irradiated in the EUROfusion collaboration

**STEM imaging of irradiation induced defects in Eurofer97 steel variants irradiated in the  
EUROfusion collaboration**

January 2022

Prepared by  
OAK RIDGE NATIONAL LABORATORY  
Oak Ridge, TN 37831-6283  
managed by  
UT-BATTELLE, LLC  
for the  
Karlsruhe Institute of Technology  
under contract NFE-16-06240

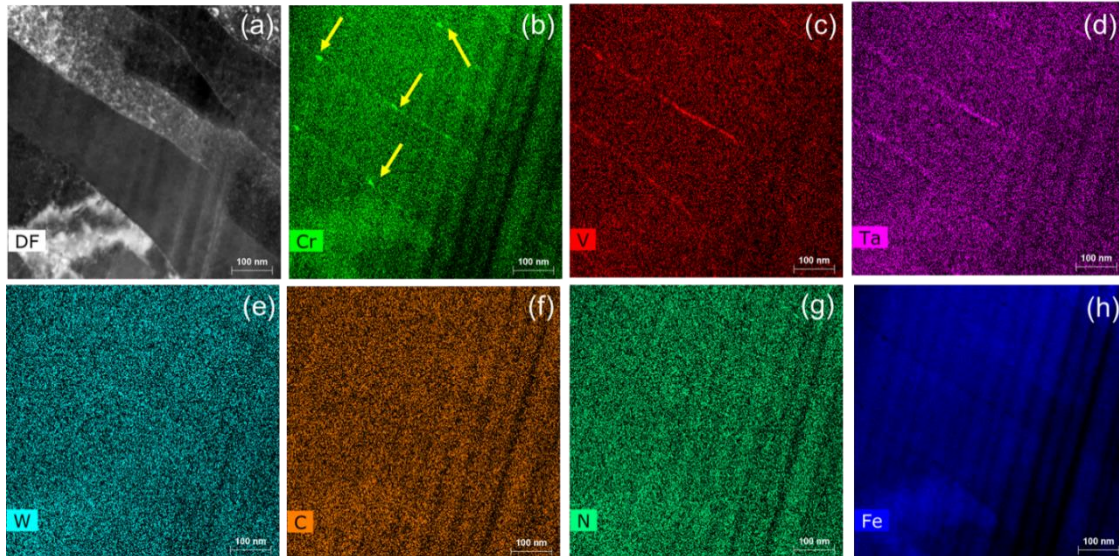
Figure 1: STEM-EDX mapping of K series steel in nonirradiated state. (a) MAADF image, (b-h) EDX maps of different elements in the steel. Dark lines at the left of EDX maps are artefacts due to FIB milling curtains. Yellow arrows show some Cr rich areas on the laths.

In nonirradiated condition, K series steel consisted of no precipitates. This steel had comprised of large prior austenite grains. For convenience, the nonirradiated microstructure and the STEM-EDX mapping results that were reported in Ref. [1] are shown in Figure 1. After irradiation, no significant evolution of the precipitation distribution occurred. Medium angle annular dark field (MAADF) and associated EDX maps taken from the irradiated sample are shown in Figure 2. It is evident in these figures that despite a few visible precipitates, the microstructure did not show evidence of any chemical redistribution or secondary phase precipitation of any sort. STEM-BF (bright field) mode and low angle annular dark field (LAADF) imaging was performed to characterize the irradiation-induced extended defects. This revealed that dislocation loops formed in the steel after the irradiation, as shown in Figure 3. Some of the identified loops are highlighted using arrows in the BF image. Figure 4 presents more examples of dislocation loops observed in this steel after irradiation and imaged at differing magnifications in STEM-BF mode. It is evident that the dislocation loop microstructure after irradiation was quite complex: numerous individual loops were identified but many loops were seen interacting with dislocation lines and/or with the neighboring loops.

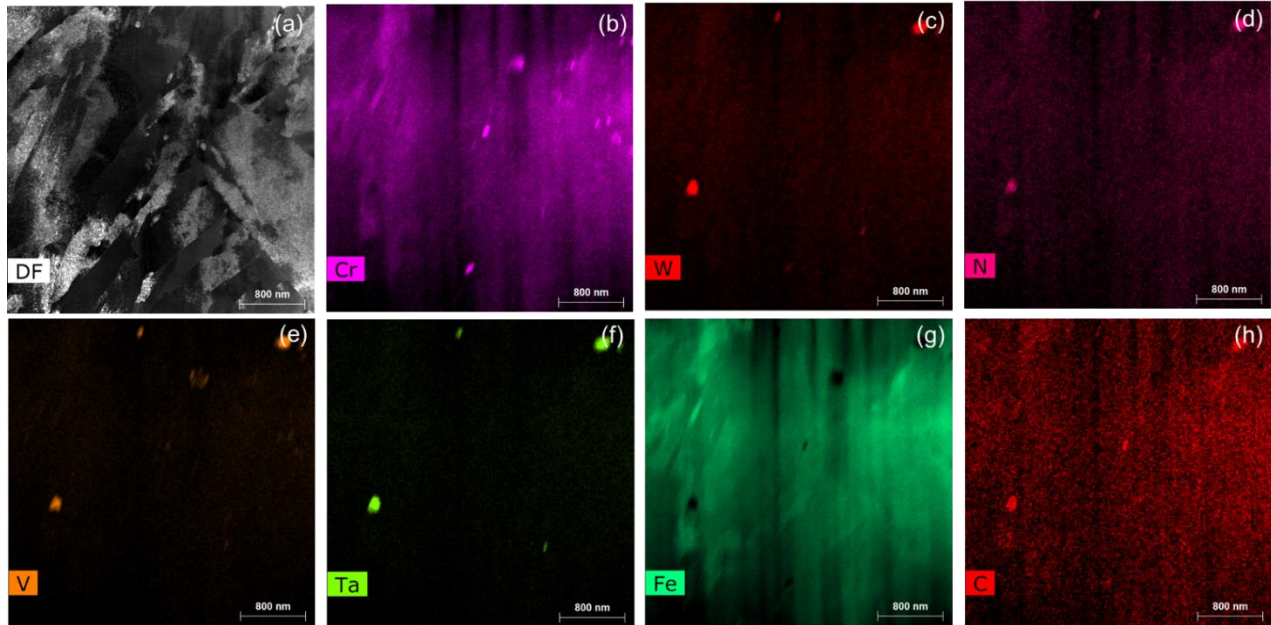
Figure 2: STEM-EDX mapping of K series steel after irradiation. (a) MAADF image, (b-h) EDX maps of different elements in the steel. Some small precipitates were seen, but the microstructure remained mostly under tempered.

Because of the complexity of performing g.b analysis on the relatively complex loop microstructure, their Burgers vector was not revealed. Numerous black dots were detected in all the STEM images when dislocation loops were imaged. Here, it is difficult to say whether these black dots were real features or created by FIB milling. These were not included for estimating the quantitative results. The average diameter and number density of the dislocation loops were 11 nm and  $\sim 1.8 \times 10^{22} \text{ m}^{-3}$ .

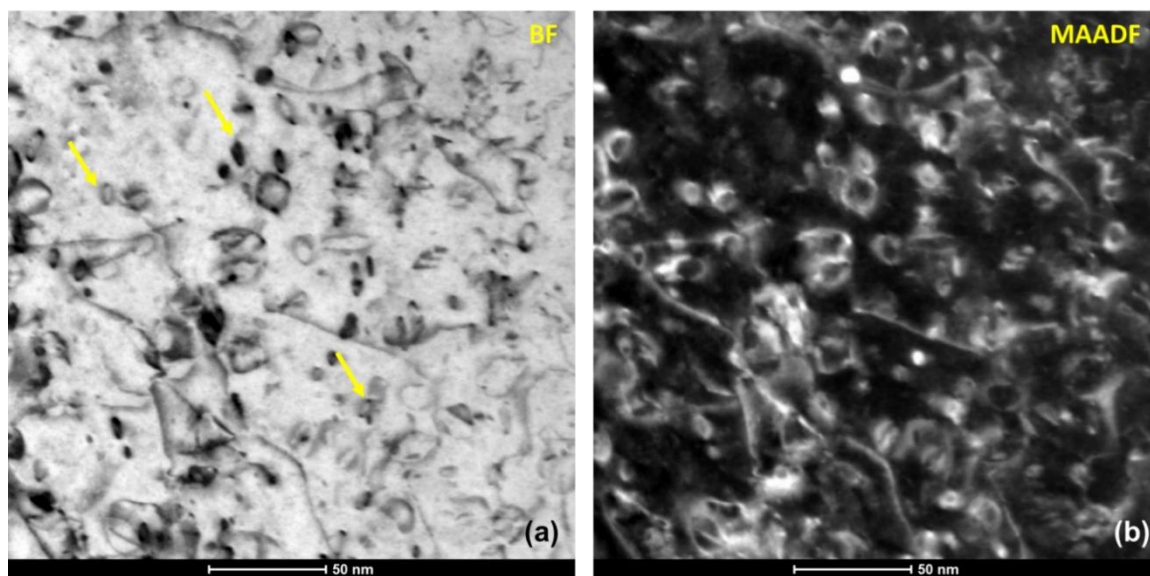
Figure 3: Dislocation loops in K series steel after irradiation. (a) STEM-BF. (b) MAADF. Imaging performed close to [001] zone axis using a  $\langle 110 \rangle$  type g vector. Some loops are indicated using arrows.

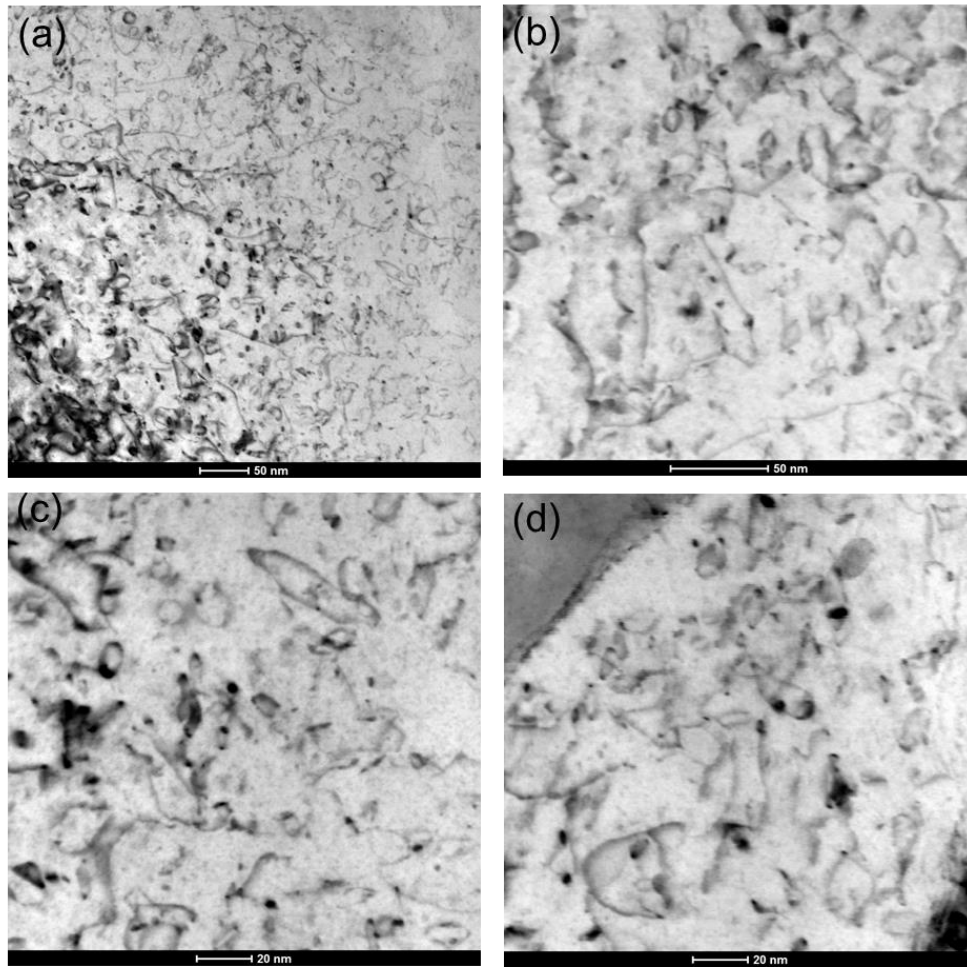
Figure 4: STEM-BF images of dislocation loops recorded at different locations and at different magnifications in the irradiated K series steel. Imaging was performed close to [101] and [100] zone axis using  $\langle 110 \rangle$  type diffraction vectors.

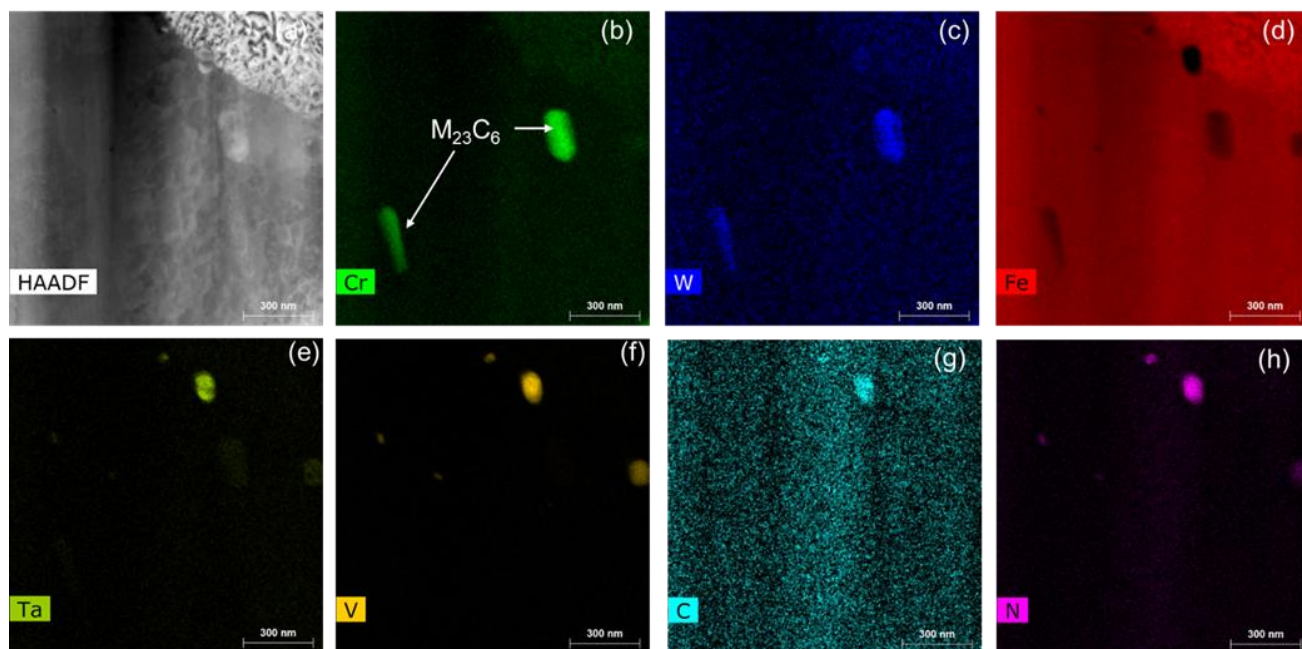
Figure 5: EDX mapping in STEM mode for H series in nonirradiated condition. (a) HAADF image. (b-h) Elemental maps.

As revealed in Ref. [1], in nonirradiated state TEM/STEM characterization of H series steel had revealed that two types of precipitate families: (i) predominantly Ta, V and N rich precipitates which are expected to be the MX precipitates and (ii) predominantly Cr, W rich phases, which are expected to be  $M_{23}C_6$  carbides. Because all the strong carbide formers typically enter  $M_{23}C_6$  phase, these particles also showed presence of Ta and V. For convenience, the STEM-EDX mapping result from the unirradiated H series steel are shown in Figure 5 where the two types of precipitate families can be identified. After irradiation, STEM-EDX mapping was again performed on a FIB foil and the results are shown in Figure 6 and Figure 7. These images revealed no significant change in the precipitate structure, because similar Cr, W rich large precipitates expected to be  $M_{23}C_6$  phase and Ta, V rich precipitates that are expected to be MX phase were identified. Except for the elements present in the alloy, no other elements, that may arise from transmutation, were detected. The precipitates after irradiation remained crystalline. This was proven by selected area electron diffraction (SAED). An example of this SAED is given in Figure 8 where crystalline diffraction spots originating from a precipitate on a grain boundary were observed. Upon indexing this SAED, the precipitate phase was identified to be  $M_{23}C_6$ .

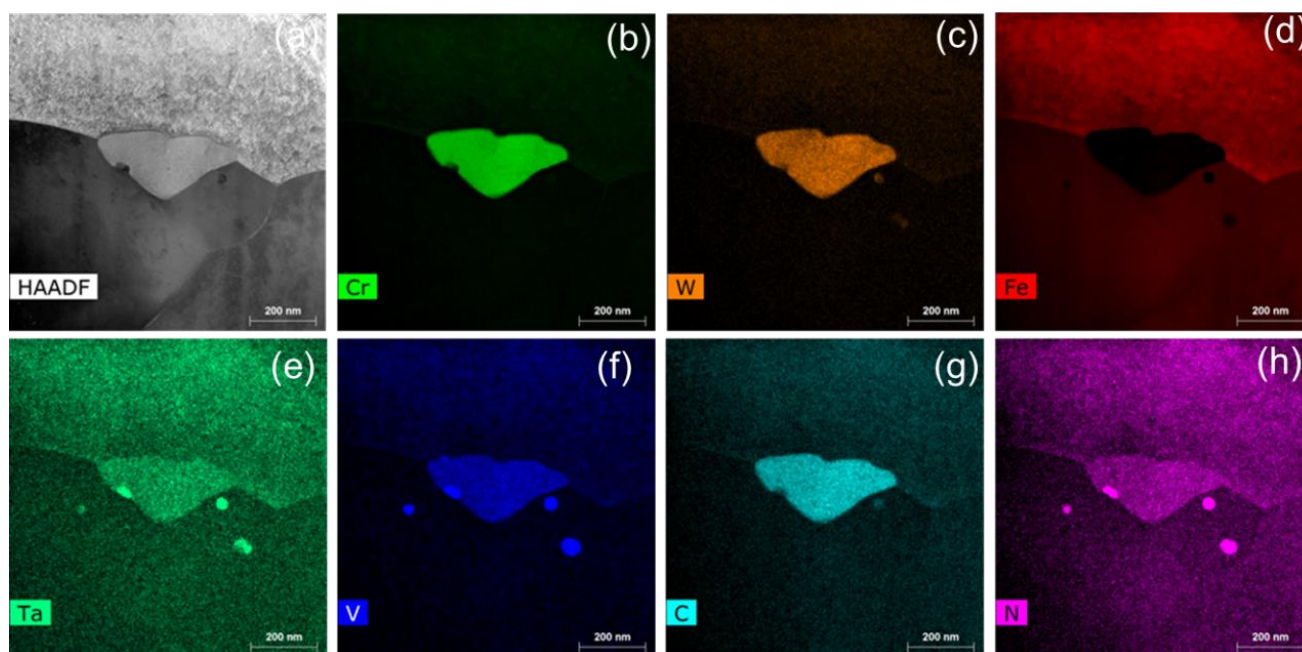
Figure 6: EDX mapping in STEM mode for H series after irradiation. (a) HAADF image. (b-h) Elemental maps.

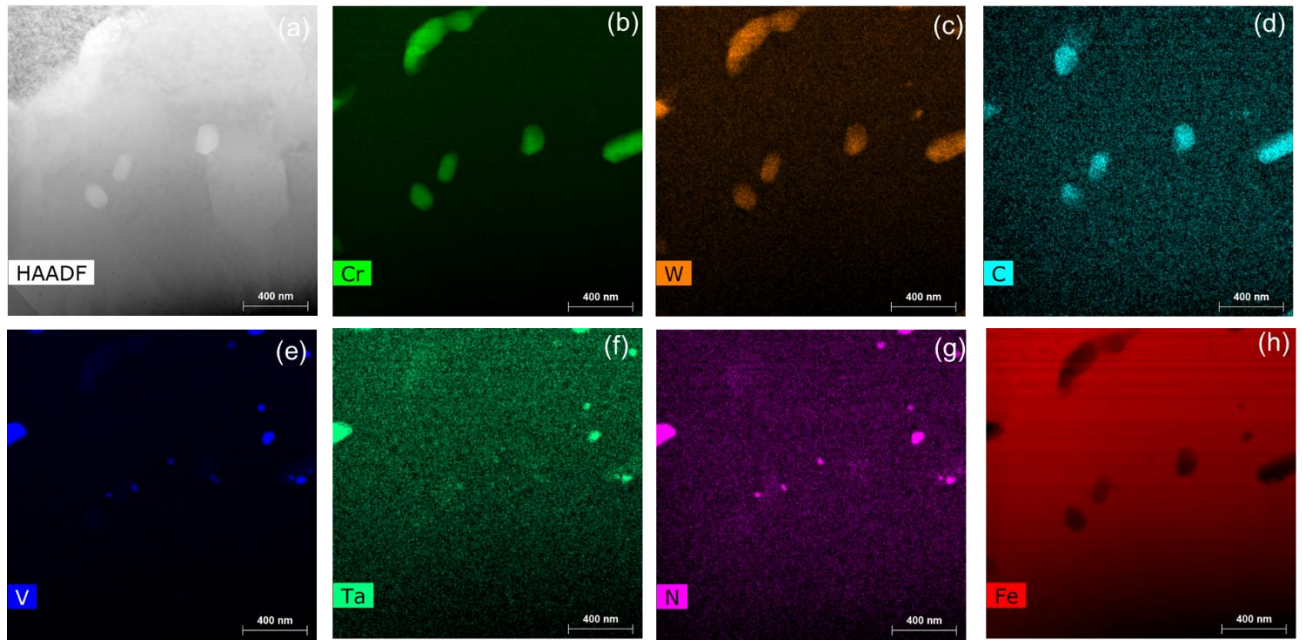
Figure 7: EDX mapping in STEM mode for H series after irradiation. (a) HAADF image. (b-h) Elemental maps, different zone.

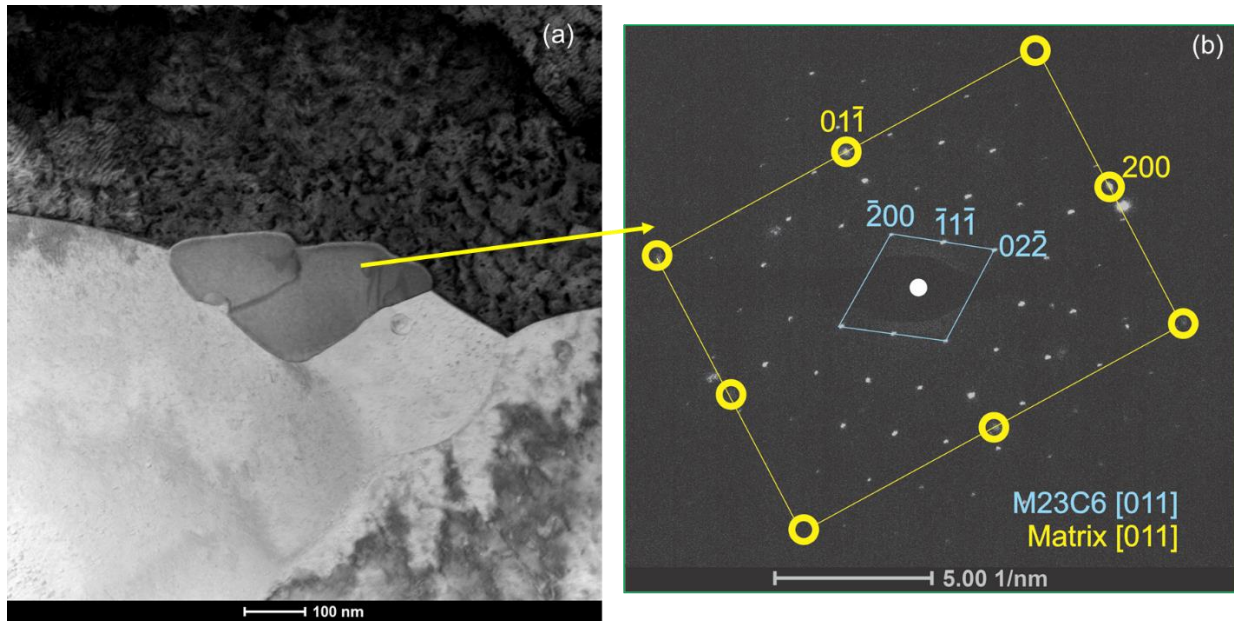
Figure 8: (a) Precipitate on a grain boundary identified as  $M_{23}C_6$  phase in irradiated H series steel. (b) Indexed SADP revealing the crystallinity and orientation relationship of the precipitate.

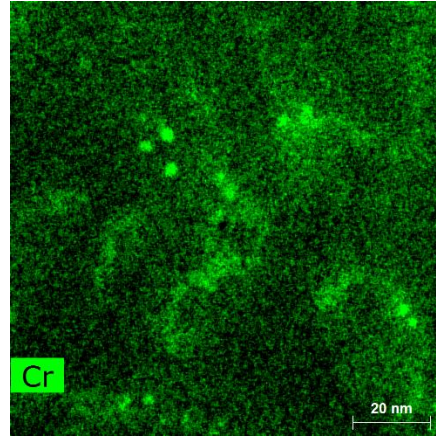
Figure 9: Cr rich globular precipitates and Cr enriched oval/ring type areas in the irradiated H series steel. No other elements were detected here other than Cr.

Further, STEM-EDX analysis also revealed some pure Cr rich precipitates in the matrix, as shown in Figure 9. Such precipitates were globular, ~2-5 nm in diameter and without any presence of other elements. We believe these may be radiation-enhanced Cr rich  $\alpha'$  phase. These precipitates were less numerous and were only observable in certain areas of the sample. Apart from these precipitates, Cr enriched areas, appearing to form as oval shaped rings were also detected when STEM-EDX was performed at higher magnifications (see Figure 9). We believe this is due to the well-known irradiation-induced segregation of Cr atoms to dislocation loop cores. Atom probe tomography (APT) would be needed to quantify this phenomenon.

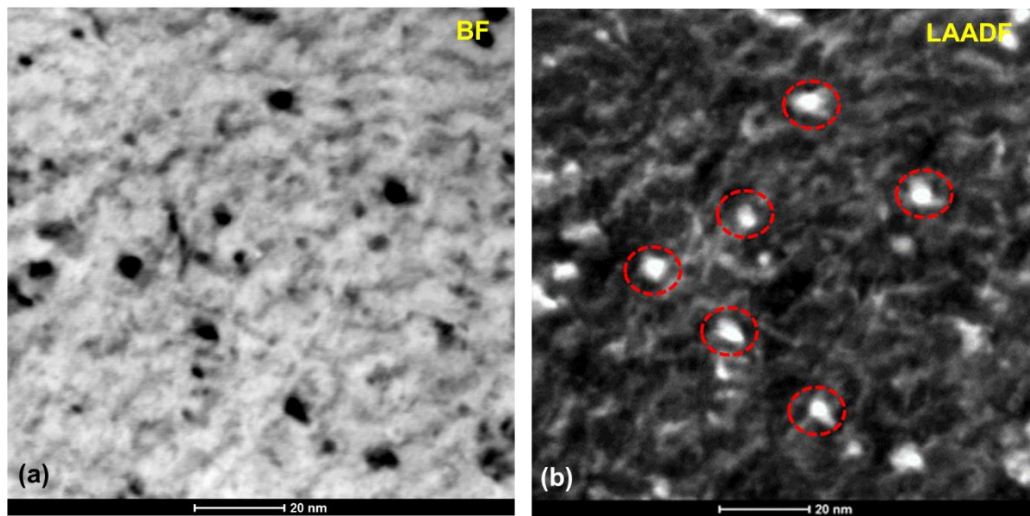
Figure 10. Dislocation loops in H series steel imaged close to [101] zone axis in (a) STEM-BF mode and (b) LAADF mode. Some loops are encircled in (b).

STEM imaging revealed irradiation-induced dislocation loops in this steel. The corresponding BF and LAADF images, obtained close to [101] zone axis, are given in Figure 10. Some of the identified dislocation loops are encircled in the LAADF image. These dislocation loops were mostly black-dot type with an average diameter of ~ 3 nm and number density of  $1.2 \times 10^{21} \text{ m}^{-3}$ . Such small loops are remarkably different to the results obtained in the K series steel where the average loop size was much larger, at 11 nm. Here, one must be cautious that the loop sizes in H series steel are very close to those expected from FIB damage. Therefore, more analysis on flashed polished samples is suggested as a future study.

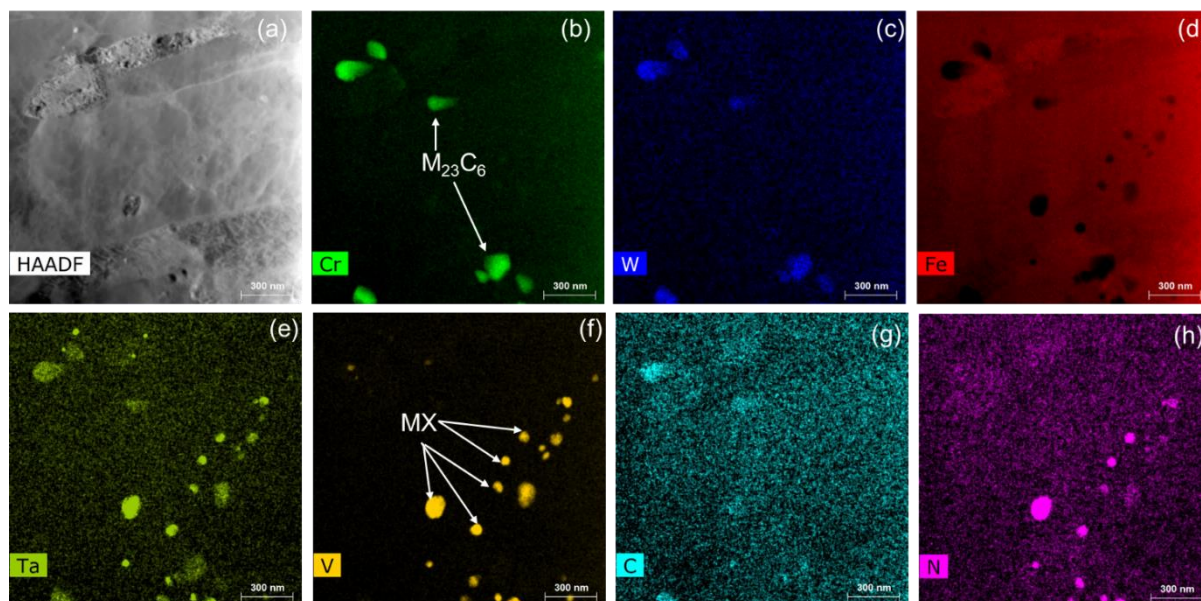
Figure 11: EDX mapping in STEM mode for nonirradiated I series steel. (a) HAADF image. (b-h) Elemental maps.

Similar to the H series steel, I series steel in the nonirradiated condition also showed the presence of primarily two types of precipitate phases: Cr, W rich larger carbides on the grain/lath boundaries that are expected to be  $M_{23}C_6$  type and Ta, V rich smaller precipitates that are expected to be the MX phases. HAADF STEM image and associated EDX elemental maps from this steel in the nonirradiated form are shown in Figure 11.

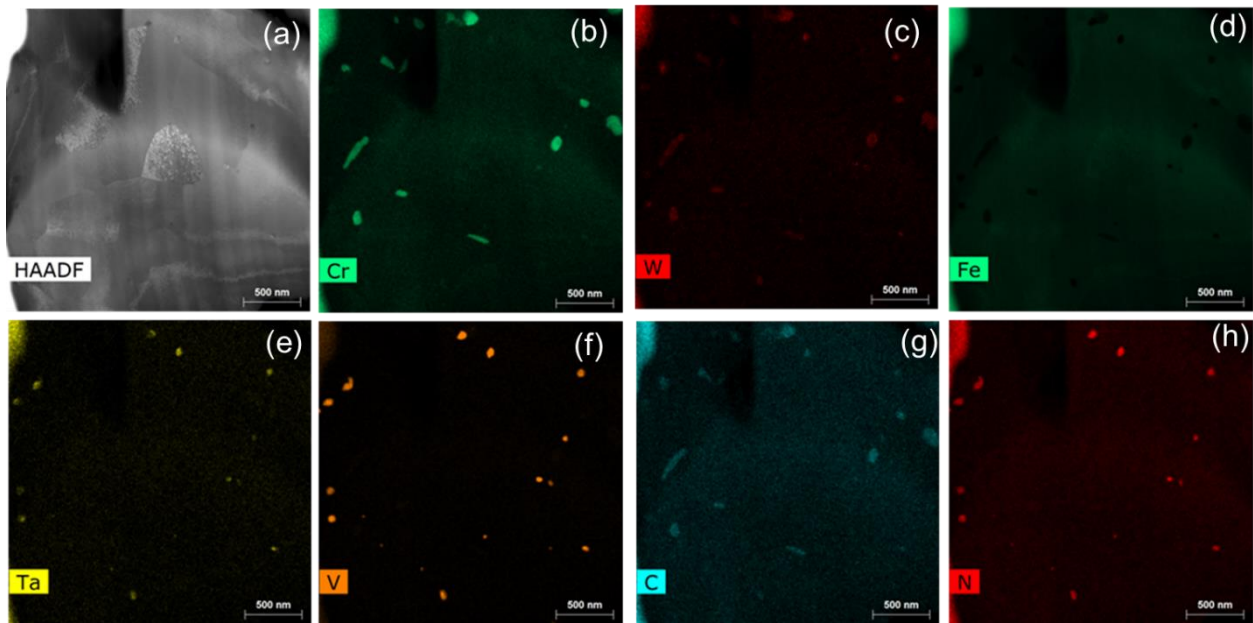
Figure 12 EDX mapping in STEM mode for irradiated I series steel. (a) HAADF image. (b-h) Elemental maps, second FIB foil.

After irradiation, similar EDX mapping was performed to see if any qualitative difference existed or not. The corresponding HAADF image and EDX mapping from the irradiated steel are given in Figure 12. Similar to the case of the nonirradiated alloy, evidence of Cr rich larger  $M_{23}C_6$  precipitates and V, Ta rich smaller precipitates were detected, with no apparent qualitative differences.

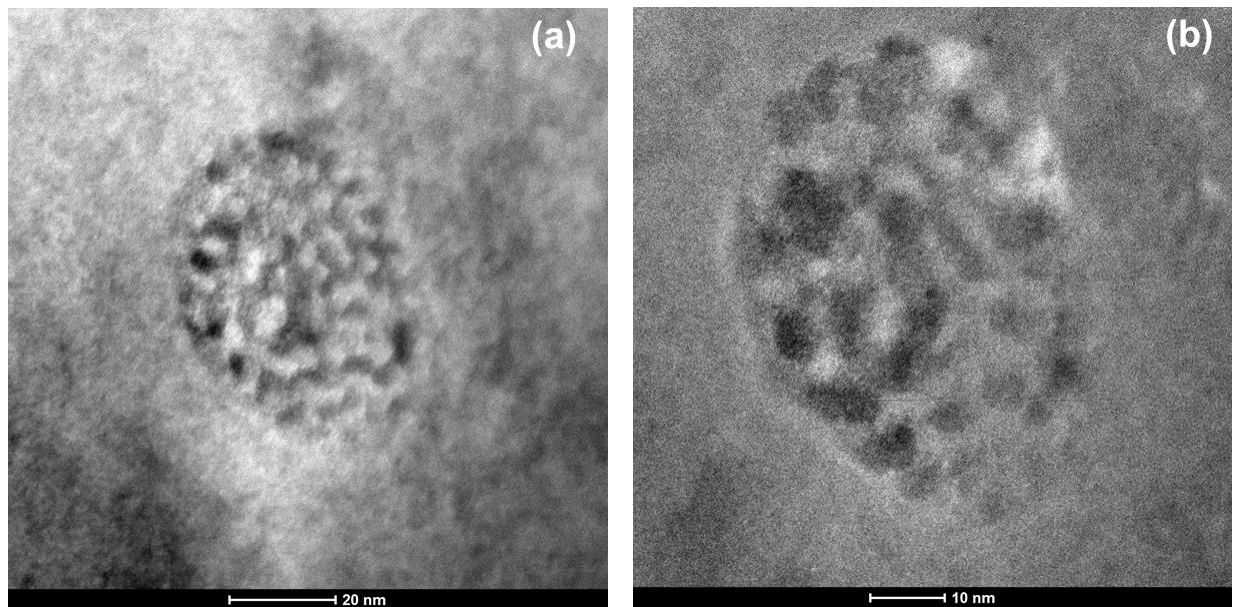
Figure 13: HAADF images of complex sponge-like precipitates in the neutron irradiated I series steel.

An interesting observation in the I series steels was that numerous precipitates were identified in the matrix that showed damaged structures caused by the neutron irradiations. These precipitates consisted of complex sponge-like sub-structures revealed by imaging in STEM mode. Two examples of such precipitates in the matrix are provided in Figure 13, where HAADF imaging revealed the intricate structural morphology within these precipitates. In these figures, we believe the much darker regions are internal holes created by the irradiation inside these precipitates. To reveal the chemistry of these precipitates, EDX mapping in STEM mode was performed. This revealed two kind of sponge like precipitates: (i) the first one being Fe, Cr, C rich as shown in Figure 14. No evidence of other elements was detected in these structures. Here, undulations in the distribution of Fe can be seen which corresponds well with the dark regions in the HAADF image. We believe these dark regions are perhaps nano-cavities/holes formed inside this precipitate. Because the particle was enriched in Fe, Cr, C, we believe this phase is  $M_{23}C_6$  that suffered degradation due to irradiation. Another set of detected particles that showed the sponge-like structure are shown in Figure 15, where we reveal that this phase was V, W and O rich, and hence implies is an oxide phase. These oxide phases were not detected in the nonirradiated I series steel and imply that these precipitates may have formed under the irradiation. What is puzzling is that Cr has strong affinity towards O. However, despite these precipitates rich in O, there was no presence of Cr. These results are qualitatively

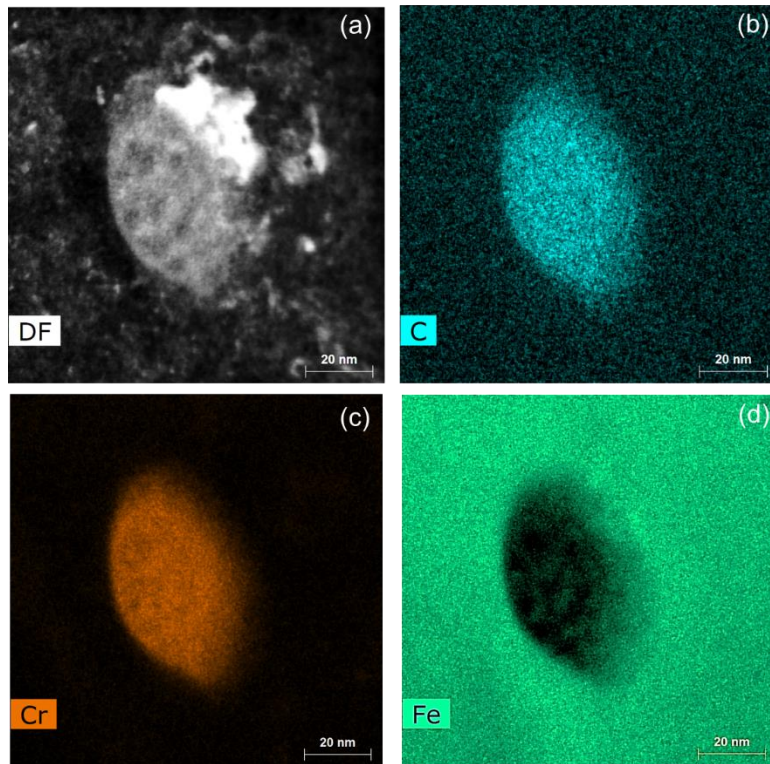
Figure 14: Fe, Cr, C rich sponge like precipitates in irradiated I series steel. (a) MAADF image and (b-d) are elemental maps.

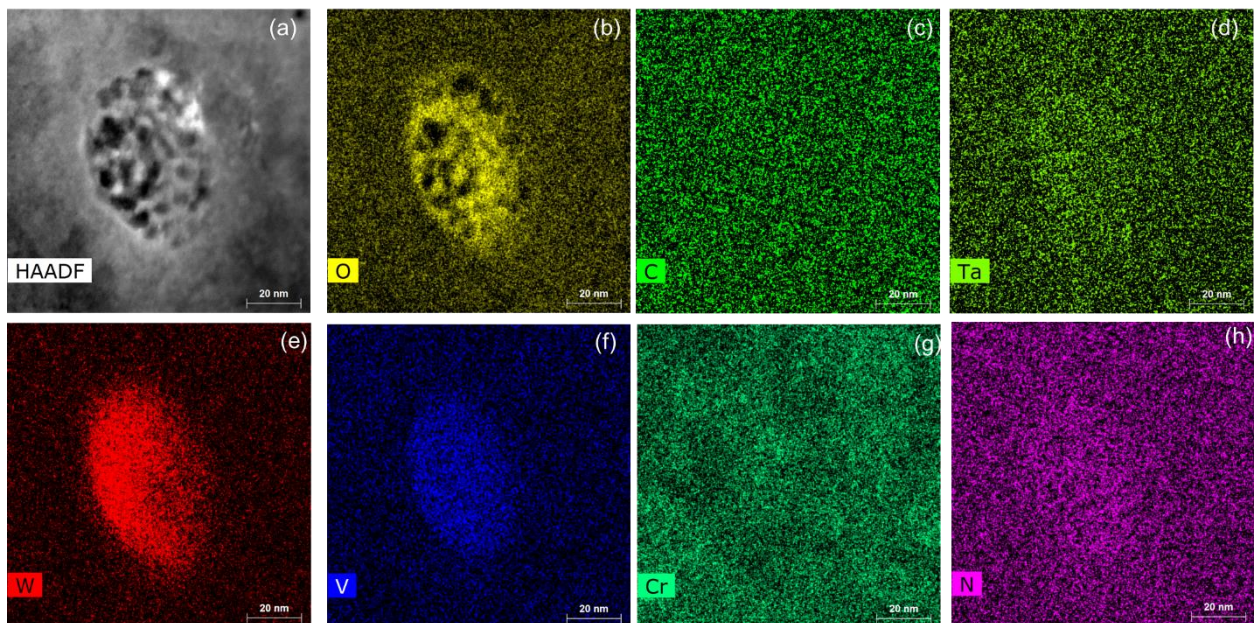
Figure 15: O, W, V rich sponge-like precipitates in irradiated I series steel.

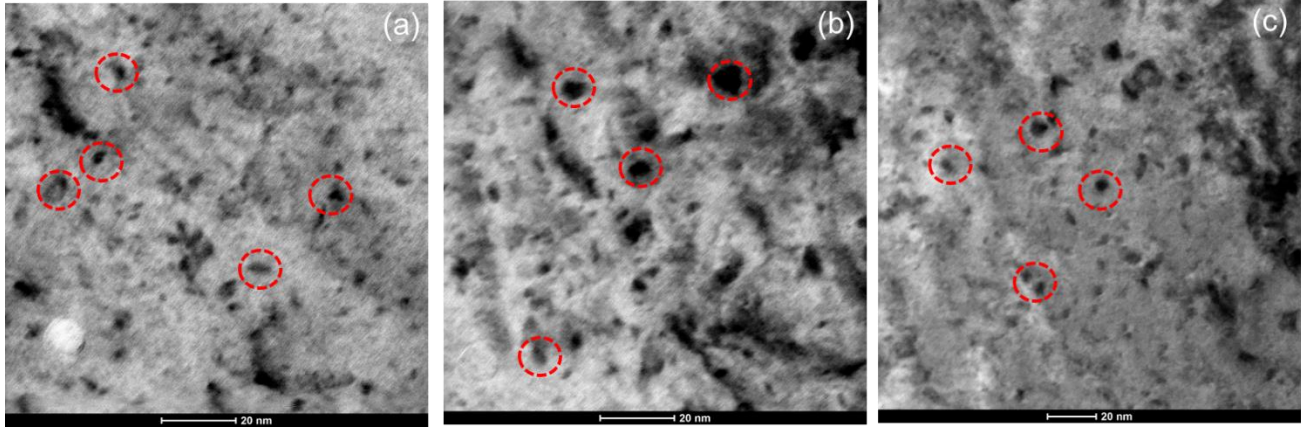
Figure 16: BF STEM images of black-dot type dislocation loops in irradiated I series steel. Imaged close to [101] zone axis. Encircled are certain black-dot type defects identified in the matrix. Zone axis = [101],  $g = \langle 110 \rangle$  type.

After performing analytical analysis of the secondary phases, STEM imaging was used to study the irradiation induced extended defects. For example, Figure 16 reveals that the dislocation loops were like black-dot type damage, very small between ~2-10 nm in diameter. Certain identified dislocating loops are encircled in Figure 16. The number density of these black dot defects was  $2.3 \times 10^{21} \text{ m}^{-3}$ .

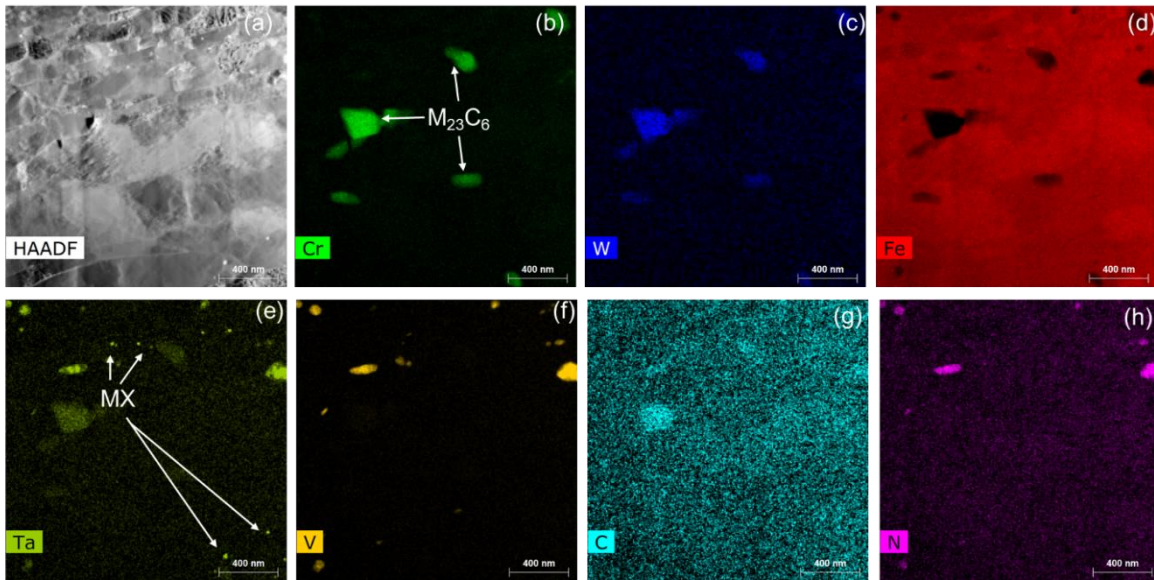
Figure 17: EDX mapping in STEM mode for nonirradiated P series steel. (a) HAADF image. (b-h) Elemental maps.

In nonirradiated condition, P series steel also consisted of Ta, V rich precipitates (MX phase) and Cr, W rich large  $M_{23}C_6$  carbides. HAADF image and STEM-EDX maps from the nonirradiated sample are given in Figure 17.

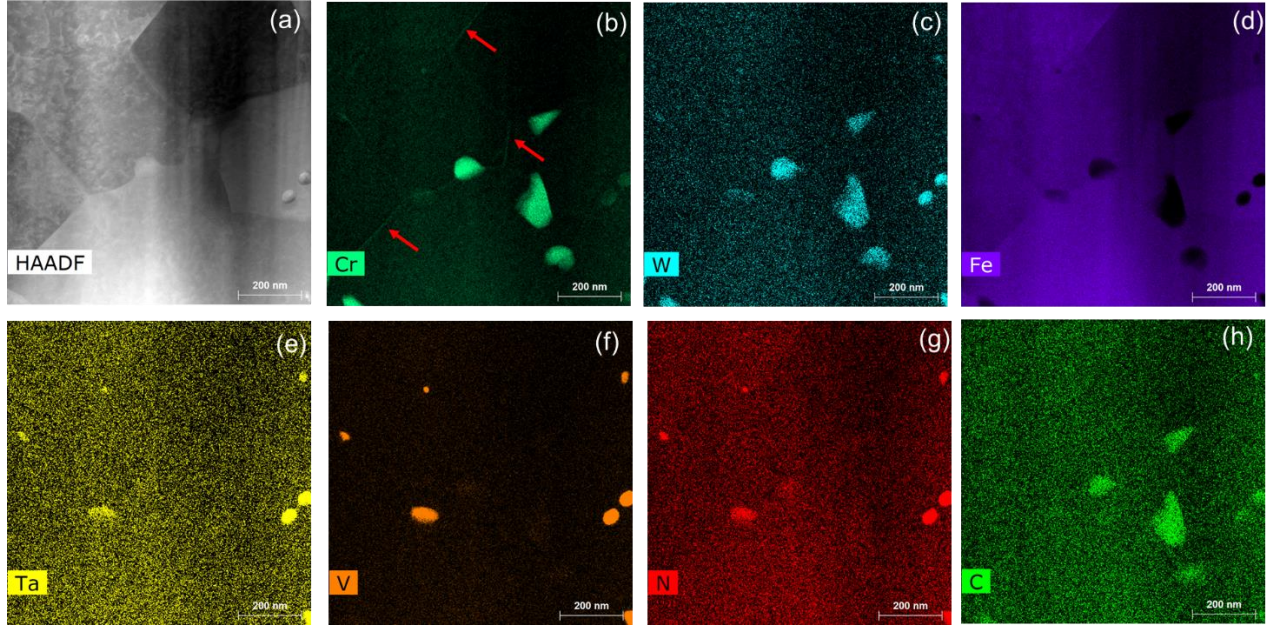
Figure 18: EDX mapping in STEM mode for irradiated P series. (a) HAADF image. (b-h) Elemental maps.

After irradiation, the presence of  $M_{23}C_6$  and MX phases was confirmed in the microstructure; no significant precipitate evolution occurred (Figure 18). Further, no sponge-like precipitate evolution, as detected in the I series steel, was observed in this alloy. EDX map for Cr suggested some segregation onto the grain/lath boundaries, which is expected for an Fe-Cr alloy and an Fe-Cr based FM/RAFM steel. A high magnification HAADF and EDX maps from the irradiated steel are shown in Figure 62 where, except for the Cr rich  $M_{23}C_6$  phase, no evidence of Cr clustering in the matrix as seen for H series steel, was detected.

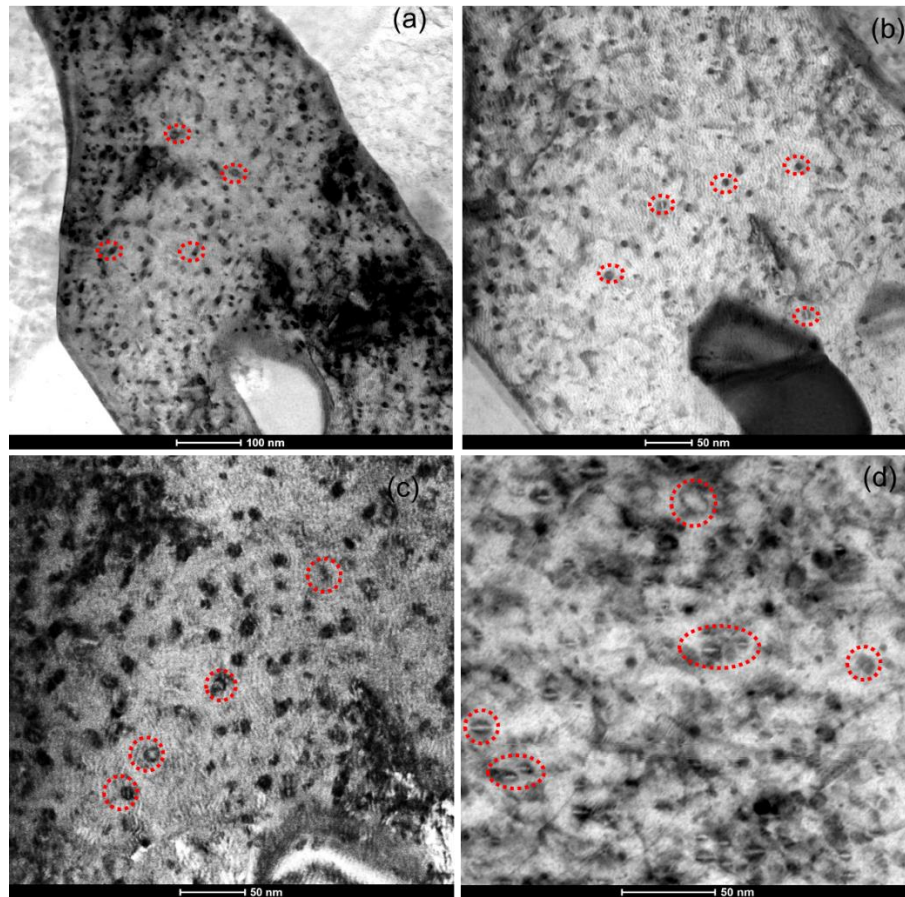
Figure 19: STEM-BF images revealing the dislocation loops in irradiated P series steel. Imaging performed close to  $[101]$  zone axis, in down axis condition. Many identified dislocation loops are encircled.

When imaged in STEM-BF mode, dislocation loops created by the neutron irradiations were revealed in the microstructure. A few examples of such loops, observed at different regions of the foil and at differing magnifications, are provided in Figure 63 where some are encircled. In many cases, these loops appeared close to on-edge configuration and generated the typical coffee-bean contrast (Figure 19). All these images were recorded close to  $[101]$  zone axis. The average diameter and number density of the dislocation loops was 6.7 nm and  $5.5 \times 10^{20} \text{ m}^{-3}$ . Once again, the microstructure is quite complicated with numerous features appearing in the size range of FIB damage.

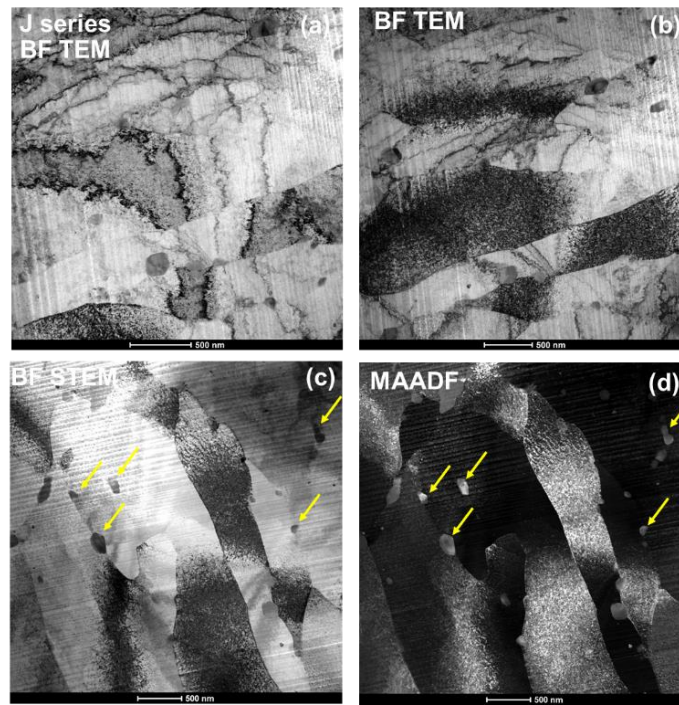
Figure 20: TEM and STEM imaging of J series steel. (a,b) Conventional BF TEM images, (c, d) BF STEM and MAADF image of the same zone.

Figure 20 presents BF TEM/STEM and MAADF images of the microstructure of J series steel. In all these figures the laths can be identified with typical large precipitates. Precipitates were better resolved in the MAADF images (indicated using yellow arrows). To better distinguish the  $M_{23}C_6$  and MX phases, EDX mapping was performed in STEM mode (see Figure 21). Large precipitates ( $> 50$  -80 nm) were Cr, W rich and are expected to be  $M_{23}C_6$ , while smaller precipitates ( $< 30$  nm) were Ta, V and N rich consistent with MX phases.

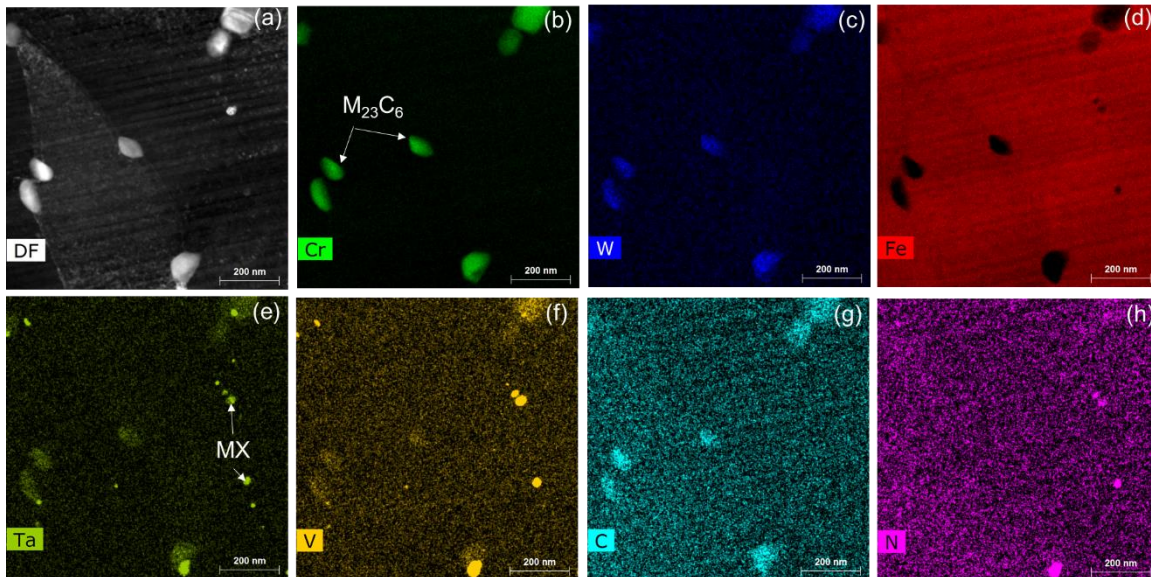
Figure 21: EDX mapping in STEM mode for J series. (a) MAADF image. (b-h) Elemental maps.

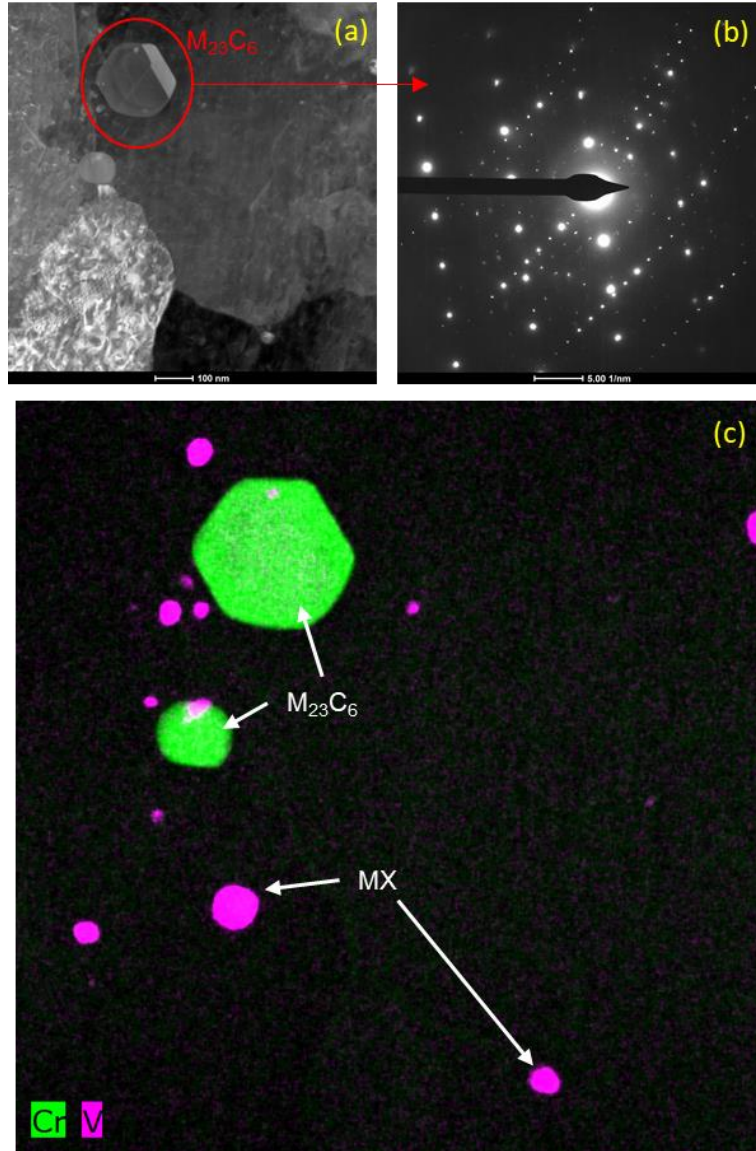
Figure 22: Characterization of precipitates in material J after irradiation. (a) STEM-MAADF image of a zone containing  $M_{23}C_6$ . (b) SAED pattern of the  $M_{23}C_6$  carbide showing crystallinity. (c) STEM EDX Cr and V map overlay to show the distribution of  $M_{23}C_6$  carbides and MX carbonitrides.

After irradiation, no significant degradation or changes to the precipitate microstructure was detected. Further, no sponge like transformation of the carbides, as seen for material I was observed. Figure 22 presents an overview of the precipitate microstructure after irradiation, imaged in STEM-EDX mode where the coarse  $M_{23}C_6$  and V rich MX phases can be seen. Selected area electron diffraction pattern recorded

from the  $M_{23}C_6$  carbide shows that these phases remained fully crystalline after the irradiation, with no evidence of any amorphization.

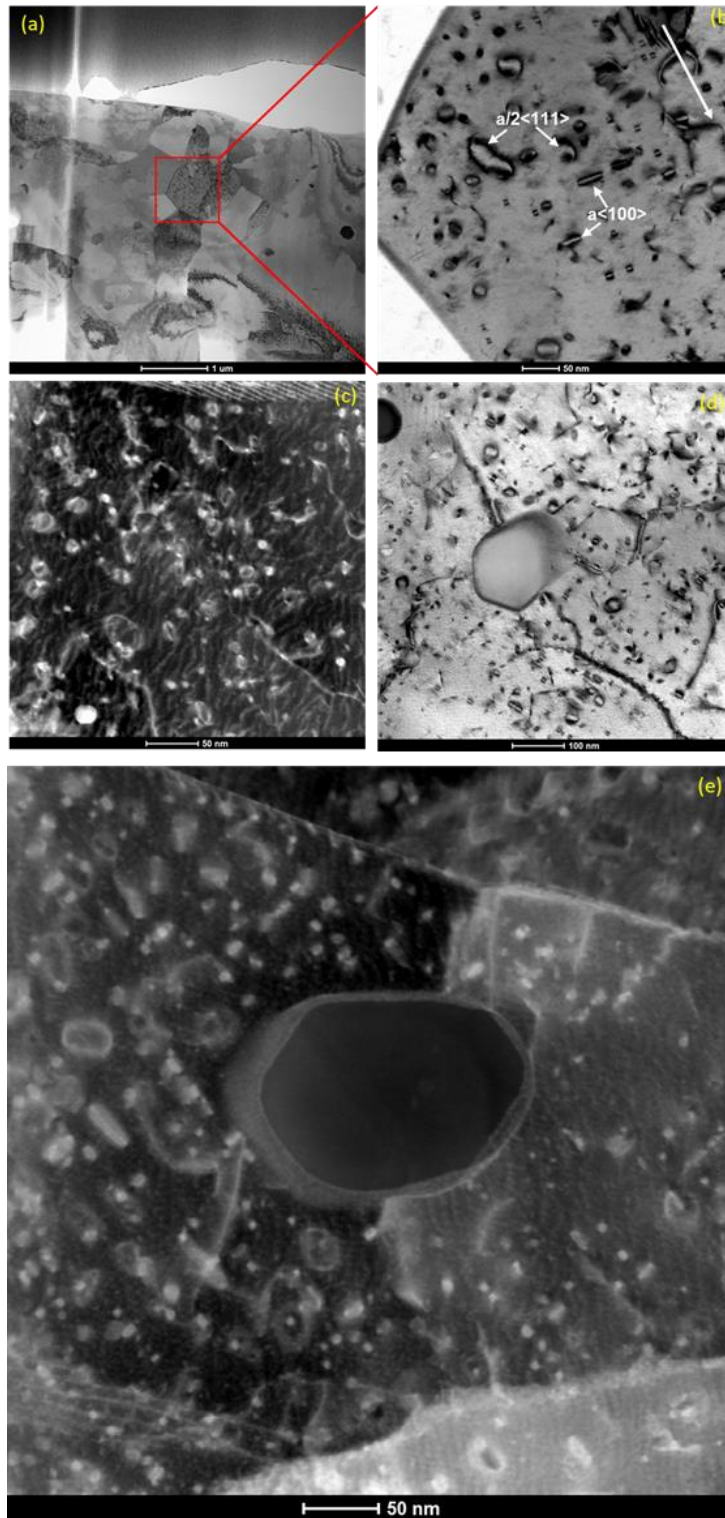
Figure 23: Characterization of dislocation loops in material J after irradiation. (a) STEM-BF image of the foil overview showing a grain close to [001] zone axis. (b) High magnification image of dislocation loops detected in the highlighted grain in (a) when imaged with (110) type g vector close to [001] zone axis,

deviation parameter  $s > 0$ . (c) MAADF image of dislocation loops in a grain. (d) STEM-BF image of dislocation loop distribution around a large  $M_{23}C_6$  carbide. (e) Overview of loop distribution imaged close to  $[001]$  zone axis around a large  $M_{23}C_6$  carbide.

Extended defects such as dislocation loops formed in this alloy due to irradiation. Figure 23a presents an overview of the FIB foil where a grain close to diffraction conditions with visible defect contrast is presented. When the same grain was magnified and imaged close to  $[001]$  axis, dislocation loops were clearly identified. While performing g.b analysis on the nanometric grains is challenging, the Burgers vector of the loops can be inferred based on the selected diffraction condition and zone axis. In Figure 23b, the loops appearing on-edge aligned along  $[010]$  or  $[001]$  directions were  $a\langle 100 \rangle$  type dislocation loops while all the other loops that were not on-edge were  $a/2\langle 111 \rangle$  type. This shows that  $a\langle 100 \rangle$  type loops form in RAFM steels at temperatures as low as 300 °C, that contradicts decades of data produced in Fe-Cr alloys and FM steels by ion irradiations. Figure 23c and d present different areas of the foil imaged in MAADF and BF conditions where the overview of the dislocation loop microstructure can be seen. Figure 23d shows a MAADF image of loops around a large  $M_{23}C_6$  carbide where no apparent loop denuded zone around the

precipitate is visible. Compared to the previous alloys, the size of loops was larger in material J, with some loops as large as 50-75 nm and lower number density ( $0.85 \times 10^{20} \text{ m}^{-3}$ ).

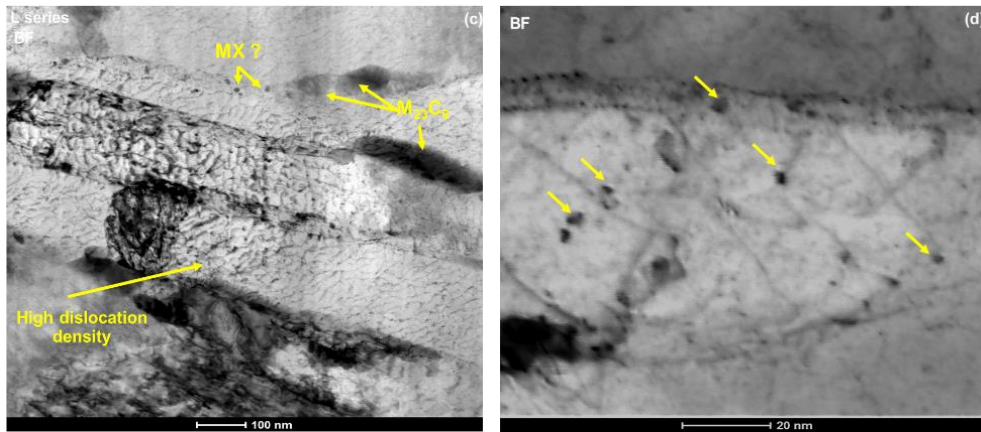
Figure 24: STEM imaging of L series steel. (a, b) BF and MAADF images showing the sample overview, with some precipitates indicated using arrows. (c) BF image close to two beam conditions showing the high dislocation density. (d) High magnification BF STEM image close to two-beam condition revealing some small precipitates.

Figure 24 and Figure 25 show BF and MAADF images of the sample showing the typical lath structure in material L, adapted from Ref. [1]. Large carbides were detected along the lath boundaries, which are expected to be the  $M_{23}C_6$  or  $M_7C_3$  type [3]. Some small precipitates were also detected. These precipitates were slightly better visible in the MAADF images compared to BF. These small precipitates have been shown to be mainly Cr, V rich  $M_2X$  nitride phase instead of MX carbo-nitrides [3]. Figure 24 was imaged close to 2-beam conditions which brought the high dislocation density of the laths come into contrast. Figure 25 shows a few 5-7 nm size precipitates detected in the steel which can be either  $M_2X$  or MX.

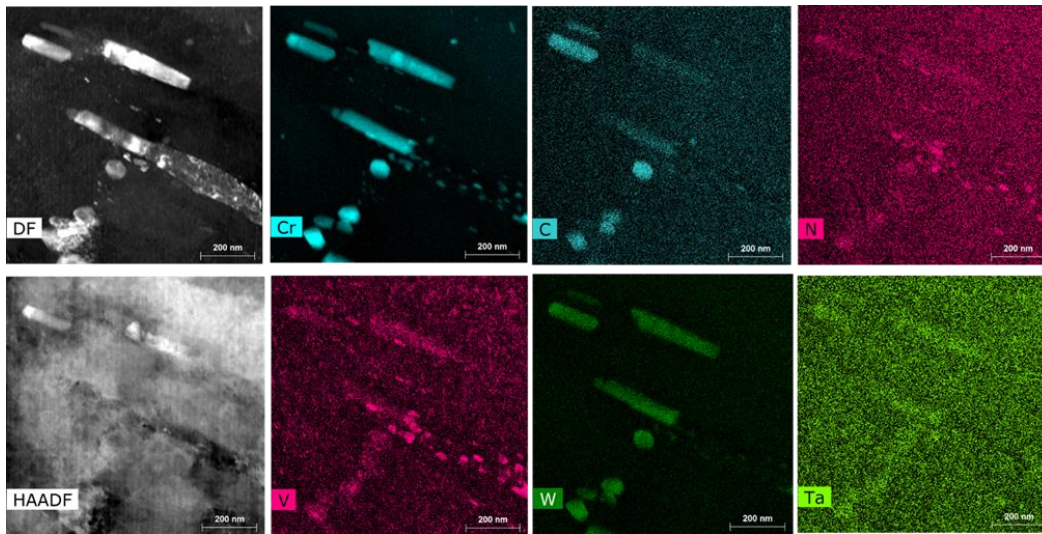
Figure 25: STEM-EDX mapping of precipitates in L series steel, along with an MAADF (DF) and HAADF.
