# STEM imaging of irradiation induced defects in Eurofer97 steel variants irradiated in the EUROfusion collaboration

**STEM imaging of irradiation induced defects in Eurofer97 steel variants irradiated in the  
EUROfusion collaboration**

January 2022

Prepared by  
OAK RIDGE NATIONAL LABORATORY  
Oak Ridge, TN 37831-6283  
managed by  
UT-BATTELLE, LLC  
for the  
Karlsruhe Institute of Technology  
under contract NFE-16-06240

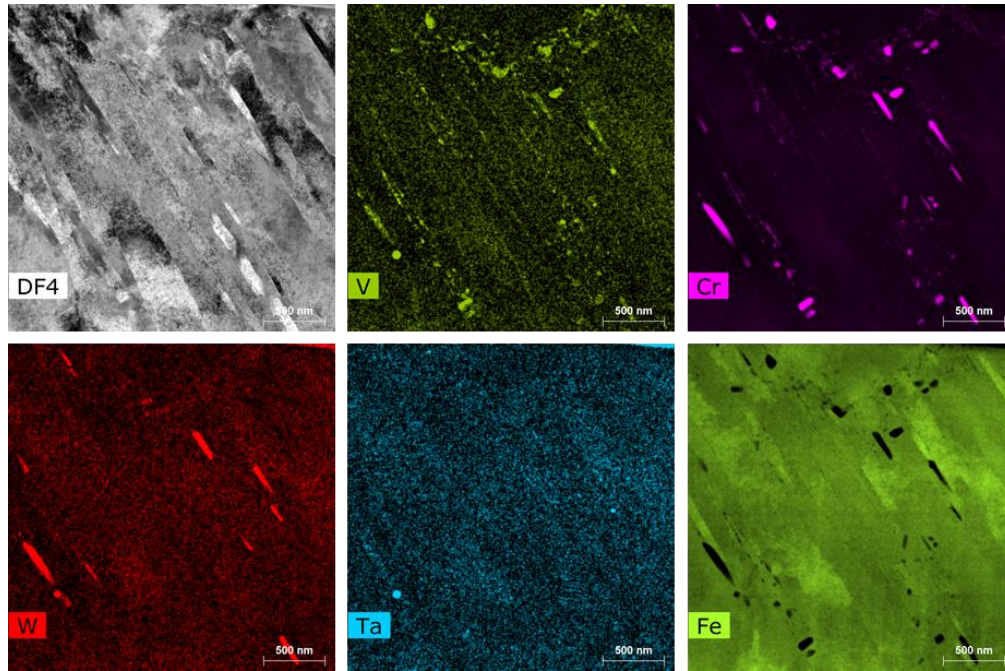
Figure 26: Characterization of L series steel after irradiation. LAADF image of the laths is presented along with STEM-EDX maps of the same area showing the precipitate distribution.

After irradiation, Figure 26 presents an overview of the lath structure and STEM-EDX maps. The lath structure appeared stable after irradiation, with no drastic differences as compared to nonirradiated results reported in Refs. [1,3]. The precipitate microstructure also looked similar to the one recorded before irradiation with large Cr, W rich carbides located primarily on the lath boundaries, while Cr, V rich smaller particles located inside the grains (but also on the lath boundaries). Only a few Ta rich precipitates were detected, which further confirmed a lack of MX phase in this alloy. To clearly distinguish the large Cr rich carbides ( $M_{23}C_6$  or  $M_7C_3$ ) versus the Cr, V rich precipitates ( $M_2X$  or MX), the count maps of Cr and V are overlaid in Figure 27.

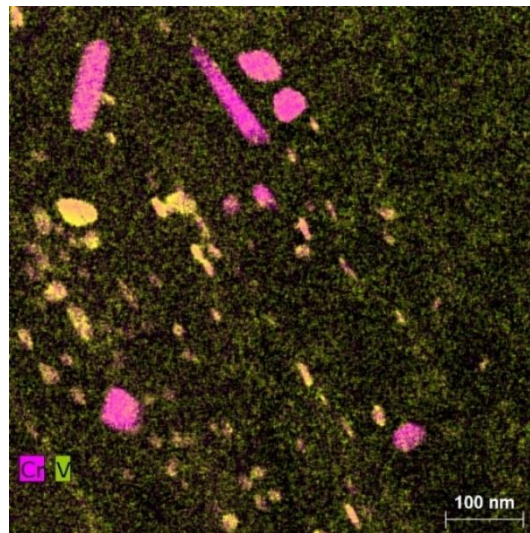
Figure 27: Overlay of Cr and V STEM-EDX maps to show the different precipitate families in L series steel after neutron irradiation.

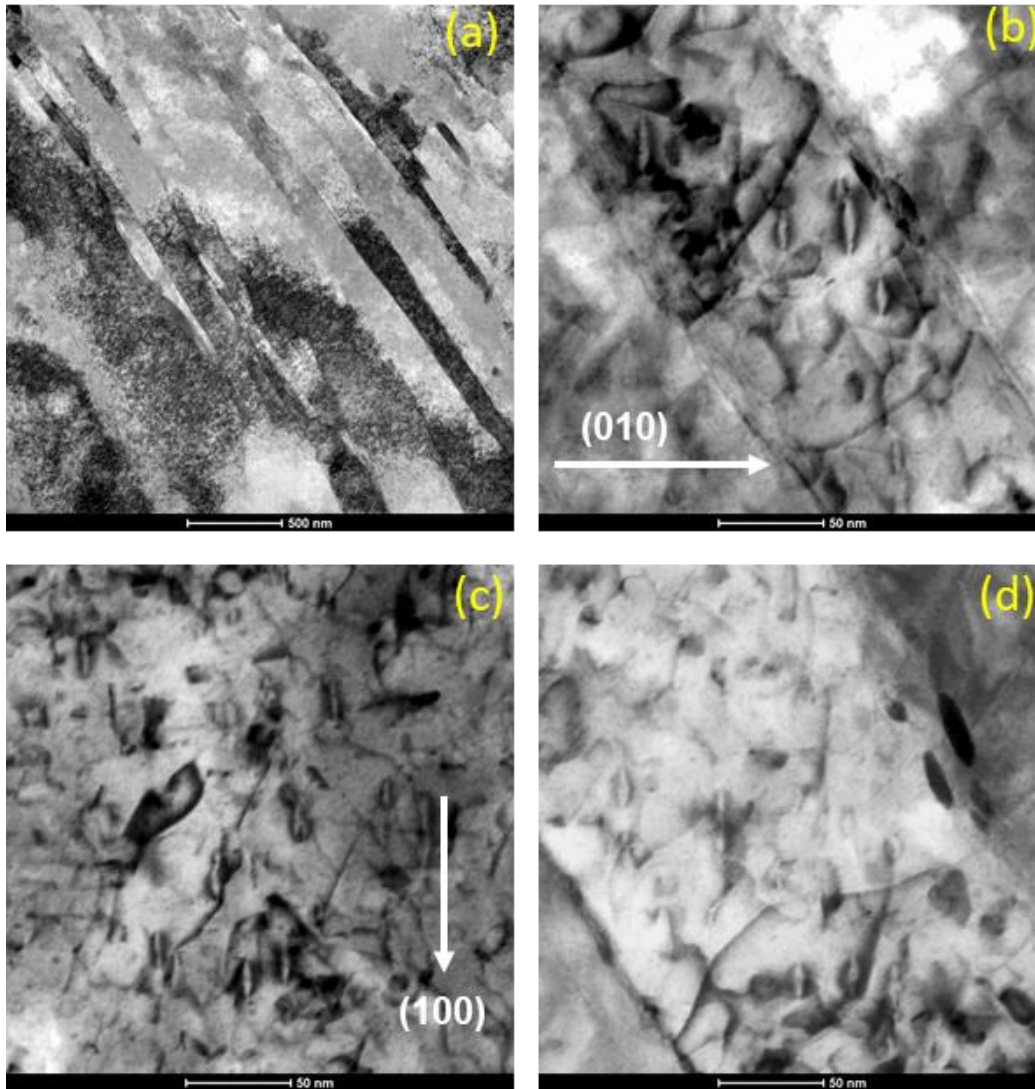
Figure 28: Characterization of dislocation loops in neutron irradiated L series steel using STEM-BF imaging. (a) Overview of the lath structures with dislocation loops. (a) Dislocation loops inside a nanometric lath; loops aligned close to on-edge condition when imaged close to  $[001]$  zone axis with a  $\langle 110 \rangle$  type g vector. (b, c) Similar loops detected in different laths that were also imaged close to  $[001]$  zone axis.

Dislocation loops formed in material L after irradiation. This can be seen in the different BF STEM images shown in Figure 28. While a g.b analysis was not possible due to the difficulty of tilting very fine nanometric laths to different orientations, some indication of the Burgers vector was obtained from the laths close to  $[001]$  orientation. In Figure 28b and c, numerous dislocation loops appeared close to on-edge condition with elongated coffee bean contrast when imaged with  $\langle 110 \rangle$  type diffraction vectors available along a  $[001]$  zone axis. Only  $a\langle 100 \rangle$  type loops appear on-edge under such imaging conditions in bcc metals, which shows that the on-edge loops in Figure 28 were mostly  $a\langle 100 \rangle$  loops. These results are consistent with results on material J in the previous section, and supports the hypothesis that under neutron irradiation conditions,  $a\langle 100 \rangle$  loops can form in large quantities at temperatures as low as  $300\text{ }^{\circ}\text{C}$  and this behavior is different from decades of data produced by ion irradiations in the Fe-Cr system. The loops in material L were large, ranging between  $\sim 10 - 45\text{ nm}$  in diameter.

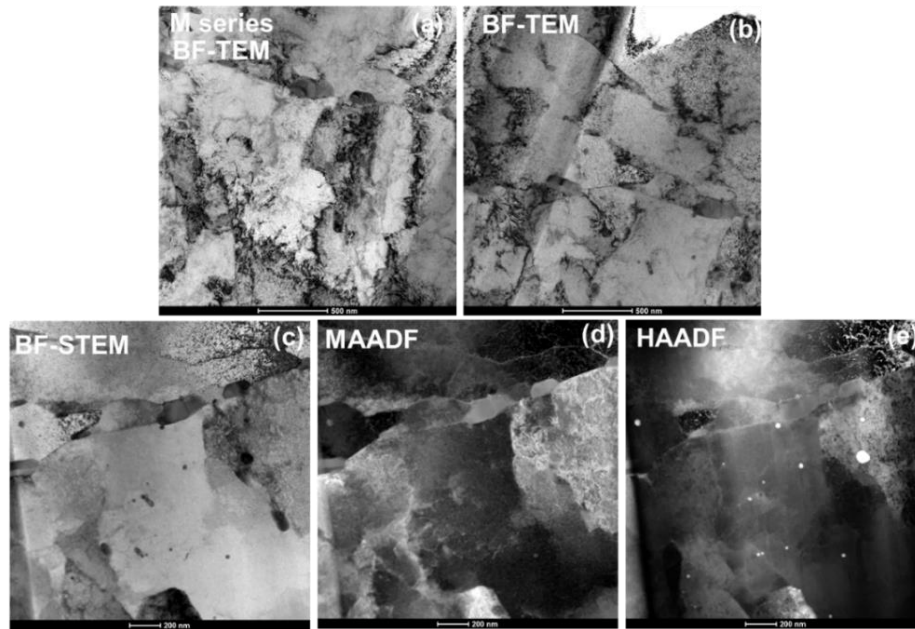
Figure 29: TEM/STEM imaging of nonirradiated M series steel. (a, b) BF TEM images. (c, d, e) STEM BF, MAADF and HAADF images of the same zone showing precipitates. (f, g, h) STEM BF, MAADF and HAADF images.

Material M was the double austenized version of Eurofer97. In nonirradiated condition, TEM/STEM imaging of M series steel are presented in Figure 29. Due to high Ta content, round MX carbides were easily recognizable in the HAADF images where they appeared bright on a relatively dark background. EDX maps obtained from the same zone on which STEM was performed are presented in Figure 30, where the bright objects in HAADF images were confirmed to be Ta rich phase (expected to be MX), while the larger precipitates ( $>100$ - $150$  nm) rich in Cr, W are expected to be  $M_{23}C_6$ .

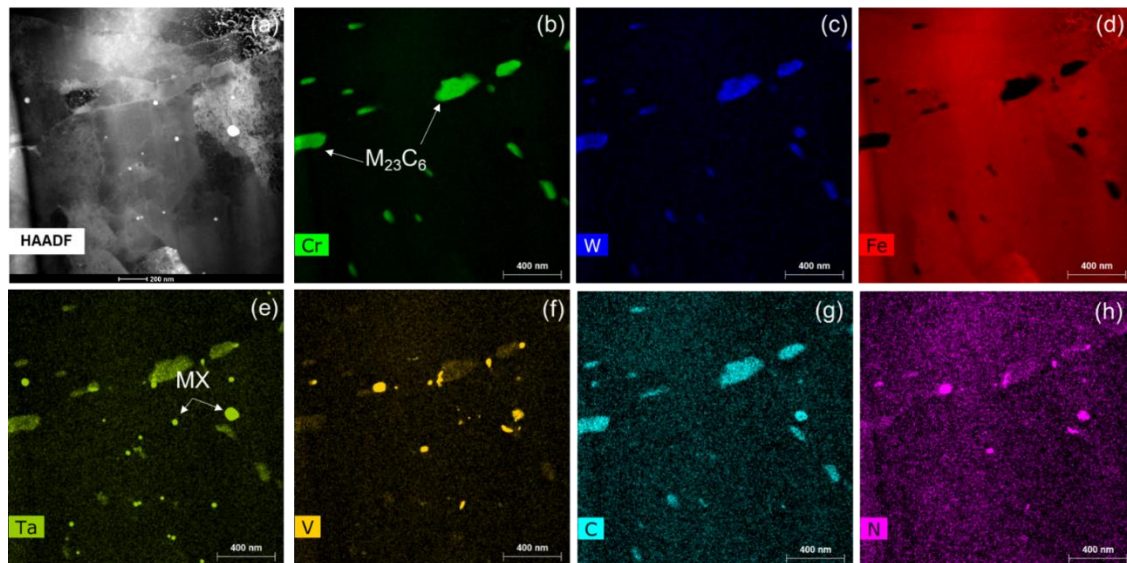
Figure 30: TEM and STEM imaging of M series steel. (a, b) BF TEM images. (c, d, e) STEM BF, MAADF and HAADF images of the same zone showing precipitates. (f, g, h) STEM BF, MAADF and HAADF images in a different FIB foil of same zone.

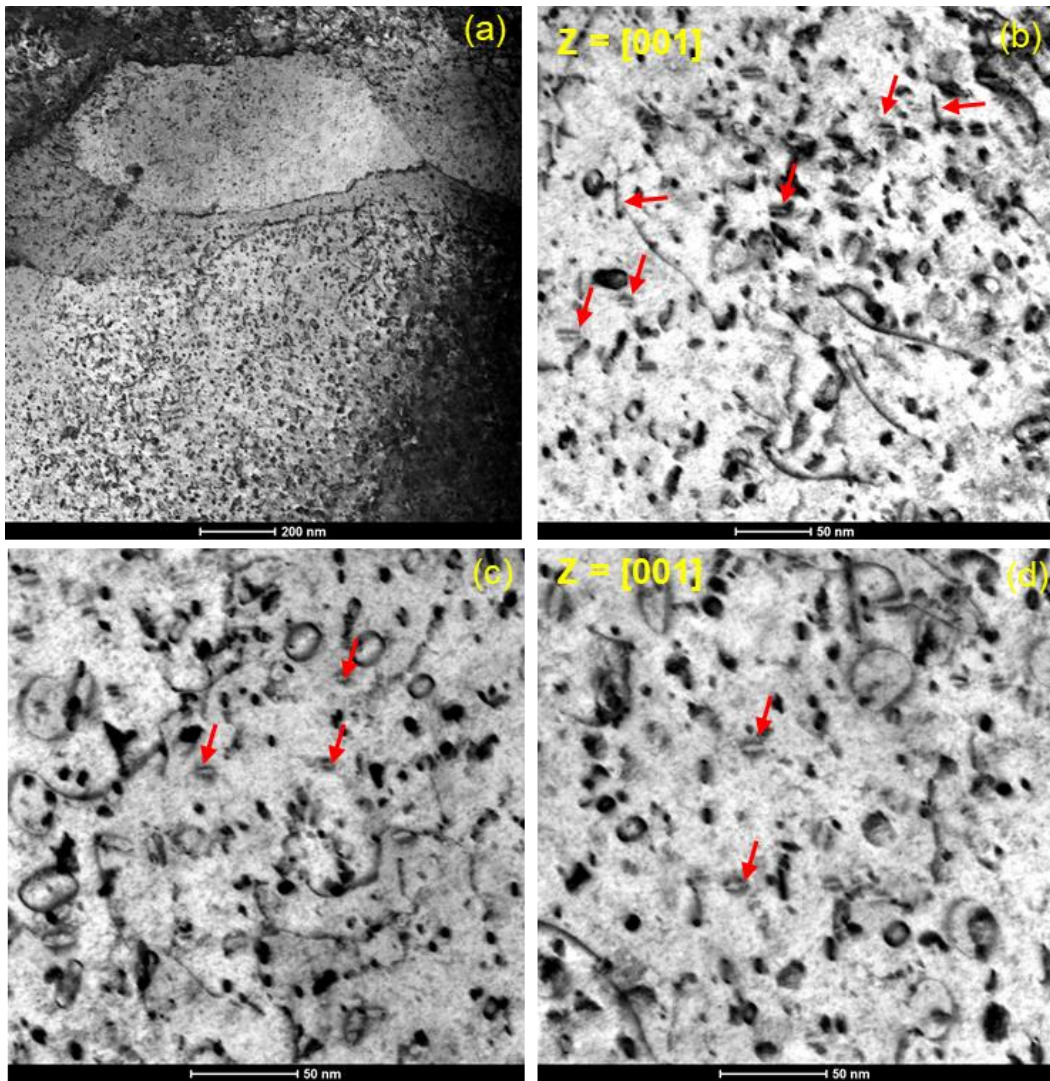
Figure 31: STEM BF imaging of dislocation loops in material M after neutron irradiation. (a) Overview of the grains and the defect structures. (b, c, d) Dislocation loops imaged close to  $[001]$  zone axis with a  $\langle 110 \rangle$  type  $g$  vector. Loops appearing close to on-edge as elongated coffee-beans (expected to be  $a\langle 100 \rangle$  type) are indicated using red arrows.

After irradiation, EDX mapping on material M was not performed because data from the previous alloys suggested no major degradation of the particles after the irradiations (except for the peculiar observations in material E). The microstructure of this steel after irradiation consisted of dislocation loops. The loop diameters ranged between as low as ~3-4 nm to as high as 51 nm. In Figure 31, an overview of the dislocation loop microstructure in this steel is presented. Similar to material L and J, there appears to be presence of  $a\langle 100 \rangle$  type loops, indicated by the red arrows in the figure. Such loops were close to on-edge configuration when imaged with  $g$  vectors available in a  $[001]$  zone axis and were aligned along the general  $\langle 100 \rangle$  directions. However, comparing Figure 31 with imaging from material L and J suggests the fraction of such  $a\langle 100 \rangle$  loops are lower in material M. In Figure 31, all the dislocation loops that do not appear close to on-edge (coffee bean like contrast) are expected to be the  $a/2\langle 111 \rangle$  type. Higher magnification images showing loops in this material are presented in Figure 32.

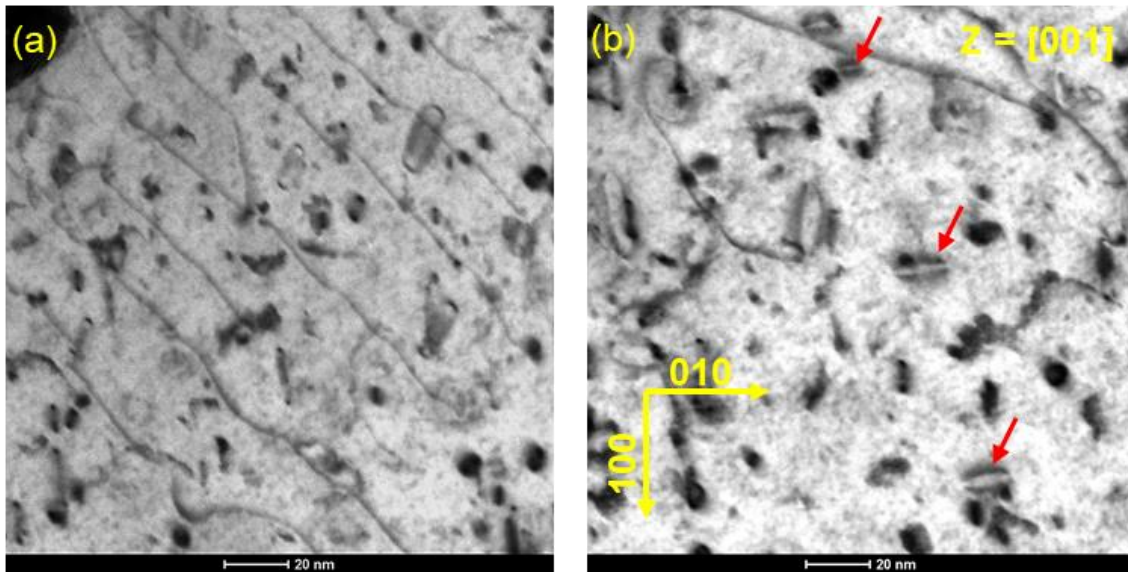
Figure 32: STEM BF imaging of dislocation loops in material M after neutron irradiation. (a, b) High magnification micrographs of dislocation loops imaged close to  $[001]$  zone axis with a  $\langle 110 \rangle$  type g vector. Red arrows indicate loops close to on-edge configuration aligned along  $\langle 100 \rangle$  directions, indicating they are  $a\langle 100 \rangle$  type.

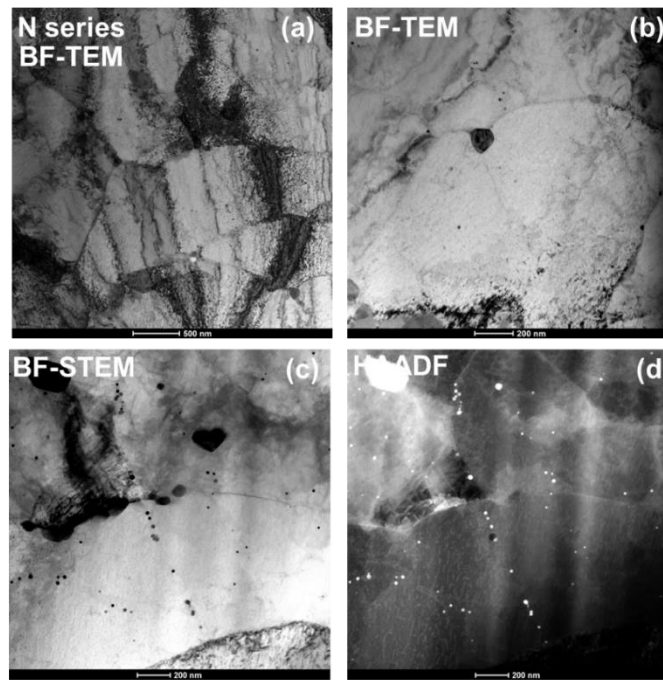
Figure 33: TEM/STEM imaging of the nonirradiated microstructures of material N (a, b) BF TEM images showing the general microstructures. (c, d) BF STEM and HAADF image of the same zone showing MX carbonitrides in the steel.

Material N was similar to M as it was also double austenized, however it consisted of different chemistry. In nonirradiated condition, the starting precipitate distribution of N was similar to M (as highlighted in Ref. [1]). There were large globular MX particles, visible in the STEM images in Figure 33 and Figure 34.

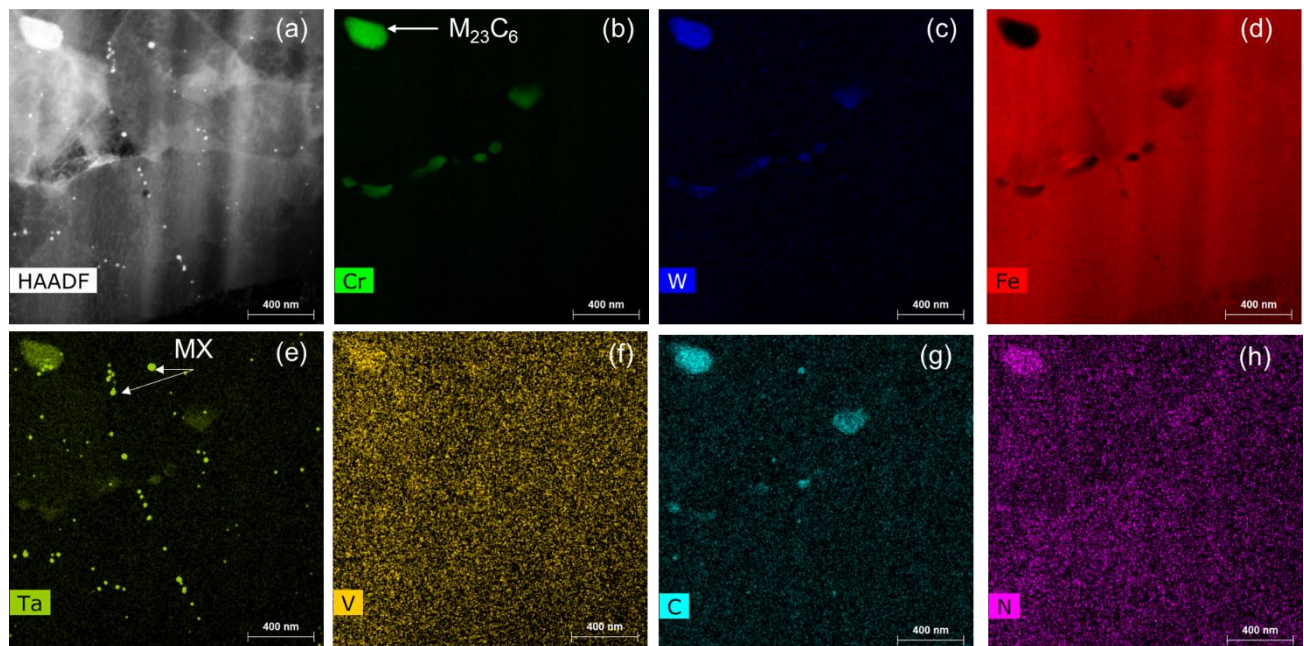
Figure 34: Analytical STEM characterization of the nonirradiated material N microstructure. (a) HAADF image of a zone which is the same zone as in Fig. 33. (b-h) STEM-EDX mapping showing elemental distribution.

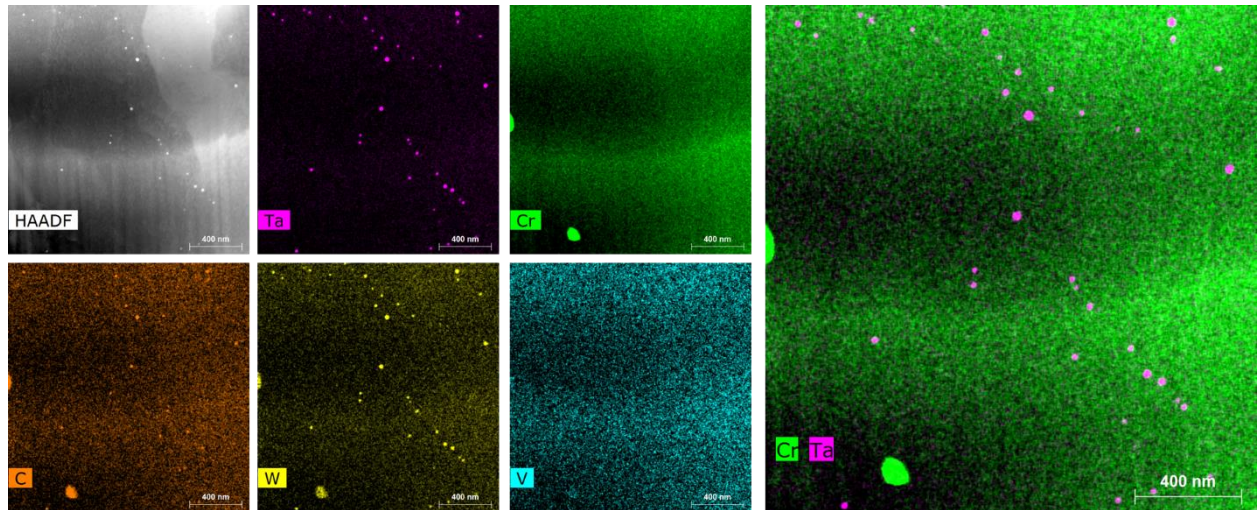
Figure 35: Analytical STEM characterization of the HFIR irradiated material N. An overlay of Cr and Ta map is also presented to identify the distribution of MX in this alloy.

After irradiation, similar to the results in other alloys, the precipitate microstructure did not alter much. The microstructure still showed the presence of large Cr rich carbides that are expected to be  $M_{23}C_6$  and Ta rich MX carbonitrides. Because of a lack of vanadium in the alloy, the MX carbide appear as vanadium free in the STEM-EDX maps (Figure 35).

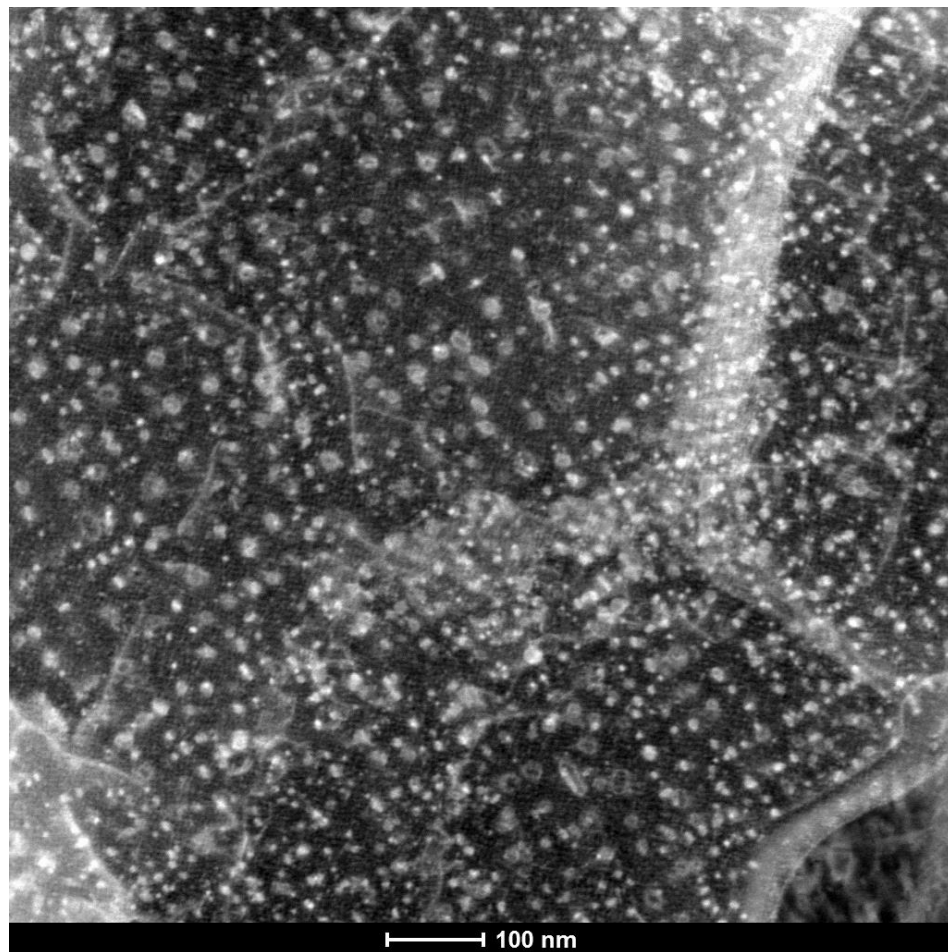
Figure 36: LAADF STEM image showing the dislocation loop distribution in the material N after HFIR irradiations.

Dislocation loops formed in this material upon irradiation. A large overview of the loop microstructure is presented in the LAADF image in Figure 36. The diameters of the dislocation loops in this material were similar to material M, ranging between  $\sim 3$  nm to 57 nm, and a number density of  $1.04 \times 10^{20} \text{ m}^{-3}$ . A relatively high magnification overview using STEM BF imaging is presented in Figure 37. While the imaging was performed close to  $[001]$  zone axis, except a few features, there was no obvious presence of on-edge loops. This suggests a lack of  $a\langle 100 \rangle$  loops in this material. This difference in the loop population versus the other alloys needs careful future fundamental investigation. Chemistry of an alloy affects the nature and type of dislocation loops in the FeCr system. It is quite likely that subtle changes in the chemistries of the different alloys has an effect on the relative population of  $a\langle 100 \rangle$  vs  $a/2\langle 111 \rangle$  type loop types.

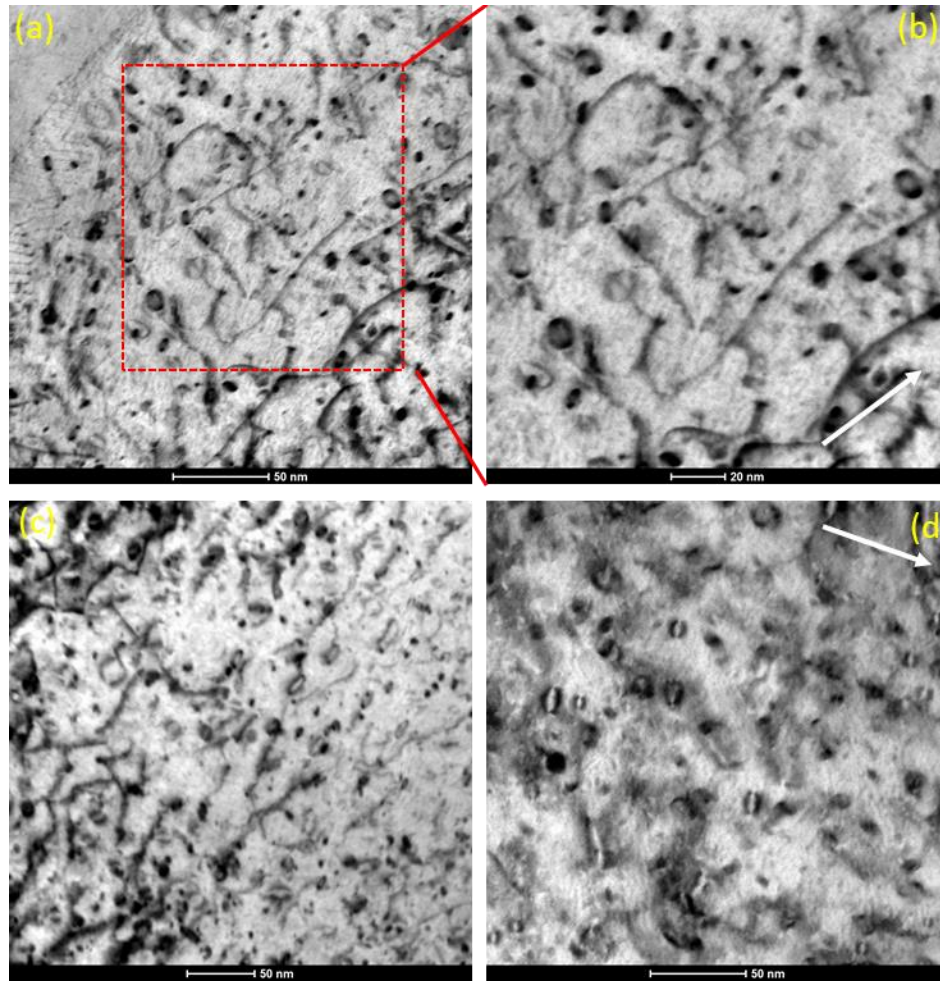
Figure 37: BF STEM images of dislocation loops in material N. (a) Overview of a region showing an area of analysis. (b) High magnification image of the square area in (a). (c and d) Two different locations in the foil that were imaged close to [001] zone axis.

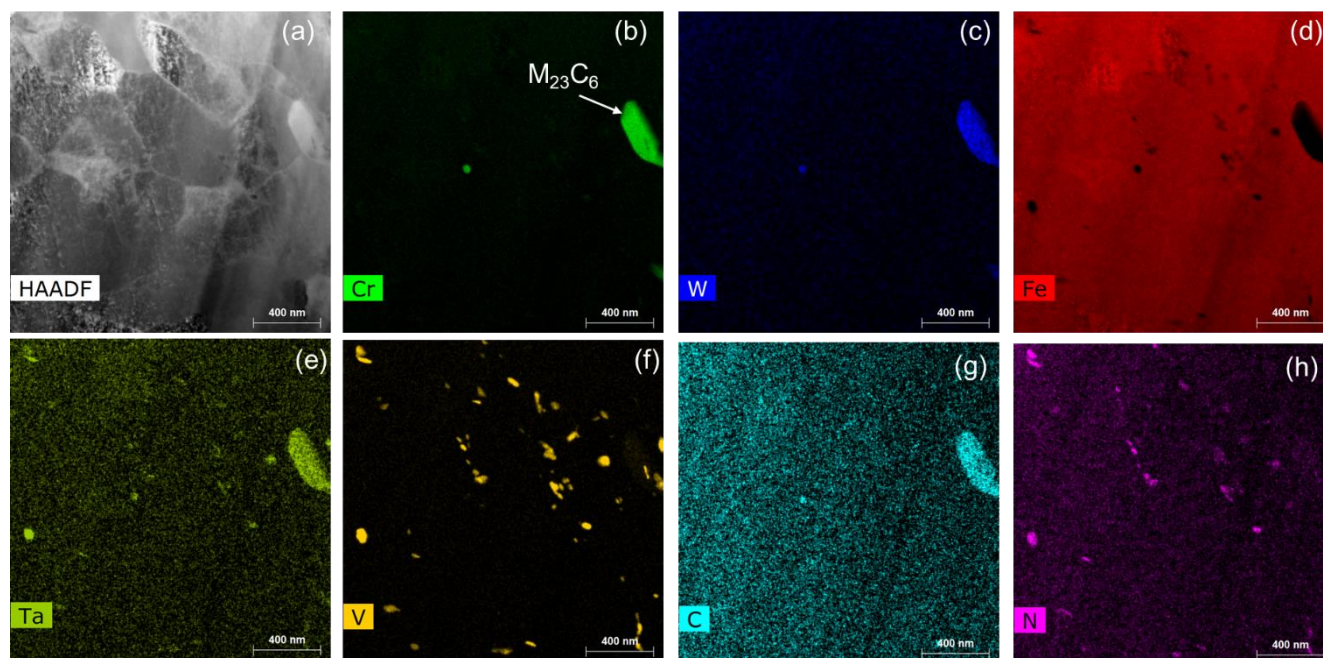
Figure 38: STEM-EDX mapping of nonirradiated O series steel (a) HAADF image (b-h) EDX maps of same zone.

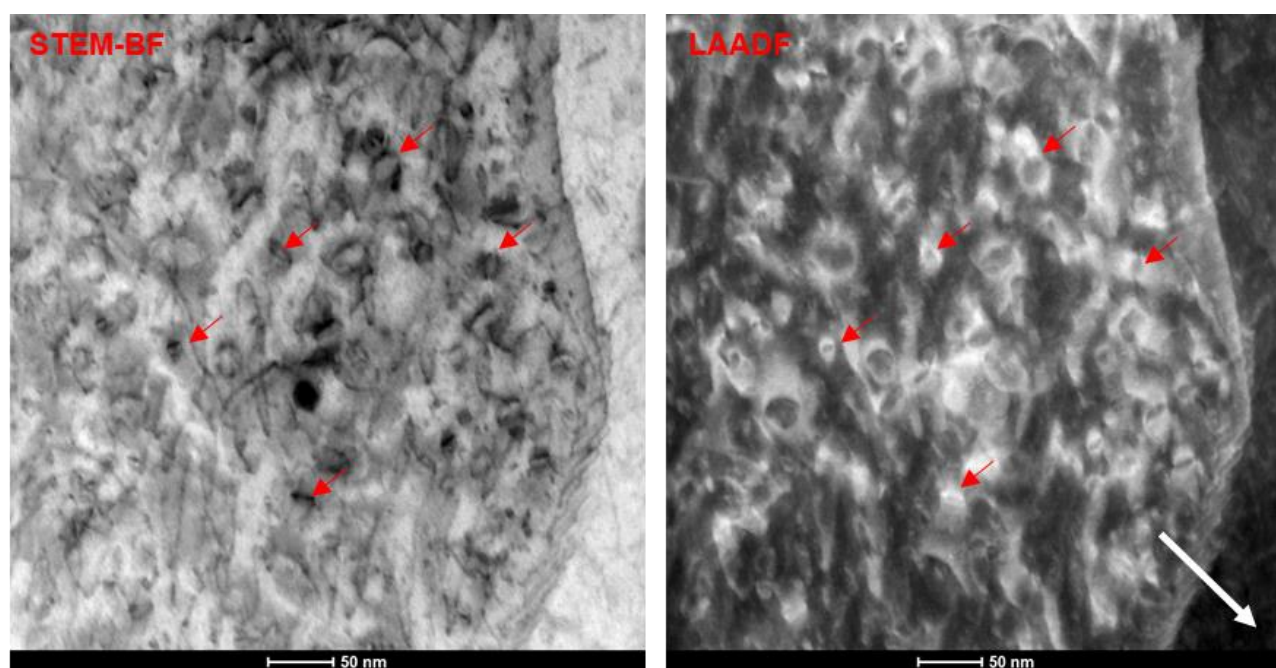
Figure 39: STEM-BF and LAADF imaging of the same zone in irradiated material O showing dislocation loops. Some identified loops are indicated using red arrows. Zone axis =  $[101]$ ,  $g = (-101)$ . The direction of the  $g$  vector is annotated in the figure with a white arrow.

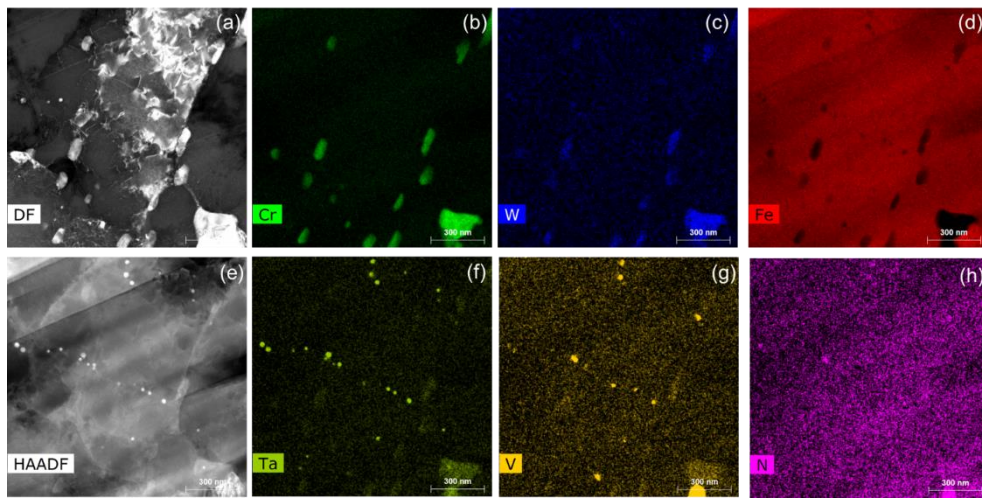
Figure 40 STEM imaging and EDX mapping of E series steel in nonirradiated condition.

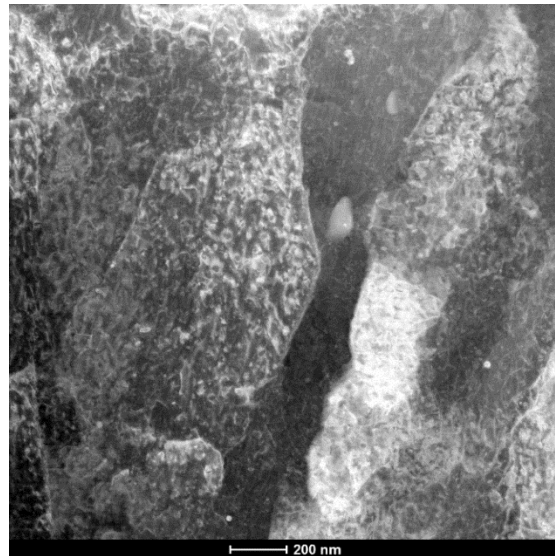
Figure 41: LAADF STEM image overview of irradiated material N. The bright features shows an entangled network of dislocation loops.

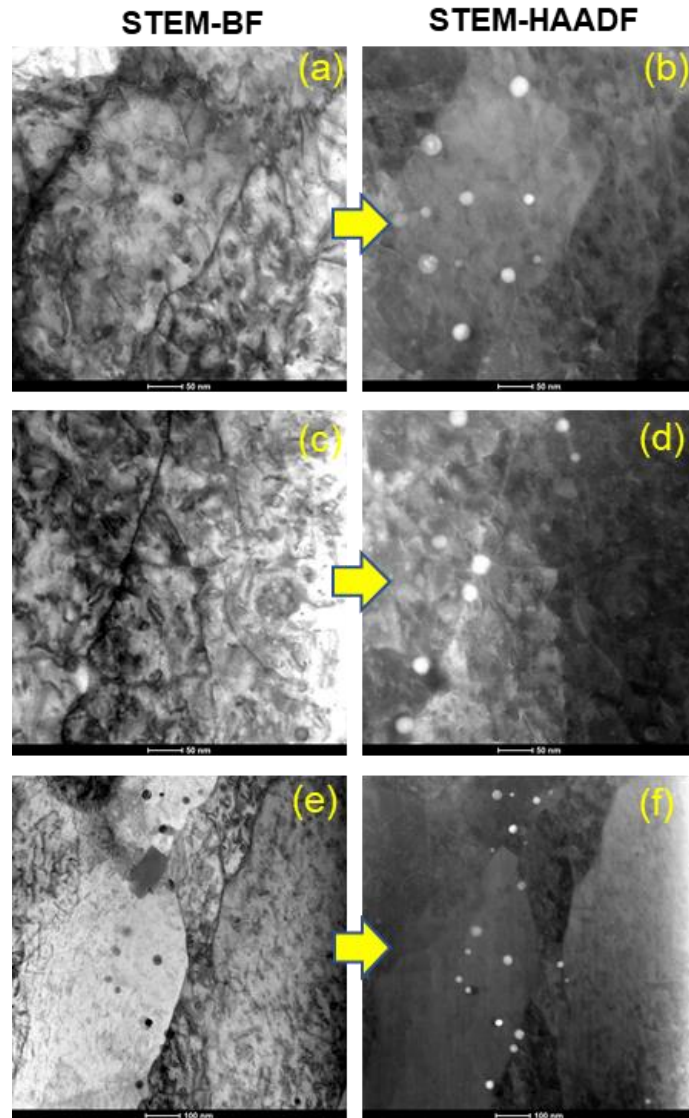
Figure 42: Series of BF STEM and HAADF images showing the irradiated microstructures of material E. The loops formed a dense entangled network in this material. Bright objects in the HAADF images are the coarse MX type carbonitrides. The HAADF images are recorded from the same area where BF imaging was performed.

Material E was Eurofer97 which was given a technological treatment to simulate abnormal conditions occurring during the fabrication process or during welding. In the nonirradiated condition, this alloy consisted of very coarse carbides (reported in Refs. [1,2]). However, such coarse carbides were not detectable in FIB foils because of smaller area of analysis. From Ref. [1], the overview of the initial microstructures characterized using STEM is presented in Figure 40. After irradiation, data from most previous steels has shown negligible changes to the precipitate microstructure of the alloys. So, STEM-EDX on this alloy was not performed. However, the irradiated microstructures showed a large network of entangled dislocation loops. This can be seen in the LAADF image in Figure 41. A series of STEM-BF and HAADF imaging of the same areas of an irradiated foil is presented in Figure 42 where the entangled network of loops/dislocations can be seen. For this reason, g.b analysis or estimating size or number density of dislocation loops was not possible for this sample. In Figure 42, the associated HAADF images show the coarse MX carbides in the alloy.
