# Pilot Study for Multifamily Building Ventilation and Indoor Air Quality

**Date** 9/30/2022

**Pilot Study for Multifamily Building Ventilation and Indoor Air Quality**

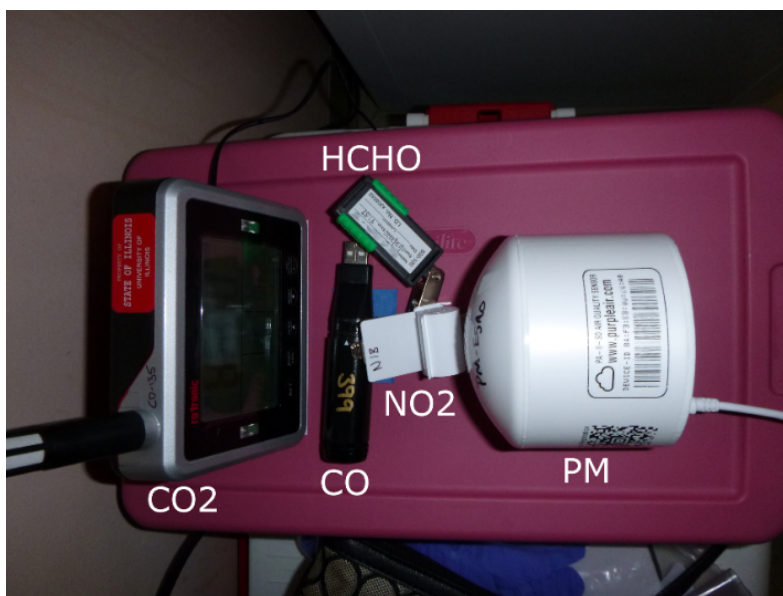
A variety of passive samplers and real-time data loggers were used to evaluate the indoor air quality (IAQ) within each unit. A plastic shoebox sized container with the loggers and samplers was deployed in each selected unit and stayed in place for nominally two weeks. The sensor package is pictured in Figure 2 (with each sensor labeled with its target contaminant) and described in Table 2.

Figure 2 - IAQ Sensor Package

Efforts were made to place the sensor package in an appropriate location, but there were several practical limitations due to the size, contents, and configuration of the apartments. The most important placement criteria was that the unit was placed in a location that would not unduly inconvenience the occupant(s), and was within reachable distance (using a ~10' extension cord) to a working, non-switched electrical outlet. Beyond that minimum requirement, sensors were never placed in bathrooms, and were only rarely placed in kitchens (in cramped efficiency apartments). When possible, sensors were placed out of direct sunlight, away from exterior walls and heat sources, away from air moving devices (HVAC registers, fans, dehumidifiers), and at least 2' above/below the floor/ceiling.

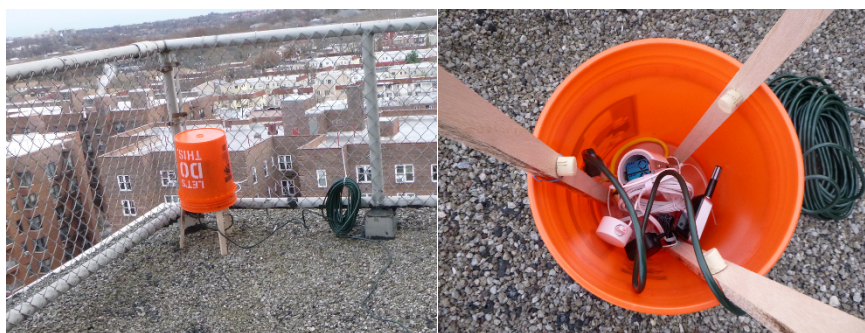
All of the contaminants measured in the units except for formaldehyde and CO were also monitored in the outside ambient air to account for the potential influence of outdoor concentrations. A partly open enclosure was constructed out of a 5-gallon bucket and some wooden “legs” (Figure 5), to protect the instruments and power supplies from inclement weather while still allowing air exposure to the sensors. This apparatus was typically placed on the building’s rooftop and secured in place with zip-ties to prevent blowing over. An extension cord coming from the apparatus was plugged into building power either through an available rooftop outlet or by routing the cord into a nearby utility room. The instruments’ moderate power consumption, the length of deployment, and the expected cold temperatures prevented the use of alternative power sources such as batteries and solar panels.

*Figure 5 - Outdoor Air Monitoring Station*

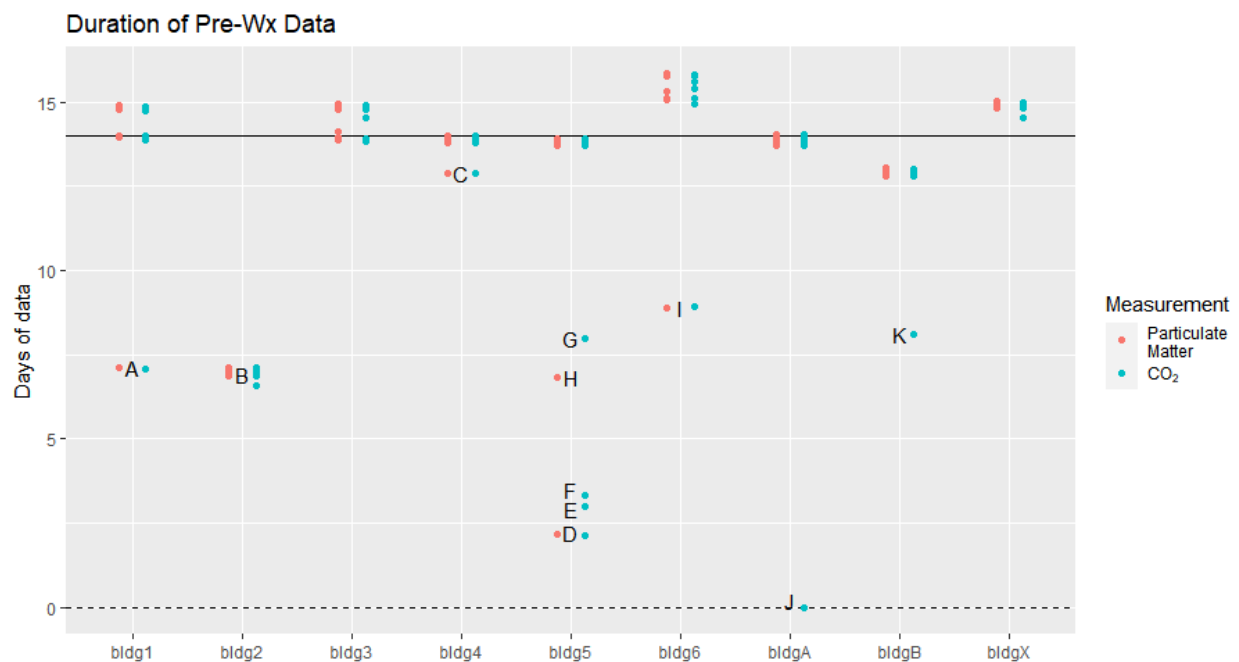
Figure 6 and Figure 7 show the amount of time that each of the plug-in sensors recorded data in each individual unit for the pre-weatherization and post-weatherization periods respectively. Ideally, all sites would have a clustering of points around ~14 days (solid black horizontal line) indicating that all sensors recorded data for the entire ~2 week period (such as building 3 in Figure 6). A data point significantly below the solid line indicates the data set was cut short, with points at zero (dotted black line) indicating no data recorded. Points of interest are called out with letters (capital for pre-weatherization and lowercase for post-weatherization) and described below each graph.

sensors needed to be deployed in quick succession without a chance to download data in between sites. This resulted in a few CO<sub>2</sub> sensors exceeding their data storage capacity, and some lost data. This was not an issue for the PM logger, which has significantly more storage space.

H: Building 5, Unit 14D – Due to the availability of the occupant, these sensors needed to be pulled after one week resulting in an abbreviated testing period.

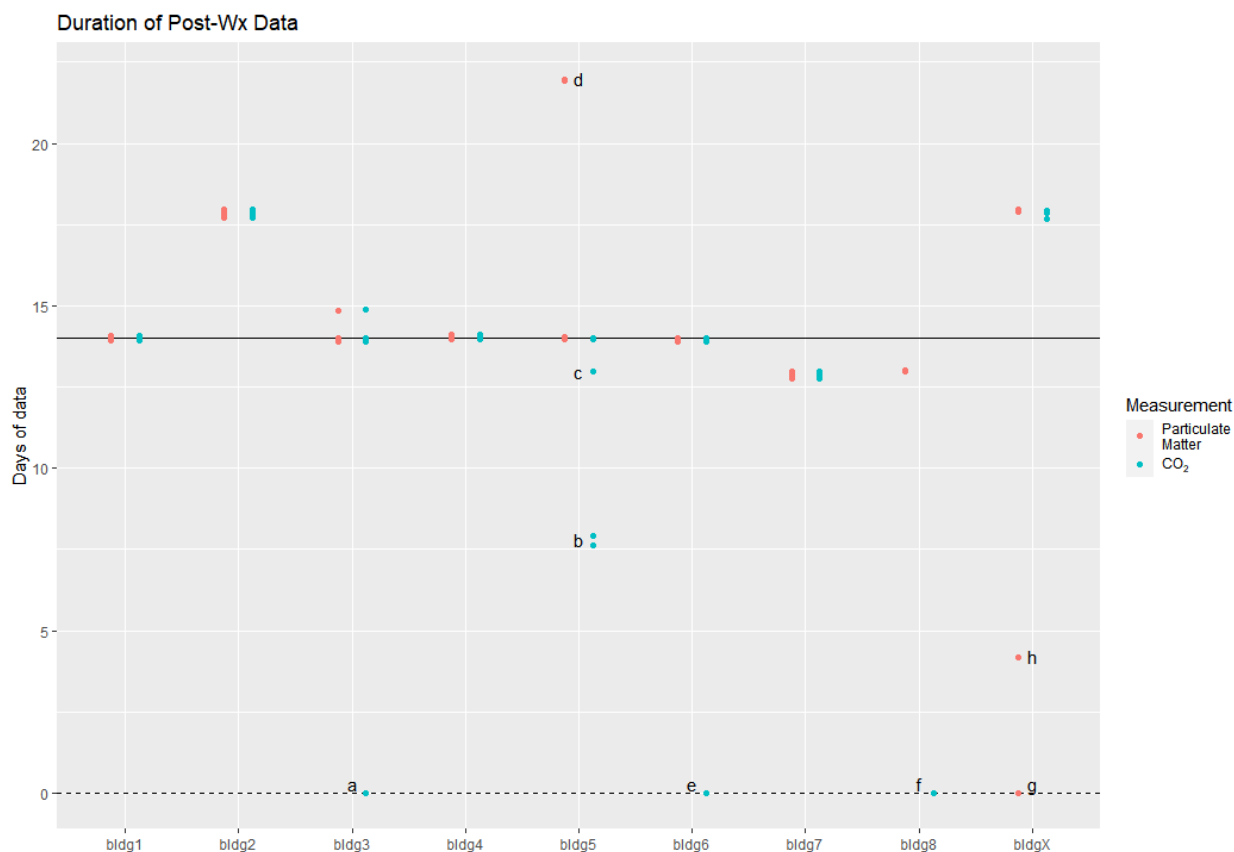
Figure 7 – Duration of Post-Wx Data with Issues Highlighted

a: Building 3, unit 15H – Only two data points recorded on sensor, presumed loose power cable.

- There were several instances of missing data from the CO<sub>2</sub> loggers which required a multi-step setup and launch process. The most widespread instance of this was at the Building 8 post-test where none of the sensors were initialized correctly, and none recorded usable data (Figure 7).

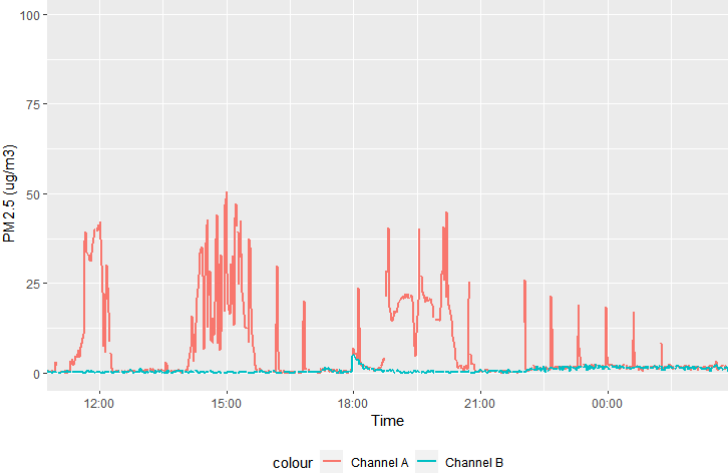
<p>BldgA Unit 1A Pre</p>	<p>Channel A exhibited unrealistic cycling.</p>	<p>Building A unit 1A Pre - PM2.5 vs time detail</p>

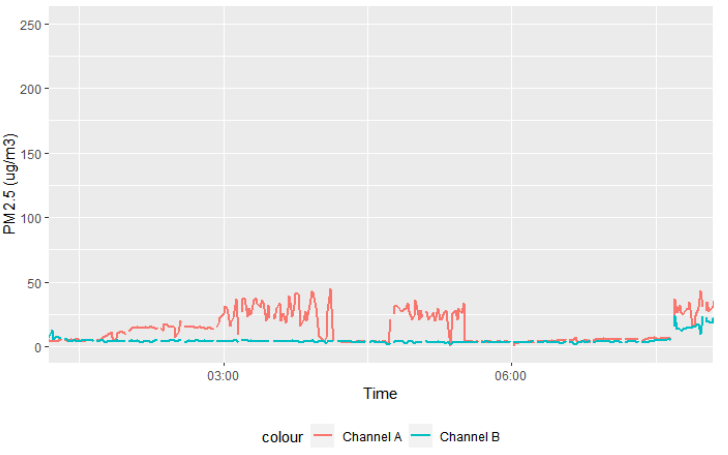
<p>colour Channel A Channel B</p>
<p>Bldg2 Unit 6H Post</p>	<p>Channel A exhibits unrealistic jumps from moderate concentrations to zero and back.</p>	<p>Building 2 unit 6H Post - PM2.5 vs time detail</p>

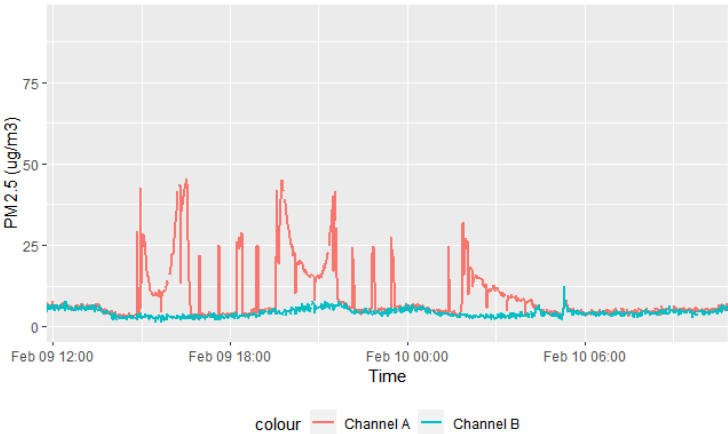
<p>colour Channel A Channel B</p>
<p>Bldg5 Unit 7K Pre</p>	<p>Channel A exhibited unrealistic cycling.</p>	<p>Building 5 unit 7K Pre - PM2.5 vs time detail</p>

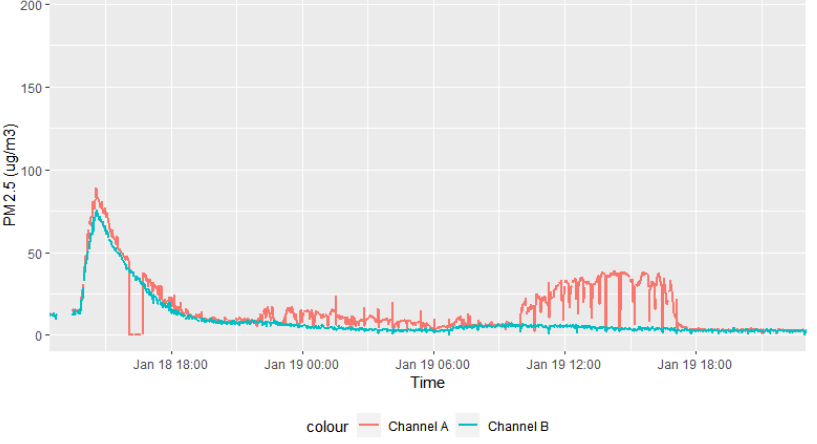
Bldg2 Unit 1H Pre	Channel A exhibited unrealistic cycling.	<p>Building 2 unit 1H Pre - PM2.5 vs time detail</p>

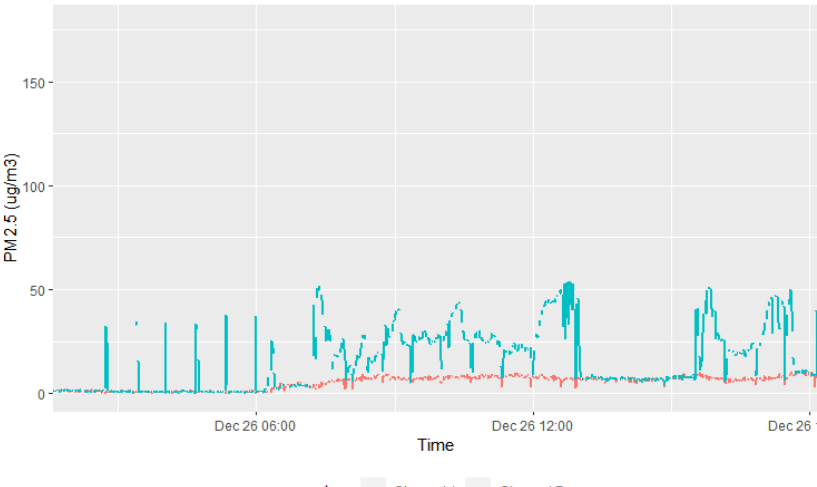
<p>colour Channel A Channel B</p>
Bldg1 Unit 12F Pre	Channel B exhibited unrealistic cycling.	<p>Building 1 unit 12F Pre - PM2.5 vs time detail</p>

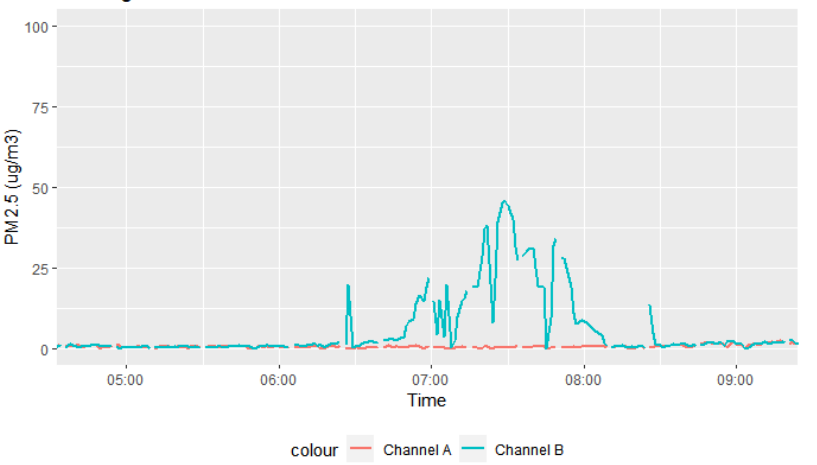
<p>colour Channel A Channel B</p>
Bldg6 Unit 11B Pre	Channel B exhibited unrealistic cycling.	<p>Building 6 unit 11B Pre - PM2.5 vs time detail</p>

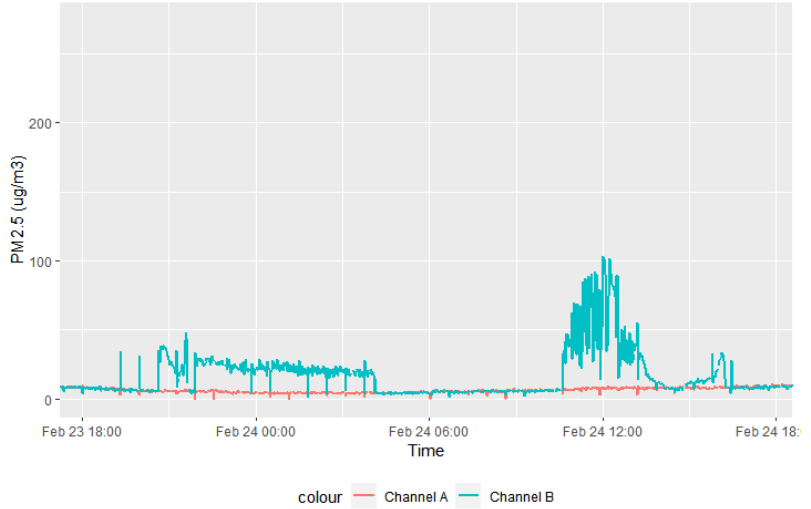
<p>BldgA Unit 1B Pre</p>	<p>Channel B exhibited unrealistic cycling.</p>	<p>Building A unit 1B Pre - PM2.5 vs time detail</p>

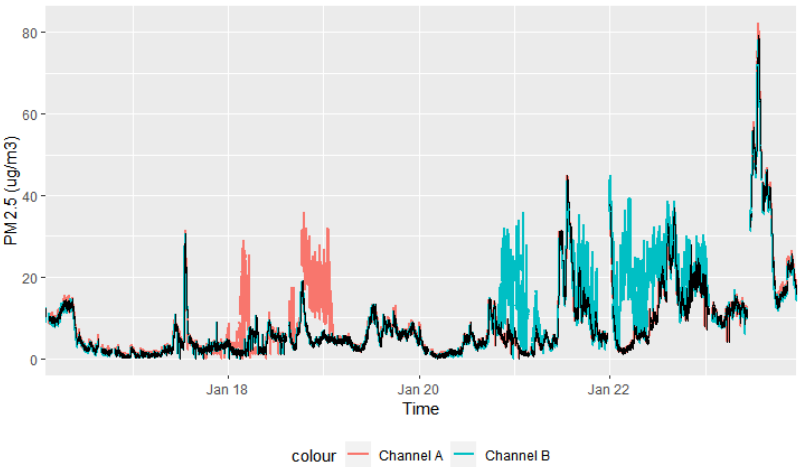
<p>colour Channel A Channel B</p>
<p>Bldg4 Unit 2N Pre</p>	<p>Both channels exhibited unrealistic cycling at different times, a manually customized data set was generated that maintained the best looking data during diverging periods (black line)</p>	<p>Building 4 unit 2N Pre - PM2.5 vs time (black =final data)</p>

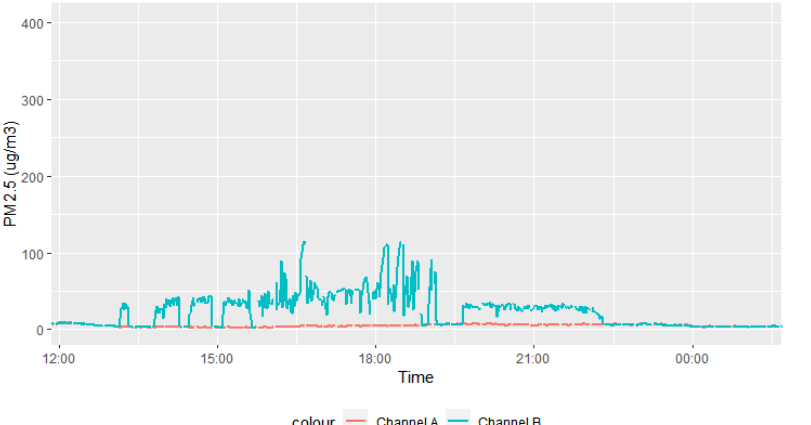
<p>colour Channel A Channel B</p>
<p>Bldg4 Unit 3M Post</p>	<p>Channel B exhibited unrealistic cycling.</p>	<p>Building 4 unit 3M Post - PM2.5 vs time detail</p>

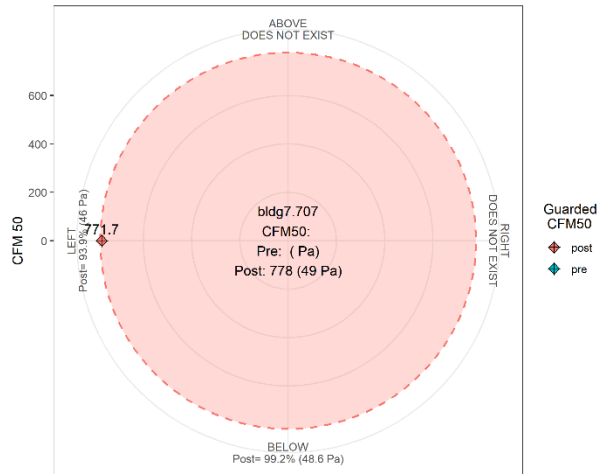
bldg7.707 CFM 50 normal (circle) vs guarded (points)  
(dotted line = Open to outside test)
