# Light Water Reactor Sustainability Program

## Post-Service Examination of PWR Baffle Bolts

### Part I. Examination and Test Plan

U.S. Department of Energy  
Office of Nuclear Energy

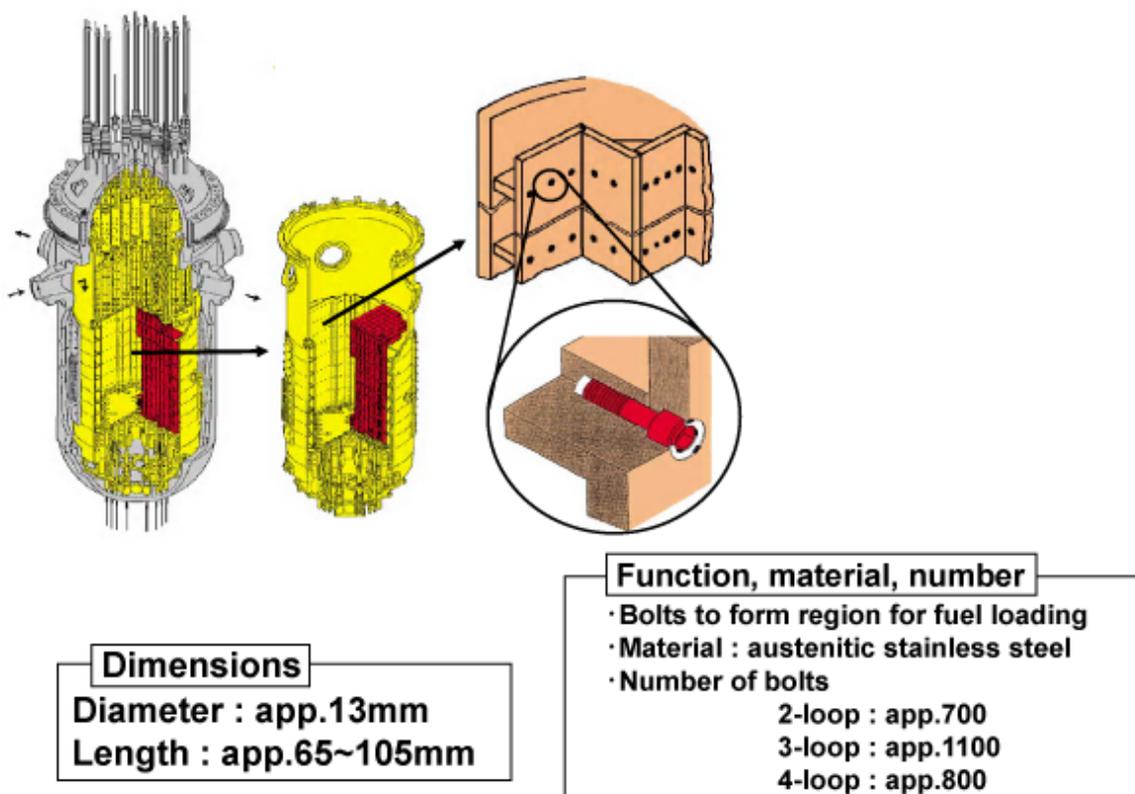
Figure 1. Schematic diagram of the reactor vessel lower internal assembly showing the wall facing the fuel assemblies consisting of the baffle and former plates secured by bolts, from [3].

Baffle bolts secure the baffle plates to the former plates in the lower internal assembly of the reactor vessel. The baffle plates are the vertical internal structure around periphery of the fuel core, with the former plates being the horizontal structural components distributed along the height of the fuel core separating the baffle plates from the core barrel (see Figure 1). For two-loop PWR designs, such as in the R.E. Ginna PWR (from here on, Ginna), there are thirty-six baffle plates and seven former plates [2]. In addition to the baffle bolts, there are bolts between the core barrel and former plates (barrel bolts), and bolts that pin the baffle plate to baffle plate on the ends (edge bolts). For a two-loop Westinghouse design, there can be up to 728 baffle bolts with up to 104 bolts at each height elevation in the lower internal assembly. The bolts can experience varied neutron flux based on the location of the bolt within the assembly as well as a fluence distribution along the length of the bolt.

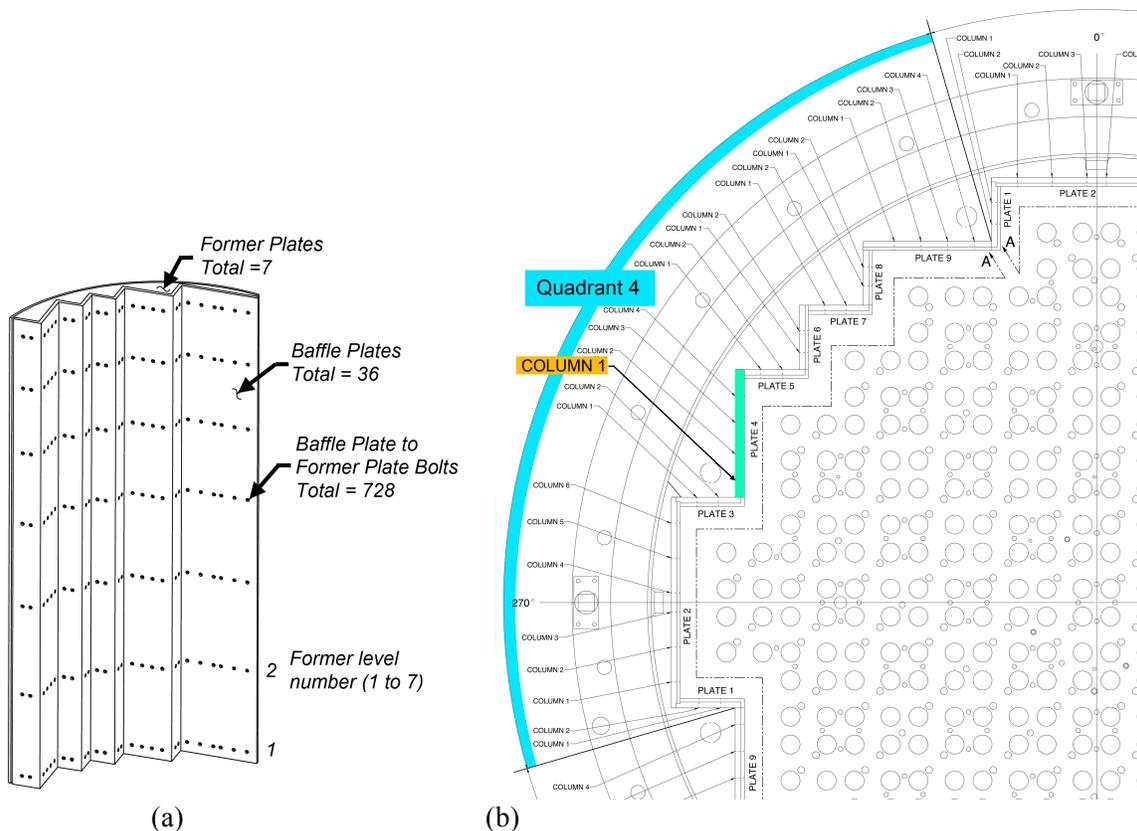
Figure 2. Diagrams of the baffle plate and bolt locations within the PWR. (a) Vertical section illustrating the various components and quantities. (b) Top view of one of four quadrants in a PWR. Diagrams help illustrate the location of position of the 4412 (Ginna ID) bolt of interest to this work. Illustrations adapted from references 2 and 12.

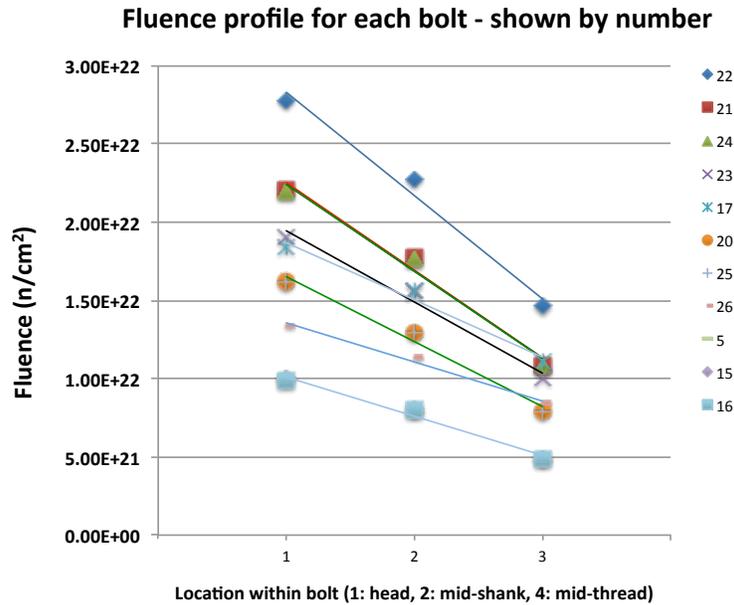
Figure 3. Graphical representation of the fluence distribution within the bolts available at Ginna.

Bolt #	Ginna ID	Fluence ( $\times 10^{22}$ n/cm <sup>2</sup> ) E>1 MeV		
		Head	Mid-Shank	Mid-Thread
22	4412	2.78	2.27	1.46
21	3933	2.21	1.78	1.09
24	4424	2.20	1.77	1.09
23	4416	1.91	1.56	1.00
17	3814	1.84	1.56	1.11
20	3925	1.62	1.30	7.90
25	4435	1.62	1.30	0.79
26	3326	1.34	1.14	0.84
5	1262	1.00	0.80	0.49
15	3212	1.00	0.80	0.49
16	3215	0.99	0.80	0.49

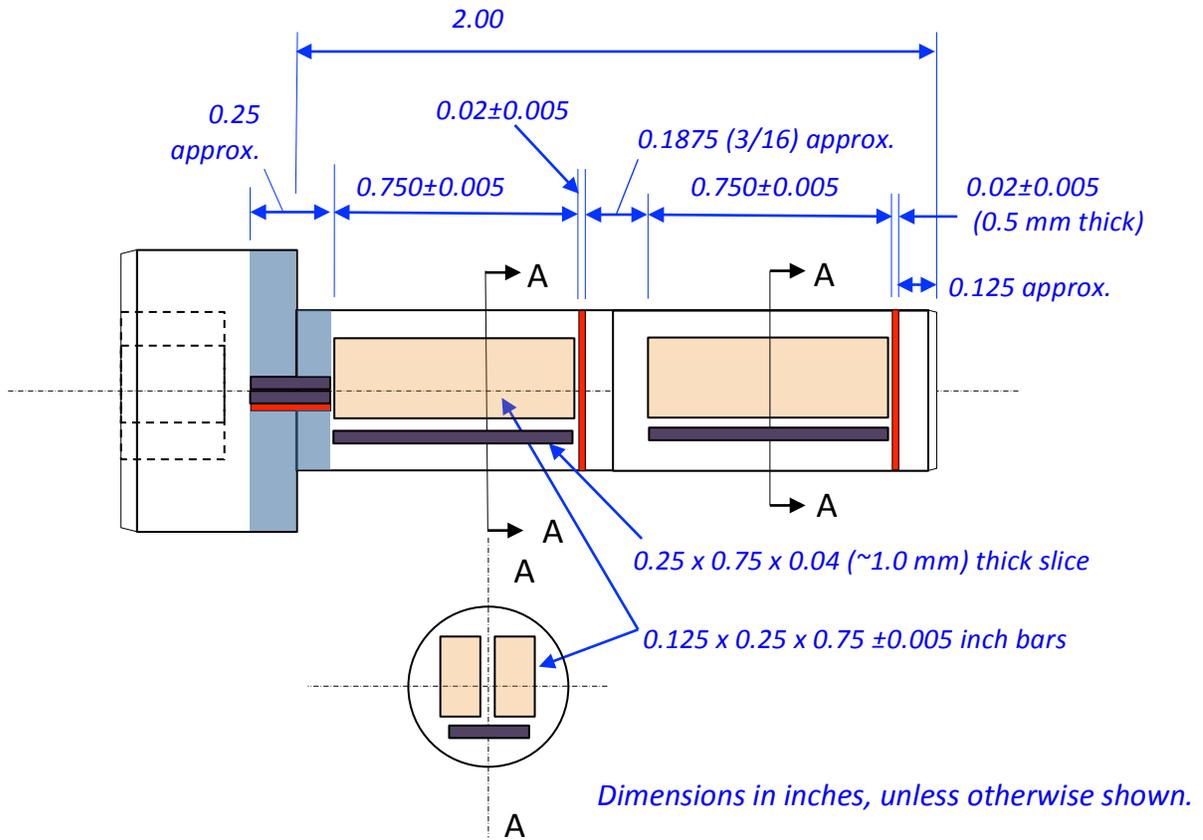
Figure 4. Simplified cutting diagrams for the baffle bolts showing the color-coded sample types to be sectioned from the bolts at the head, mid-shank and thread regions (shaded diagonal line region) for mechanical and microstructural examinations.

Bolts 22 and 23 will be sectioned into several test pieces designed for mechanical and microstructural evaluation. A schematic of the cutting plan is shown in Figure 4, with a sample numbering scheme in Figure 5. From the mid-shank and thread positions, bend bars will be fabricated. As a fluence distribution will be present within the bend bars, the high-dose ends of each bar will be marked with identifier to track extracted sample orientation relative to the original bolt orientation. Adjacent to these bars, additional slices for microstructural characterization and possible bend or subscale tensile bar fabrication will be extracted. The thinner, ~0.5 mm thick slices, will be utilized for microstructural examinations. Ideally, pending dose and handling limits, these thin sections are to be used in preparing 3 mm diameter transmission electron microscopy (TEM) discs thinned to electron transparency by electropolishing rather than focused ion beam milling (FIB). This will provide information on the defect evolution within the microstructure without damage introduced into the materials by focused ion beam milling. If further samples are needed for TEM investigations, FIB specimens can be prepared from the outer rim portion of these 3 mm discs, therefore optimizing utilization of available samples.

In addition to the materials sections removed at the mid-shank and thread locations, material will also be saved from the head of the bolt. To preserve the region consisting of the high stress concentration area that contains the fillet transition between the bolt head and shank. From the bolt head, sliced sections can be removed from which further microhardness, nano-indentation and electron microscopy could potentially be performed, pending sample dose levels. Furthermore, the material containing the high stress region will be preserved for further investigation and documentation in the ORNL hot cells should these bolts reveal visible damage during the Westinghouse inspections.

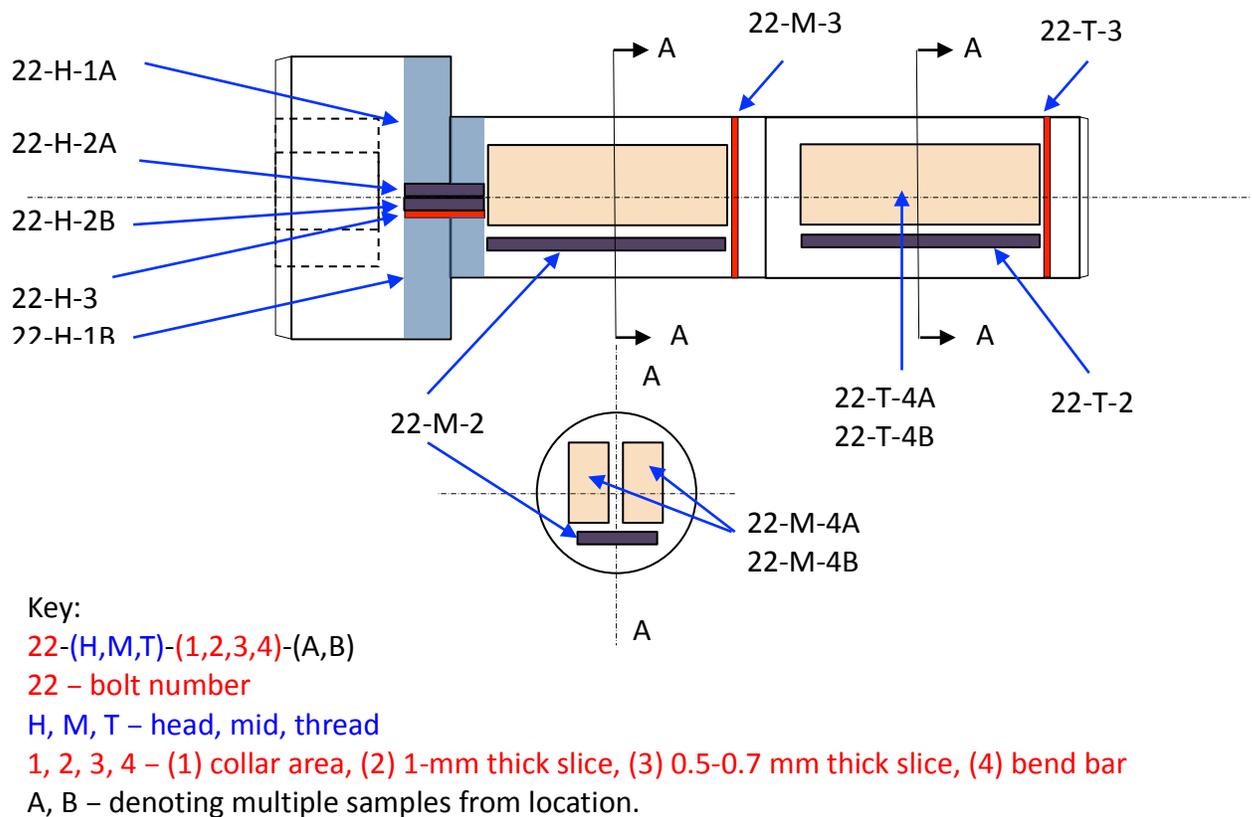
Figure 5. Sample identification diagram for the bend bar and section slices taken from the baffle bolts under investigation.
