Final Technical Report

**Additional Characterization of
Min-K T/E-1400 Thermal Insulation**

J. G. Hemrick and J. F. King

Prepared by
OAK RIDGE NATIONAL LABORATORY
Oak Ridge, Tennessee 37831-6079
managed by
UT-BATTELLE, LLC
for the
U.S. DEPARTMENT OF ENERGY
under contract DE-AC05-00OR22725

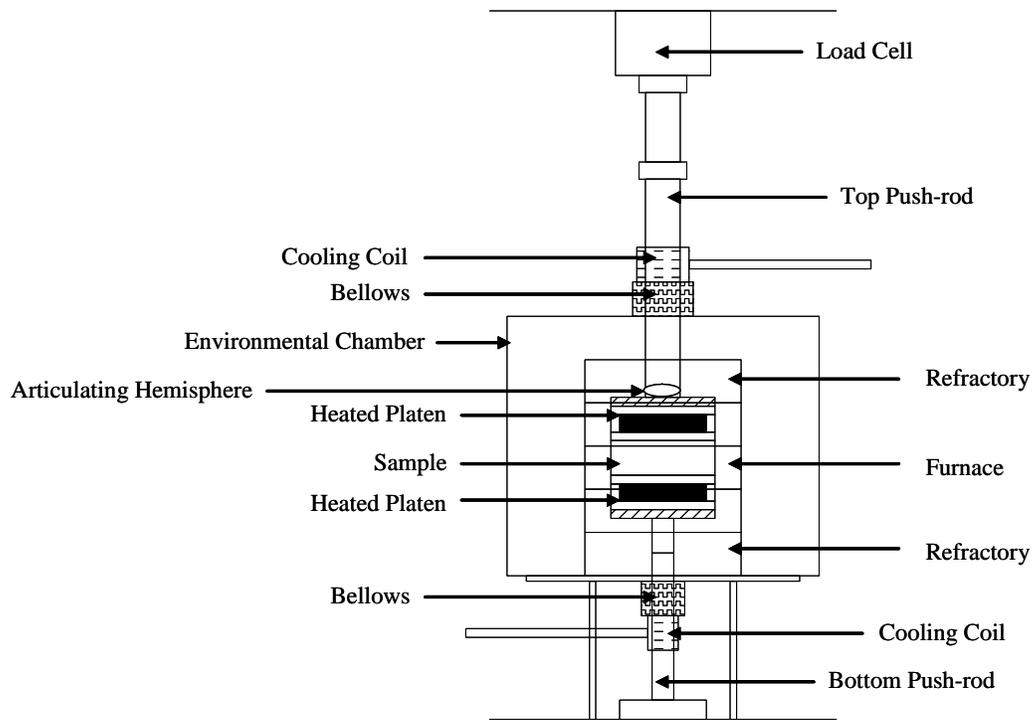
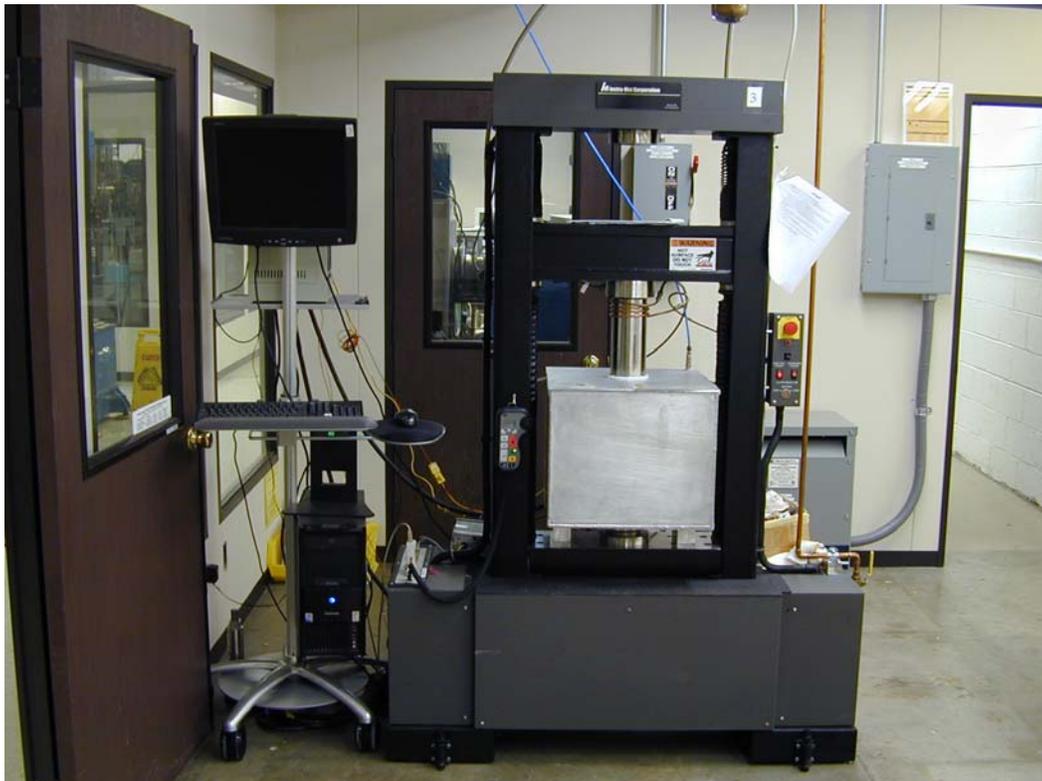
Figure 1. Gradient Stress Relaxation Test Frame Used for Changing Environments Testing.

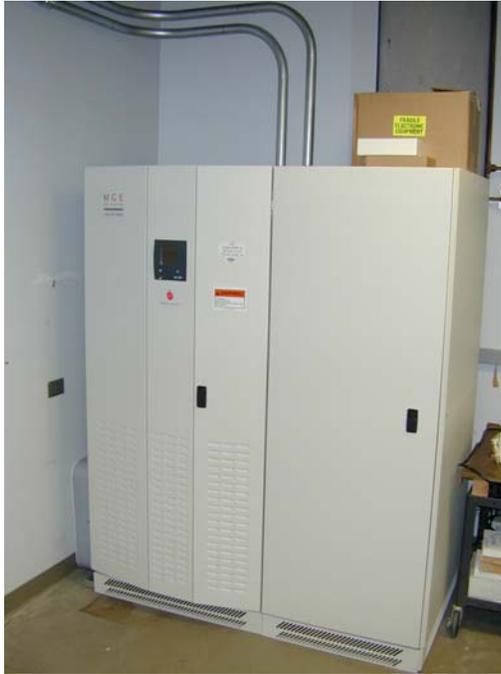
Figure 2. Installed Back-Up Power Supply System for Gradient Test Systems.

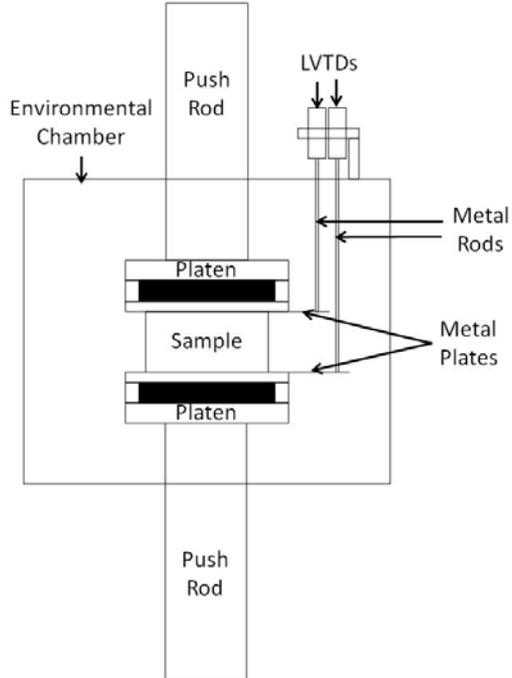
Figure 3. Schematic of LVDT Strain Monitoring System.

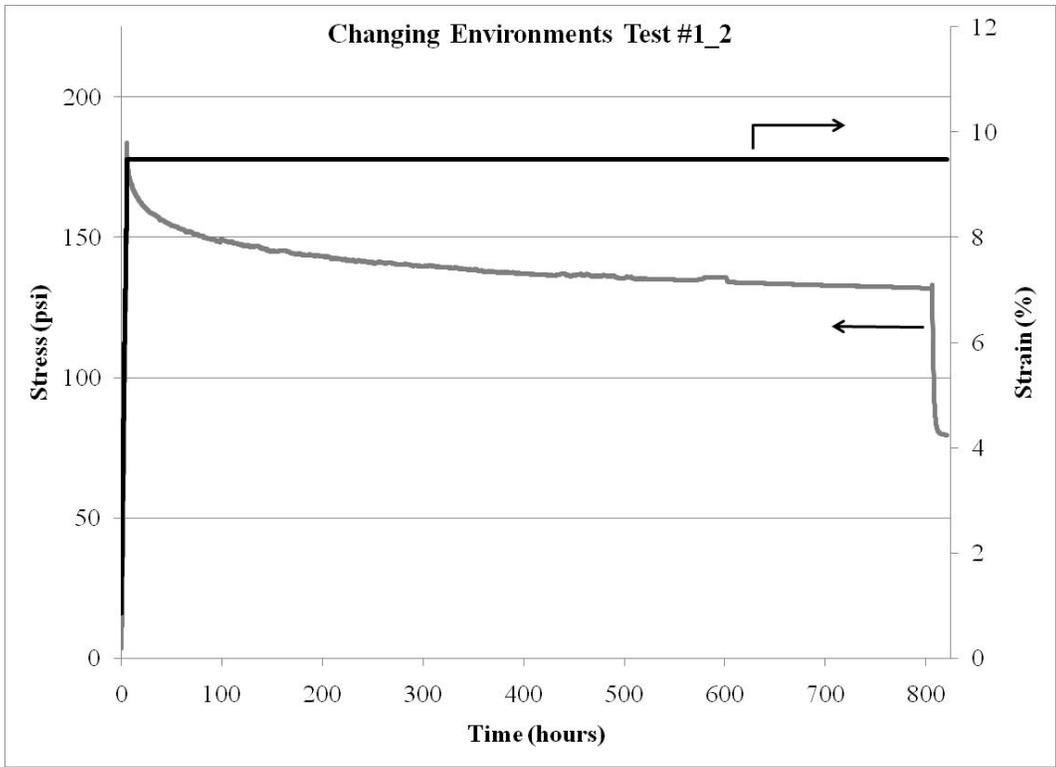
Figure 5. Results from Changing Environments Test #1_2.

Figure 5 shows Test #1_2 which was started on the same frame as Test #1_1 following repair of the cooling system. This test ran for 820 hours before being ended due to a platen failure resulting from a laboratory electrical event which kicked out the furnace controller and water chiller fuse systems. The source of this electrical failure was investigated and the other two test frames were checked for similar failures. At the time the test lost temperature, it had been relaxing for over 720 hours and had moved from an initial stress level of 184 psi to a stress level of 132 psi (1,269 to 910 kPa).

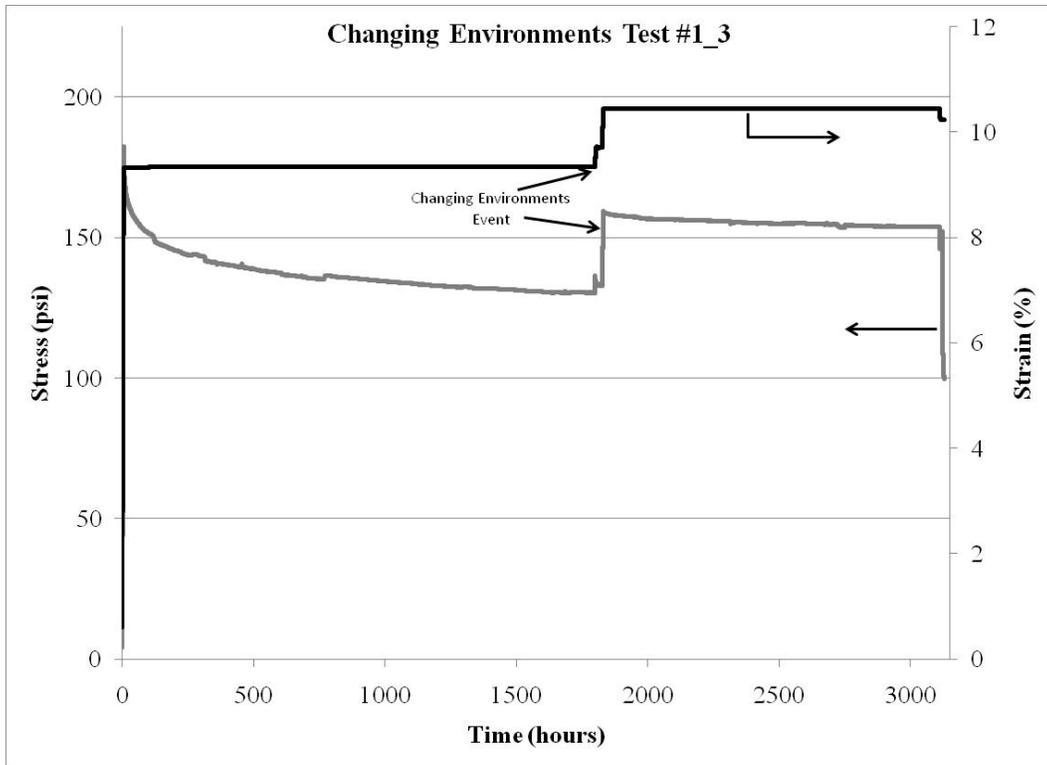
Figure 6. Results from Changing Environments Test #1_3.

Figure 6 shows Test #1_3 which was started on a second test frame. This test was run for a total of 3,129 hours before a failure of the top heater platen occurred. After relaxing for 1,795 hours to a stress level of 130 psi (896 kPa), a “changing environments” test was performed as shown in Figure 7. The top platen was cooled to 600°C and the bottom platen to 60°C, while the displacement on the test specimen was held constant by controlling off the LVDT sensors monitoring the position of the top and bottom of the test sample. Temperatures in the test chamber were allowed to equilibrate over night at which time the specimen was at a stress level of 133 psi (917 kPa). Following equilibration, 0.72% of additional strain was added to the test specimen in four increments of 0.18% strain at 10 mils/min (0.254 mm/min) spaced 60 minutes apart. Following application of the additional strain, the sample was at a stress level of 159 psi (1,096 kPa) and was again allowed to relax under constant displacement. The rate of stress relaxation appeared to return to a level similar to that before the changing environment event. The failure of the top heater platen occurred while attempting to perform the second “changing environments” test. The final stress level (prior to failure of the top platen) was 154 psi (1,062 kPa).

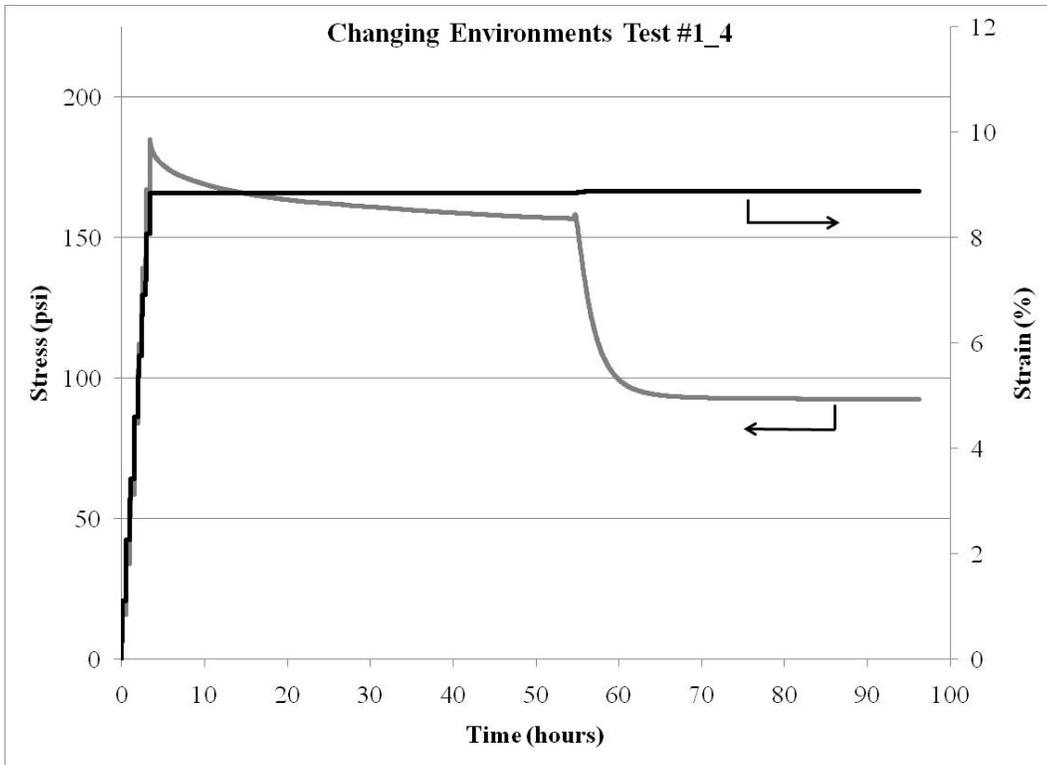
Figure 8. Results from Changing Environments Test #1_4.

Figure 8 shows Test #1_4 which was started on a third test frame and ended after only 96 hours due to a failure of the top platen and controller. Prior to the platen failure, the test had been relaxing for ≈50 hours and had moved from an initial stress of 184 psi to a stress level of 157 psi (1,269 to 1,082 kPa).

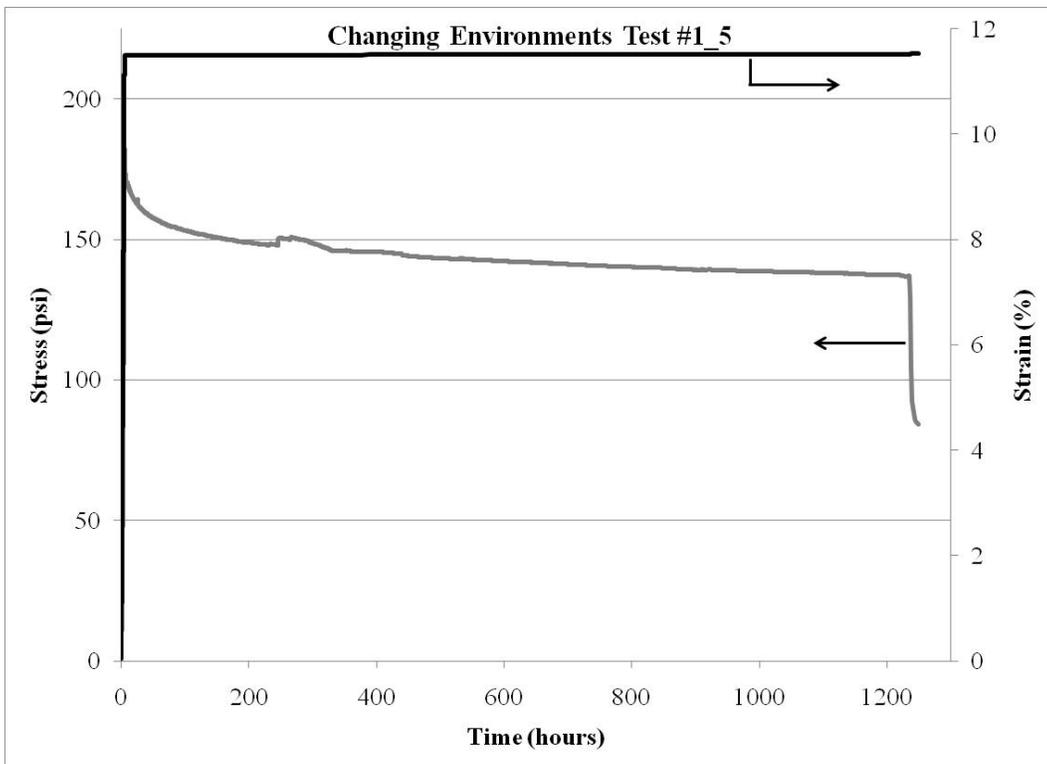
Figure 9. Results from Changing Environments Test #1_5.

Test #1_5 (shown in Figure 9) was started on the same frame as Test #1_4 following repair of the top platen. This test ran for 1,250 hours before being ended due to a failure of the top platen. At the time it was ended, it had been relaxing for over 1,225 hours and had relaxed from an initial stress of 182 psi to a stress level of 137 psi (1,255 to 945 kPa).

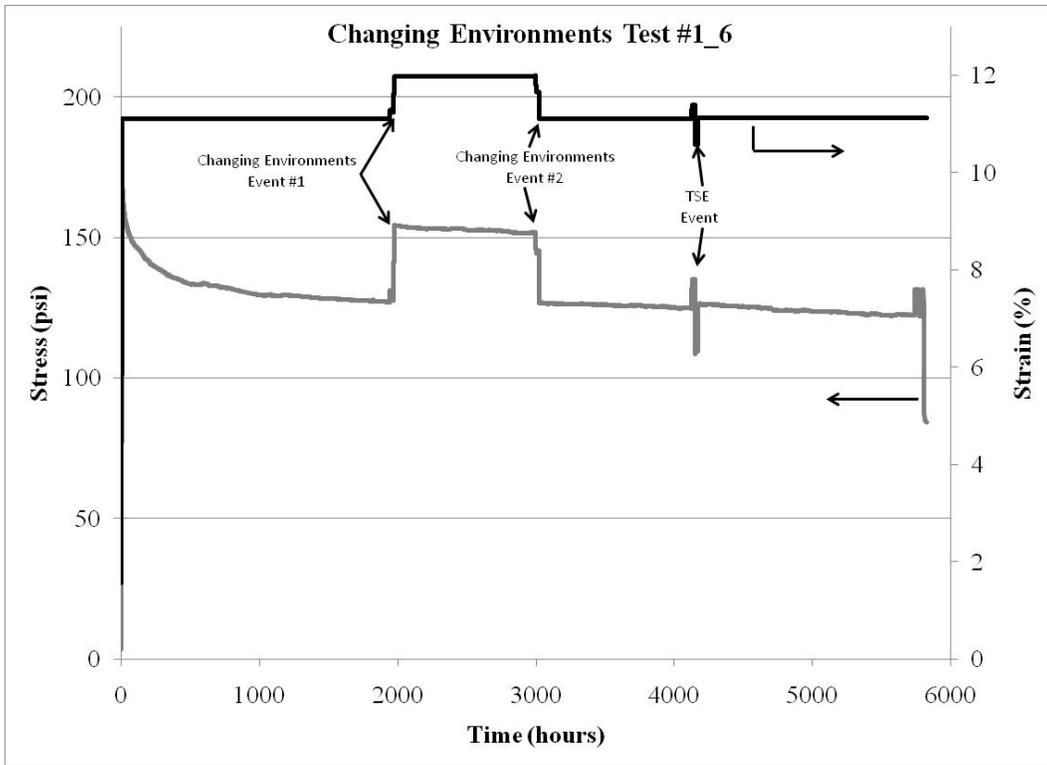
Figure 10. Results from Changing Environments Test #1_6.

Test #1_6 (shown in Figure 10) was started on the same frame as Test #1_2. This test was run for a total of 5,828 hours before being ended due to a loss of the cooling water system to the laboratory where the experiment was housed. After relaxing for 1,943 hours to a stress level of 127 psi (876 kPa), a “changing environments” test was performed as shown in Figure 11. The top platen was cooled to 600°C and the bottom platen to 60°C, while the displacement on the test specimen was held constant by controlling off the LVDT sensors monitoring the position of the top and bottom of the test sample. Temperatures in the test chamber were allowed to equilibrate over night at which time the specimen was at a stress level of 128 psi (883 kPa). Following equilibration, 0.72% of additional strain was added to

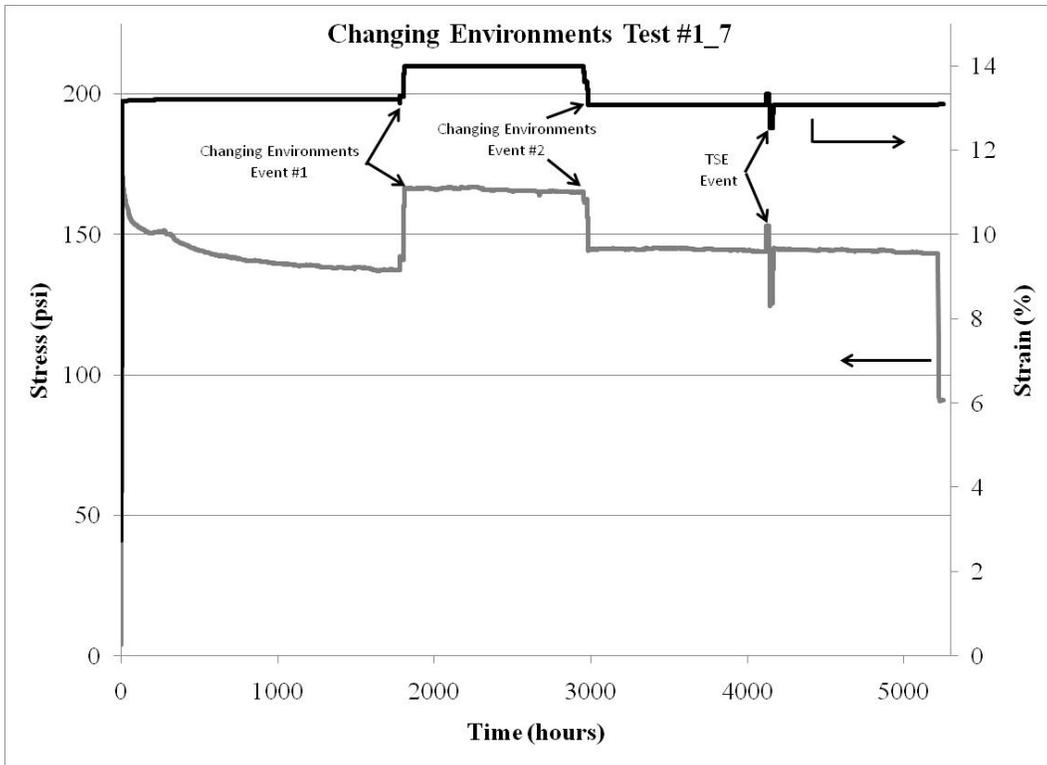
Figure 14. Results from Changing Environments Test #1_7.

Test #1_7 (shown in Figure 14) was started on the same frame as Test #1_5. This test was run for a total of 5,253 hours before being ended due to the failure of the top platen. After relaxing for 1,777 hours to a stress level of 137 psi (945 kPa), a “changing environments” test was performed as shown in Figure 15. The top platen was cooled to 600°C and the bottom platen to 60°C, while the displacement on the test specimen was held constant by controlling off the LVDT sensors monitoring the position of the top and bottom of the test sample. Temperatures in the test chamber were allowed to equilibrate over night at which time the specimen was at a stress level of 141 psi (972 kPa). Following equilibration, 0.72% of additional strain was added to the test specimen in four increments of 0.18% strain at 10

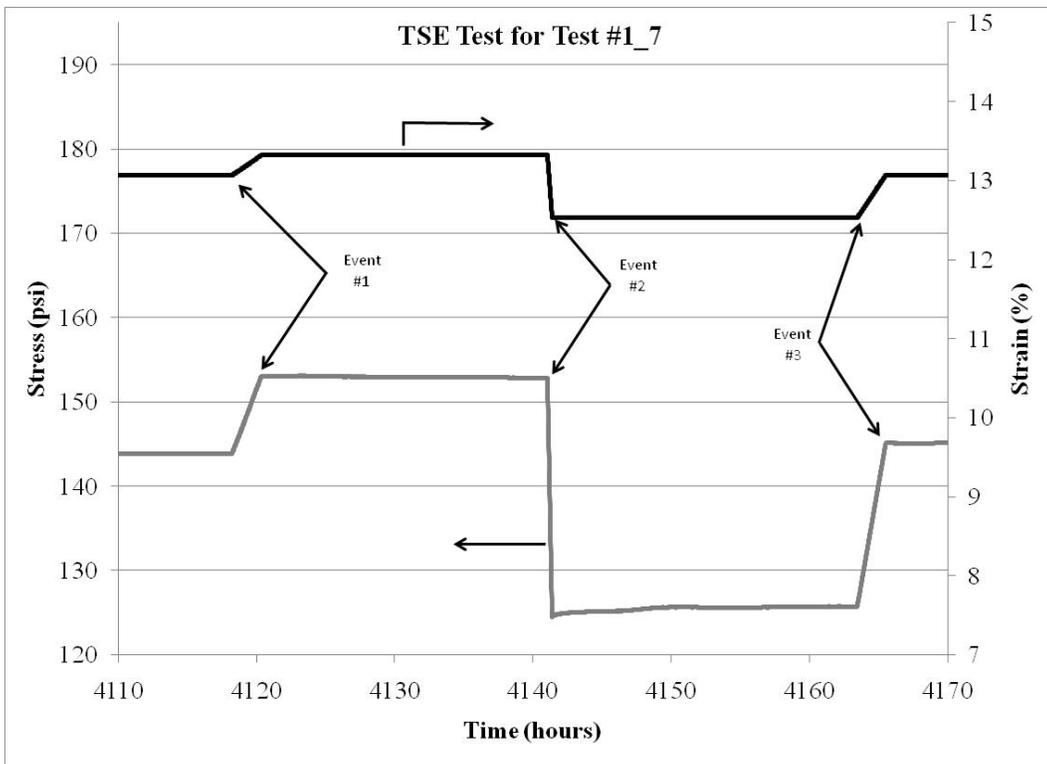
Figure 17. TSE Test for Test #1_7.

After relaxing for 4,118 hours, testing to simulate TSE expected during material service was performed on Test #1_7 as shown in Figure 17. At the time of the initiation of the events, the test was at a stress level of 144 psi (993 kPa). Improvements were made in the application of small amounts of strain based on lessons learned during the TSE testing performed during Test #1_6. Event one had a target of 0.25% increase in strain over a two hour period. An actual application of 0.253% strain over a 2.097 hour time period was realized. This resulted in an increase in stress to 153 psi (1,055 kPa). The test was then allowed to sit over night under constant displacement. The second event had a target of 0.79% decrease in strain over a 20 minute period. The actual strain application was 0.792% over a 20.448 minute time period. This resulted in a decrease in stress to 124 psi (855 kPa). The test was then allowed to again sit over night under constant displacement. The final event had a target of 0.539% increase in strain applied over a two hour period. An actual application of 0.542% strain over a 2.060 hour time period was realized. This resulted in an increase in stress to 145 psi (1,000 kPa). After the TSE event, the rate of stress relaxation appeared to return to a level similar to that before the event. The test was then allowed to relax under constant displacement until it was ended after relaxing for over 5,240 hours to a final stress level of 143 psi (986 kPa).

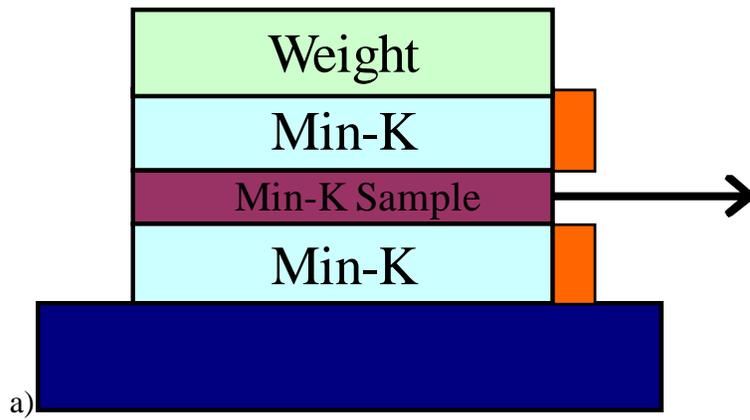
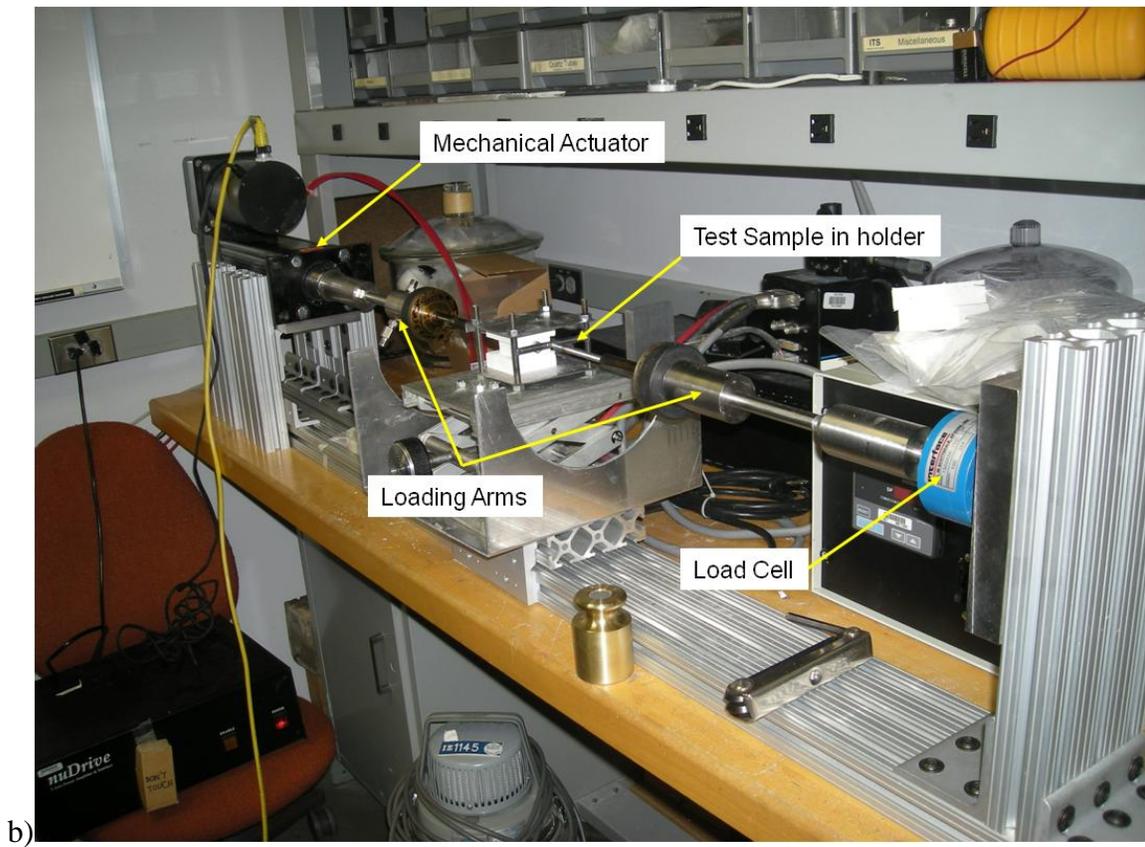
Figure 18. Original Lateral Load Test Set-Up a) Schematically and b) Pictorially.

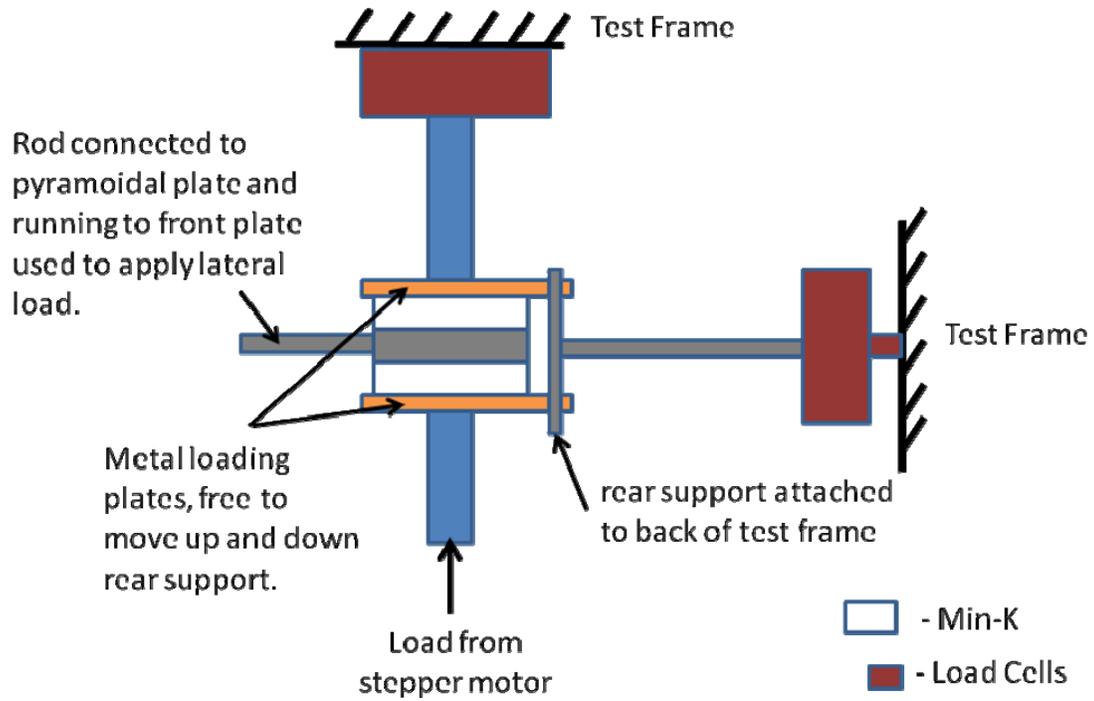
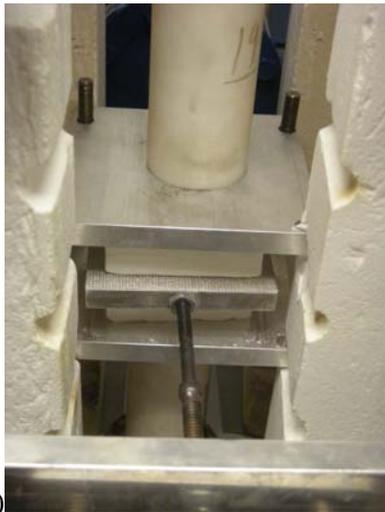
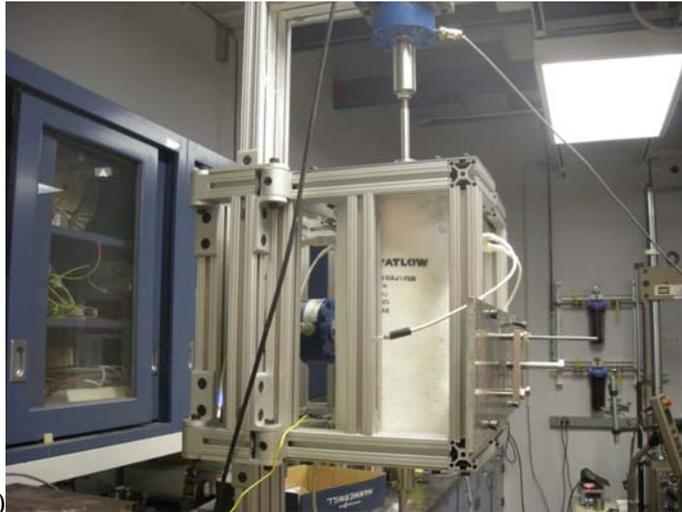
Figure 19. Lateral Load Test Set-Up after First Modification a) Schematically and Pictorially b) Showing Sample Holder and c) Showing Entire Set-Up with Furnace in Place and Front Plate Assembly for Applying Lateral Load.

After initial testing, the test set-up was again modified to eliminate lateral loading created by the transfer of forces by a moment arm produced on the rear support (see Figure 19(a) and discussion in Section 4.2) when axial loads were applied to the test assembly. The further modified set-up is shown in Figure 21. The rear support assembly was replaced with a turnbuckle connected to the center aluminum plate and load cell by hooks and eyelets. Additionally, the original metal loading plates were replaced with new plates incorporating aluminum inserts with the same "pyramidal" texture as the center plate. Also, supports were added to confine lateral movement of the push rods due to flexure. The use of the hooks and eyelets allowed the sample assembly to move without creating a lateral load during the application of the axial loading and by manipulating the turnbuckle, a lateral load could now be applied to the test assembly.

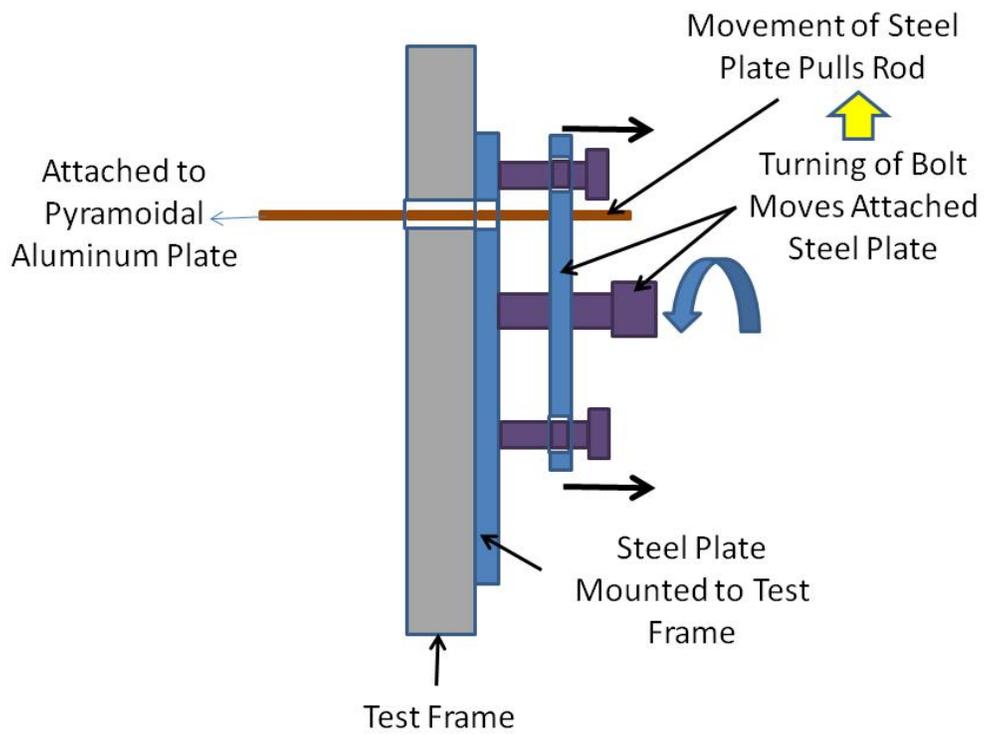
Figure 20. Schematic of Lateral Load Application for Modified Lateral Load Test Set-Up.

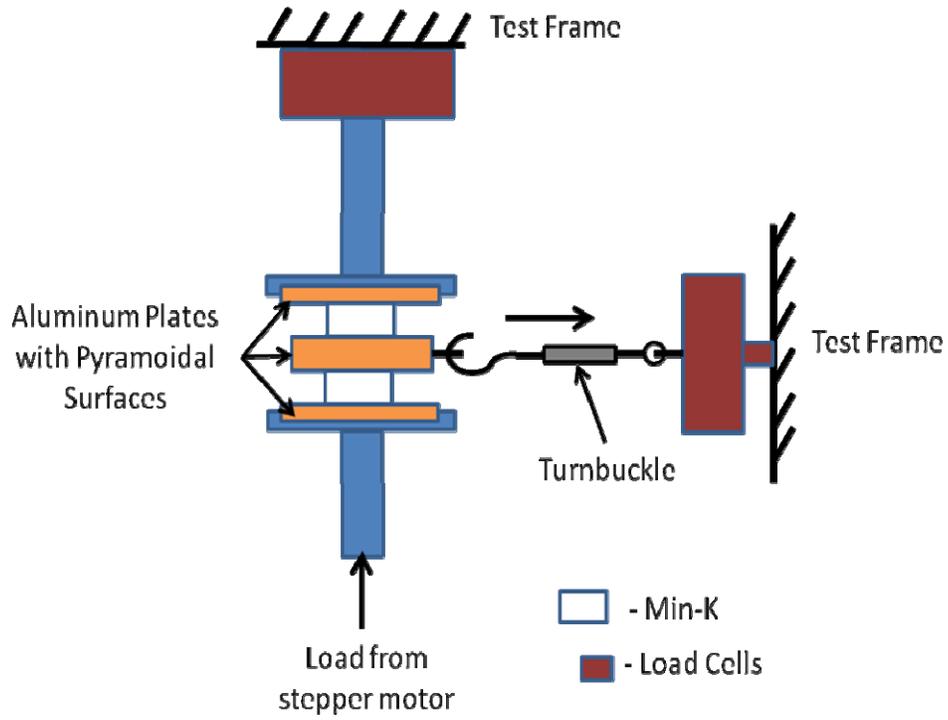
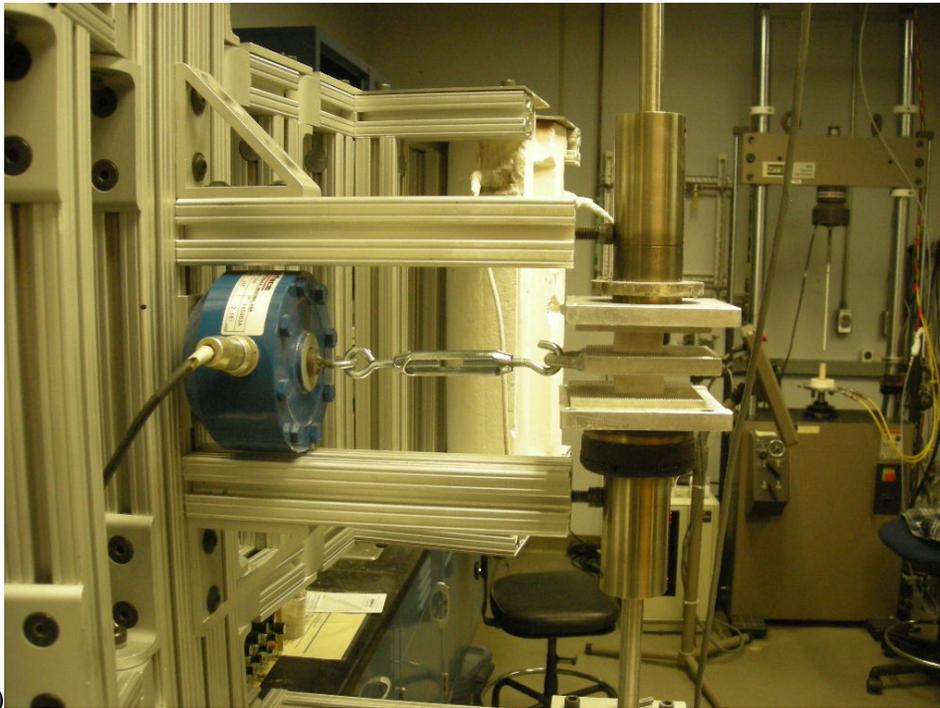
Figure 21. Lateral Load Test Set-Up after Second Modification
a) Schematically and b) Pictorially.

Tests #13 (as shown in Figure 29) was run by axially loading a 2.25" (57.15 mm) square test sample in a step fashion and observing the corresponding lateral load. After each load step the loads (both axial and lateral) were allowed to relax as the sample was held under constant axial displacement. Tests #14-16 were run by applying a lateral load to a 1" (25.4 mm) square test sample in a step fashion through turning of the frame turnbuckle assembly and observing the corresponding axial load. Again, after each load step the loads (both axial and lateral) were allowed to relax as the sample was held under the current conditions. As shown in Figure 30 for Test #14 (and also seen in Tests #15 and 16), it was found that coupling still existed between the axial and lateral loads. This was thought to be due to deflection of the frame push rods. Subsequently, work was done to stiffen the frame by providing supports to the push rods as shown in Figure 21(b).

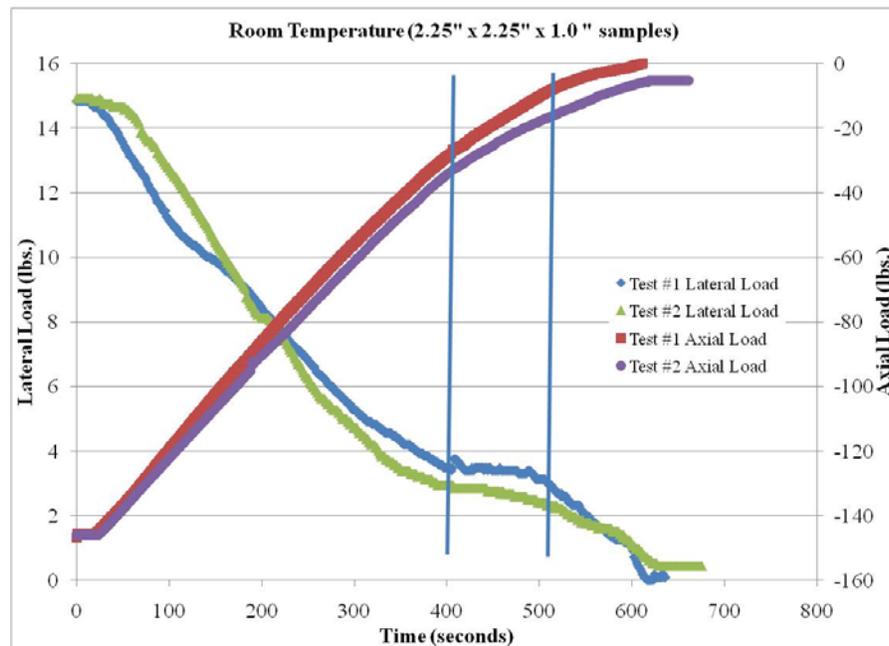
Figure 23. Results for 2.25" Samples Using Lateral Load Testing Set-Up after First Modification (Lateral Load Removed at 0.01 mm/sec).

A matrix of tests performed using the modified test frame is shown in Table 3. Results of testing performed using the test set-up after the first modification (Tests #1-10) are shown in Figure 23 through Figure 27. Figure 23 shows results from Lateral Load Tests #1 and 2 where 2.25" (57.15 mm) square samples were loaded to 145 lbs. (65.77 kg) axially and 15 lbs. (6.80 kg) laterally before the axial load was removed at a constant displacement rate of 0.01 mm/sec. The lateral load was found to decrease until it reached ≈ 3 lbs. (1.36 kg) and a corresponding axial load of ≈ 35 lbs. (15.88 kg) at which point the lateral load remained constant until the axial load was decreased to 10-15 lbs. (4.53-6.80 kg). The lateral load then began to decrease to zero as the remainder of the axial load was removed. There was good repeatability found between Tests #1 and 2. Test #3 was a repeat of these tests started at an initial axial load of 250 lbs. (113.40 kg) as opposed to 145 lbs. (65.77 kg). Results were found to be similar.

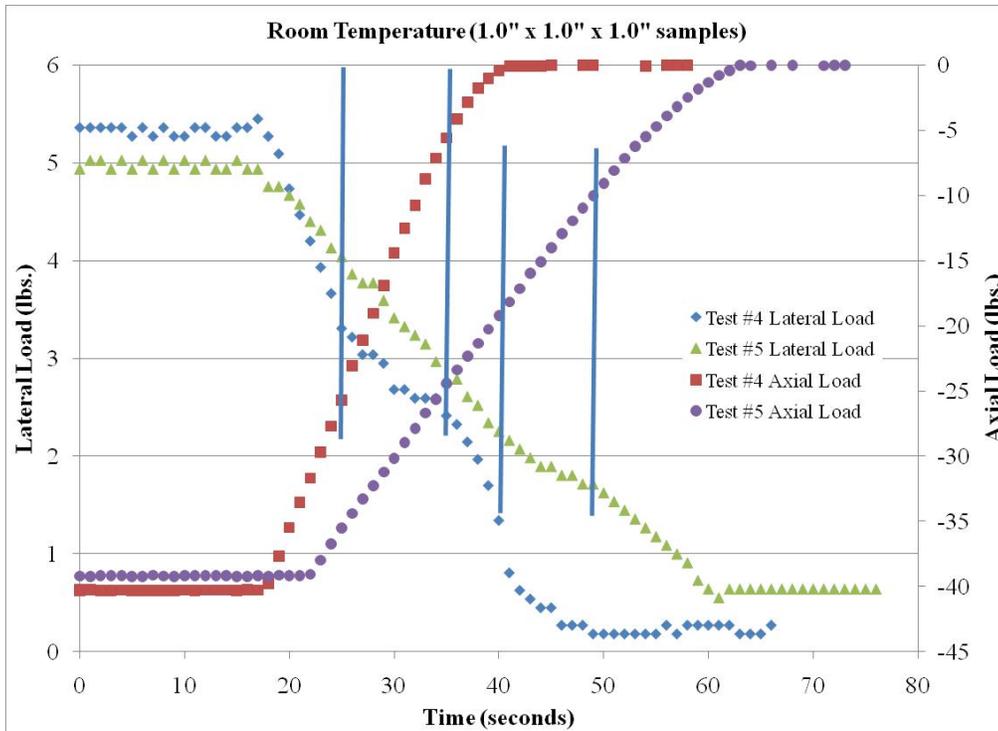
Figure 24. Results for 1" Samples Using Lateral Load Testing Set-Up after First Modification.

Figure 24 shows the results from Lateral Load Tests #4 and 5 where 1.0" (25.4 mm) square samples were loaded to 40 lbs. (18.14 kg) axially and 5 lbs. (2.27 kg) laterally before the axial load was removed at a constant displacement rate of either 0.10 mm/sec (Test #4) or 0.05 mm/sec (Test #5). For Test #4, the lateral load was found to decrease until it reached ≈ 3.25 lbs. (1.47 kg) and a corresponding axial load of ≈ 25 lbs. (11.34 kg), at which point the lateral load decreased at a much reduced rate until the axial load was decreased to ≈ 5 lbs. (2.27 kg). The lateral load then began to decrease at the original rate until it reached zero as the remainder of the axial load was removed. For Test #5, the lateral load was found to decrease until it reached ≈ 2.25 lbs. (1.02 kg) and a corresponding axial load of ≈ 20 lbs. (9.07 kg), at which point the lateral load decreased at a much reduced rate until the axial load was decreased to ≈ 10 lbs. (4.54 kg). The lateral load then began to decrease at the original rate until it reached zero as the remainder of the axial load was removed. This shows the effect of varying the displacement rate during removal of the axial load. The removal of the axial load at a faster rate (Test #4) resulted in the period of decreased lateral load loss occurring at a higher lateral load value. Test #6 (note shown) was similar to Test #4, but utilized an initial axial load of 65 lbs. (29.48 kg) as opposed to 40 lbs. (18.14). Results were found to be similar.

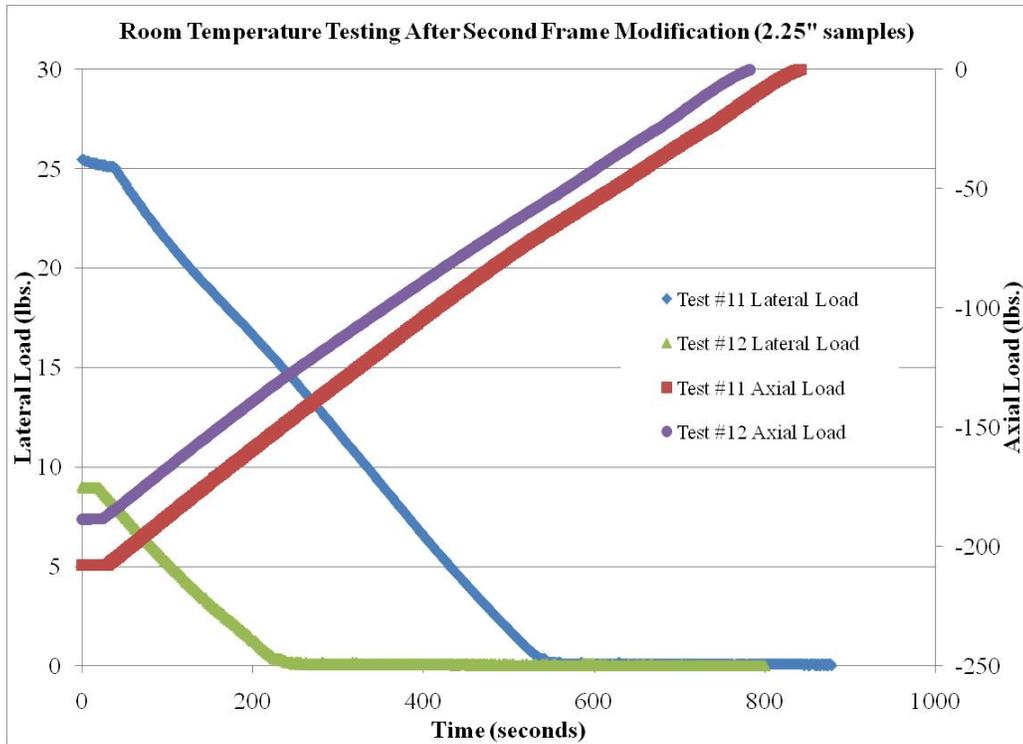
Figure 28. Results for 2.25” Samples Using Lateral Load Testing Set-Up after Second Modification.

Results of testing performed using the test set-up after the second modification (Tests #11-61) are shown in Figure 28 through Figure 48. Figure 28 shows Tests #11 and 12 run using 2.25" (57.15 mm) square samples. Test #11 was loaded axially to 207 lbs. (93.89 kg) and laterally to 25 lbs. (11.34 kg), while Test #12 was loaded axially to 188 lbs. (85.28 kg) and laterally to 9 lbs. (4.08 kg). Load removal from these tests was performed at 0.01 mm/sec. The lateral loads were found to decrease rapidly in both tests at a constant rate with the removal of the axial load, contrary to the behavior seen in previous testing discussed above. It was decided though that this test method was still not producing the desired data for analysis, therefore the test procedure was modified.

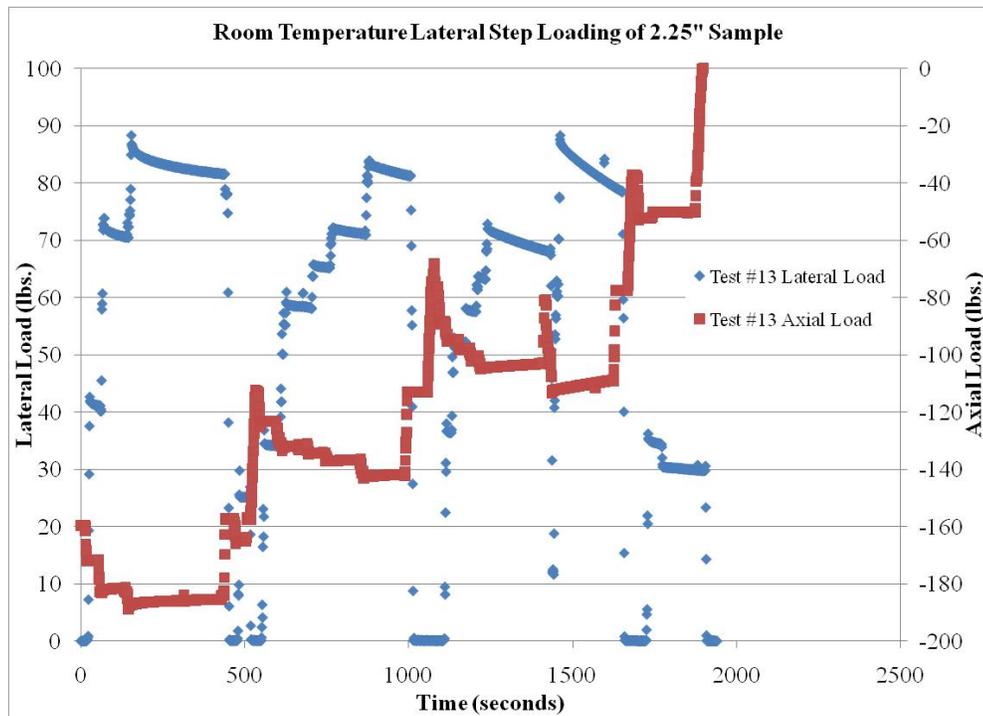
Figure 29. Results for Axial Step Loading of 2.25” Sample Using Lateral Load Testing Set-Up after Second Modification.

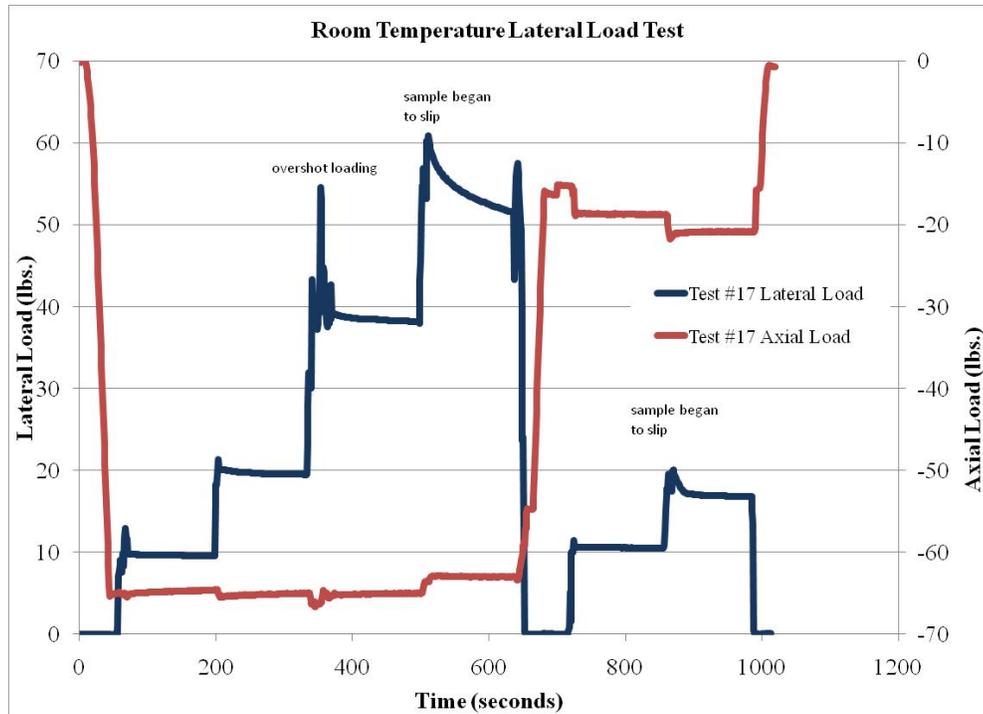
Figure 31. Results for Lateral Step Loading of 1” Sample Preloaded to 65 lbs. Axially Using Lateral Load Testing Set-Up after Second Modification.

After stiffening the test frame, Test #17 was run by axially loading a 1" (25.4 mm) square test sample to 65 lbs. (28.48 kg), then performing a lateral step loading as done for Tests #14-16. Results of this test are shown in Figure 31. The sample began to slip when the lateral load reached ≈ 60 lbs. (27.22 kg). The lateral load was then removed from the sample and the axial load was reduced to 15 lbs. (6.80 kg). The sample was then reloaded laterally in a step fashion while under 15 lbs. (6.80 kg) of axial load. The sample began to slip under this condition when the lateral load reached ≈ 20 lbs. (9.08 kg). At this time both the axial and lateral loads were removed and the test ended.

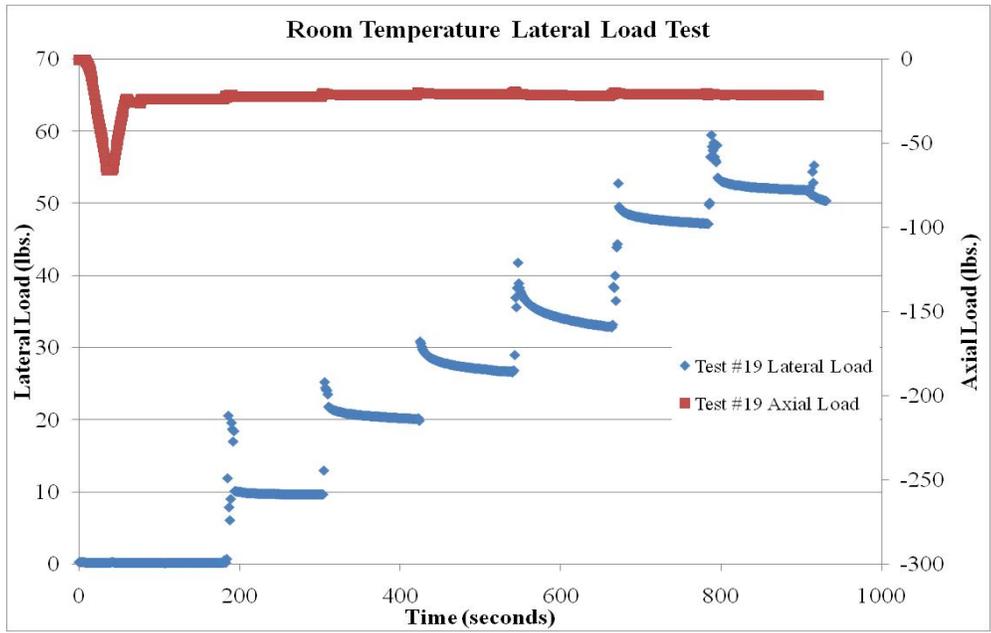
Figure 33. Results for Lateral Step Loading of 1” Sample Preloaded to 25 lbs. Axially After Being Subjected to Initial Axial Loading of 65 lbs.

Tests #18-21 were also run using 1” (25.4 mm) square test samples. Test #18, 20, and 21 were axially loaded to 65 lbs. (29.48 kg), before being laterally loaded at steps of 10, 20, 30, 40, 50, 60 and 65+ lbs. (4.54, 9.07, 13.61, 18.14, 22.68, 27.22 and 29.48+ kg). An example of this testing is shown in Figure 32. These samples were all successfully loaded in excess of 60 lbs. (27.22 kg) without failure. For Test #19 an initial axial load of 65 lbs. (29.48 kg) was applied, immediately followed by a reduction of the axial load to 25 lbs. (11.34 kg). The sample was then stepped through the same lateral loading used above. This sample failed while going to 60 lbs. (27.22 kg) of lateral load as shown in Figure 33.

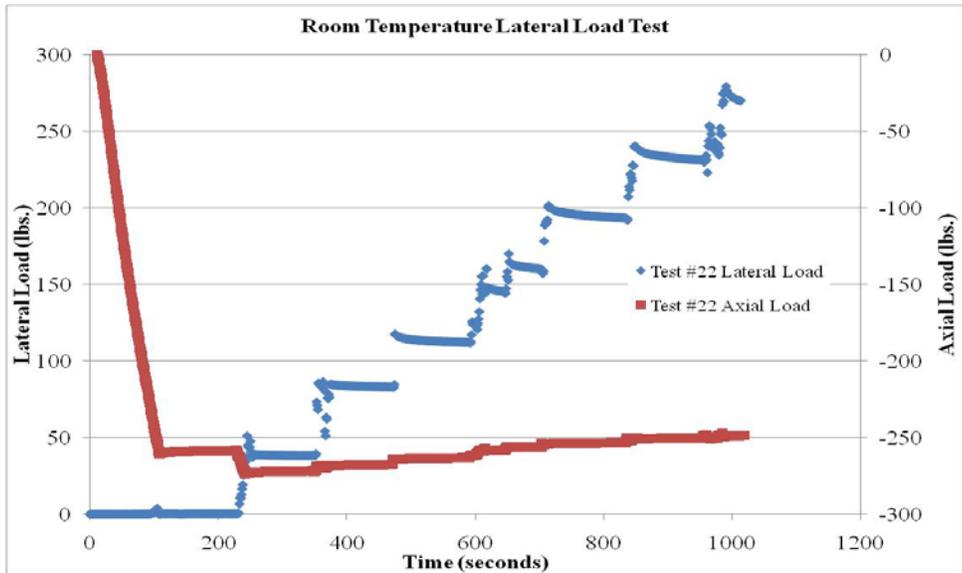
Figure 34. Results for Lateral Step Loading of 2.25” Sample Preloaded to 270 lbs. Axially.

Tests #22-24 were run using a 2.25” (57.15 mm) square test samples axially loaded to 270 lbs. or ≈ 55 psi (122.47 kg or ≈ 0.4 MPa) before being stepped through lateral loads of 50, 85, 115, 150, 170, 200, 250, and 285 lbs (22.68, 38.56, 52.16, 68.04, 77.11, 90.72, 113.40, and 129.27 kg). The samples in all of these tests began to fail while going to 250 lbs. or ≈ 50 psi (113.40 kg or ≈ 0.3 MPa) and fully failed while going to 285 lbs or >55 psi (129.27kg or >0.4 MPa) as shown in Figure 34.

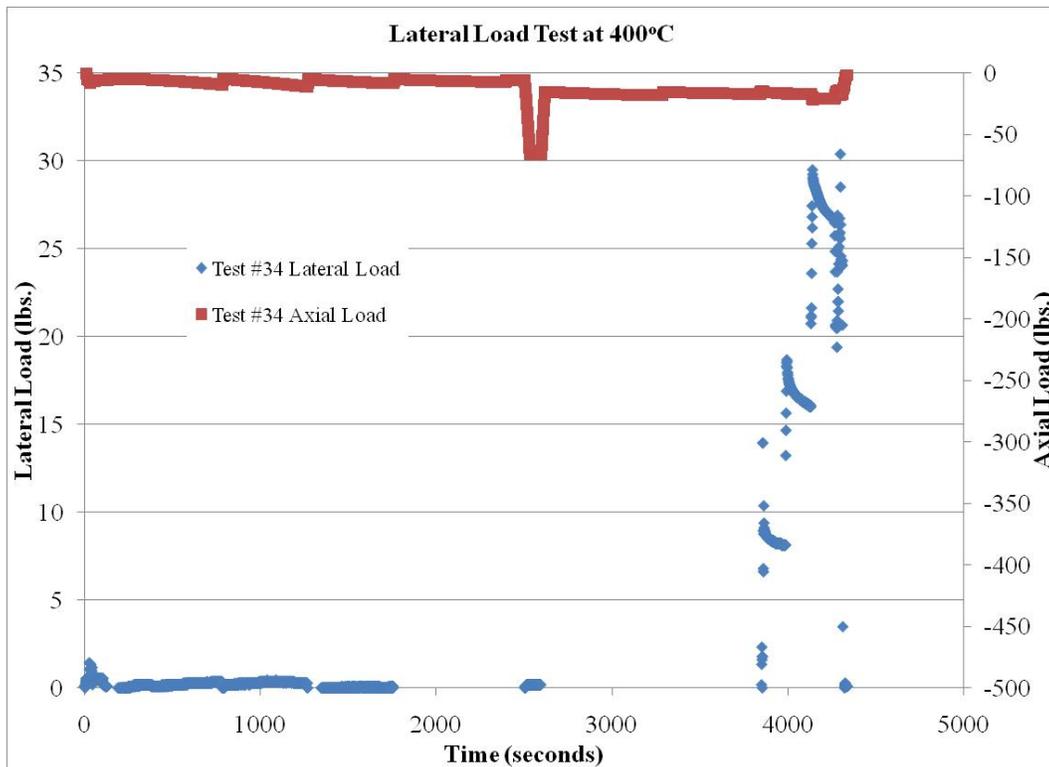
Figure 41. Results for Lateral Step Loading of 1" Sample at 400°C Preloaded to 65 and 15 lbs. Axially After Heating.

load and was at a level of ≈ 25 lbs. (11.34 kg) at the time of failure. Tests #34 and 35 were replicates of Test #33. The axial load was maintained during these tests and these samples failed while going to a lateral load of 30 lbs. (13.61 kg) as shown in Figure 41, which is more of the level expected.
