Final Technical Report

**Additional Characterization of
Min-K T/E-1400 Thermal Insulation**

J. G. Hemrick and J. F. King

Prepared by
OAK RIDGE NATIONAL LABORATORY
Oak Ridge, Tennessee 37831-6079
managed by
UT-BATTELLE, LLC
for the
U.S. DEPARTMENT OF ENERGY
under contract DE-AC05-00OR22725

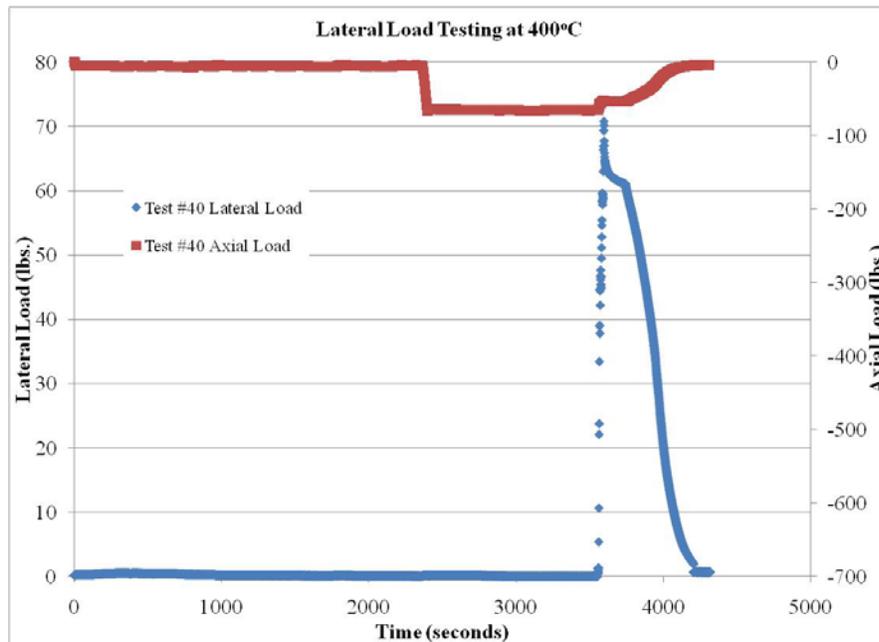
Figure 43. Results for 1" Sample Using Lateral Load Testing Set-Up at 400°C.

To ascertain dependence between the axial and lateral loads, Test #40 was run at 400°C using a 1" (25.4 mm) square test sample by initially loading the sample axially to 65 lbs. (29.48 kg) and laterally to 75 lbs. (34.02 kg) after heating. The lateral load was then removed while monitoring the axial load as shown in Figure 43. Both loads were found to fall off simultaneously.

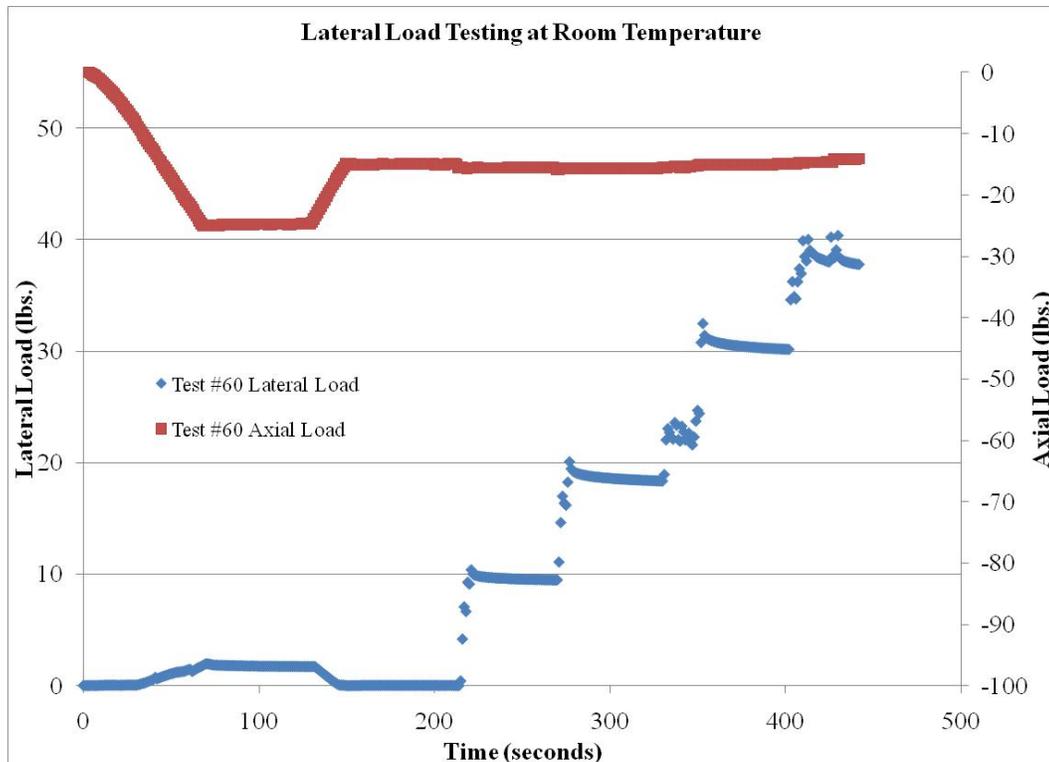
Figure 48. Results for 1" Sample Preloaded to 25 and 15 lbs. Axially at Room Temperature.

40 lbs. (4.54, 9.07, 13.61, and 18.14 kg). The sample failed while going to 40 lbs. (18.14 kg) of lateral load as shown in Figure 48. This is thought to be due to uneven loading of the sample due to not enough initial load being applied to embed the pyramidal surfaces of the platens. Therefore, Test #61 was run by loading to 35 lbs. (15.88 kg) axially and then immediately reducing the load to 15 lbs. (6.80 kg). This sample failed while going to 30 lbs. (13.61 kg) of lateral load as expected and seen previously (see Figure 41).

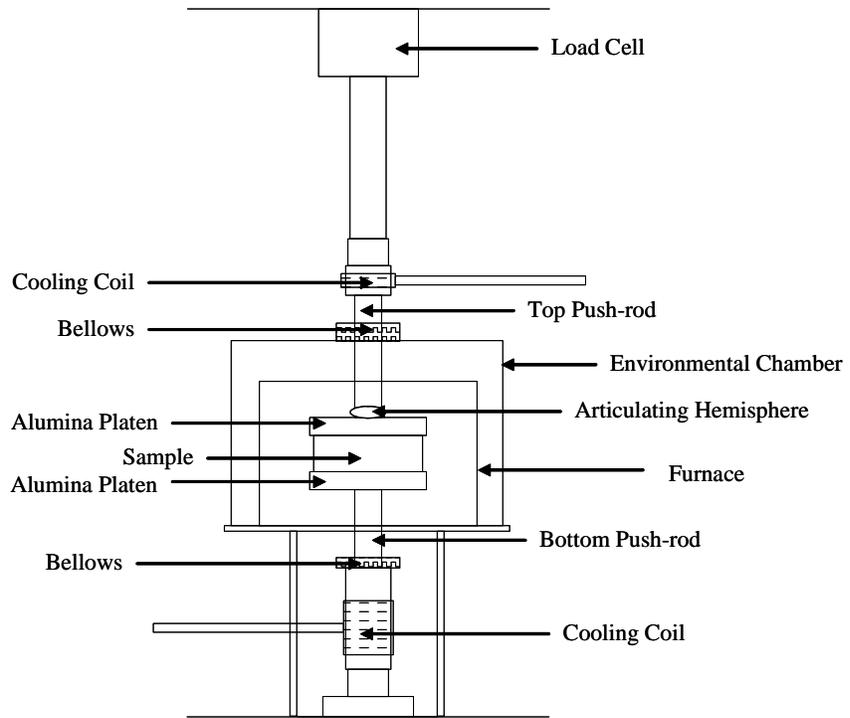
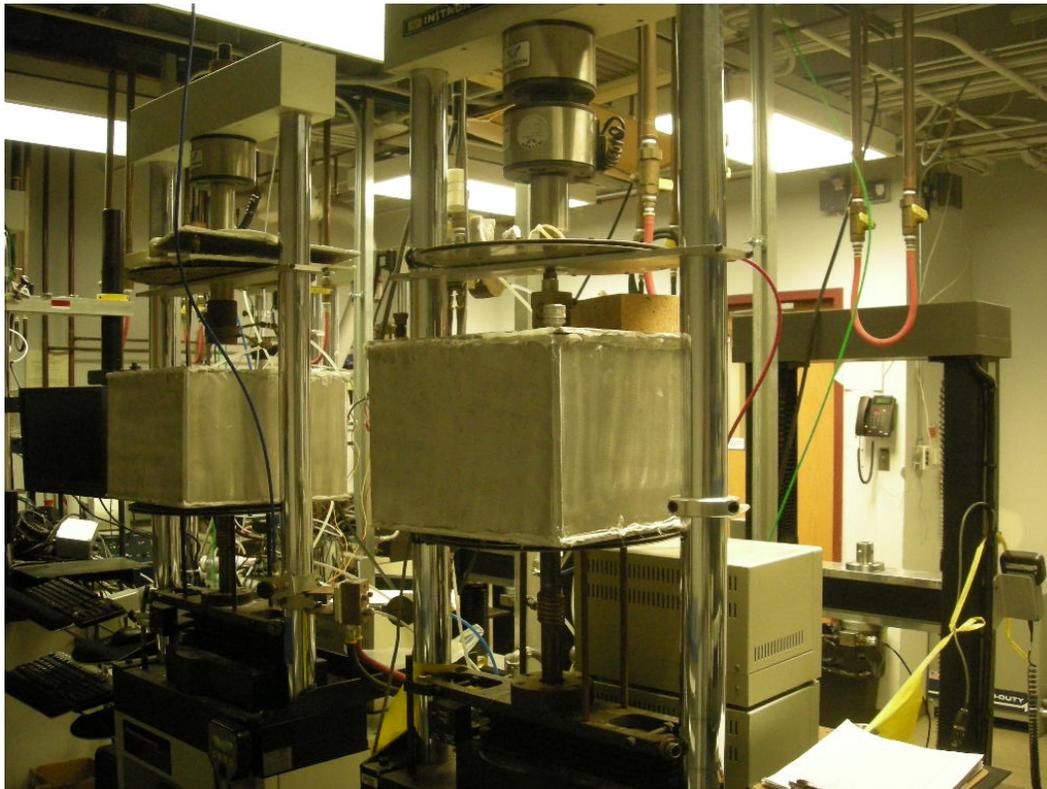
Figure 49. Isothermal Stress Relaxation Test Frame.

Testing was performed using 6” (15 cm) diameter, 2” (5 cm) long cylindrical samples using the set-up shown in Figure 49. Each independent experimental station had a load capacity of 10,000 lbs. (4,536 kg). The experimental stations included a stiff frame, one load cell, one electromechanical actuator and a computerized system for data acquisition and control. In addition, each experimental station included a furnace to subject cylindrical test specimens of Min-K 1400 to a prescribed isothermal temperature. The operation of the furnace was controlled using a digital temperature controller and type-K thermocouples with the test set-up enclosed in an aluminum environmental chamber with helium flow (99.999% purity, flow rate of 70 mm) to maintain a prescribed atmosphere. Frames were connected to a back-up power supply similar to that shown in Figure 2 to provide uninterrupted power in the event of a laboratory power failure and a water chiller/circulator system to provide constant temperature cooling water to the test frames.

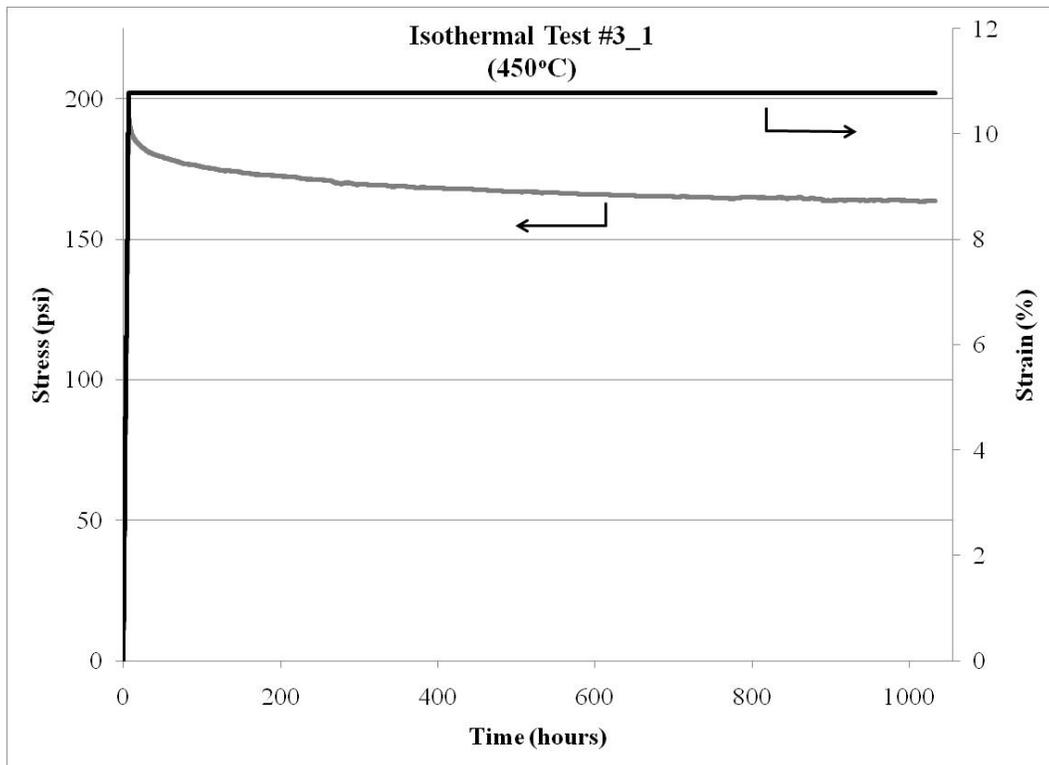
Figure 50. Isothermal Test #3_1 (450°C).

Figure 50 shows results from Test #3_1 which was performed at 450°C. This test was ended after determining that enough data for accurate predictions had been collected. At the time the test was ended, it had been relaxing for over 1,025 hours and had reached a level of 164 psi (1,131 kPa).

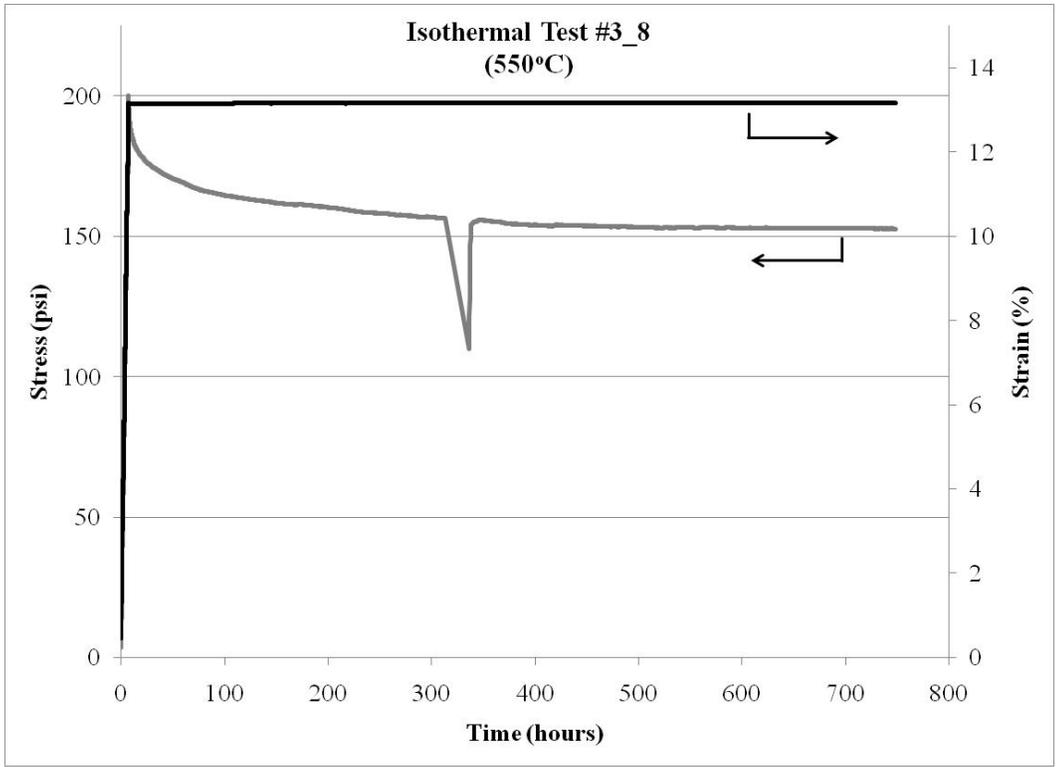
Figure 56. Isothermal Test #3_8 (550°C).

Figure 56 shows the results from Test #3_8 which was also performed at 550°C. This test lost temperature (and subsequently lost load to approximately 110 psi/758 kPa) after relaxing for approximately 300 hours due to a problem with the cooling water supply system in the lab that activated the over-temperature controller on the test system furnace. It was brought back up to temperature following repair of the problem and the load level was found to return to expected levels equivalent to those before the loss of cooling water. Upon being brought back up to temperature, the test was allowed to relax for another 440 hours (total relaxation time of over 740 hours) before being ended when it was determined that enough data for accurate predictions had been collected. At the time the test was ended, it had reached a level of 153 psi (1,055 kPa).

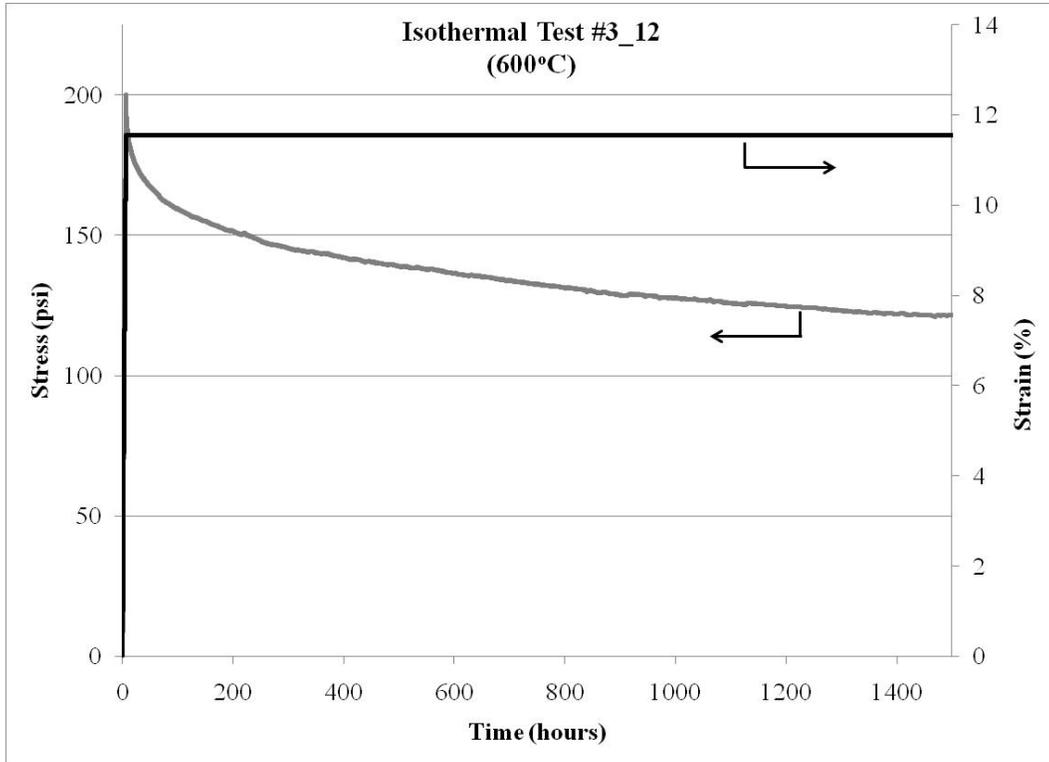
Figure 60. Isothermal Test #3_12 (600°C).

Figure 60 shows the results for Test #3_12 which was performed at 600°C. This test was allowed to continue until the end of the project, therefore substantially more relaxation data than collected for the other tests was obtained. The test relaxed for over 4,670 hours and to a level of 102 psi (703 kPa).
