**ORNL /IAT ARMATURE DIAGNOSTICS
DEMONSTRATION TEST REPORT:
PART TWO: BENCH DEMONSTRATION**

Date Published: Dec 2005

Prepared by
OAK RIDGE NATIONAL LABORATORY
P.O. Box 2008
Oak Ridge, Tennessee 37831-6283
managed by
UT-Battelle, LLC
for the
U.S. DEPARTMENT OF ENERGY
under contract DE-AC05-00OR22

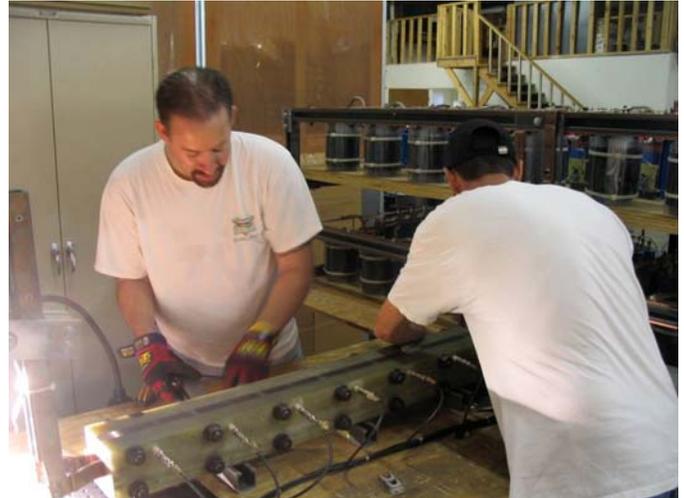
Figure 1 Benchtop railgun

The railgun is depicted in Figure 1 as it is being prepared. After several firings, the muzzle was modified to accommodate optical fiber probes. Figure 2 provides additional views. The bottom frame reveals the location of the two fiber probes. One senses the arrival of the armature, and the other delivers the excitation laser light and captures the fluorescence, directing it to a detector and data acquisition system.

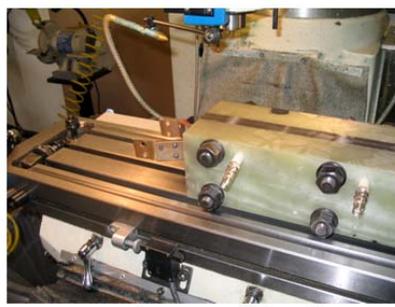
Figure 2 Views of railgun

Rail Gun exit without shunt

Preparing to Modify Rail Gun

Rail Gun Exit with Temperature Probe

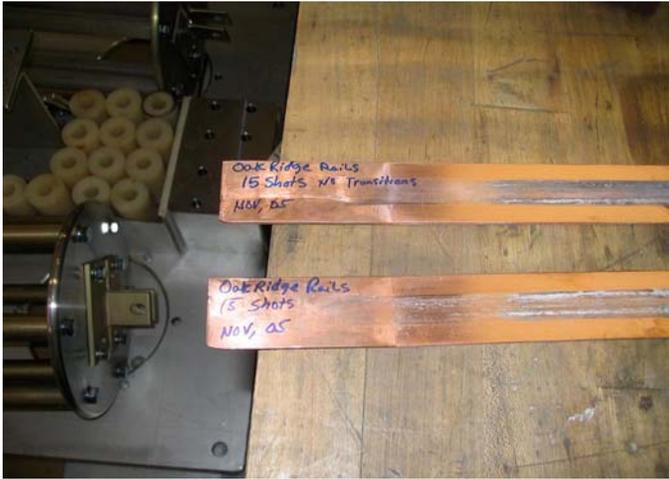
Figure 12 Rail Pair for shots 1 – 15

The temperature determinations are given in the table. The top three results are for measurements outside the muzzle and were obtained using the first rail pair, Figure 12. These rails apparently did not experience transition during their fifteen shots of operation.
