# Preparation of Simulated LBL Defects for Round Robin Experiment

**PREPARATION OF SIMULATED LBL DEFECTS  
FOR ROUND ROBIN EXPERIMENT**

Revision 2  
Date Published: July 2016

Work sponsored by  
US DEPARTMENT OF ENERGY  
Office of Nuclear Energy - Advanced Reactor Technologies  
under the  
Advanced Gas Reactor Fuel Development and Qualification Program

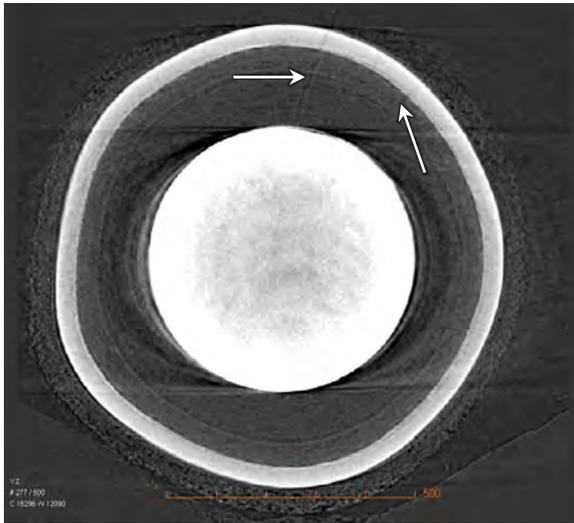
GIF-02

X-ray tomography was performed on all particles selected for use in the round robin experiment after removal of each particle from the Crystalbond (as shown in Appendix A) by dissolving the epoxy in acetone. The location of the TRISO layer fractures visible in each tomograph is indicated by an arrow.
