# Wastewater Triad Project: Final Summary Report

ORNL/TM-2001/129

Nuclear Science and Technology Division

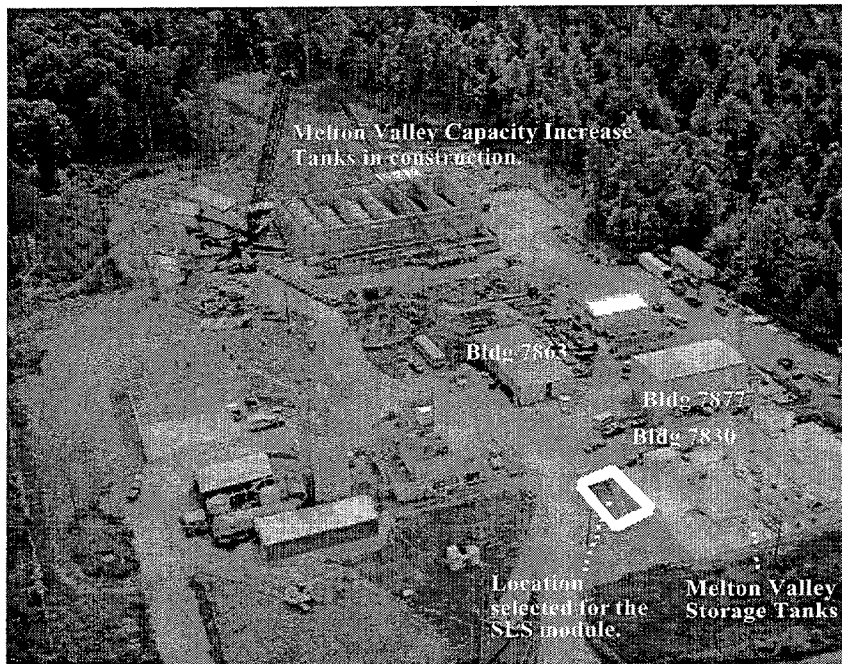
**Fig. 2. Aerial photograph of the MVST facilities during construction for the capacity increase tanks.**

The MVSTs constitute a major fraction of the waste storage capacity for the active LLLW system and are the targeted collection point for waste from ongoing research and reactor operations at ORNL. The MVST facility consists of eight 50,000-gal stainless steel horizontal tanks, each about 60 ft long and 12 ft in diameter. The tanks were built within an underground concrete vault containing a stainless steel liner for spill containment. The walls and ceiling of the vault provide containment and radiation shielding. The vault also includes a pump-and-valve vault (PW), where piping is routed from the MVST feed lines, drain lines, sample lines, and other connections. The waste transfer piping for the tanks is routed within the PW to two large progressive-cavity pumps designed for cross-site and inter-tank transfers. The vault also includes a high-efficiency particulate air (HEPA)-filtered ventilation system for control of airborne contamination. An above-ground control room (Building 7830) housing the tank level instrumentation, ventilation system controls, and pump controls is located adjacent to the south side of the vault. An aerial photograph of the MVST facility is shown in Fig. 2.

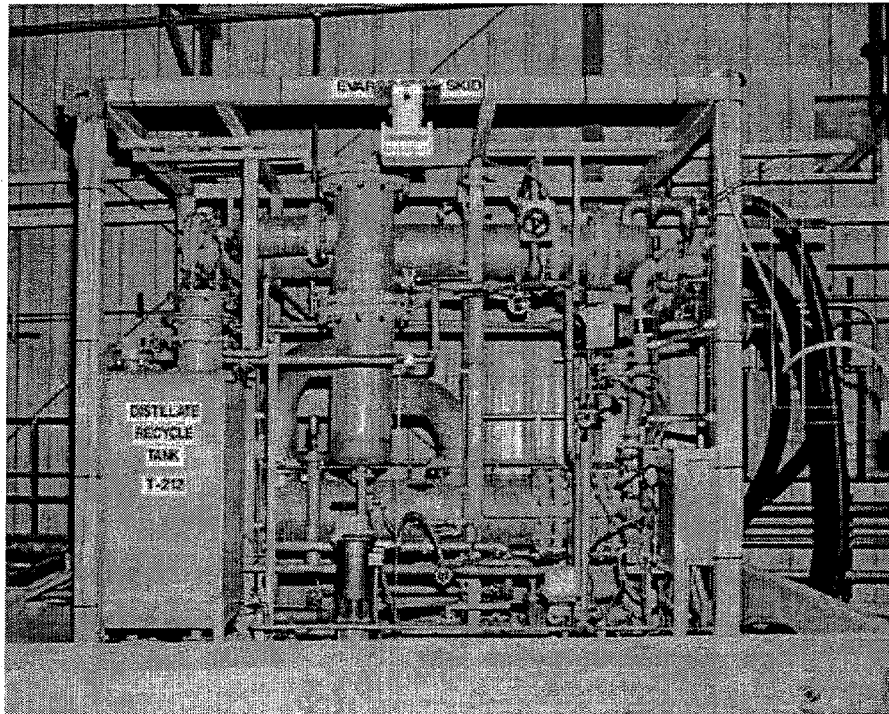
**Fig 3. Photograph of the OTE skid prior to the placement of the concrete shields.**

Fabrication of the unit by Delta Thermal was initiated in the spring of 1995 and completed in September 1995. The system was fabricated in five modular skids including (1) the feed skid, containing the feed holding tank and concentrate recirculation tank; (2) the distillate skid, including a distillate holding tank and transfer pump; (3) the heating skid, including an electric heat exchanger with an ethylene glycol recirculation system; (4) a cooling skid, including two fin-fan heat exchangers and ethylene glycol recirculation system; and (5) the main evaporator skid, containing the evaporator heat exchanger, the vapor separation unit, the condenser, and feed circulation pumps. Photographs of the evaporator skid and the heating skid are presented in Figs. 3 and 4, and a photograph of the OTE feed skid, evaporator skid, CsR feed skid, and ion-exchange skid after installation in Building 7877 is presented in Fig. 5. A basic flow diagram for the OTE system presented in Fig. 6, shows the four basic loops within the system for heating, cooling, reducing pressure, and concentrating the feed.

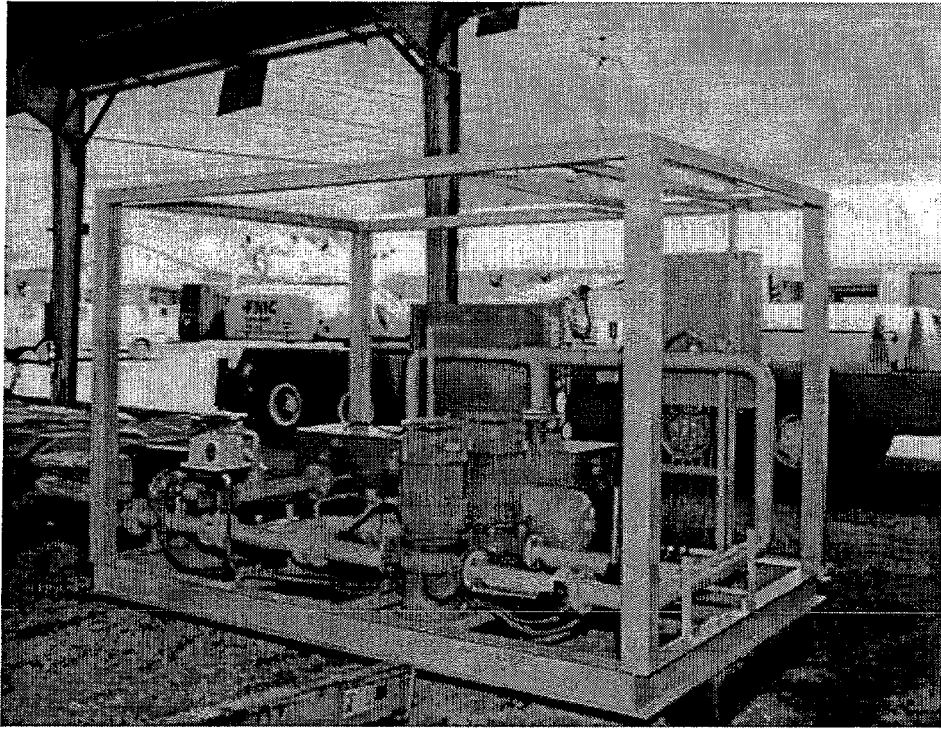
**Fig. 4. Photograph of the OTE heater skid prior to installation.**

Energy in the form of hot water (at 190°F and approximately 190 gal/min) was supplied to the evaporator by an electric boiler (a self-contained thermostatically controlled unit, incorporating flow and temperature sensing units) and a pressure relief valve. A conductivity element/transmitter monitored the heating fluid for any indication of a leak and signaled a control valve, which stopped flow to the boiler should the conductivity exceed a predetermined set point. Thermocouples monitored the temperature into and out of the shell and tube heat exchanger. A flow transmitter monitored the heating loop flow.

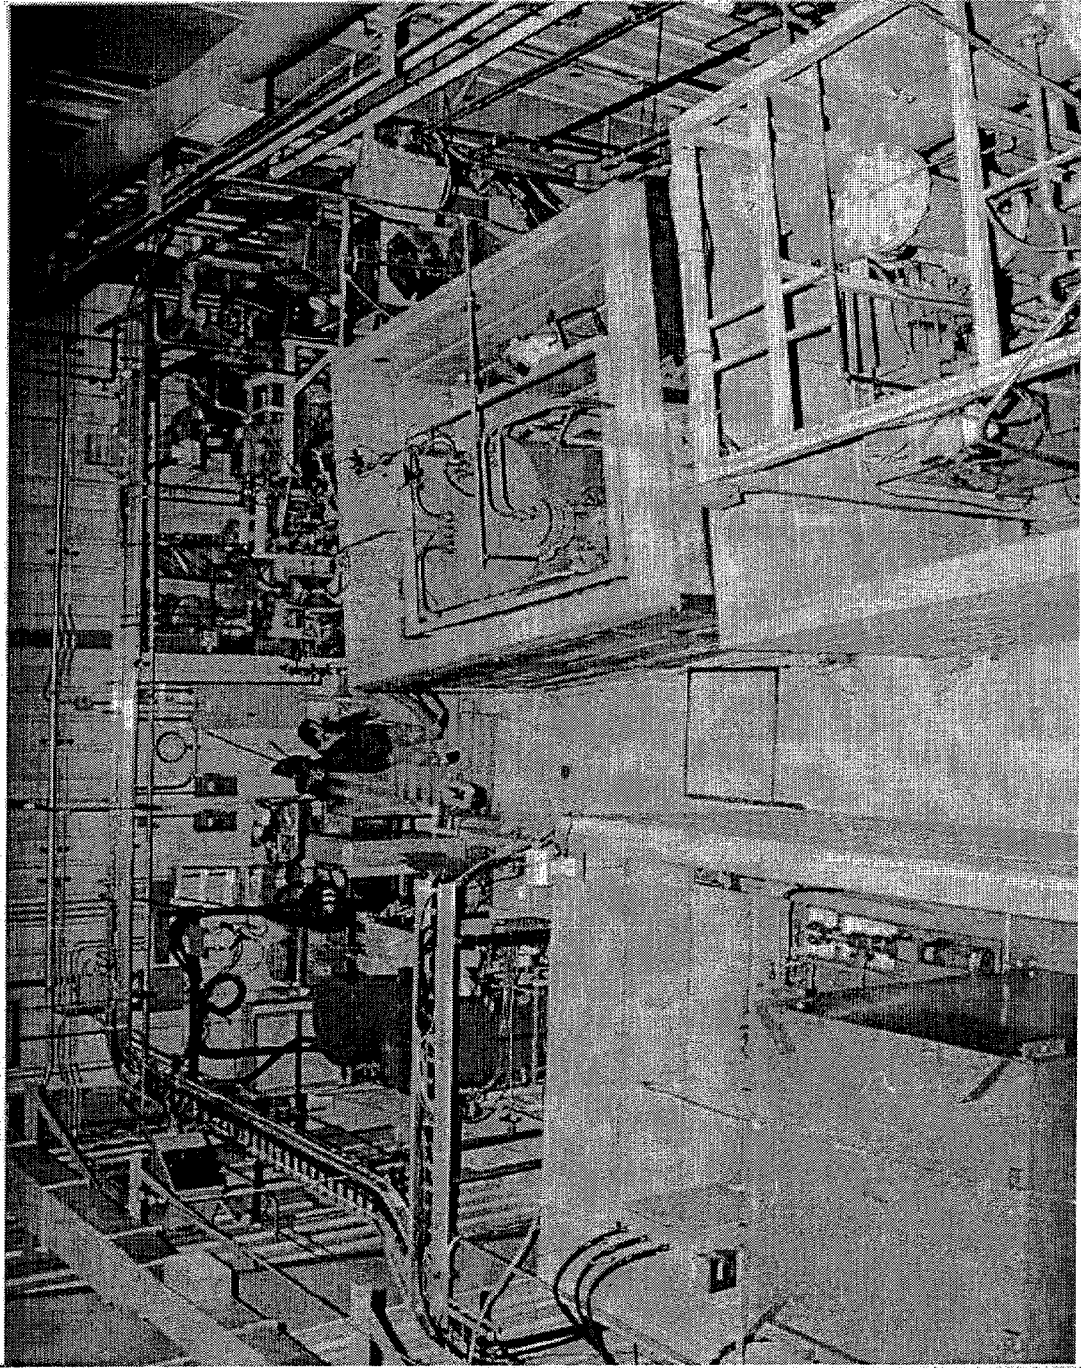
**Fig. 5. Overhead view of the OTE evaporator skid, OTE feed skid, CsR feed skid, and CsR ion-exchange skid after installation had been completed.**

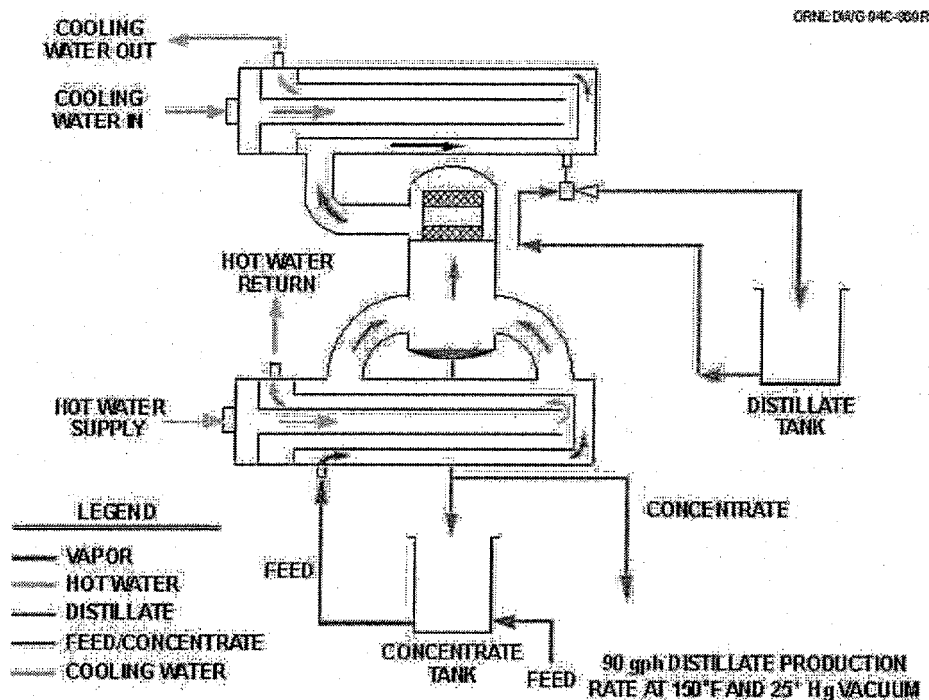
**Fig. 6. Schematic diagram showing the four basic loops for the OTE system: the heating loop, the cooling loop, the distillate loop, and the concentrate loop.**

Operation of the distillate loop provided several services to the overall unit process: system vacuum, seal water flow for concentrate recycle, reflux spray, unit rinsing, and distillate discharge to a holding tank. The distillate was pumped from a distillate recycle tank through eductors [serving as vacuum pumps pulling a vacuum on the shell, separator, and condenser assembly) and then back to the distillate tank.

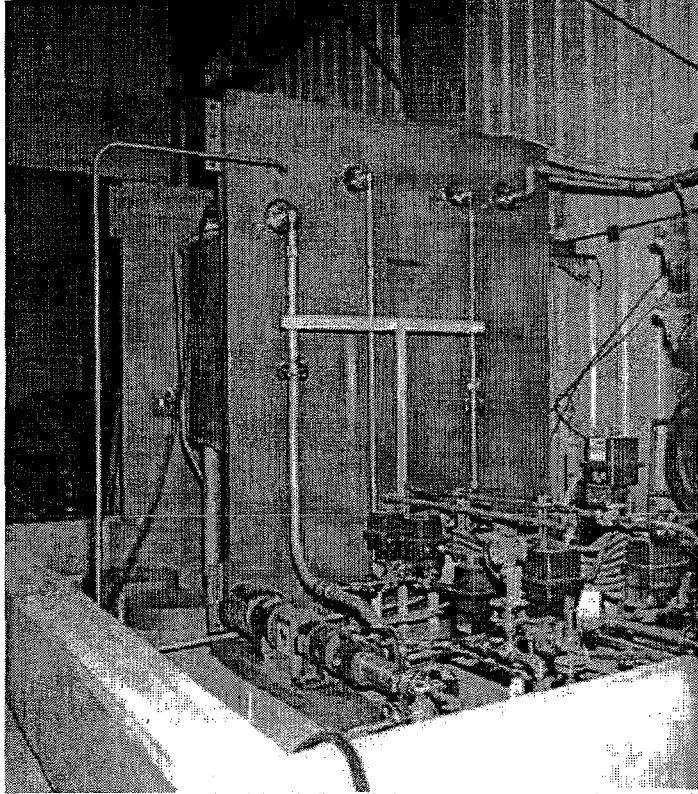
**Fig. 7. Photograph of the CsR feed skid during installation of the feed tank shielding.**

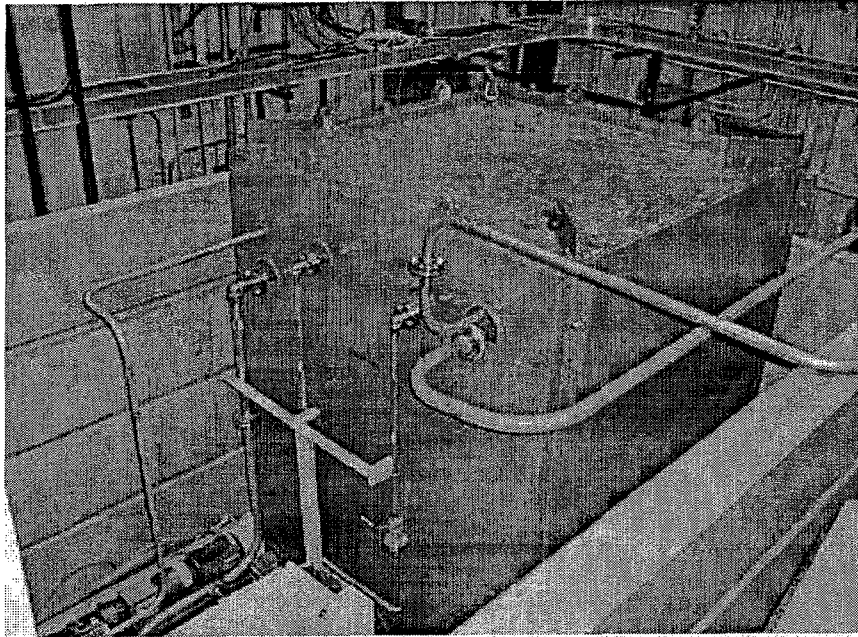
**Fig. 8. Photograph of the feed tank skid with all shielding installed.**

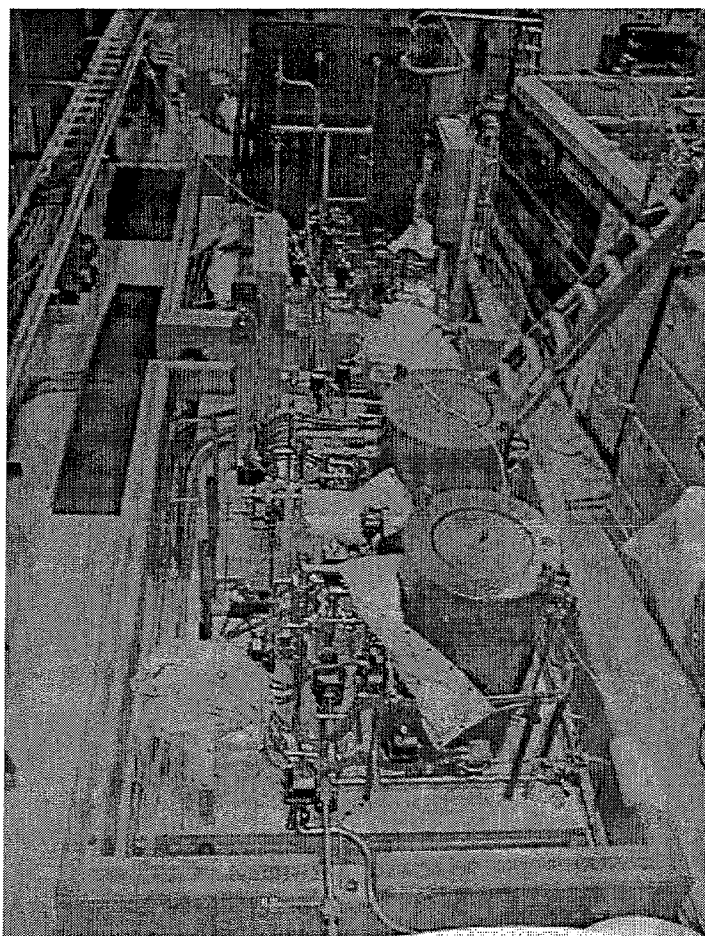
**Fig. 9. Photograph of the ion-exchange skid showing the shielded ion-exchange columns during installation.**

A photograph of the ion-exchange skid is presented in Fig. 9. The ion-exchange skid contained a 25- $\mu$ m stainless steel, back-washable filter (F-1), two ion-exchange vessels, (X- 1 and X-2)) and all associated piping and controls. Piping and controls were provided so that the CsR columns could be operated independently, in series with either column in the lead position, or in parallel. The piping also allowed for bypass of the filter unit if desired. Top connections were used for both the filter housing and the columns for access when shield modules were in place. The ion-exchange vessels, with 30-cm inside diameter and 97-cm height (12 x 38in.), were fabricated from 316L stainless steel and rated for 150 psig. The columns were supplied with 100-mesh Johnson screen outlet collectors. The filter and ion-exchange columns were surrounded by cylindrical shield units providing 5 3/8- and 5 1/2-in. thickness of lead shot encased in 1/4-in. rolled plate. The tops of the filter and ion-exchange columns were shielded with 4-in. thick steel plate. The CsRD system was designed so that the filter or columns could be remotely removed with or without the shielding in place. (Prior to the remote operation, process personnel would have to enter the process building to release the quick disconnects located external to the vessel shielding.) An automated sampling system was used to remotely collect liquid samples from the filter inlet and from the inlet and effluent of both columns.

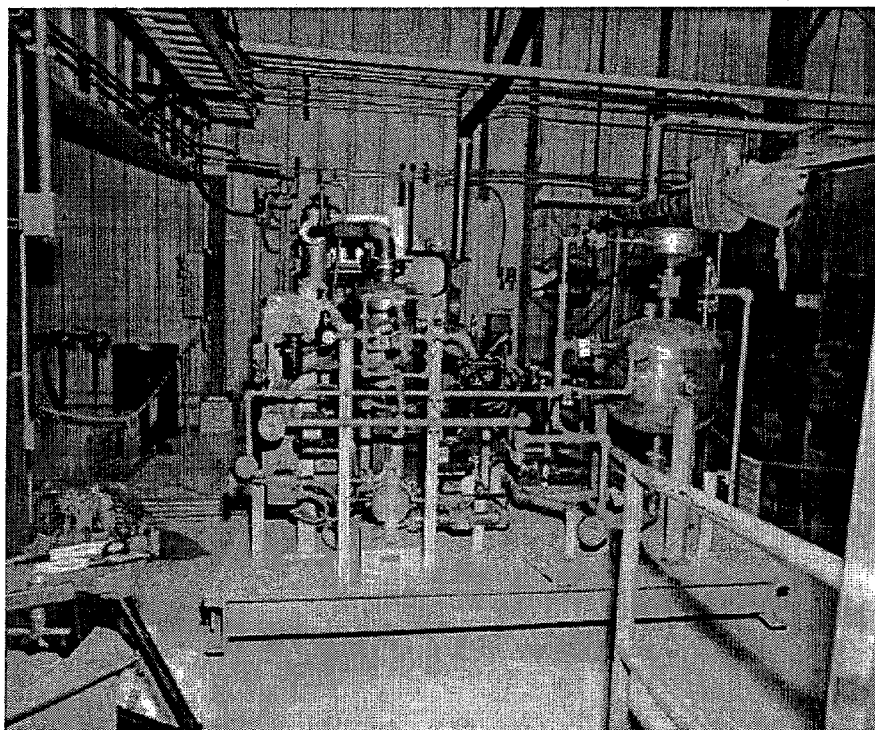
**Fig. 10. Photograph of the sorbent-slucing/drying skid.**

A photograph of the sorbent sluicing/drying skid is presented in Fig. 10. Using this skid, the fresh sorbent (IE-911) was sluiced into the ion-exchange columns and the exhausted, cesium-loaded sorbent was containerized and dewatered for disposal. The sorbent sluicing/drying skid contained a stainless steel sorbent loading tank (TK-2), which was ~50-cm outside diameter and -60 cm in height. The TK-2 vessel was designed and rated for pressures up to 150 psig to allow for pressurized transfer of slurries of water and IE-911. In the initial design and demonstration, the spent sorbent was sluiced and dewatered, using this system, in modified 30-gal stainless steel drums. The initial plans required the use of these drums for transporting all of the spent sorbent to SRS for vitrification studies. Prior to the WTP operations, the CsR system was modified to use stainless steel, high-integrity containers (HICs) with a capacity of 65 ft<sup>3</sup> for the receiving, drying, and storage of the spent sorbent., These HICs were designed and constructed by TTI Engineering and were designed to meet the Waste Package Criteria, as specified in the NTS WAC, Revision 1, excluding Sects. 3.2.5, 3.2.7, 3.2.9, and 3.2.10. In addition, they were excluded from the stacking requirements in Sect. 3.2.3.

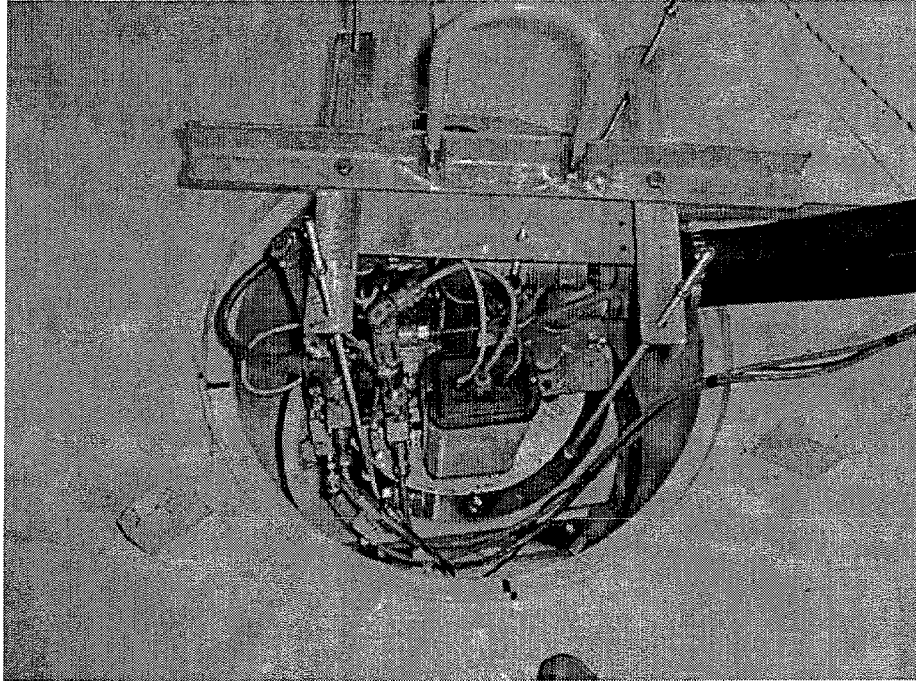
**Fig. 11. Photograph of the fill head installed on the shielded high-integrity container.**

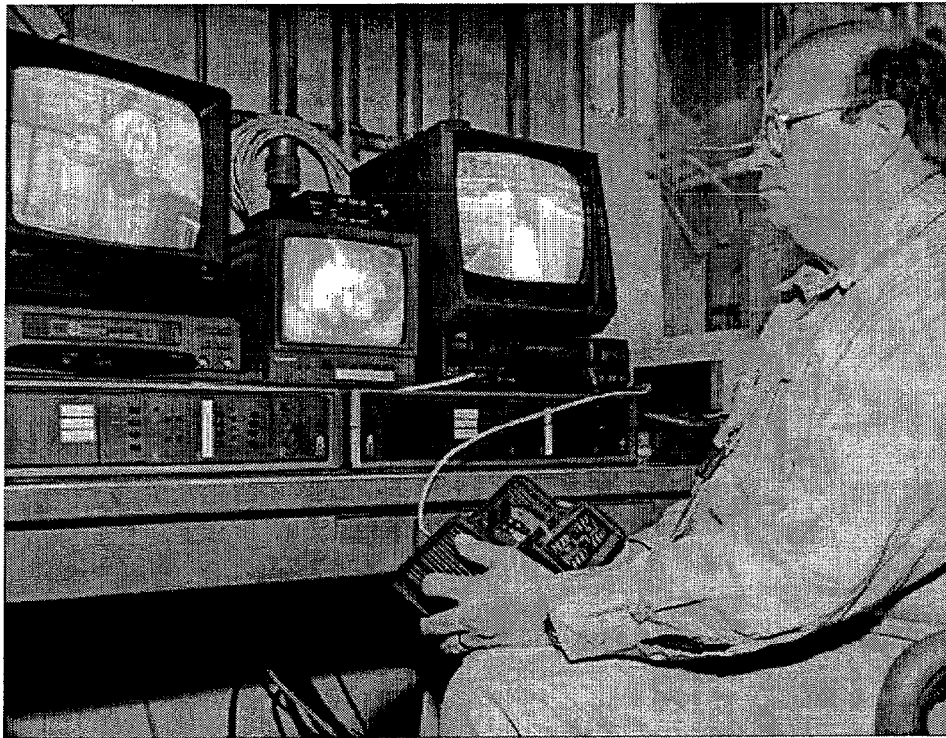
**Fig. 12. Photograph taken during remote operations with the overhead crane.**

The HIC was placed inside a concrete cask for shielding purposes prior to the introduction of radioactive materials. A photograph of the cask is presented in Fig. 13. It was constructed from reinforced concrete, except for the 30-in. access cover, which was steel/concrete. The walls, top, and bottom were 21 in. thick. The cask had an internal volume of 95 ft<sup>3</sup> and was designed to accept an HIC with a maximum diameter of 58 in., a maximum height of 59 in., and a maximum weight of 5000 lb. The access cover to the cask could be attached by use of the overhead remote crane located in Building 7877.

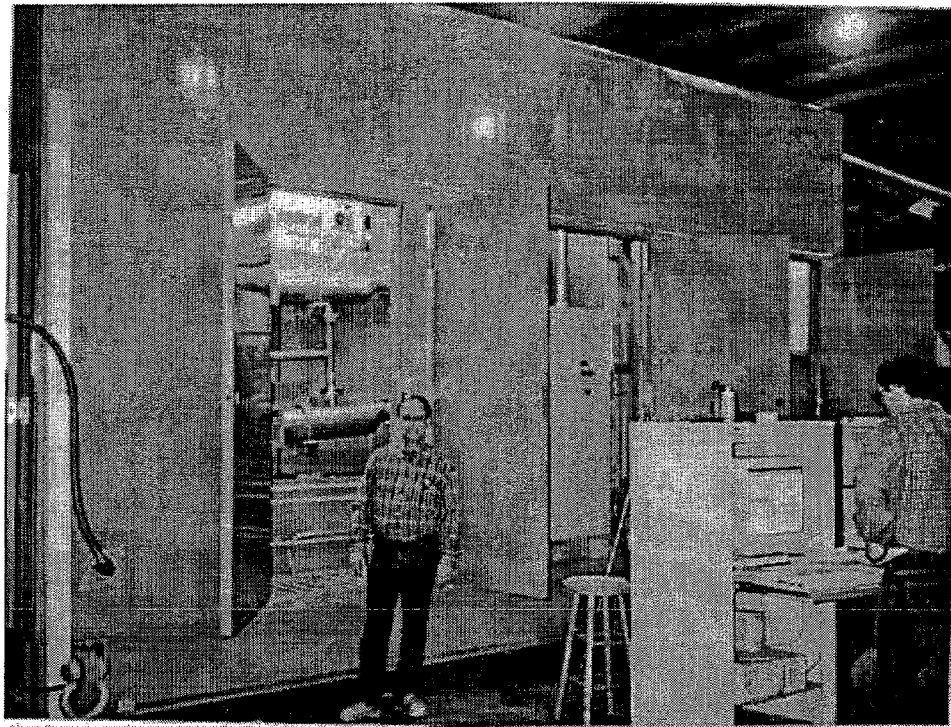
**Fig. 14. SLS system during acceptance testing at the NUMET facility.**

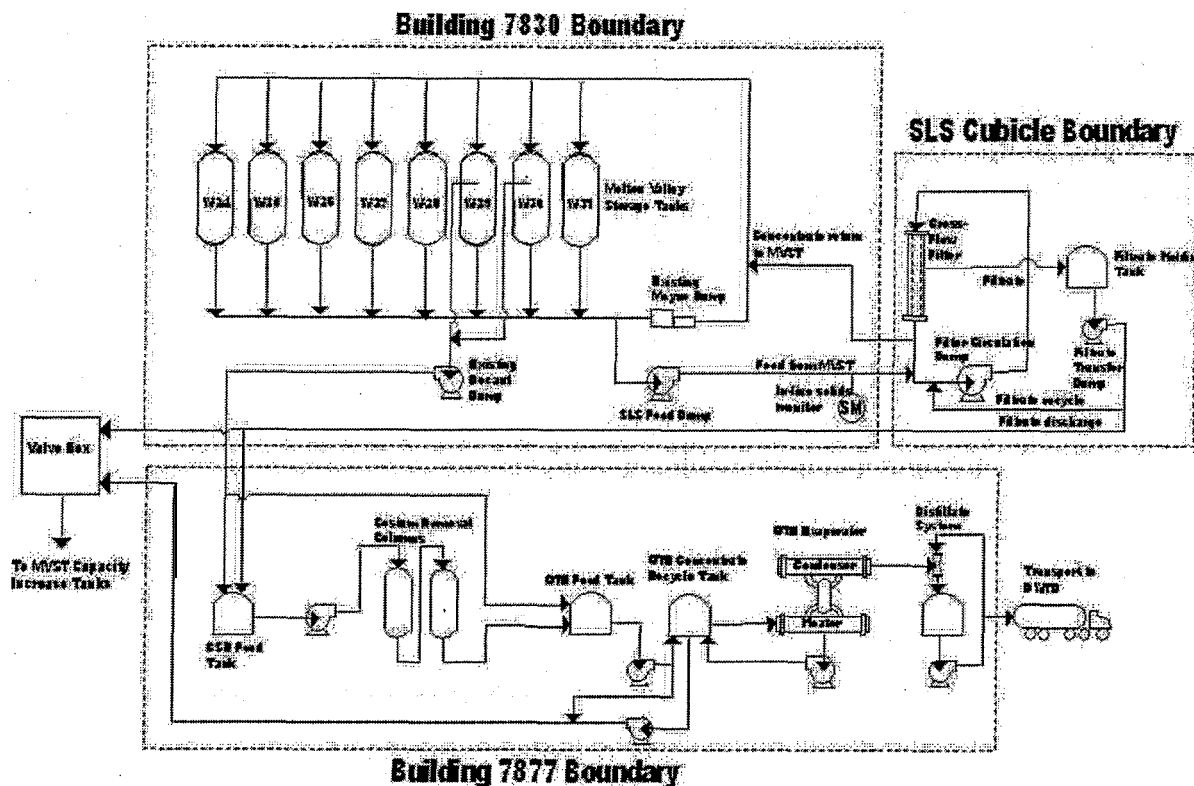
Fig. 19. Schematic drawing of the WTP system.

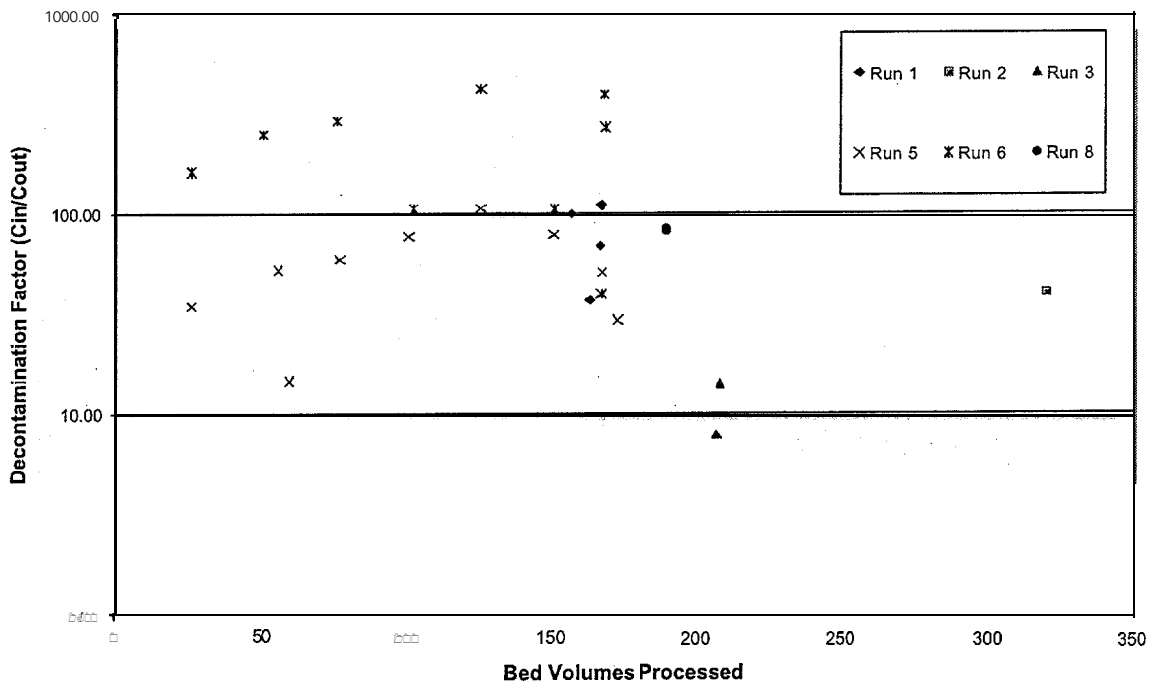
**Fig. 20. Graph of the decontamination factors for the CsR system for the WTP operational campaigns.**

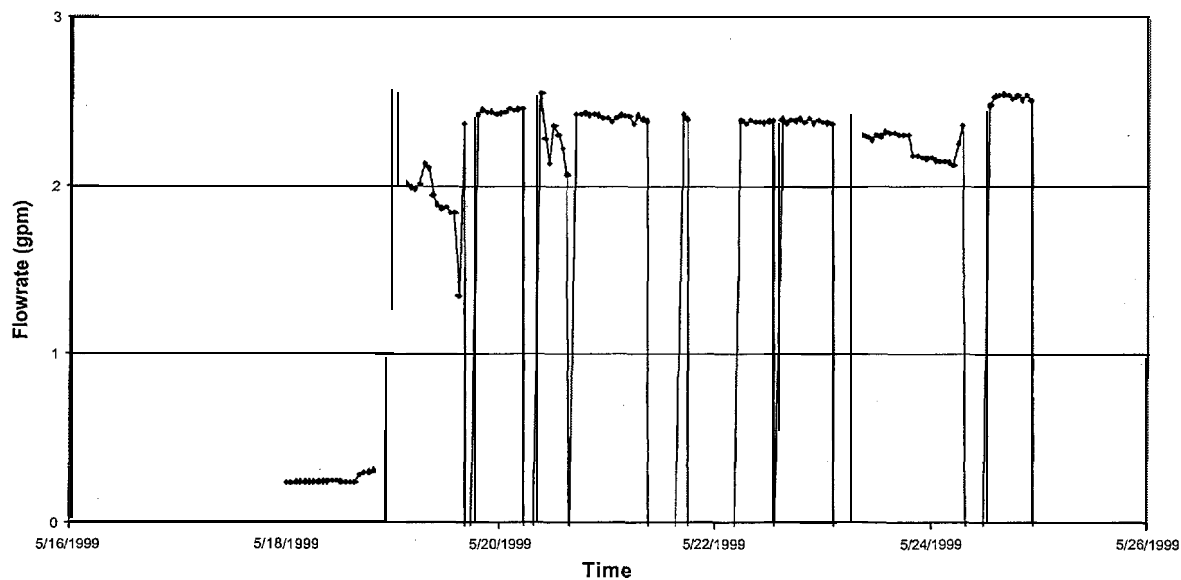
**Fig. 21. Flow rate for the WTP system as a function of time for the first WTP operational campaign.**

discovered on the input module of the OTE local maintenance panel. This connection was repaired, and radioactive supernatant was introduced to the CsR system at 2300 h on May 18. The flow-rate with time for the first campaign is presented in Fig. 21, and the pressure drop through the filter and two ion-exchange columns is presented in Fig. 22. The flow-rate through the ion-exchange columns was maintained at 2 gal/min for the first 18 h of operation and raised to 2.5 gal/min for the remainder of the run. Immediately after startup, the pressure drop across the first column, X-1, started to increase and, after 9 h of operation, had reached 32 psig. Over the next 6 h, the pressure drop had increased to >36 psig and the control system was issuing periodic high-pressure warnings because the maximum pressure drop across the columns was approaching the maximum allowable limit of 50 psig. As a result, X-1 was backwashed in an attempt to reduce the pressure drop across the column. Immediately after backwashing, the pressure drop across the column fell to less than 5 psig. It is speculated that the pressure drop increase was the result of solids precipitating from solution as the pH of the sorbent reached equilibrium with the supernatant being processed. After the pH of the sorbent and supernatant reached equilibrium, no additional precipitation occurred and no increase in the pressure drop across the columns was noted.

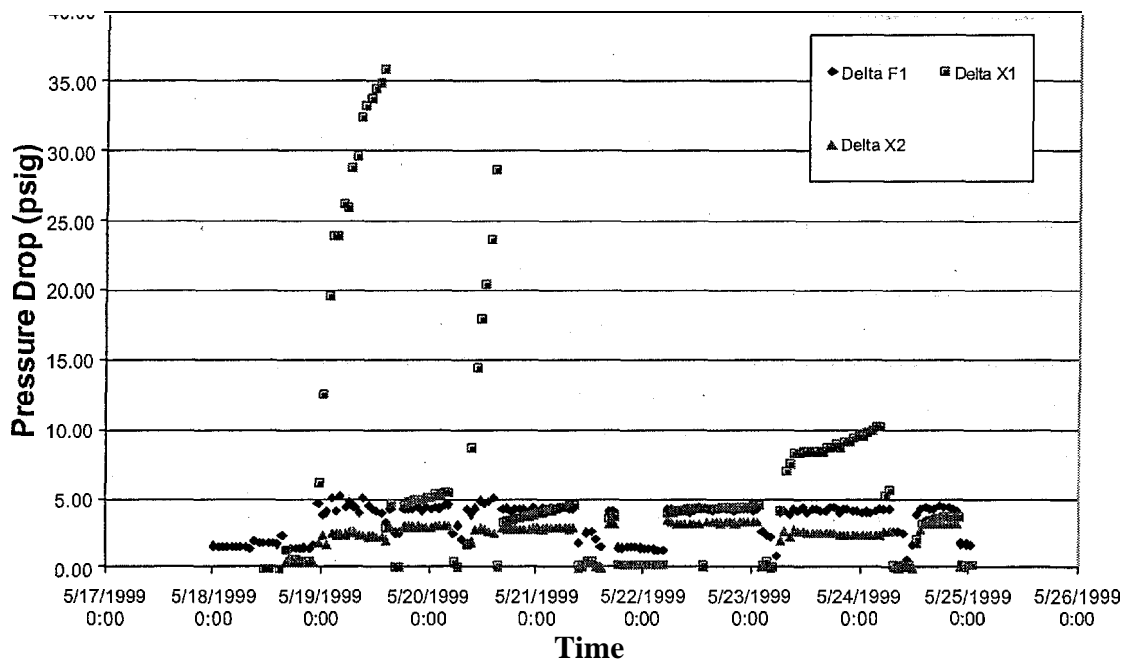
**Fig. 22. Pressure drop through the CsR prefilter and ion-exchange columns during the first WTP operational campaign.**

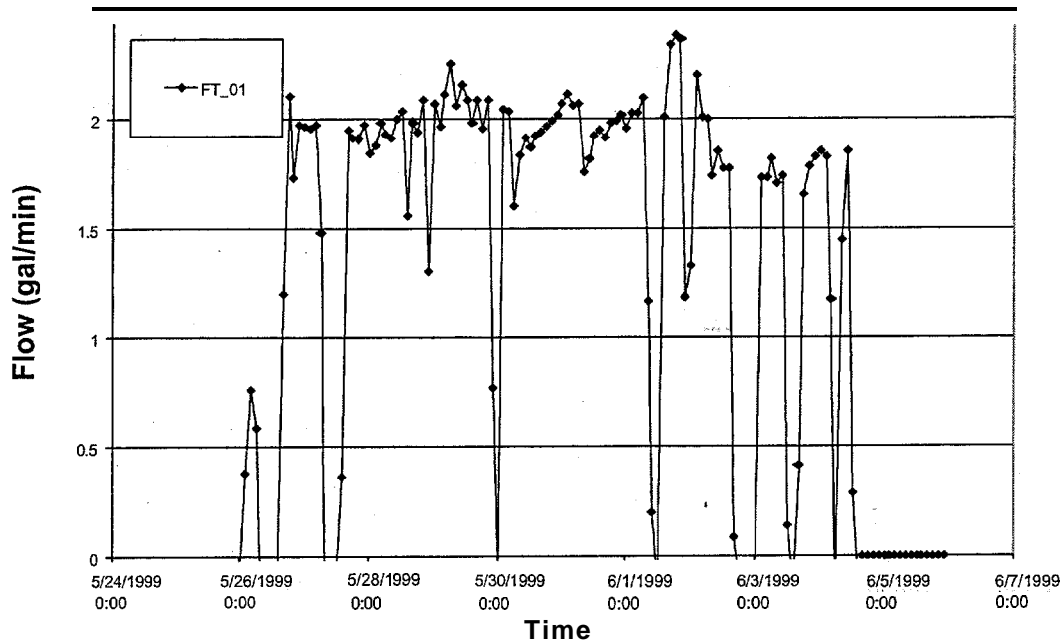
Fig. 23. Flow rate through the WTP system as a function of time for the second WTP campaign.

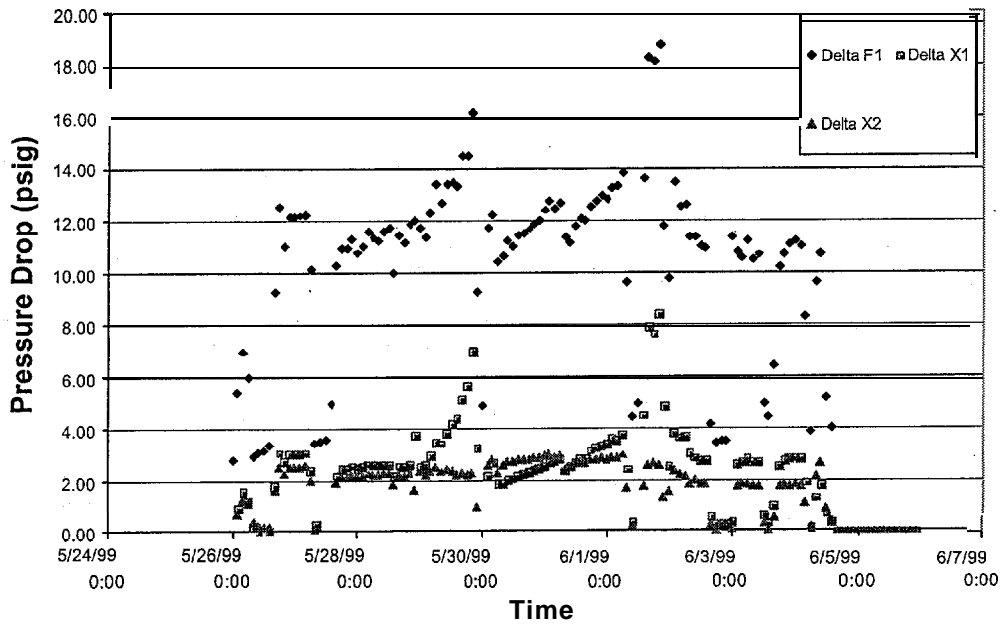
Fig. 24. Pressure drop through the CsR prefilter and ion-exchange columns during the second WTP operational campaign.

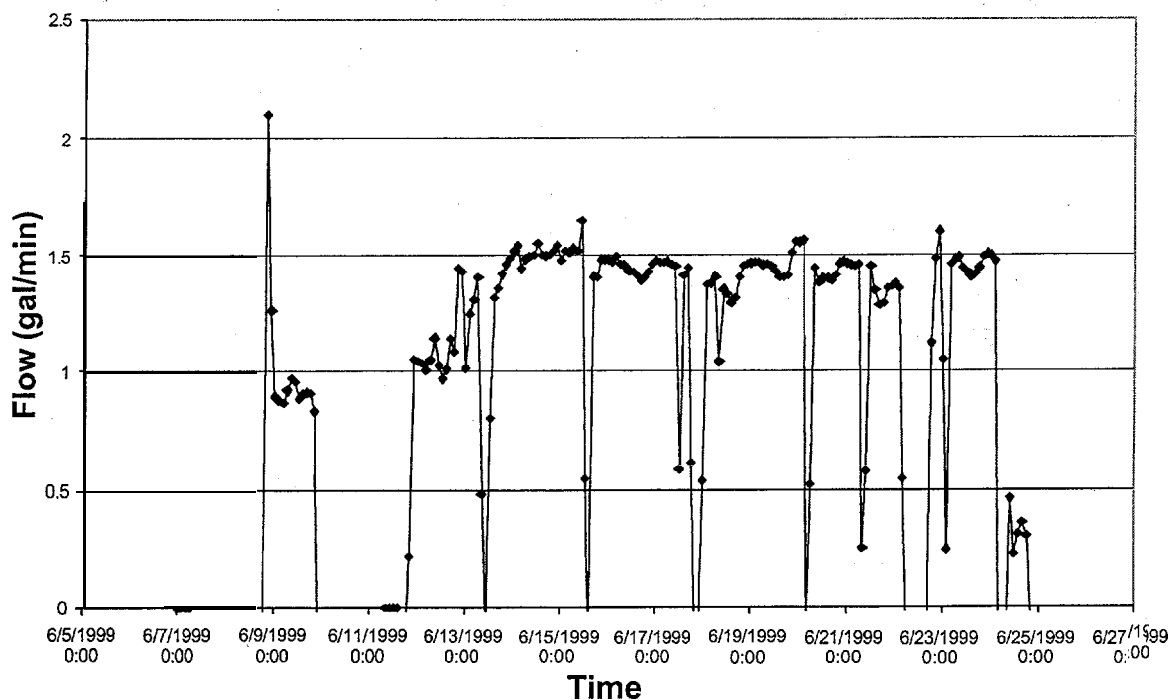
**Fig. 25. Flow rate through the WTP system as a function of time for the third WTP operational campaign.**

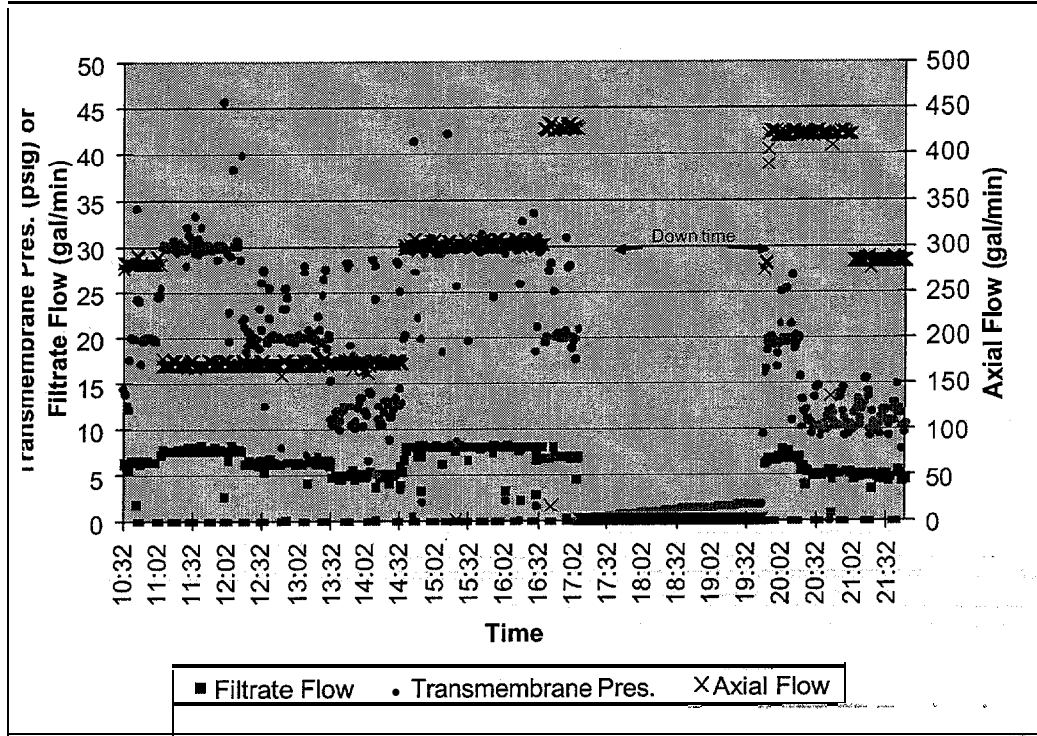
Fig. 26. Filtrate flow, transmembrane pressure, and axial flow as a function of time during the third WTP Campaign (Series 1, tests 1-7, tank W31).

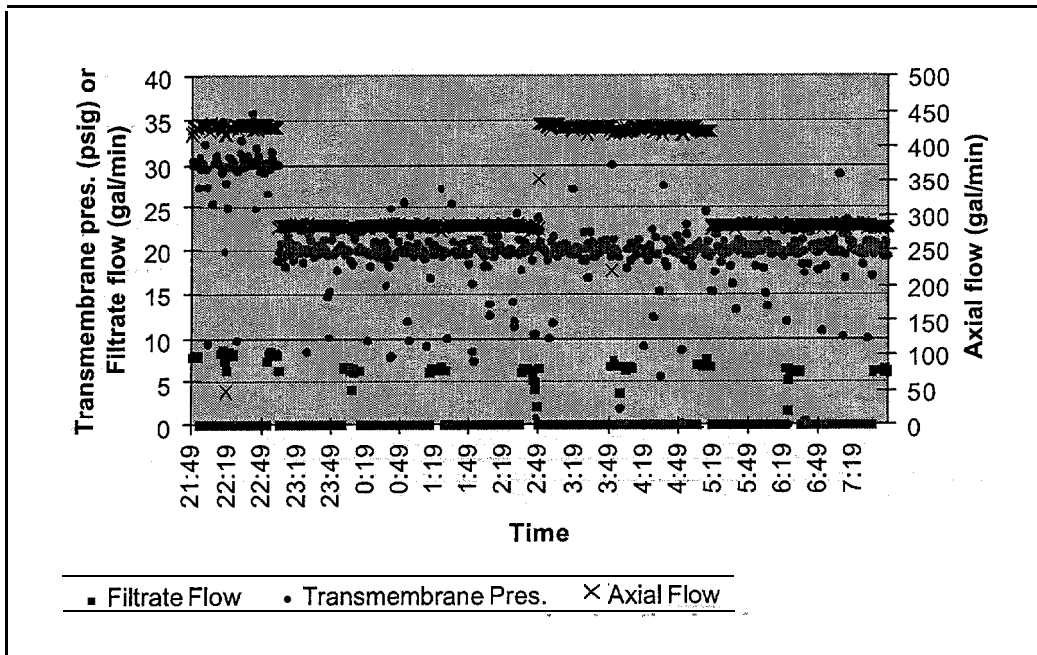
Fig. 27. Filtrate flow, transmembrane pressure, and axial flow as a function of time during the third WTP Campaign (Series 1, tests S-12, tank W31).

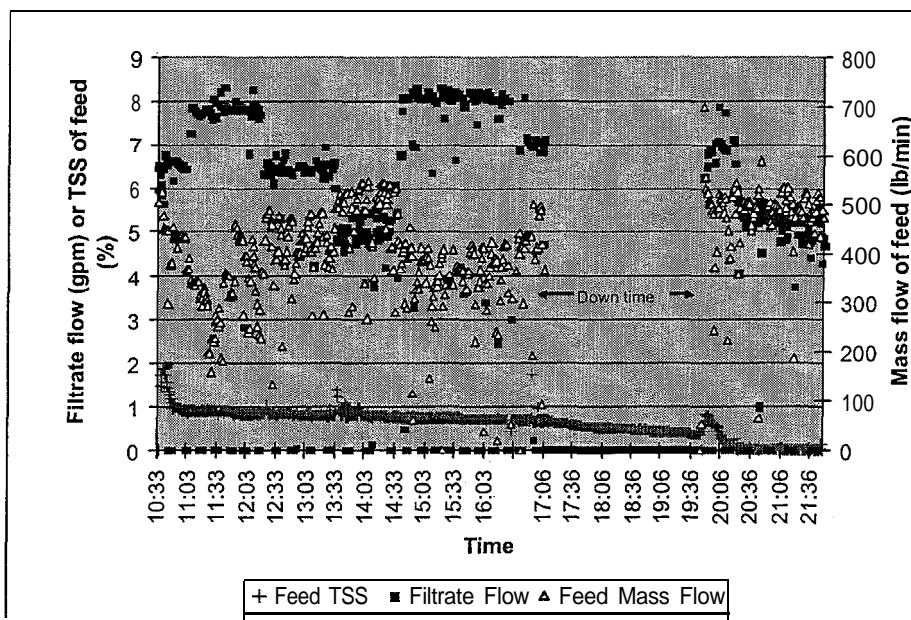
Fig. 28. Filtrate flow, feed TSS, and feed mass flow as a function of time during the third WTP Campaign (Series 1, tests 1-7, tank W31).

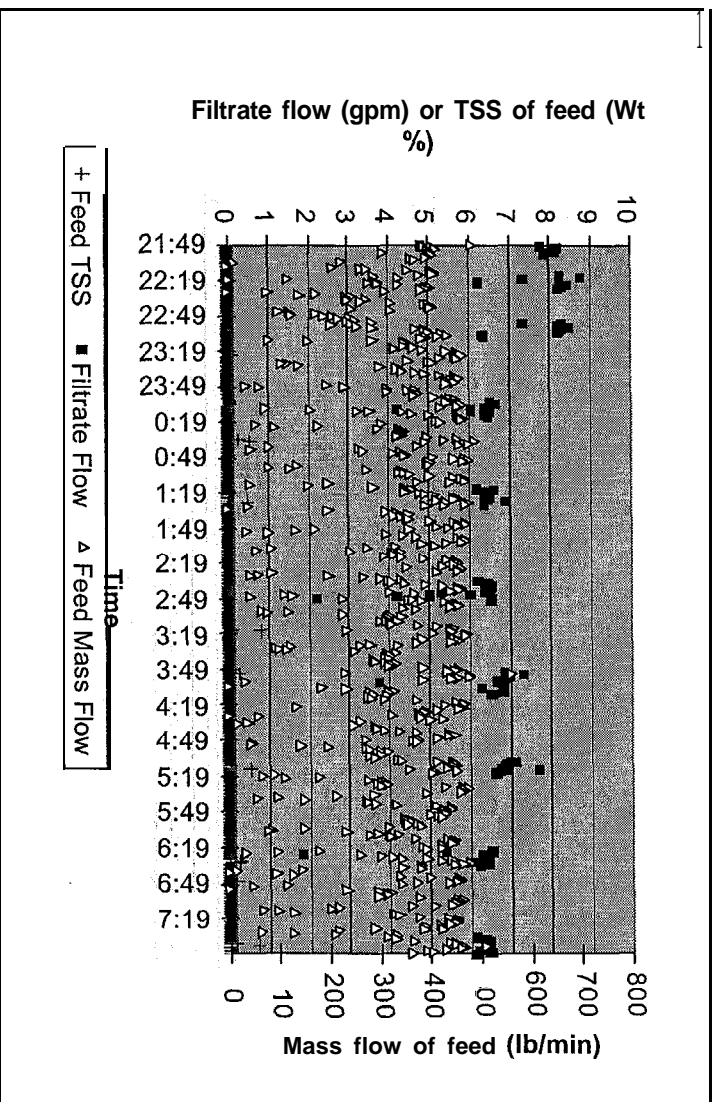
Fig. 29. Filtrate flow, feed TSS, and feed mass flow as a function of time during the third WTP Campaign (Series 1, tests 8-12, tank W31).

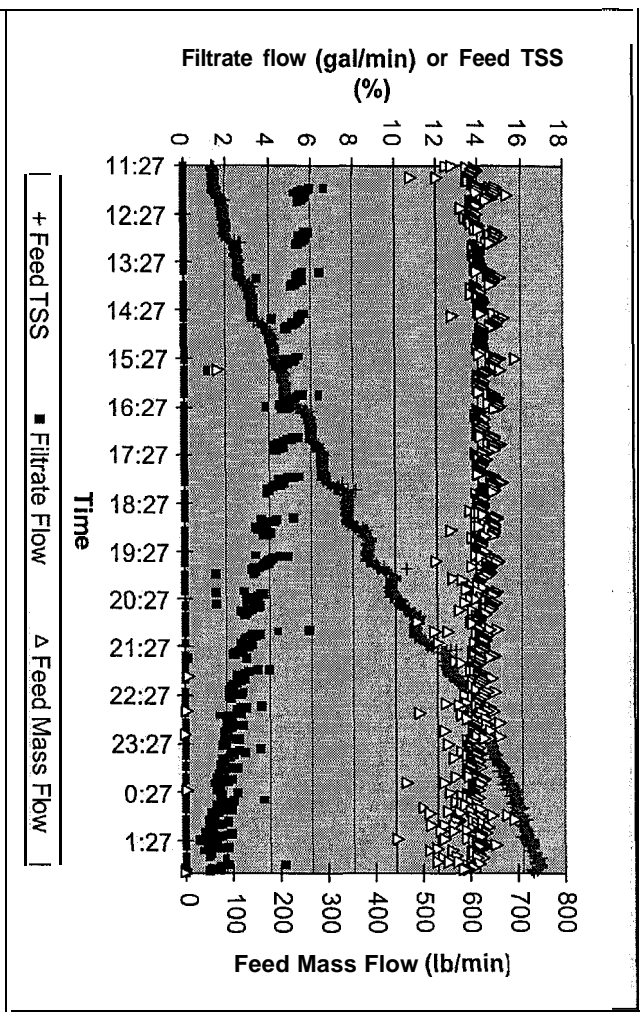
Fig. 30. Feed TSS, filtrate flow, and feed mass flow as a function of time near the end of processing tank W31 for the third WTP Campaign.

On June 23, the UDS content of the feed began a steady increase, rising from 1.5 to 16.7 % over a 14-h period. Operational data for the SLS system during this period is presented graphically in Fig. 30 and 31. The increasing UDS concentration and corresponding increase in feed density resulted in a filtrate flow reduction from 6 to 1 gal/min ( $0.12$  to  $0.02 \text{ gal min}^{-1} \text{ ft}^{-2}$ ). This increase in solids content was caused by the gradual collapse of the depression in the sludge surrounding the SLS suction pipe in W3 1. When UDS concentrations in the feed increased to 22%, the third campaign was terminated and draining/flushing of the SLS system was initiated. Problems were encountered during the draining and flushing operations due to the flow characteristics of the heavy sludge. These problems have been detailed in a previous report.<sup>8</sup>

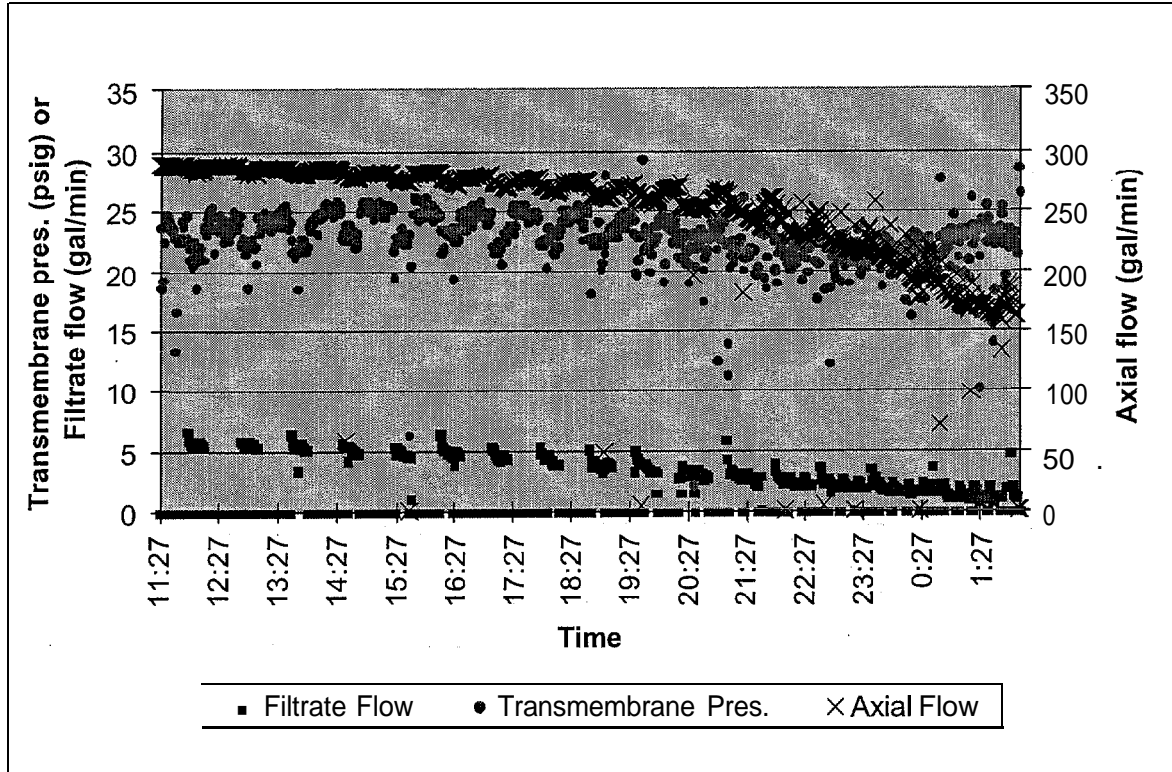
Fig. 31. Filtrate flow, axial flow, and transmembrane pressure as a function of time near the end of processing for tank W31 during the third WTP Campaign.

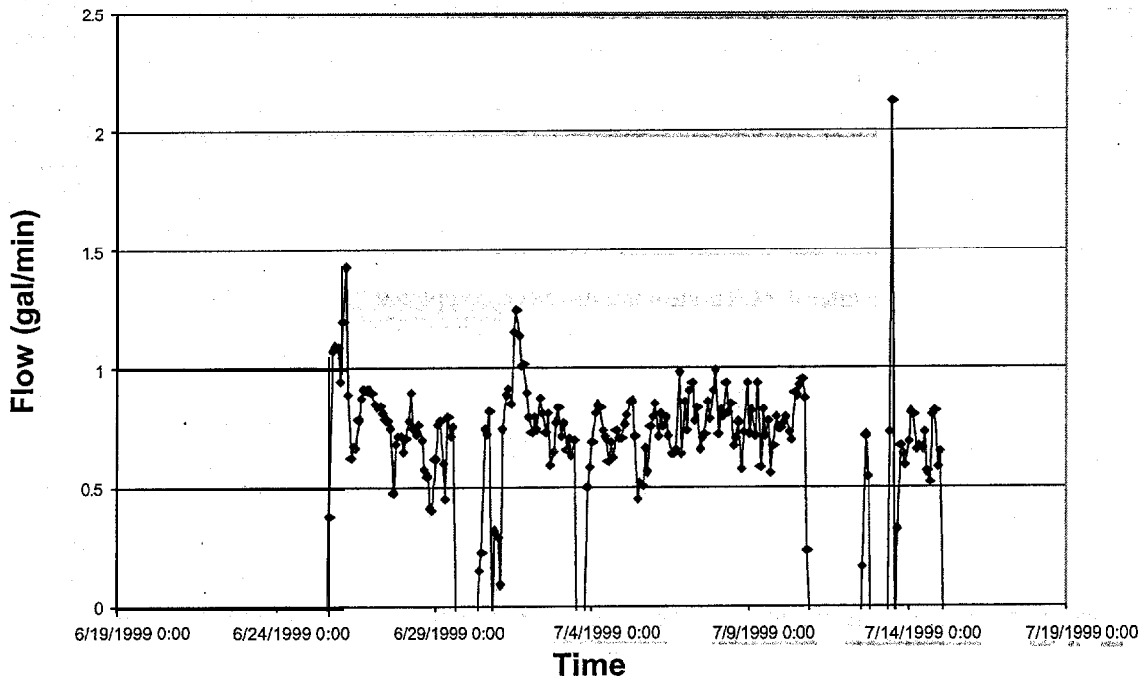
**Fig. 32. Flow rate through the WTP system as a function of time for the fourth WTP operational campaign.**

The fourth WTP campaign utilized only the OTE system. MVST W29 had a nitrate concentration of 150,000 mg/L (2.4  $M$ ). The volume reduction for the OTE was set at 63% when the run was initiated to obtain a nitrate concentration of 6.5  $M$  in the evaporator bottoms. In summarizing this campaign, the operational period lasted 467 h (19.5 days), with -63 h (2.6 days) of downtime. All of the downtime for this campaign was associated with operational or equipment problems. Foaming of supematant during processing was the principal cause of operational difficulties. The adverse consequences of foaming included level control difficulties for process vessels, poor distillate quality, scaling of heat exchange surfaces, and subsequent overall system control problems. These problems reduced the throughput of the evaporator to 0.6–0.8 gal/min, as shown in Fig. 32. During this campaign, 21,000 gal of LLLW was processed, 9800 gal of distillate was produced, and an overall volume reduction of 48% was achieved.
