# Wastewater Triad Project: Final Summary Report

ORNL/TM-2001/129

Nuclear Science and Technology Division

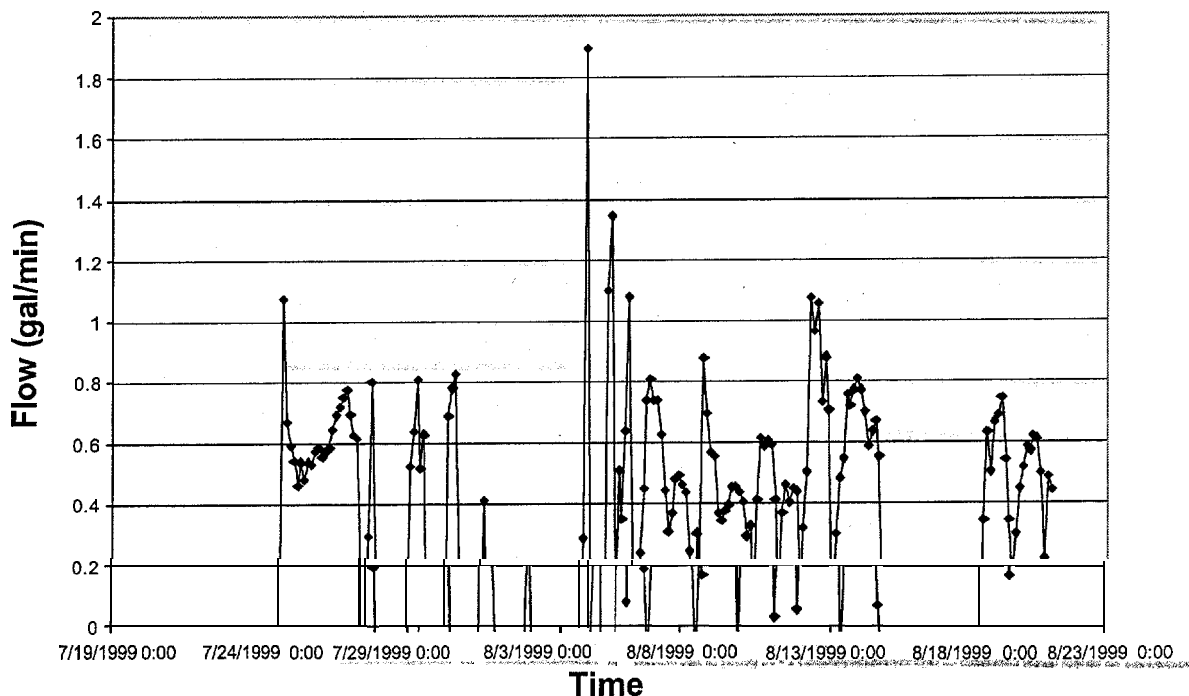
Fig. 33. Flow through the WTP system as a function of time for the fifth WTP campaign.

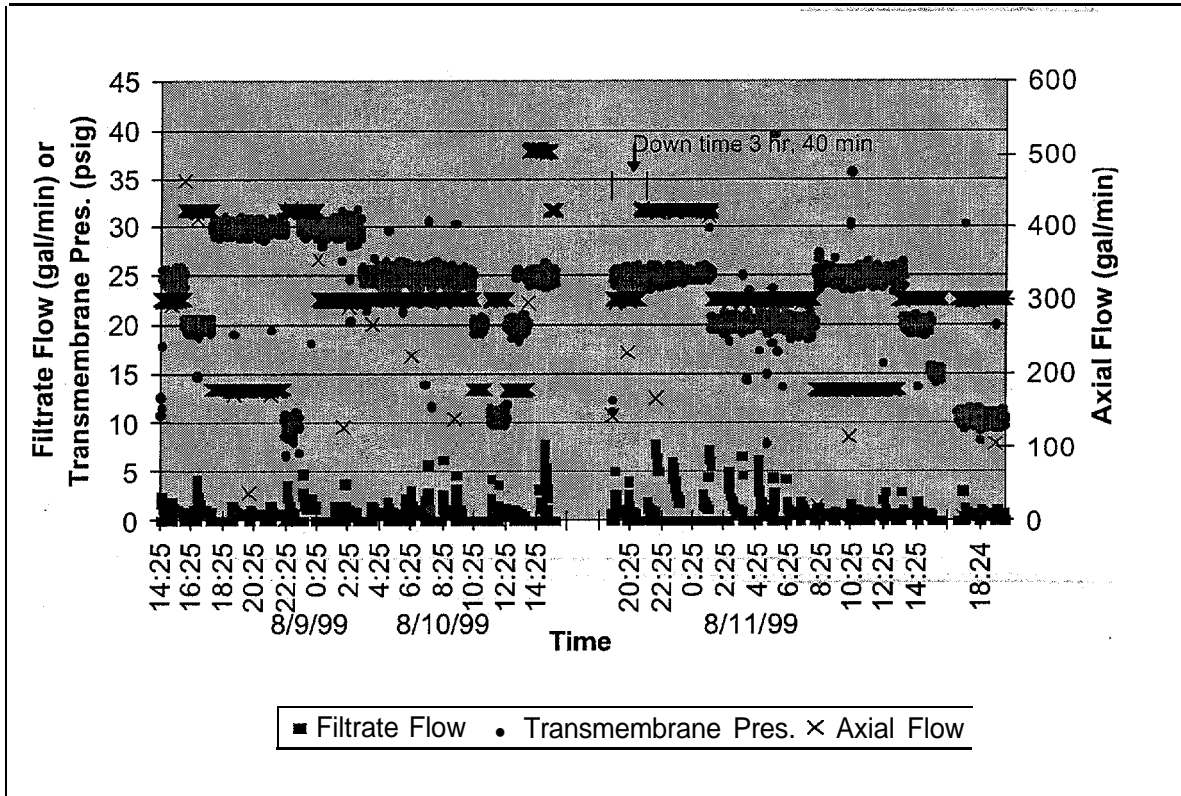
**Fig. 34. Filtrate flow, transmembrane pressure, and axial flow as a function of time during the fifth WTP Campaign (Test Series 2, tank W26).**

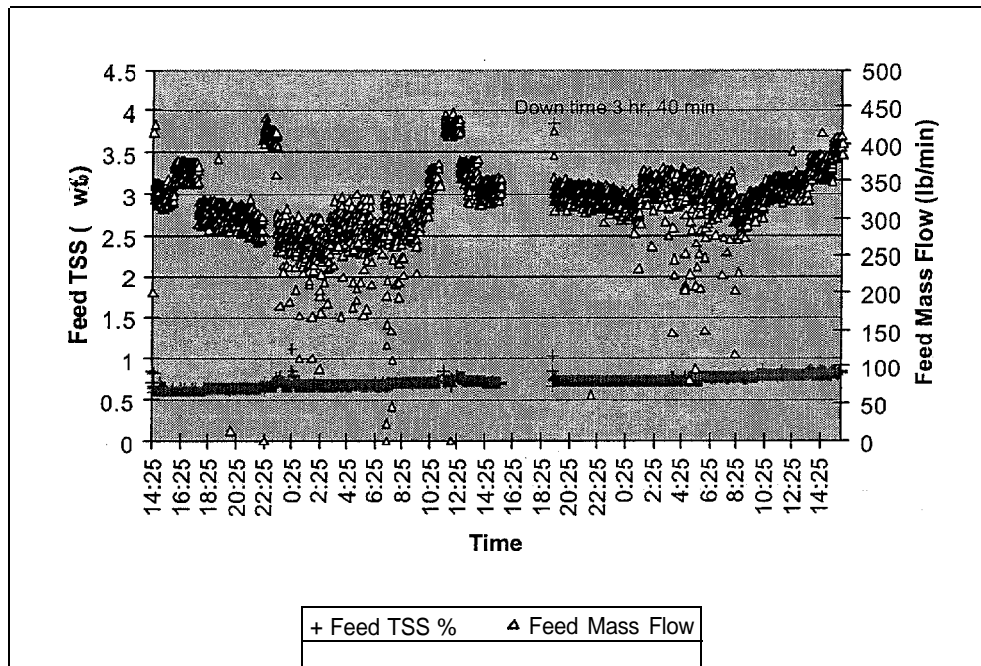
Fig. 35. Feed mass flow and TSS as a function of time during the fifth WTP Campaign (Series 2, tank W26).

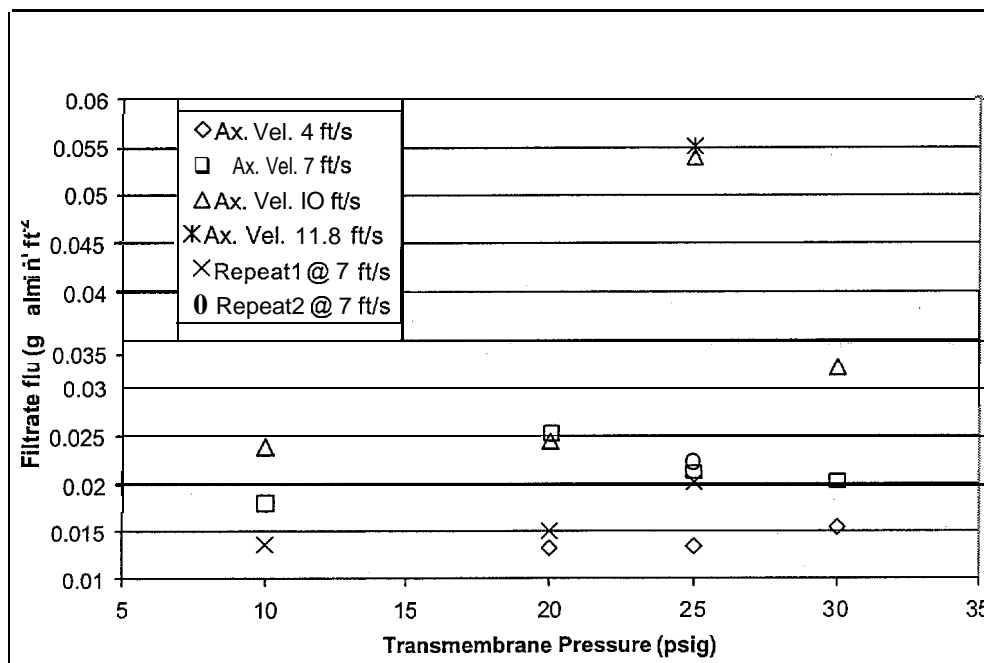
Fig. 36. Average filtrate flux as a function of transmembrane pressure during the fifth WTP Campaign (Test Series 2, tank W26).

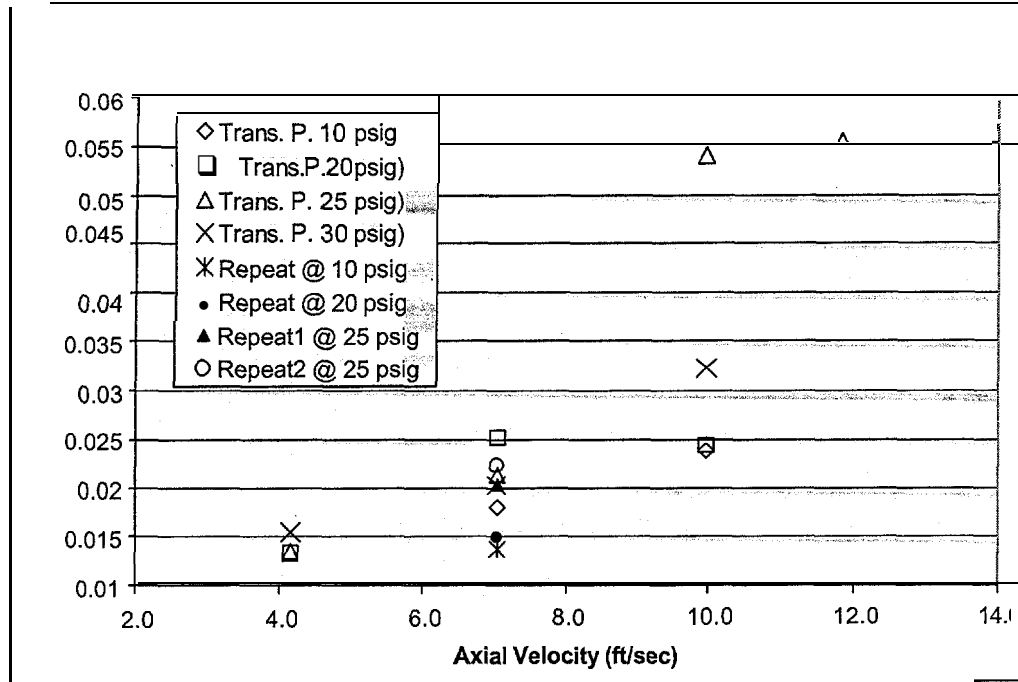
Fig. 37. Average filtrate flux as a function of axial velocity during the fifth WTP Campaign (Test Series 2, tank W26).

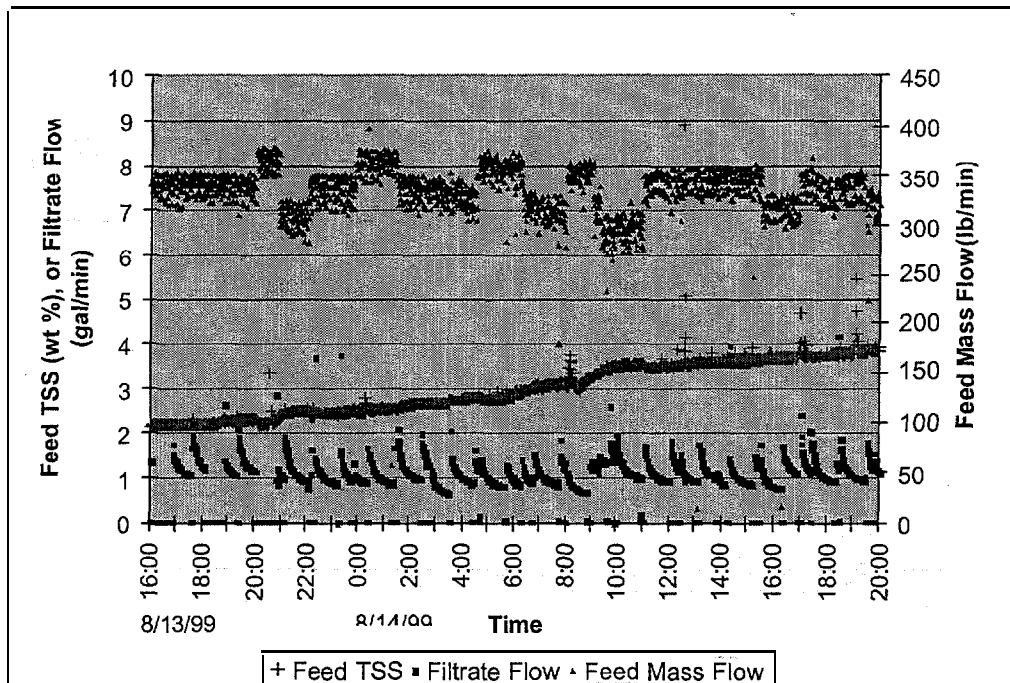
Fig. 38. Feed mass flow, feed TSS, and filtrate flow as a function of time during the fifth WTP Campaign (Test Series 3, tank W26).

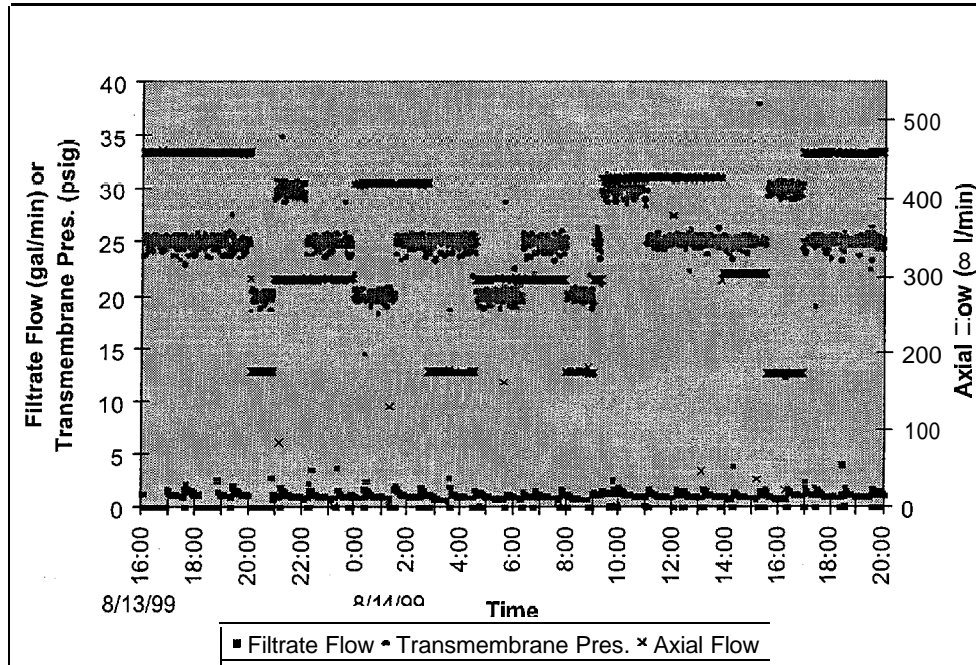
Fig. 39. Filtrate flow, axial flow, and transmembrane pressure as a function of time during the fifth WTP Campaign (Test Series 3, tank W26).

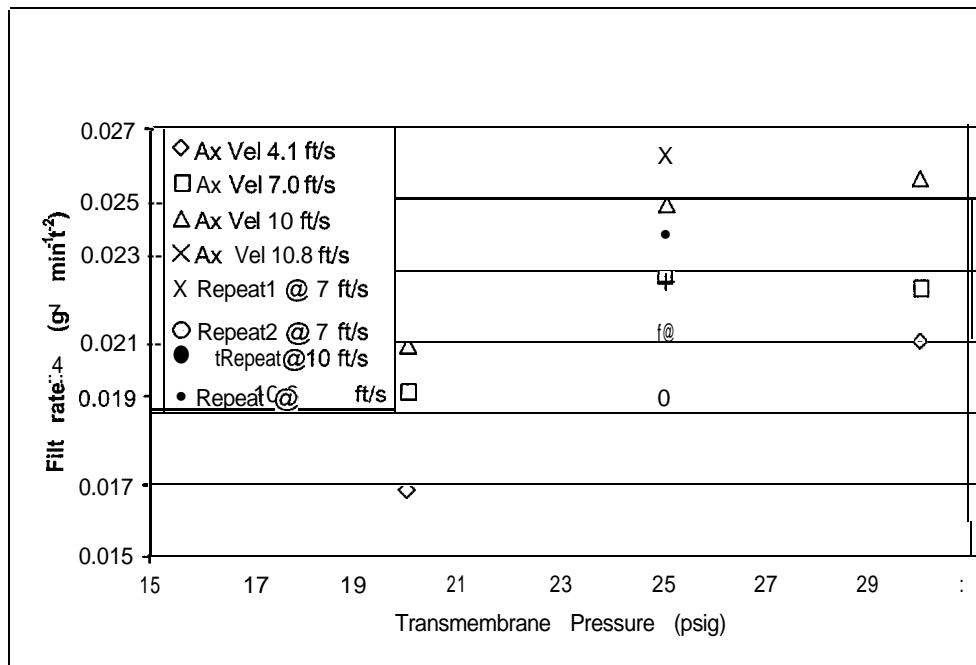
Fig. 40. Average filtrate flux as a function of transmembrane pressure during the fifth WTP Campaign (Test Series 3, tank W26).

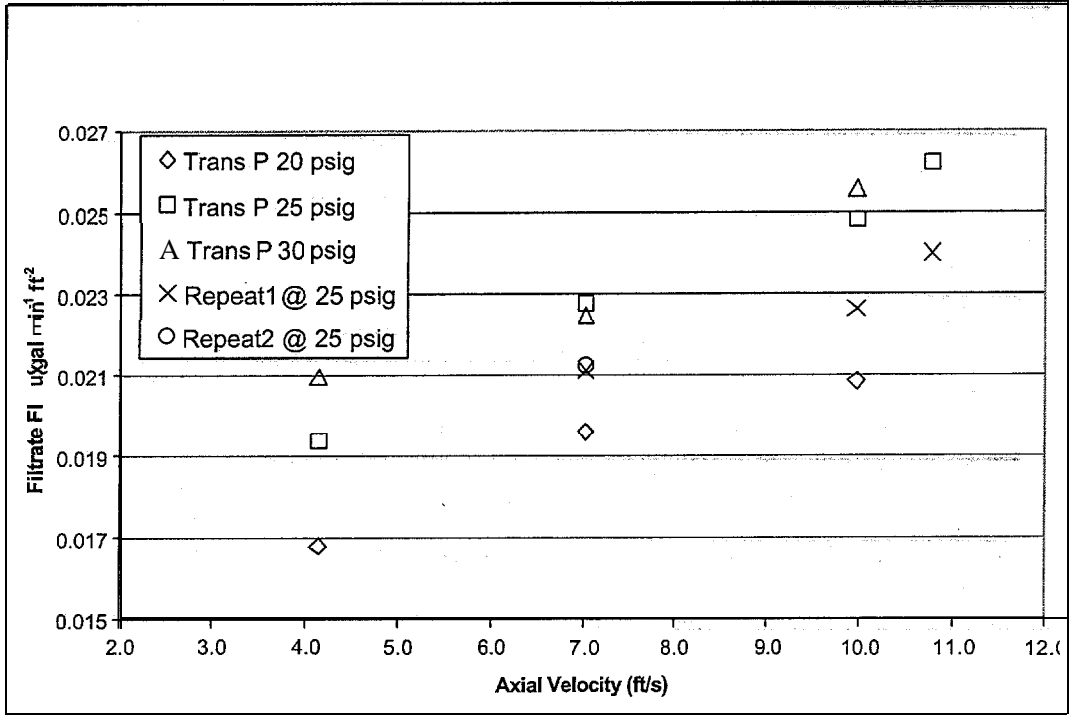
Fig. 41. Average filtrate flux as a function of axial velocity during the fifth WTP Campaign (Test Series 3, tank W26).

greater influence of transmembrane pressure on filtrate flux than was shown in the Series 2 tests. Figure 41 shows that increasing the axial velocity also increased filtrate flux by an amount similar to that caused by increasing the transmembrane pressure.

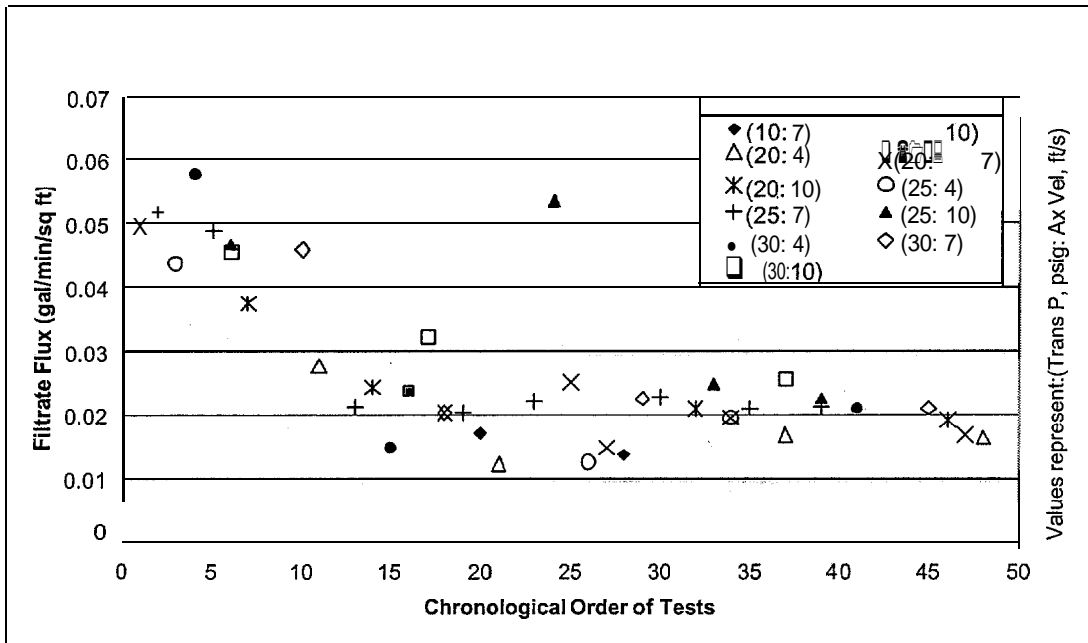
Fig. 42. Average filtrate flux as a function of test chronological order for tank W26 during the fifth WTP Campaign.

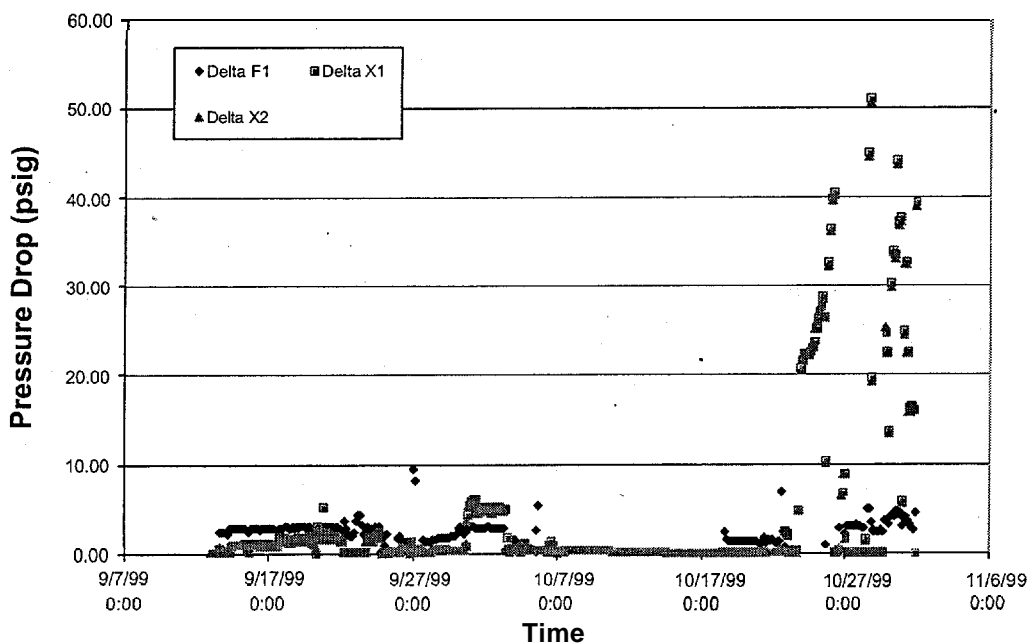
Fig. 43. Pressure drop across the prefilter and ion-exchange columns during the sixth WTP campaign.

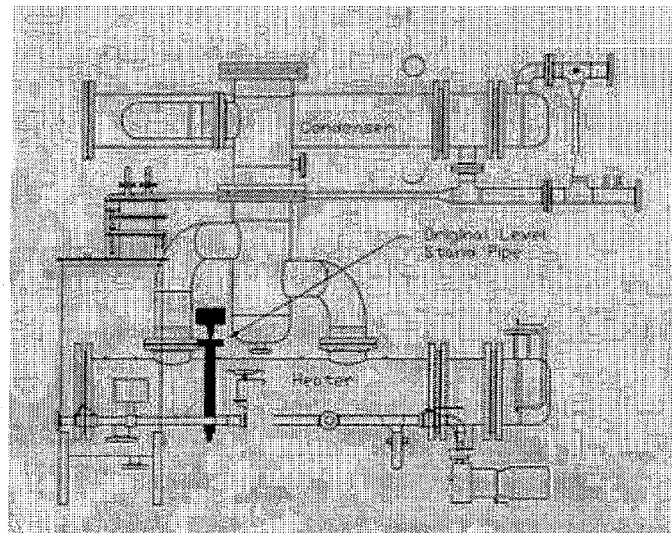
**Fig. 44. Front view of the OTE evaporator skid showing the location of the standpipe containing the instrument for monitoring the OTE shell level.**

The evaporator shell level control had been a recurring problem with the evaporator and was caused primarily by the design of the level instrument ports located on the evaporator shell extension. The evaporator shell level control had a cascading effect on the control of the rest of the system, so operational stability of the evaporator system as a whole was dependent on accurate level control in this vessel. Views of the evaporator shell with the level instrument configuration highlighted are shown in Figs. 44 and 45. The level float was placed in a 3-in.-diam standpipe piped to the top and bottom of the evaporator shell with  $\frac{3}{4}$ -in.-diam lines. Solids that had accumulated in the lines connecting the standpipe to the evaporator shell could not be removed by flushing and acid cleaning. Attempts to remove the solids using a plumber's auger were also unsuccessful. The 16-in.-diam flange and sight glass for the OTE evaporator shell were removed and replaced with a modified extension and new sight glass. A drawing of the extension is shown in Fig. 46. The extension added 11 in. to the evaporator length and included a standpipe located within the evaporator shell. The standpipe was open ended to prevent accumulation of solids. The liquid level float was moved to the new standpipe. This work was carefully planned to minimize radiation exposure to those performing the installation.

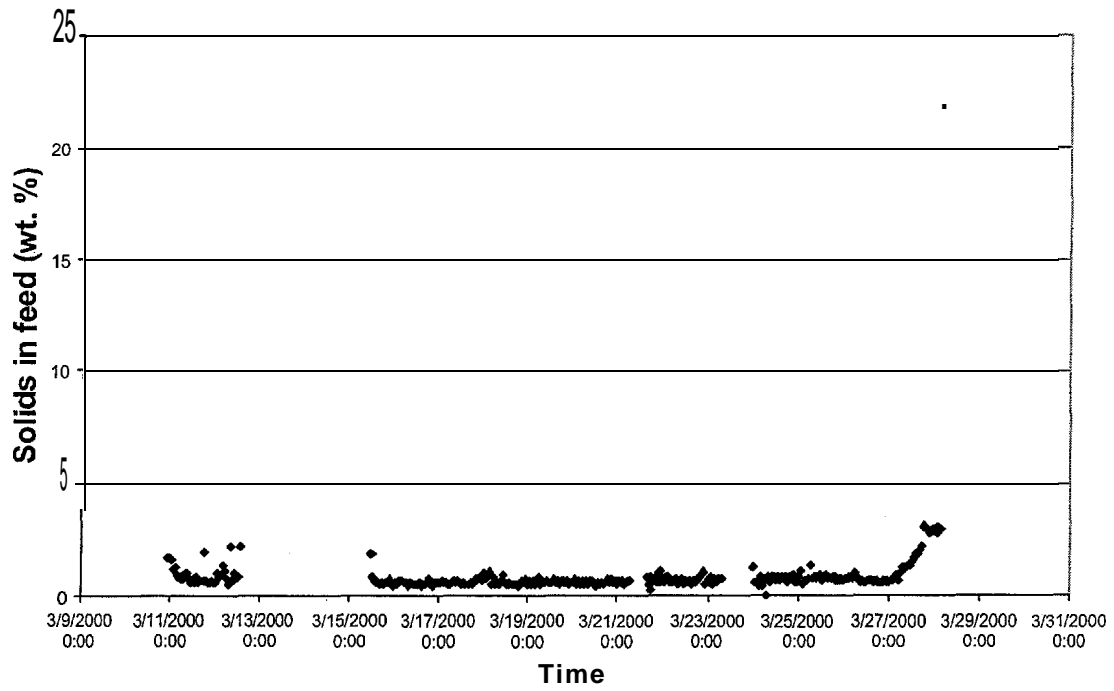
Fig. 47. Solids content of the SLS feed as a function of time for the ninth WTP campaign.

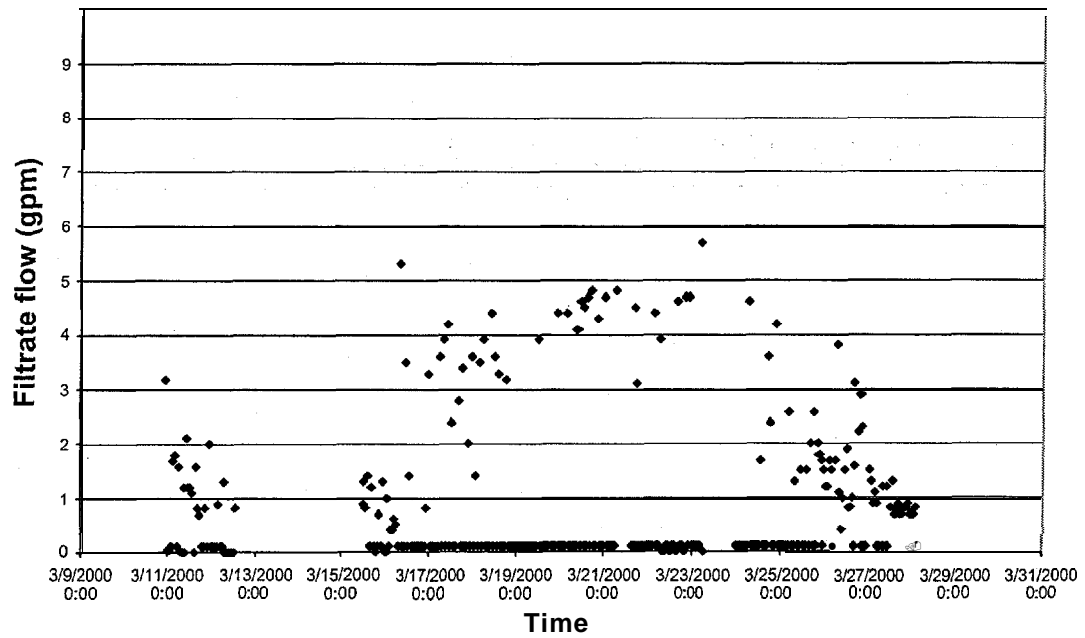
Fig. 48. Filtrate flow rate as a function of time for the ninth WTP operational campaign.

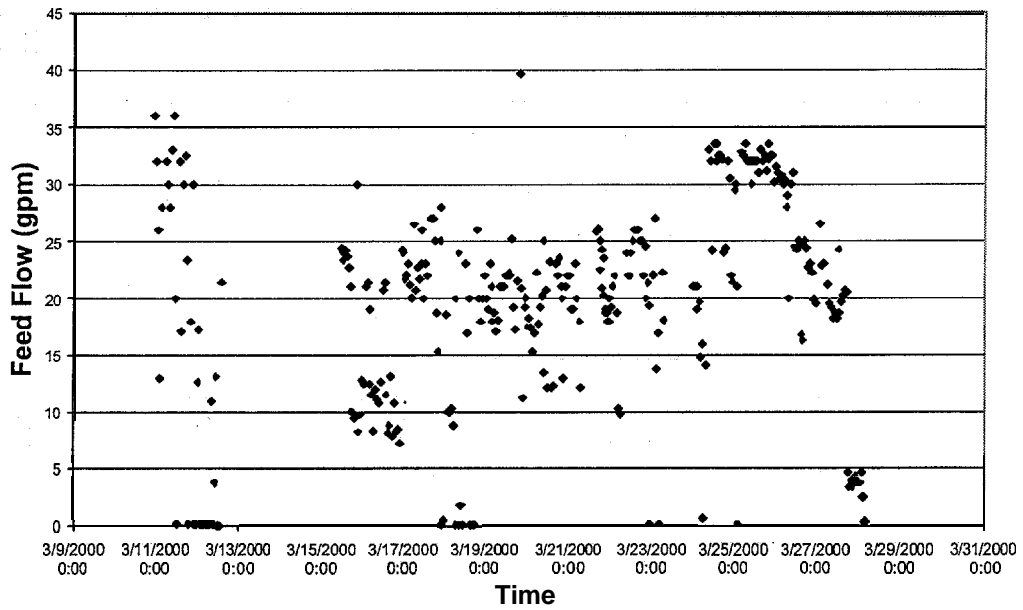
Fig. 49. Feed flow rate to the SLS system as a function of time for the ninth WTP operational campaign.

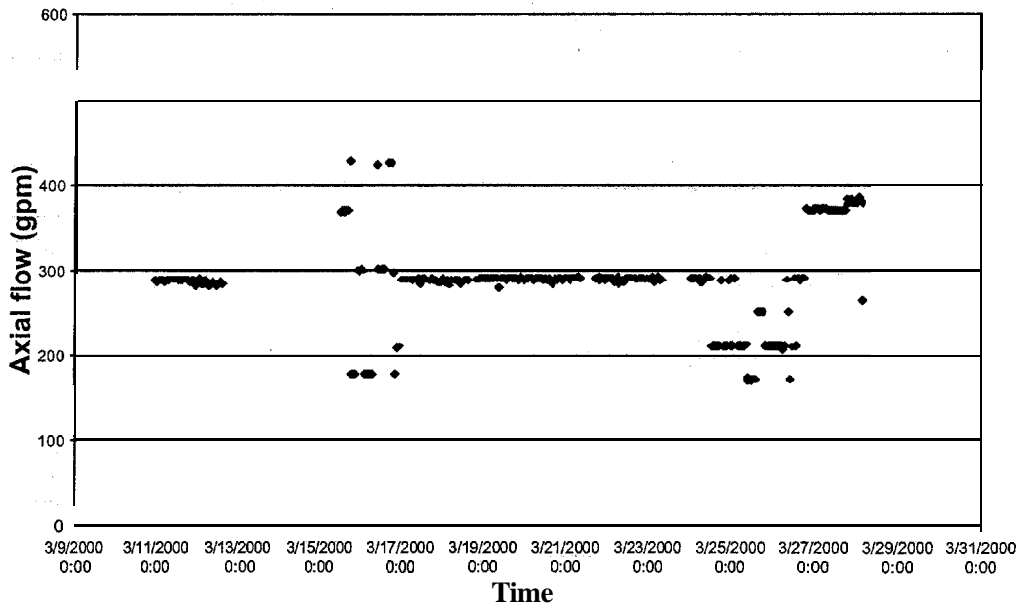
Fig. 50. Axial flow rate across the filter elements as a function of time for Run 9.

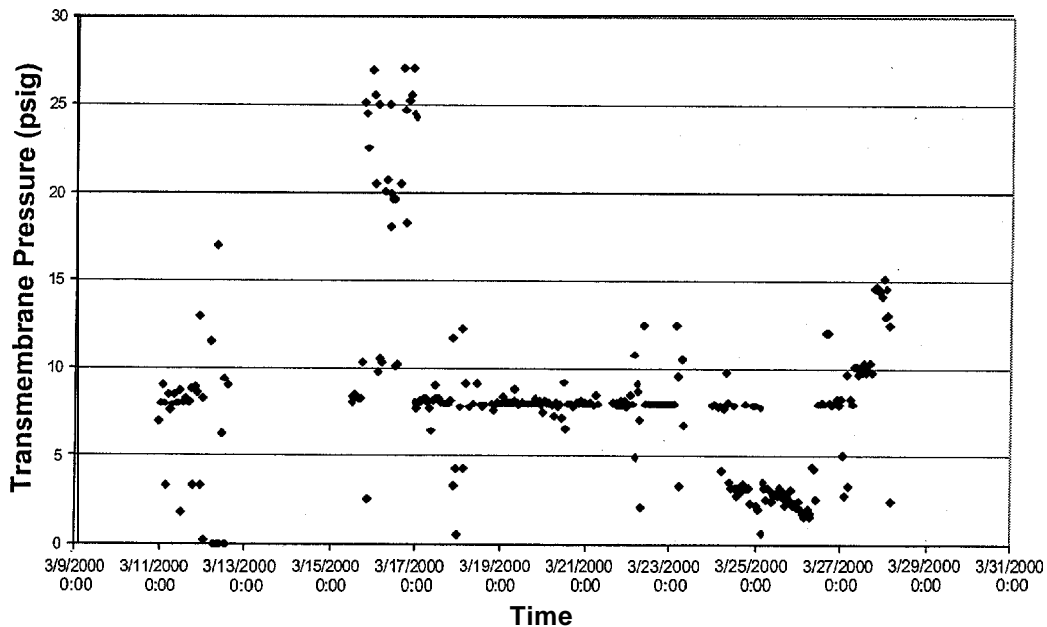
**Fig. 51. Transmembrane pressure as a function of time for the ninth WTP operational campaign.**

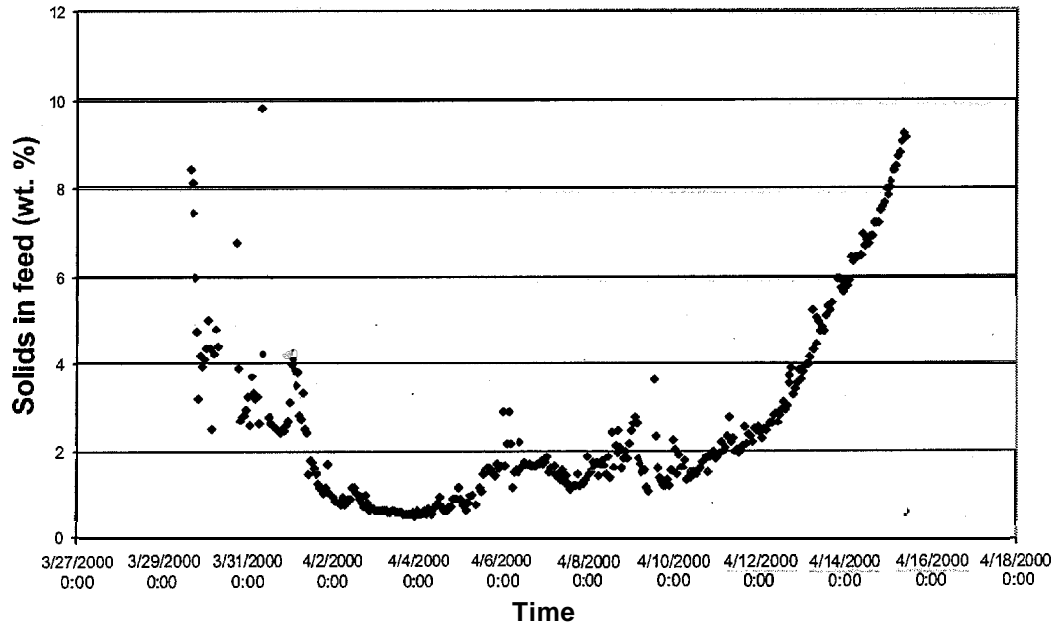
Fig. 52. Solids content of the SLS feed as a function of time for the tenth WTP campaign.

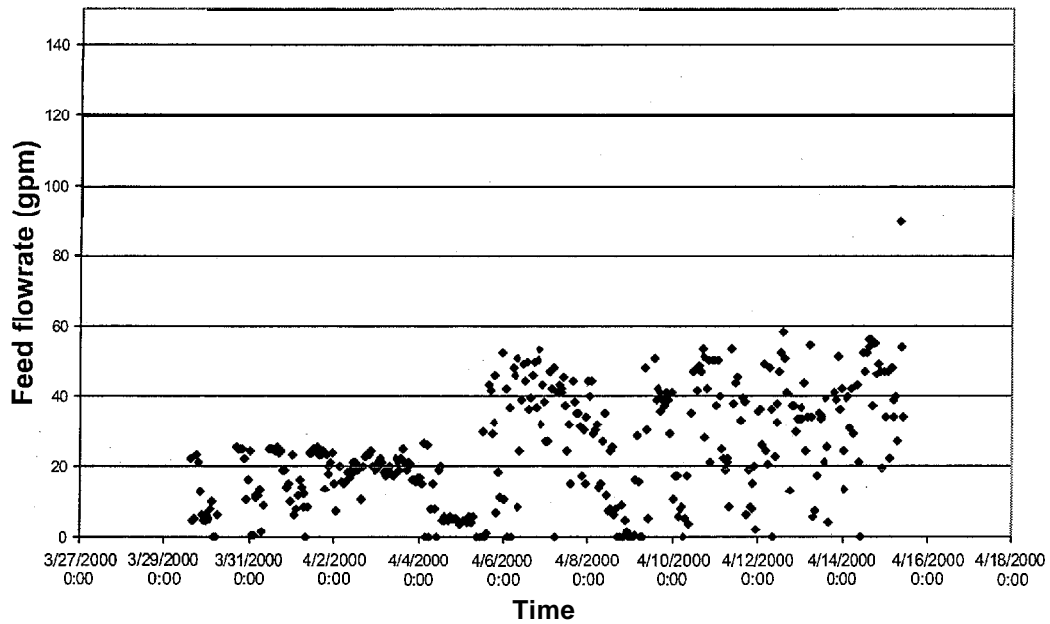
Fig. 53. Flow rate of the feed to the SLS system as a function of time during the tenth WTP operational campaign.

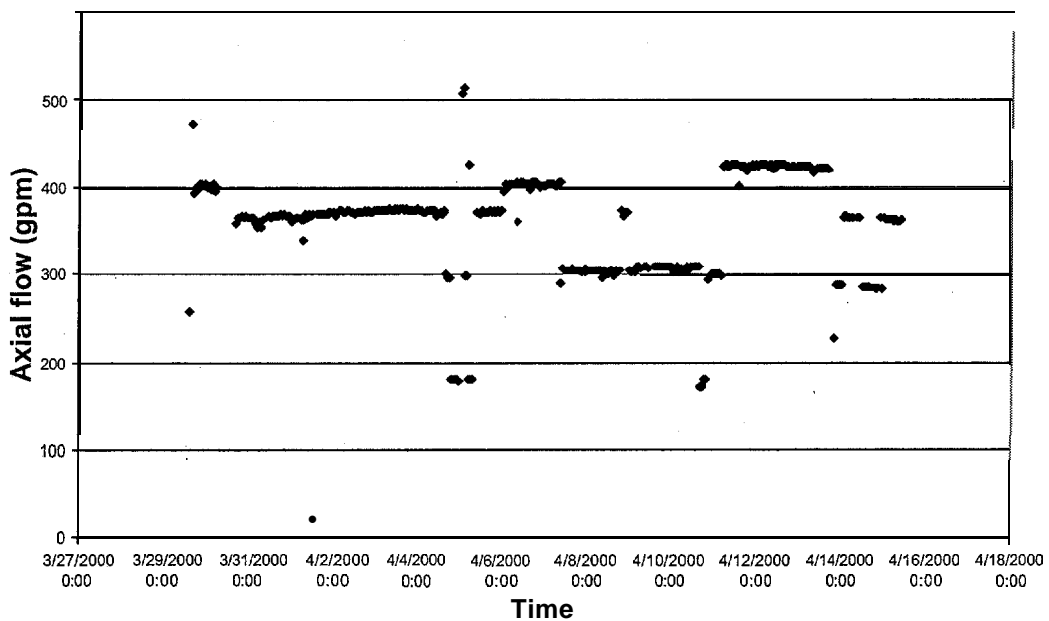
Fig. 54. Axial flow rate across the filter elements as a function of time for the tenth WTP operational campaign.

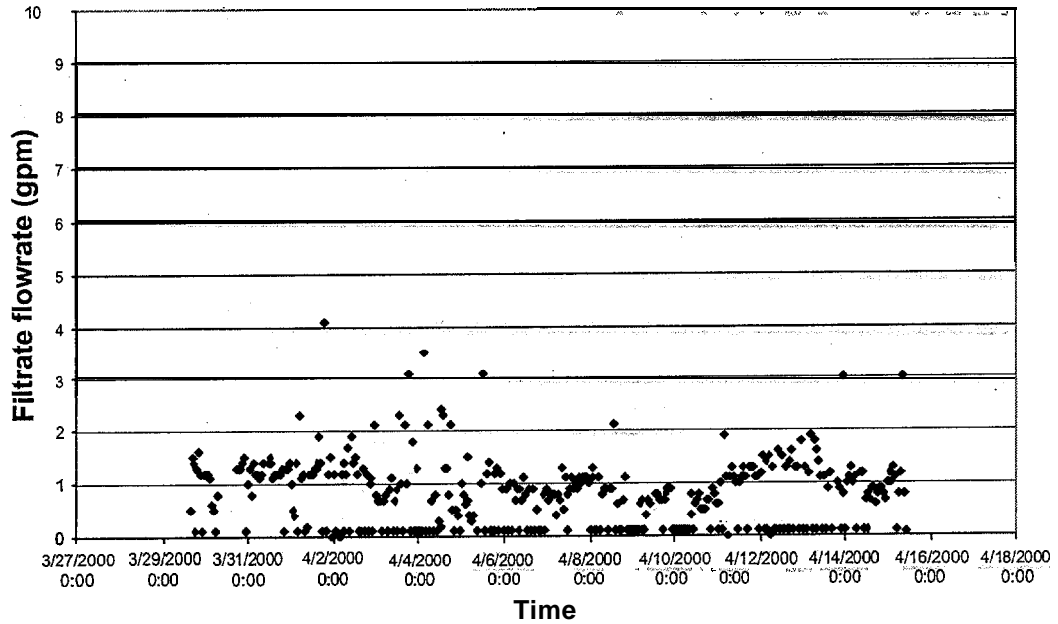
Fig. 55. Filtrate flow rate as a function of time for the tenth operational campaign.

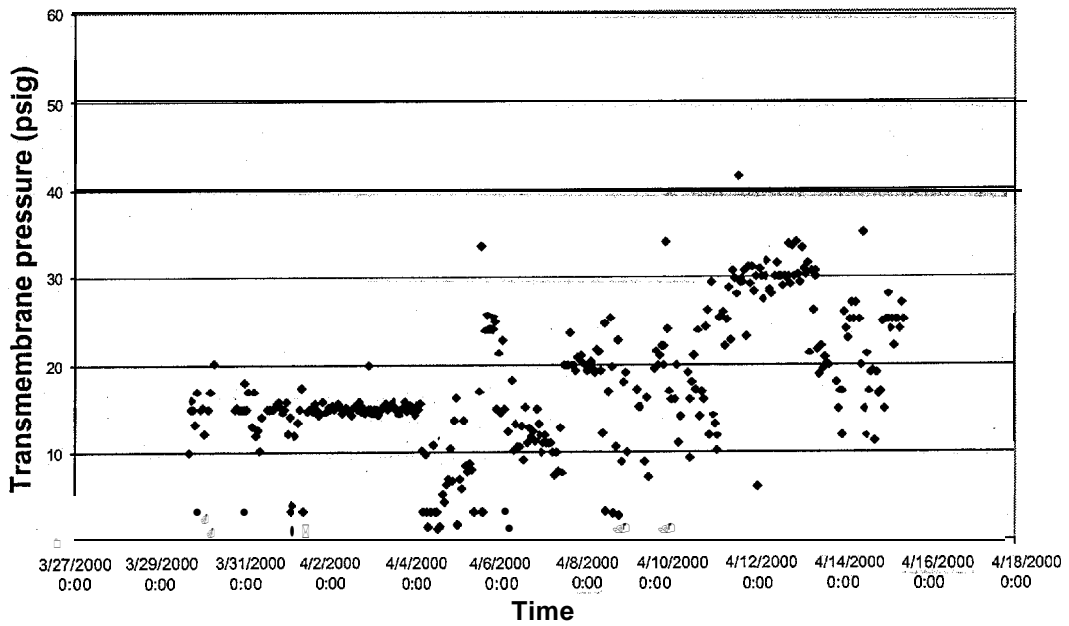
Fig. 56. Transmembrane pressure as a function of time for the tenth WTP operational campaign.

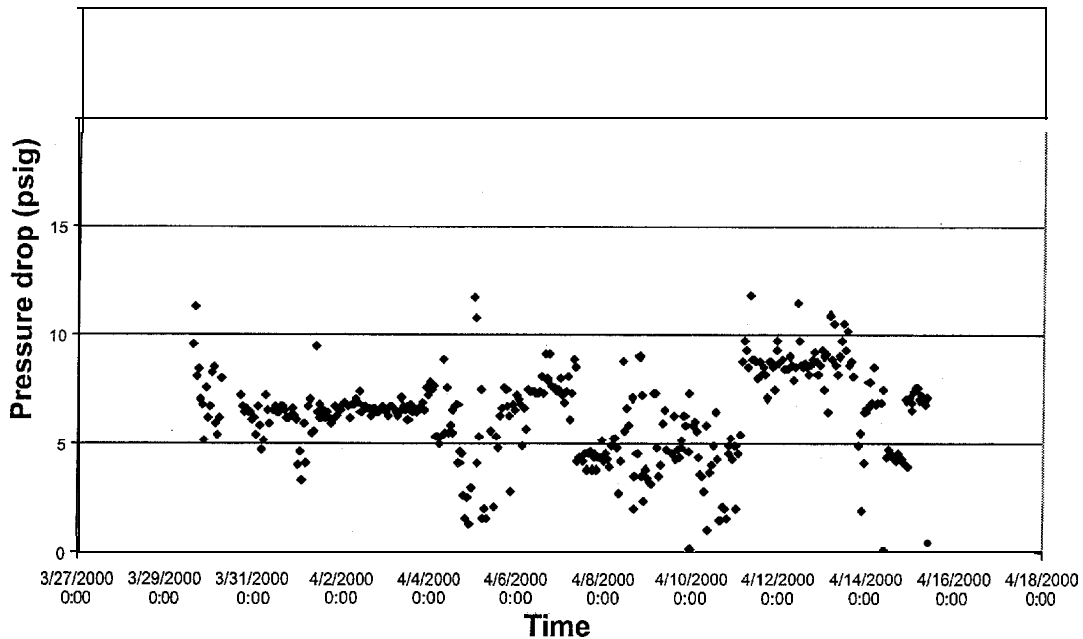
**Fig. 57. Pressure drop across the filters as a function of time for the tenth WTP operational campaign.**

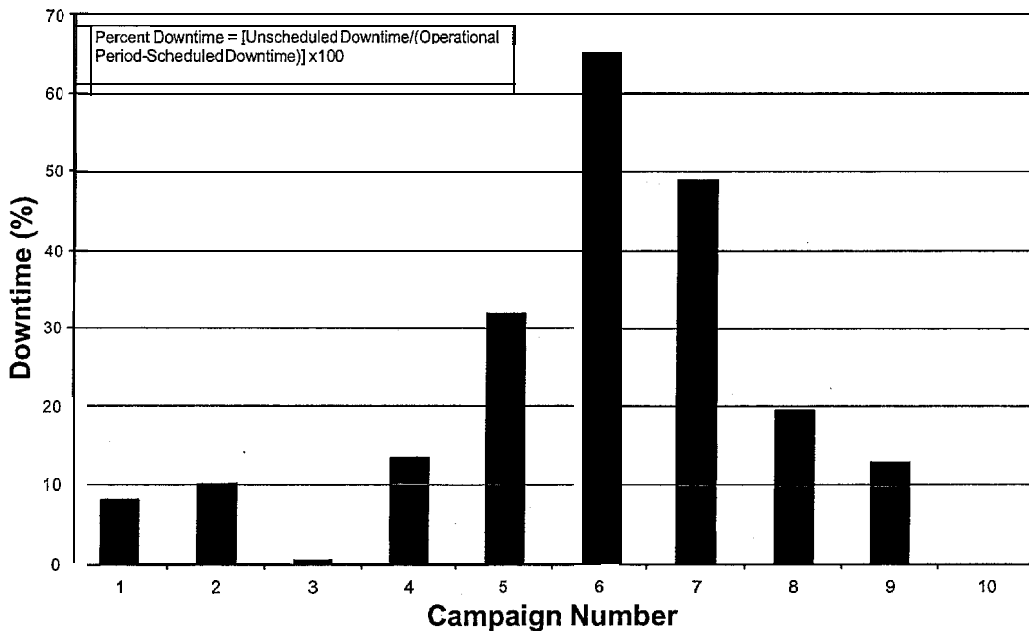
**Fig. 58. Percent operational downtime for each WTP campaign.**

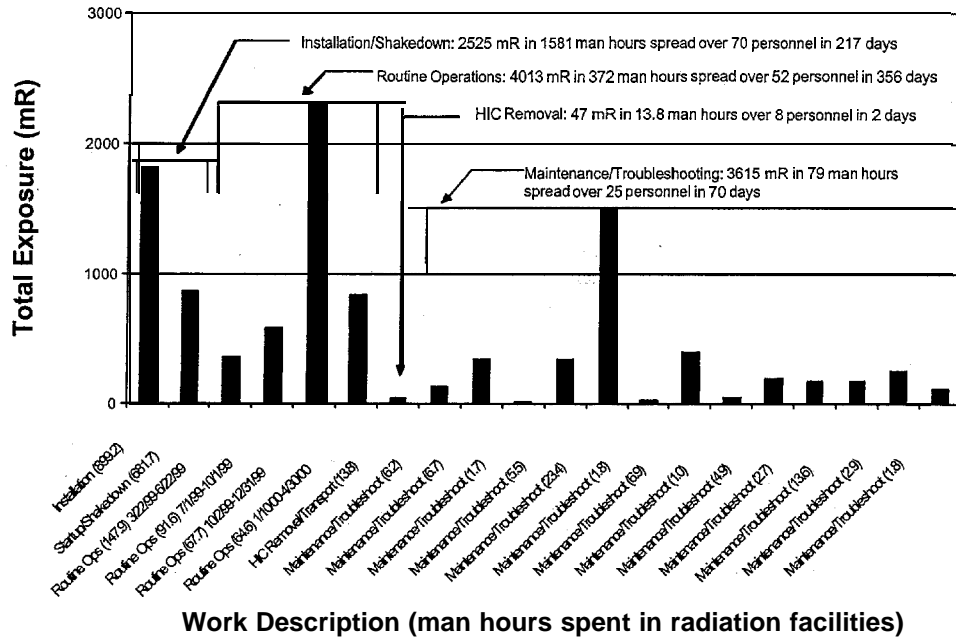
Fig. 59. Total radiation exposure received during the WTP during the various operational periods.

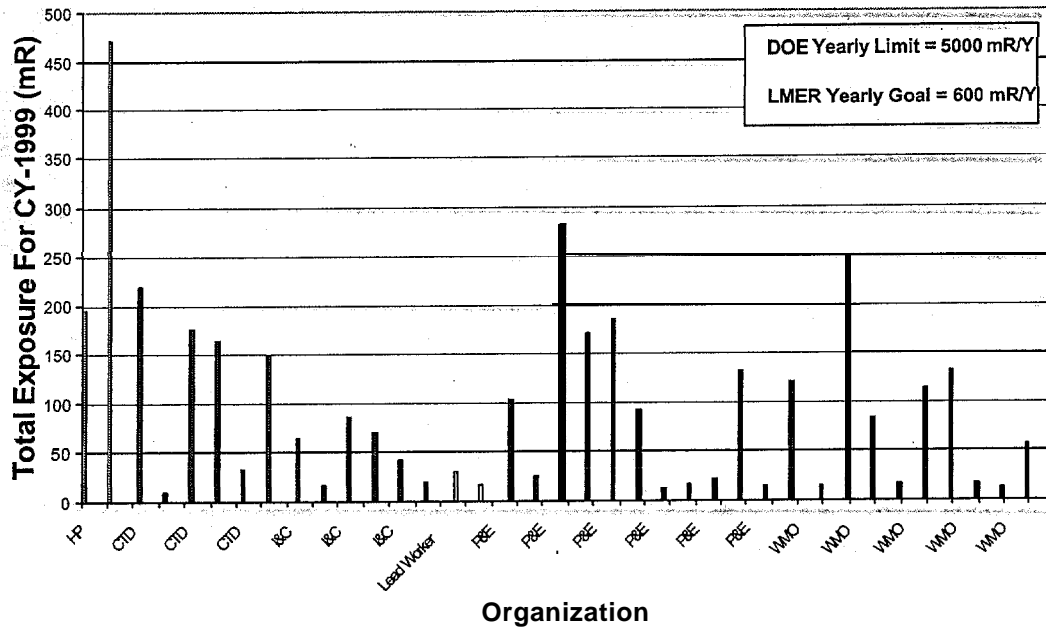
Fig. 60. Radiation levels received by WTP individuals during the 1999 calendar year broken down by organization (includes only personnel whose exposure exceeded 10 mR for the calendar year).
