Primer on Durability of Nuclear Power Plant Reinforced Concrete Structures - A Review of Pertinent Factors

Oak Ridge National Laboratory

**U.S. Nuclear Regulatory Commission
Office of Nuclear Regulatory Research
Washington, DC 20555-0001**

Manuscript Completed: November 2006

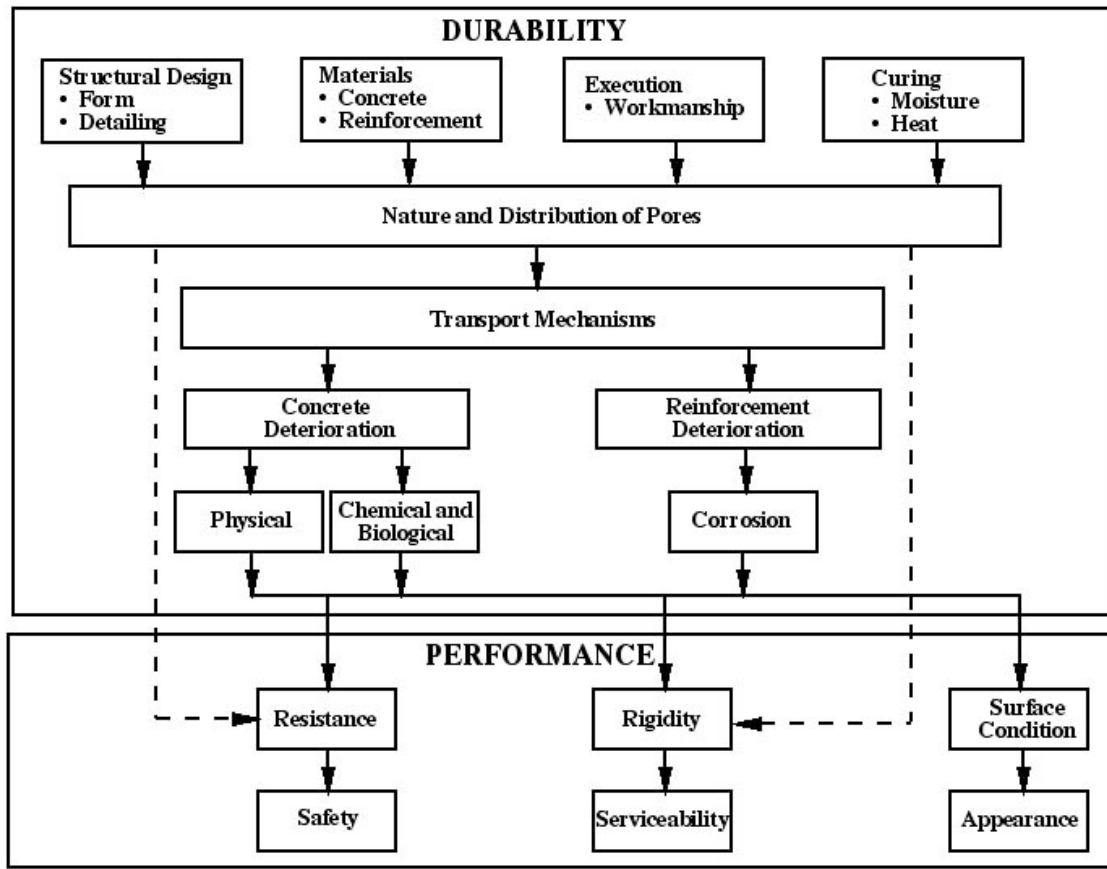
Figure 1.1 Relationship between the concepts of concrete durability and performance.

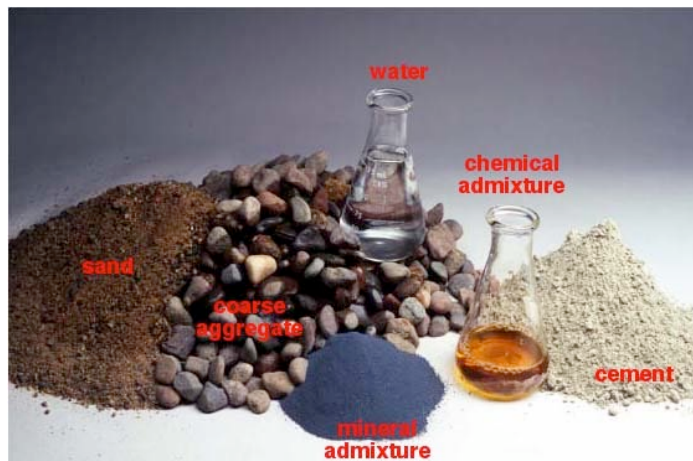
Figure 3.1 Basic concrete constituent materials

ultra-lightweight (e.g., vermiculite and perlite) to lightweight (e.g., expanded clay shale or slate-crushed brick) to normal weight (e.g., crushed limestone or river gravel) to heavy-weight (e.g., steel or iron shot). Sometimes chemical or mineral admixtures are added during the mixing process to enhance durability (air entrainment), improve workability (enhanced placement and compaction), modify hardening and setting characteristics, aid in curing, reduce heat evolution, or provide other property improvements.³⁰ Basic concrete constituent materials are identified in Figure 3.1.

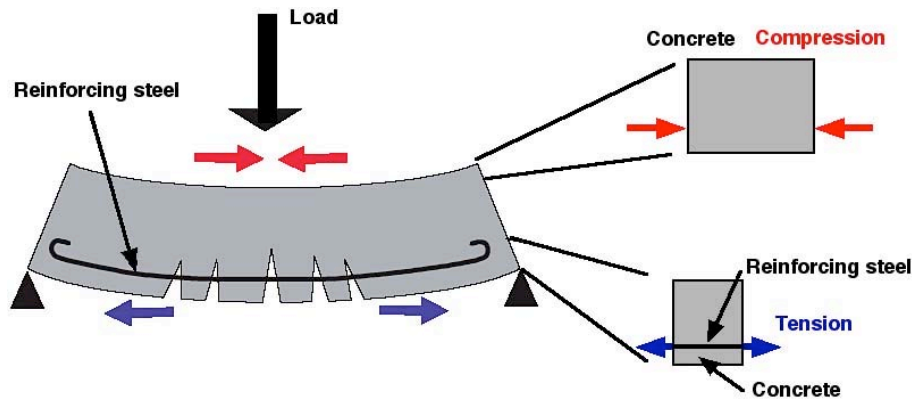
Figure 3.2 Principle of reinforced concrete.

Concrete tensile strength is about one-tenth to one-fifth its compressive strength so concrete can not be relied upon to withstand very high tensile stresses. This limitation is overcome by embedding steel reinforcement in the concrete. The concrete and steel thus work in concert, Fig. 3.2. In addition to resisting tensile loads, the bonded steel reinforcement is used to control the extent and width of cracks,

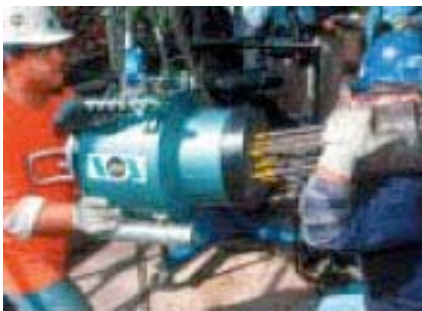
**Figure 3.3 Example of a multistrand tendon.**

The tendons are installed within preplaced ducts in the containment structure and post-tensioned from one or both ends after the concrete has achieved sufficient strength. After tensioning, the tendons are anchored by buttonheads, wedges, or nuts. Corrosion protection is provided by filling the ducts with wax or corrosion-inhibiting grease (unbonded), or portland cement grout (bonded). Supplemental conventional reinforcing is also used to minimize shrinkage or temperature effects and to provide local load-carrying capacity or load transfer. With the exception of Robinsion 2 (bar tendons) and Three Mile Island 2 (strand tendons), plants that have post-tensioned containments utilize unbonded tendons so that the tendons can be inspected and replaced (if necessary). Bellefonte and Ginna each have grouted tendons (rock anchors) to which tendons are attached. Figure 3.3 presents an example of a multistrand tendon for a general civil engineering application.

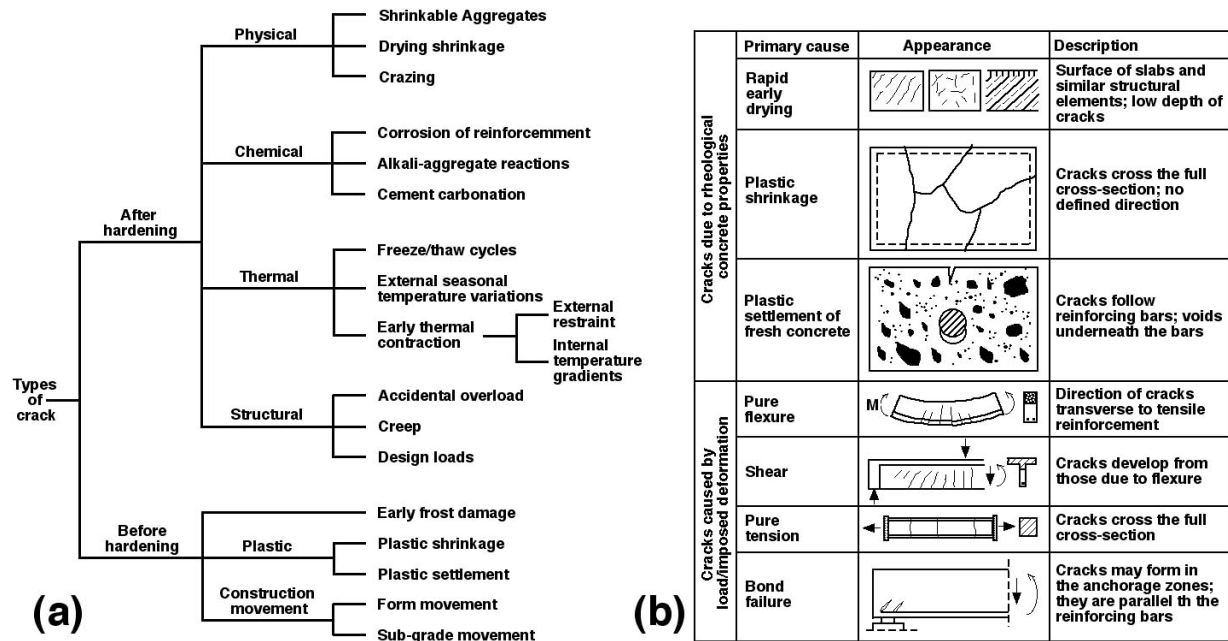
Figure 4.1 Relationship between primary causes and types of cracks in concrete.

capacity). Figure 4.1a provides information on the types of cracks that can form in concrete structures⁷ and Figure 4.1b provides a description and appearance of several of the crack forms.⁵⁷

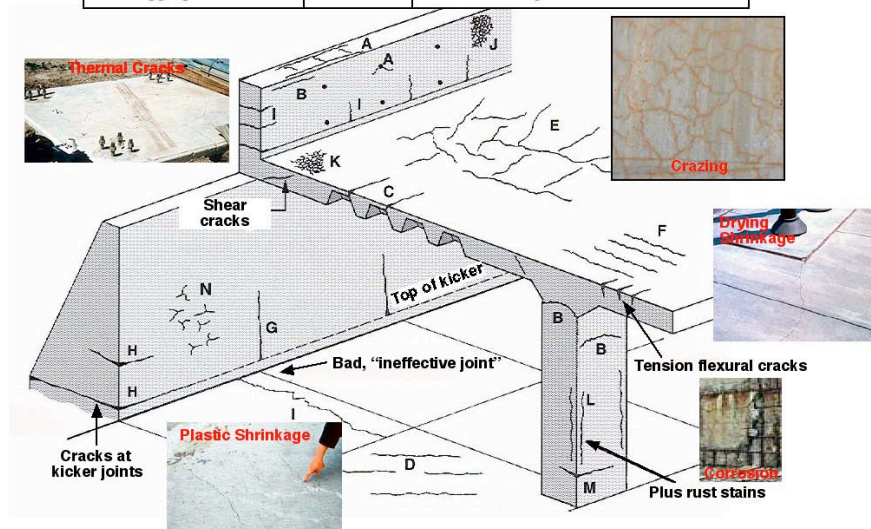
Figure 4.2 Examples of intrinsic cracks in a hypothetical structure.

Type of Cracking	Designation	Time of Occurrence
Plastic settlement	A, B, C	Ten minutes to three hours
Plastic shrinkage	D, E, F	Thirty minutes to six hours
Early thermal contraction	G, H	One day to two to three weeks
Long-term drying shrinkage	I	Several weeks or months
Crazing	J, K	One to seven days - sometimes much later
Corrosion of reinforcement	L, M	Several years, but may be sooner
Alkali-aggregate reaction	N	More than five years

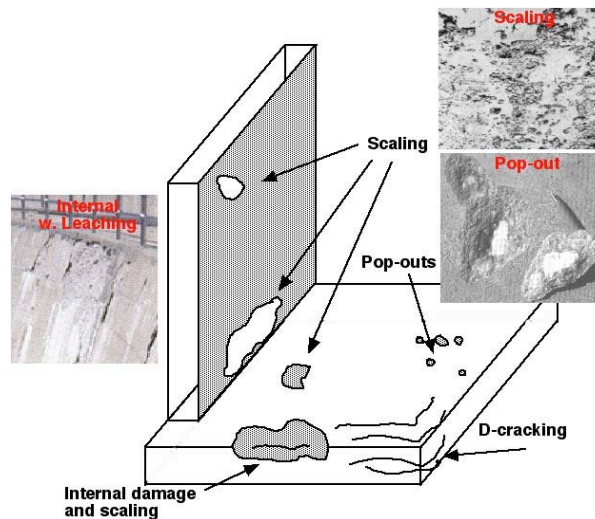
Figure 4.4 Types of freeze-thaw damage.

Damage to concrete resulting from freezing and thawing attack can take several forms:⁺ expansion, internal cracking, and spalling; scaling associated with application of salt; and pop-outs.^{61,62} Internal damage is confined primarily to the mortar and is associated with freeze-thaw damage of young concrete or mature cement paste that does not have a pore structure capable of resisting stresses that develop due to freeze-thaw occurrence. Scaling is delamination of the concrete surface. Weakness may exist at the surface due to an inherent weakness of the concrete due to excessive water, excess mortar, or treatment during construction. The surface layer may become detached if the stresses occurring exceed the tensile or bond strength holding the layer to the substrate. Scaling may develop from a shallow surface feature into internal damage. It often is associated with application of de-icing chemicals that cause the temperature of the concrete surface to change rapidly which induces a thermal shock that can cause cracking and surface scaling. Also, if salts are present in the pore solution the osmotic pressure is increased since moisture tends to move toward zones of higher salt concentrations. A pop-out is a small volume of concrete that has separated from the body of the concrete to leave a roughly conical depression. The most common cause of pop-outs is stress resulting from freeze-thaw action within the coarse aggregate particle that causes cracking of the particle and simultaneous fracture of the concrete between the particle and nearest concrete face. Aggregates that produce pop-outs are generally sedimentary (e.g., cherts, sandstones, shales, and limestones), but can be calcareous or siliceous or gravel or crushed rock, and have a high porosity.⁶³ Internal damage occurs in the form of cracking, is confined to mortar, and is associated with freeze-thaw damage to cement paste that does not have a pore structure capable of resisting the stresses that develop. Figure 4.4 presents a schematic of the types of freeze-thaw damage as well as examples.⁶¹

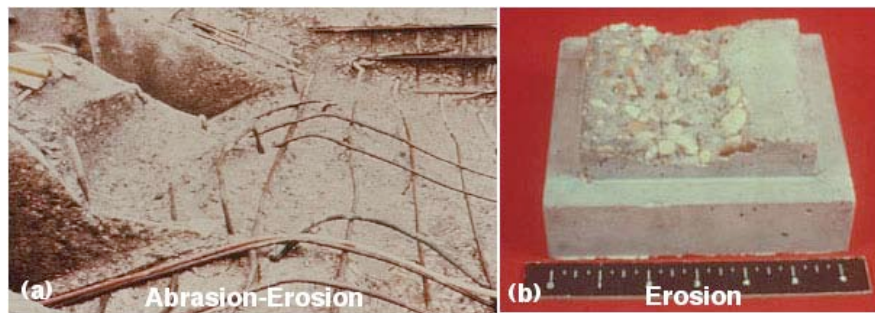
Figure 4.5 Abrasion-erosion of concrete: (a) abrasion-erosion damage in a concrete stilling basin and (b) erosion of conventional concrete.

Abrasion/Erosion/Cavitation Progressive loss of material at the concrete surface can occur due to abrasion, erosion, or cavitation. Abrasion generally refers to dry attrition due to rubbing or grinding of aggregate or other debris on the concrete surface, while erosion is normally used to describe wear by the abrasive action of fluids containing solid particles in suspension. Mechanical abrasion is usually characterized by long shallow grooves in the concrete surface and spalling along monolithic joints. Concrete surfaces abraded by water-borne debris are generally smooth and may contain localized depressions. Cavitation is the formation of bubbles or cavities in a liquid. In hydraulic structures, the liquid is water, and the cavities are filled with water vapor and air. The cavities form where the local pressure drops to a value that will cause the water to vaporize at the prevailing water temperature. Formation of these cavities is usually triggered by concrete surface irregularities that are subjected to high-velocity water flow. Cavitation bubbles will grow and travel with the flowing water to an area where the pressure field will cause collapse. When a bubble collapses or implodes close to or against a solid surface, an extremely high pressure is generated, which acts on an infinitesimal area of the surface for a very short time. A succession of these high-energy impacts will damage almost any solid material.⁶⁶ Figure 4.5 presents examples of concrete abrasion-erosion.^{66,67}

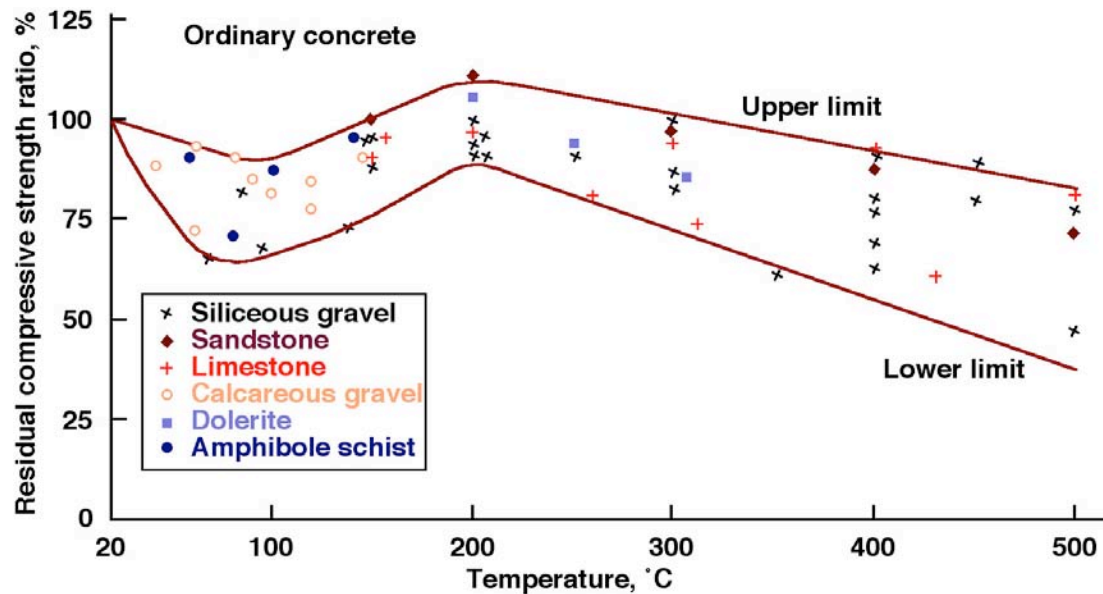
Figure 4.6 Effect of temperature on residual compressive strength: unsealed specimens.

and porosity of aggregate, rate of heating, permeability, use of pozzolans, moisture state, mix proportions, and loading and sealing conditions during heating.

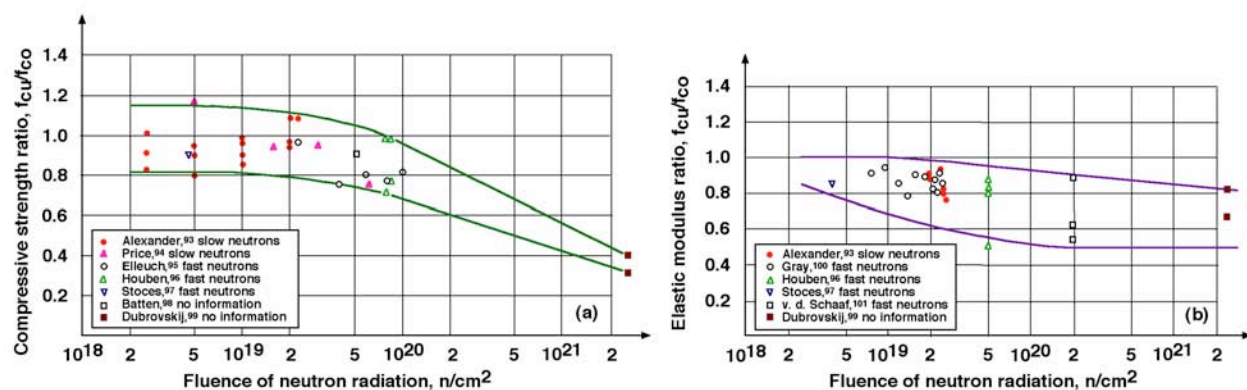
Figure 4.7 Effect of neutron radiation on concrete compressive strength and modulus of elasticity relative to unirradiated and unheated control specimen results.

Prolonged exposure of concrete to irradiation can result in decreases in tensile and compressive strengths and modulus of elasticity. Figure 4.7 presents a summary of the effects of neutron radiation on the compressive strength and modulus of elasticity of several concretes.⁹⁰ Results in the literature⁹⁰ indicate that: (1) for some concretes, neutron radiation of more than 1×10^{19} neutrons/cm² or 10^{10} rads of dose for

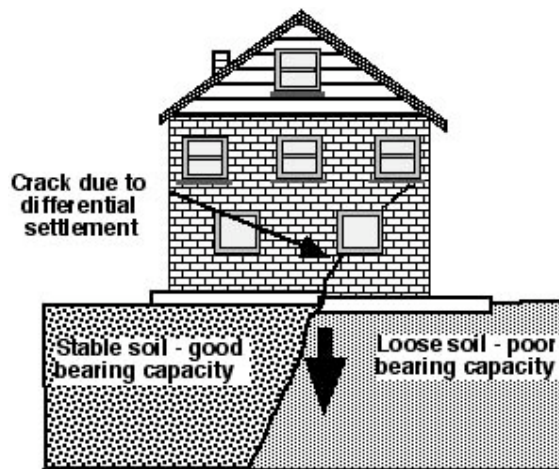
Figure 4.8 Example of differential settlement cracking in a building structure due to inadequate foundation design.

Uniform settlement will not normally cause structural distress, although if excessive it can result in damage or misalignment of connecting services or structures. Differential settlement is more of a concern as it can cause misalignment of equipment and lead to overstress conditions in structures (e.g., cracking such as illustrated in a building structure in Fig. 4.8). The amount of settlement is dependent on the physical properties of the foundation material at the site, which may range from bedrock (minimal settlement expected) to compacted soil (some settlement expected). Settlement is generally allowed for in the design of the structures and is not expected to be significant. When a structure such as a nuclear power plant is sited on soils, the potential for settlement is acknowledged and monitoring programs may be implemented to confirm that design allowables are not exceeded.

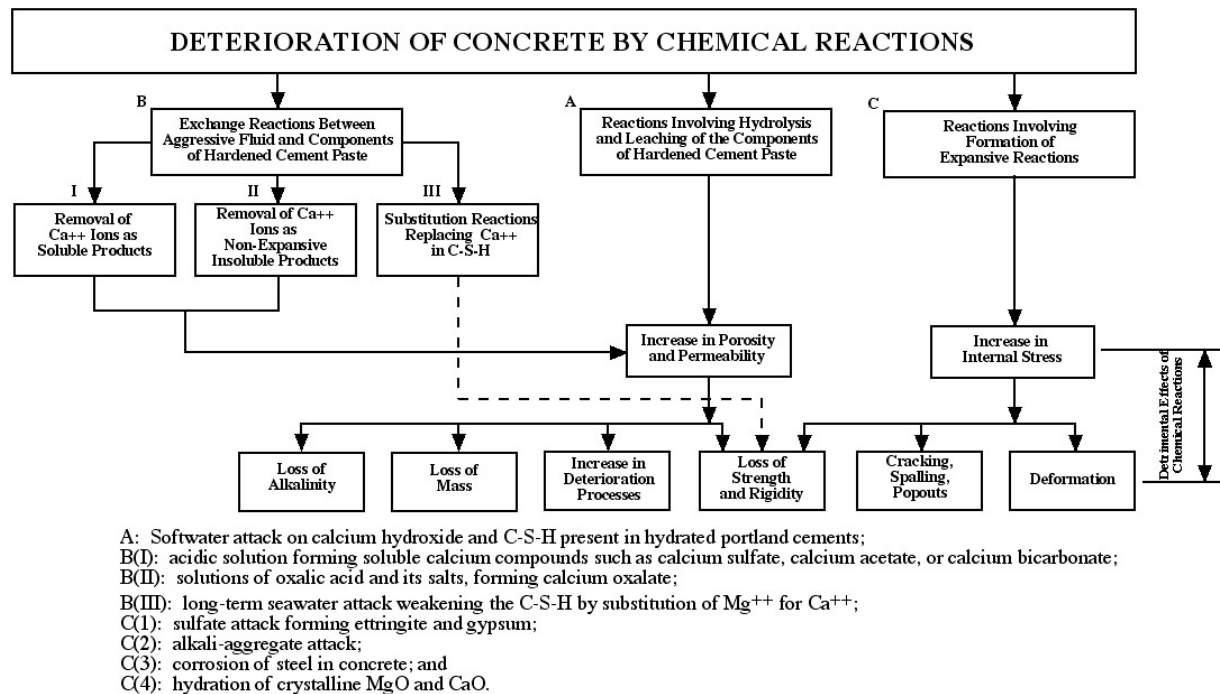
Figure 4.9 Types of chemical reactions responsible for concrete deterioration.

Chemical attack involves the alteration of concrete through chemical reaction with either the cement paste or coarse aggregate, or embedded steel reinforcement.** Generally, the attack occurs on the exposed surface region of the concrete (cover concrete), but with the presence of cracks or prolonged exposure, chemical attack can affect entire structural cross sections. Chemical causes of deterioration can be grouped into three categories: (1) hydrolysis of cement paste components by soft water; (2) cation exchange reactions between aggressive fluids and the cement paste; and (3) reactions leading to formation of expansion products.¹⁰⁹ Figure 4.9 presents a summary of the types of chemical reactions responsible for concrete deterioration and the detrimental effects that can occur.¹¹⁰ Chemical attack of concrete may occur in several different forms as highlighted in the following sections.

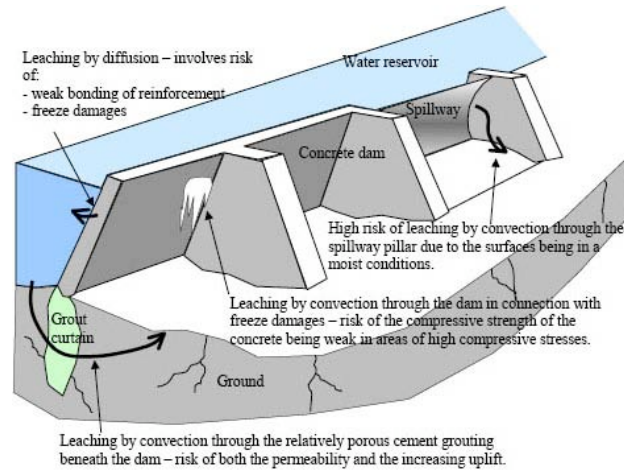
Figure 4.11 Typical leaching types observed in concrete hydraulic structures such as a dam.

Leaching of cementitious materials mainly involves the transportation of ions from the interior of the material through its pore system outwards into the surroundings. In the leaching process solid compounds in the concrete are dissolved by water that has penetrated and are transported away either by diffusion based on the concentration gradients or convection through the flow of water. Pure water that contains little or no calcium ions, or acidic ground water present in the form of dissolved carbon dioxide gas, carbonic acid, or bicarbonate ion, tends to hydrolyze or dissolve the alkali oxides and calcium-containing products. Water with a pH less than 12.5 is aggressive toward concrete since it destabilizes the cementitious hydration products. The rate of leaching is dependent on the amount of dissolved salts contained in the percolating fluid, rate of permeation of the fluid through the cement paste matrix, and temperature. Extensive leaching causes an increase in porosity and permeability thus lowering the strength of the concrete and making it more vulnerable to hostile environments (e.g., water saturation and frost damage, or chloride penetration and corrosion of embedded steel). Figure 4.11 shows a schematic of different types of leaching found in concrete hydraulic structures.¹¹³ Examples of leaching in a concrete dam and a tendon gallery of a nuclear power plant are shown in Figure 4.12. Concrete leaching is basically of three types: (1) leaching at free surfaces of the concrete, (2) leaching from the interior of concrete, and (3) leaching at surfaces of cracks in concrete.¹¹⁴ Figure 4.13 presents conceptual models for each of the leaching types. Of these types, (a) is generally of little importance, (b) is serious and can result in serious damage, and (c) is difficult to deal with and complicated to assess. Concretes produced using low water-cement ratios, adequate cement content, and proper compaction and curing are most resistant to leaching.

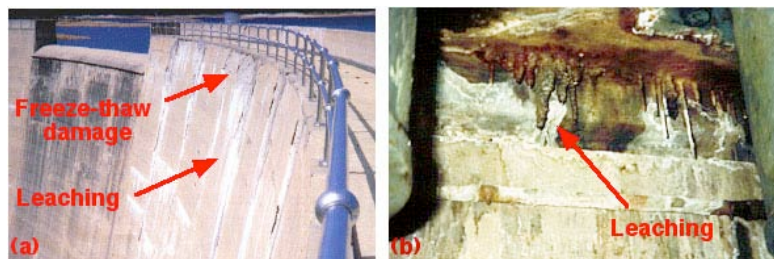
Figure 4.12 Examples of leaching of concrete: (a) dam with freeze-thaw damage and leaching, (b) nuclear power plant tendon gallery leaching.

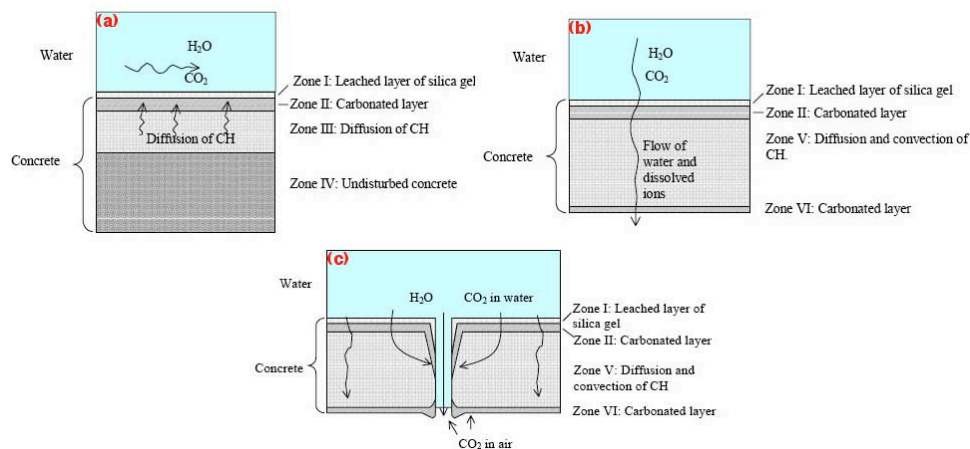
Figure 4.13 Conceptual models for concrete leaching mechanisms: (a) leaching from free surfaces, (b) homogeneous percolation through porous concrete, and (c) leaching from surfaces of cracks. CH = calcium hydroxide.

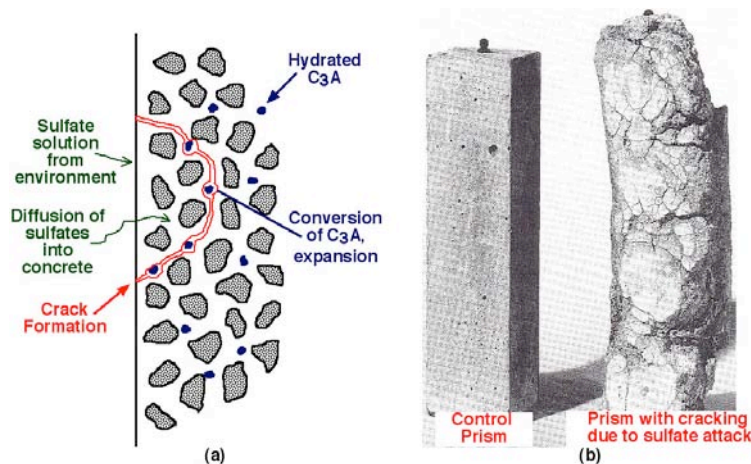
Figure 4.14 Concrete cracking due to sulfate attack: (a) mechanism, (b) example of concrete cracking due to sulfate attack.

Sulfate Attack All sulfates are potentially harmful to concrete. Sulfate attack of concrete is caused by exposure of concrete products or structures to an excessive amount of sulfate from internal or external sources. Internal sulfate attack results when a soluble source of sulfates is incorporated into the concrete at the time of mixing through the hydraulic cement, presence of natural gypsum or pyrite in the aggregate, and admixtures. External sulfate attack is most common and typically occurs when water containing dissolved sulfates penetrates the concrete. Magnesium, sodium, calcium, and potassium sulfates present in soils, ground water, and sea water react with the calcium hydroxide and if enough water is present, result in expansion and irregular cracking of the concrete that can lead to progressive loss of strength and mass. The degree of sulfate attack depends on water penetration, the sulfate salt and its concentration and type, the means by which the salt develops in the concrete (e.g., is it rising and drying causing crystallization), and the chemistry of the binder present in the concrete. Sulfate attack of hardened concrete generally appears in two forms: expansive formation of ettringite and gypsum in the hardened concrete causing cracking and exfoliation, and softening and dissolution of the hydrated cementing compounds due to direct attack on these compounds by sulfate or by their decomposition when calcium hydroxide reacts with the sulfates and is removed.⁴⁷ The end result of sulfate attack can be excessive expansion, delamination, cracking, and loss of strength. Figure 4.14 illustrates the mechanism of sulfate (sodium) attack and presents an example of cracking resulting from sulfate attack. It has been reported that at a concentration of about 0.2% sulfate content in ground water concrete may suffer sulfate attack, magnesium sulfate can be more aggressive than sodium sulfate, and there are three key chemical reactions between sulfate ions and hardened cement pastes: (1) recrystallization of ettringite, (2) formation of calcium sulfoaluminate (ettringite), and (3) decalcification of the main cementitious phase (calcium silicate hydrate).¹¹⁵

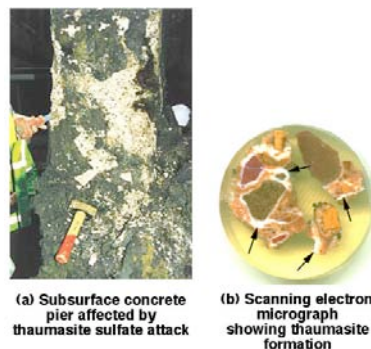
Figure 4.15 Thaumasite sulfate attack.

A rare form of sulfate attack is through formation of thaumasite as a result of the reaction between the calcium silicates in the cement, calcium carbonate from limestone aggregates or fillers, and sulfates, usually from external sources.⁵⁶ Coincident factors for thaumasite sulfate attack in susceptible concrete include: source of sulfates, presence of mobile ground water, source of calcium silicate hydrate, presence of carbonate, and a low temperature (<10°C).¹²⁰ Thaumasite sulfate attack forms slowly and can destroy a significant part of the calcium silicate hydrate that eventually results in a soft, white, pulpy mass that causes total disintegration of the concrete and exposes the steel reinforcement. Figure 4.15 presents a subsurface concrete pier affected by thaumasite sulfate attack in the United Kingdom. However, serious damage to concrete or masonry due to thaumasite formation has not been a common occurrence.

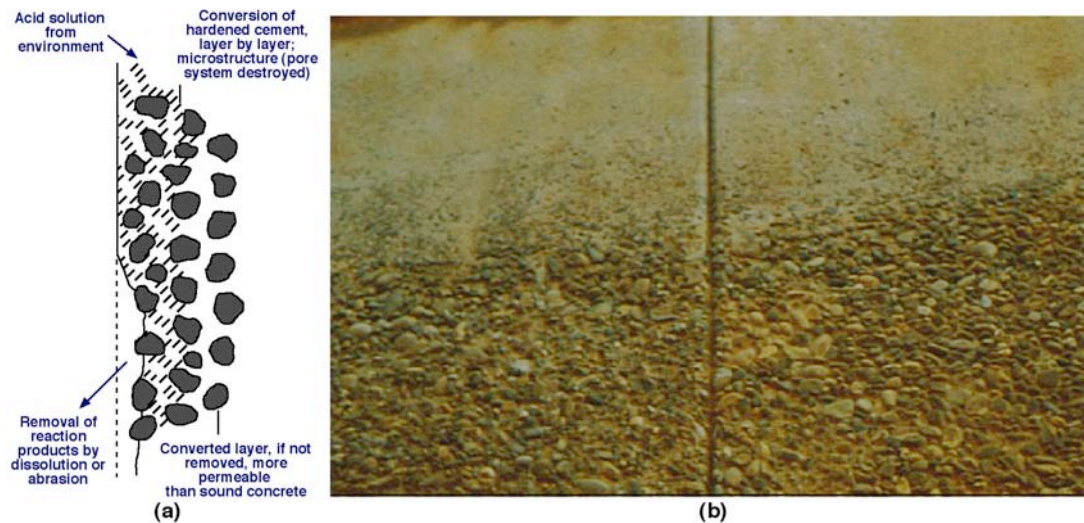
Figure 4.17 Surface loss due to acid attack: (a) mechanism, (b) example of acid attack on concrete wall.

so much the aggressiveness of the attacking acid, but more the solubility of the resulting calcium salt. The rate of deterioration is also accelerated if the aggressive chemical solution is flowing. Since under acid attack there is a conversion of the hardened cement, the concrete permeability is not as important as for other types of chemical attack (e.g., leaching and sulfate attack). Nitric, hydrochloric, and sulfuric acids are very aggressive as their calcium salts are readily soluble and removed from the acid front. Organic acids such as formic, acetic, and lactic are also corrosive to portland cement concrete. Other acids such as phosphoric, carbonic, tannic, and humic are less harmful as their calcium salts have low solubility and inhibit the attack by blocking the pathways within the concrete. Oxalic acids have negligible affect on portland cement concretes. Carbonic, humic, and sulfuric acids are the acids most commonly encountered by concrete since they are found in natural ground waters. Visual examination of concrete undergoing acid attack will show disintegration of the concrete in the form of loss of cement paste and aggregate from the matrix. Due to the large buffering capacity of concrete and the relatively small amount of acid contained in rain, acid rain will convert only an insignificant amount of the concrete.⁵⁷ Acid rain is even a smaller threat to nuclear power plant structures than general civil engineering concrete structures because of their massive cross sections. Surface coatings and a dense concrete with a low water-cement ratio provide improved resistance to acid environments. Figure 4.17 illustrates the mechanism of acid attack and presents an example of acid attack on a concrete wall.

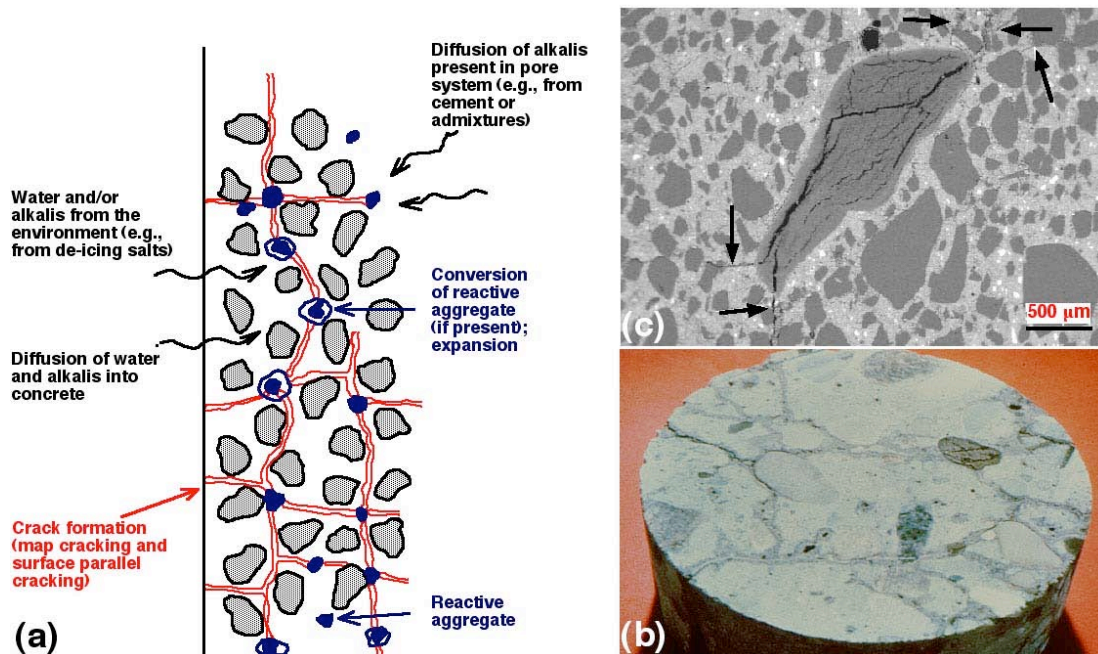
Figure 4.18 Concrete cracking due to alkali-silica reaction: (a) mechanism, (b) resulting gel that causes expansion and cracking, (c) polished section of concrete showing chert particle with extensive internal cracks extending from aggregate as noted by arrows.

the alkali-silicate ions and expands, which can disrupt the concrete.* Figure 4.18 presents the mechanism of alkali-silica reaction (ASR) and the gel resulting from alkali-aggregate reaction that causes expansion

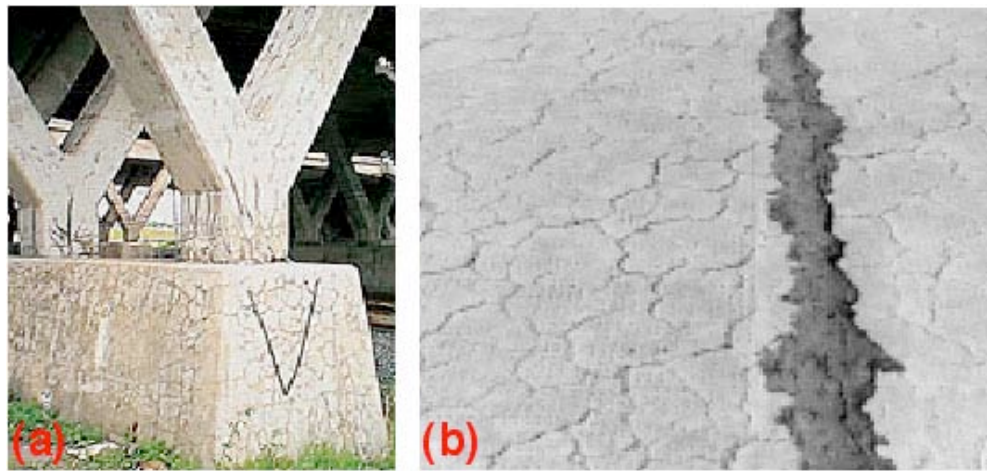
Figure 4.19 Examples of concrete cracking: (a) alkali-silica reaction in bridge pier, (b) alkali-carbonate reaction in sidewalk with exudation of joint material.

strength in excess of 50% with losses for smooth bars greater than for ribbed bars.^{135,136} Prestress developed by the ASR expansion can enhance the shear strength and stiffness of beams.¹³⁷ Figure 4.19 presents examples of alkali-aggregate reactions in concrete structures.

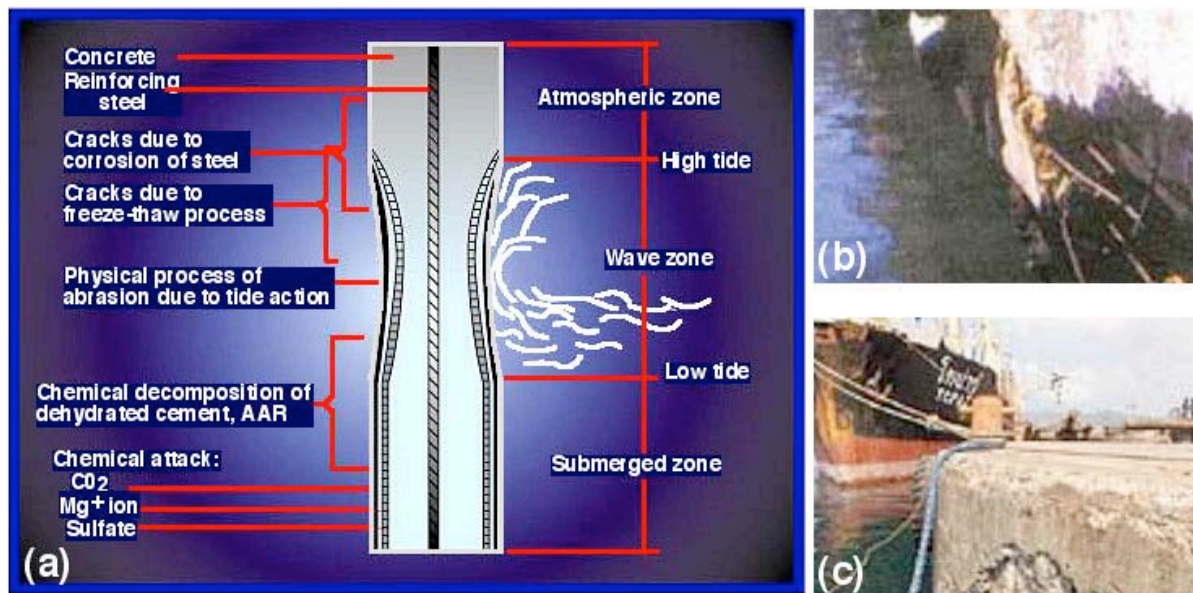
Figure 4.20 Sea water attack of concrete: (a) mechanism, (b) and (c) examples of attack.

Aggressive Water Attack[#] Concrete in service may be exposed to aggressive waters, with the most common deleterious ion being sulfate.¹⁴³ In other waters, acids and chemical by-products from industrial processes may be present. Some locations have sea water or brackish water in contact with concrete. Most sea waters have a pH of 7.5 to 8.4, are fairly uniform in chemical composition, contain about 3.5% soluble salts by weight, with Na^+ and Cl^- having the highest ionic concentrations, but Mg^{2+} and SO_4^{2-} are also present.¹⁰⁹ Reaction of magnesium sulfate with the cement hydration products leads to formation of ettringite, calcium sulfate, and insoluble magnesium hydroxide (brucite) that reduces the rate of attack of dense concrete. The rate of attack is further reduced by the formation of aragonite (calcium carbonate) which forms more readily in the tidal zone than the surface layers of a completely immersed element.⁴⁶ Concrete exposed to a marine environment may deteriorate as a result of combined effects of chemical action of sea water constituents on cement hydration products, alkali-aggregate expansion if reactive aggregates are present, crystallization pressure of salts within concrete if one face of the structure is subject to wetting and others to drying conditions, frost action in cold climates, corrosion of embedded steel reinforcement, and physical erosion due to wave action or floating objects. Figure 4.20 presents a diagrammatic representation of deterioration of concrete exposed to sea water as well as examples of sea water attack.

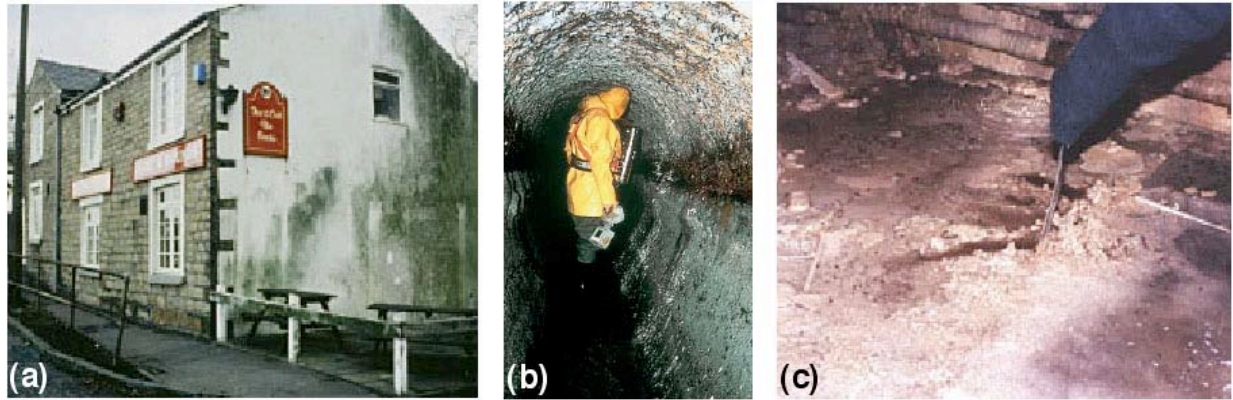
Figure 4.21 Concrete biological attack: (a) algae growth on outside wall of house, (b) biogenic sulfuric acid attack in sewer system, (c) decaying concrete floor in flooded cellar.

Formation of capillaries within the concrete during the hydration process and the capillary action of water provide a means for penetration of microorganisms into concrete. The metabolism of microorganisms results in the excretion of sulfuric or nitric acid that can contribute substantially to the degradation of cementitious materials. A number of organisms are capable of causing the dissolution of concrete through leaching of calcium and other alkaline binding materials.¹⁴⁶ These organisms are known to cause serious damage to sewer lines, buildings, and monuments. In environments where reduced sulfur compounds are present, such as sewers, the production of sulfuric acid by sulfur oxidizing bacteria (thiobacilli) forms a corrosive layer that causes extensive cement degradation. The sulfuric acid reacts with the free lime [$\text{Ca}(\text{OH})_2$] to form gypsum ($\text{CaSO}_4 \cdot 2\text{H}_2\text{O}$) that produces a corroding layer on the concrete surface that penetrates into the concrete. The newly formed gypsum crystals react with calcium aluminate in the cement to produce ettringite that further contributes to the degradation of concrete by increasing the internal pressure leading to formation of cracks that, in turn, provide a larger surface area for the corrosion process.¹⁴⁷ In environments where reduced sulfur compounds are limiting, such as on buildings, nitric acid-producing nitrifying bacteria have been found to play a role in concrete degradation.¹⁴⁸ The action of nitric acid on the calcareous components of concrete results in the production of calcium nitrate (soluble salt) that is either lost from the concrete resulting in formation of corrosion pits or remains to add salt to the pore water. The sulfate-reducing bacteria are primarily responsible for degradation of concrete above ground and the nitrifying bacteria for degradation below ground.¹⁴⁹ Microbes have extremely diverse modes of metabolism, are natural inhabitants of soil, and can survive extreme environments such as the inner wall of a geothermal cooling tower.¹⁵⁰ Concrete can also be corroded by gluconic, malic, and oxalic acids produced by fermentative bacteria that are natural soil inhabitants.¹⁵¹ Figure 4.21 presents examples of biological attack of concrete and Table 4.8 provides a summary of the effects of microorganisms on building materials.

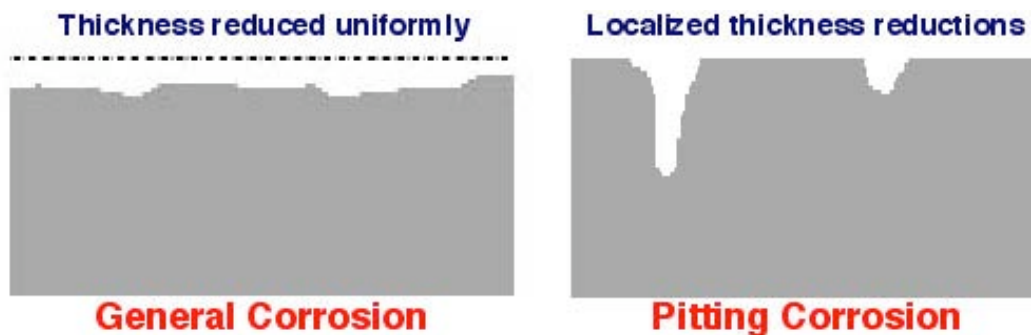
Figure 4.22 Illustrations of general and pitting corrosion of a metal surface.

Corrosion of conventional steel in concrete is an electrochemical process that can assume the form of either general or pitting corrosion. General corrosion refers to a relatively uniform reduction of thickness over the surface of a corroding material. It is relatively easy to measure and monitor. Pitting corrosion is a localized form of corrosion in which the bulk of the surface remains unattacked. Pitting corrosion is often found at locations where resistance against general corrosion provided by passive surface films has broken down. Figure 4.22 presents schematics illustrating general and pitting corrosion.

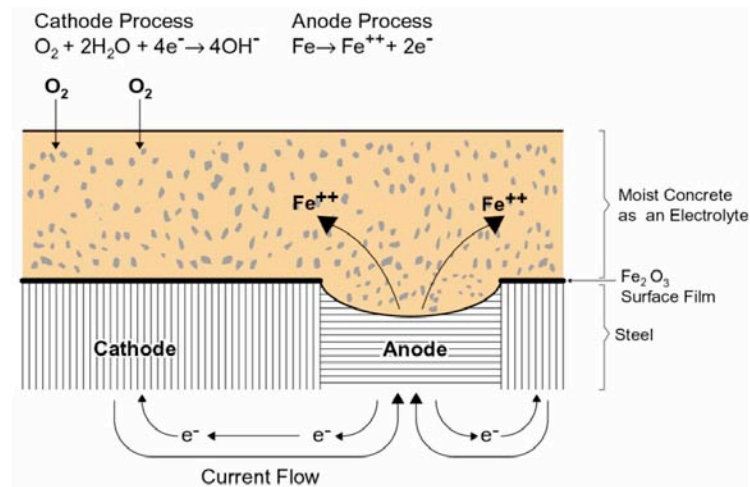
Figure 4.23 Electrochemical reaction illustrating corrosion of steel in concrete.

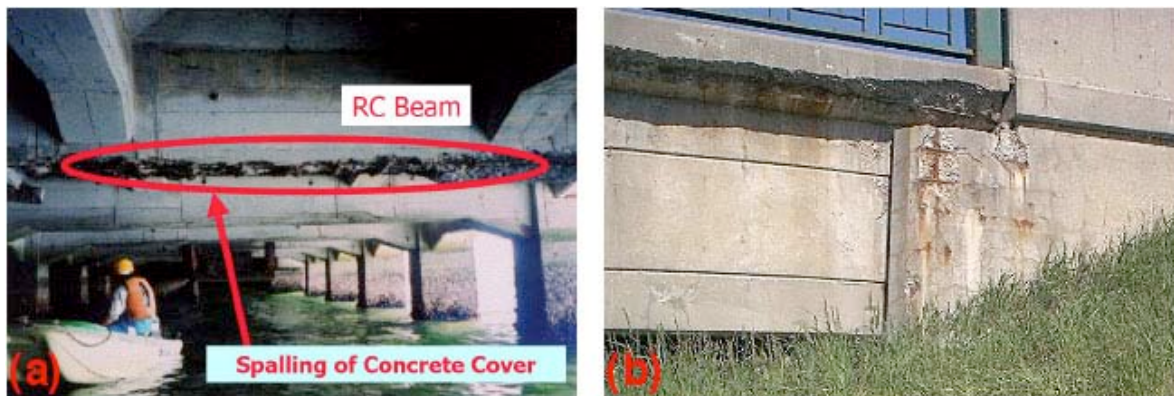
Figure 4.24 Corrosion of reinforced concrete: (a) sea water structure, (b) bridge structure.

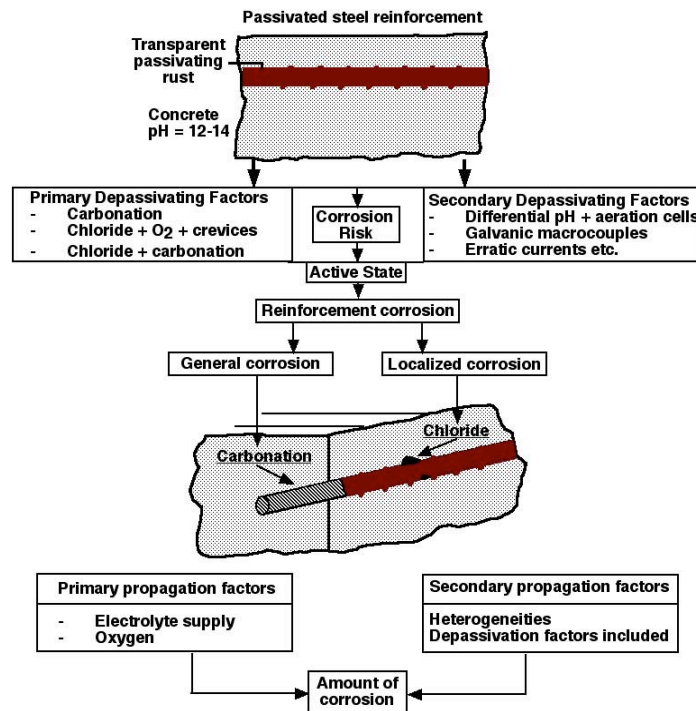
Figure 4.25 Factors leading to depassivation of steel in concrete.

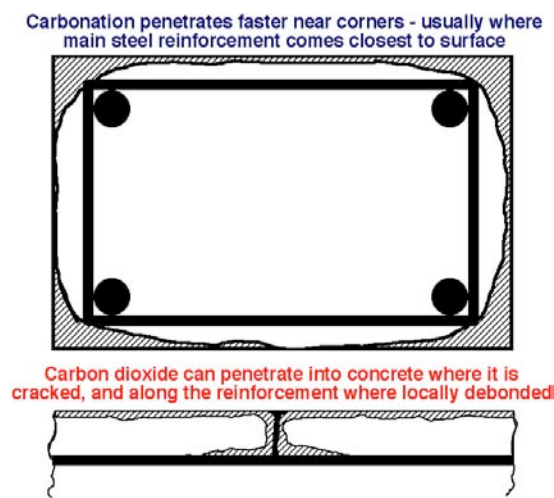
Figure 4.26 Carbonation penetration.

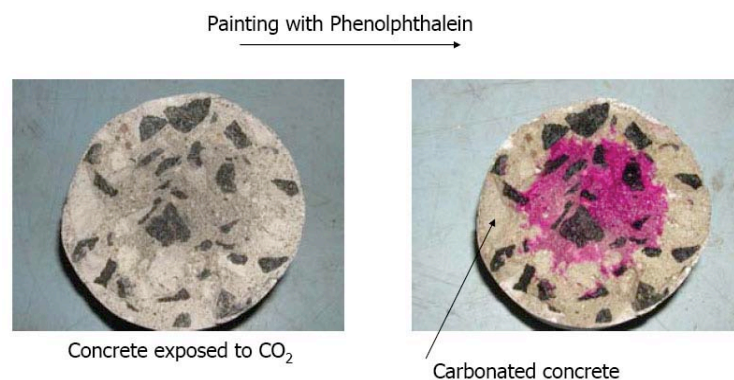
Figure 4.27 Use of phenolphthalein to identify carbonated concrete.

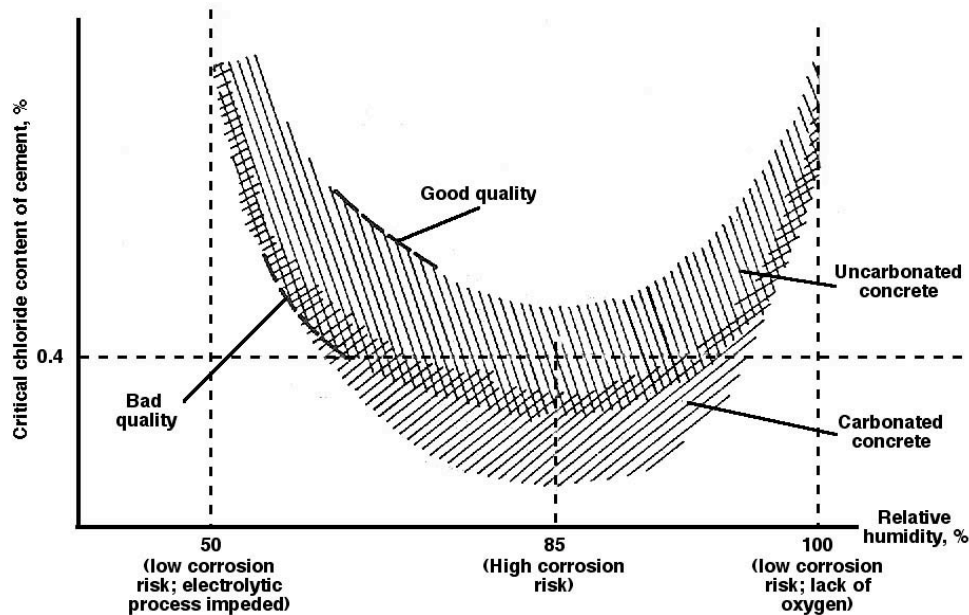
Figure 4.28 Variation of critical chloride content with environment.

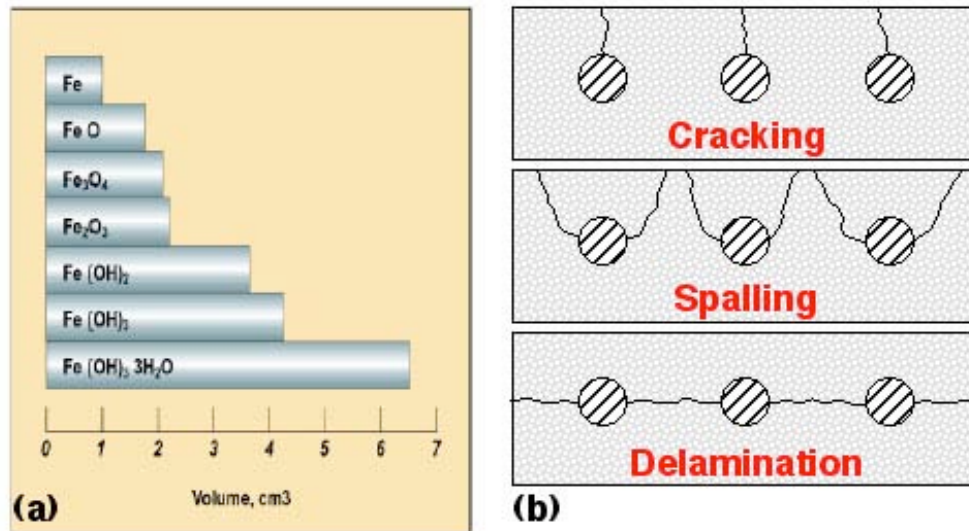
Figure 4.29 Oxidation states of iron and representations of visible forms of corrosion.

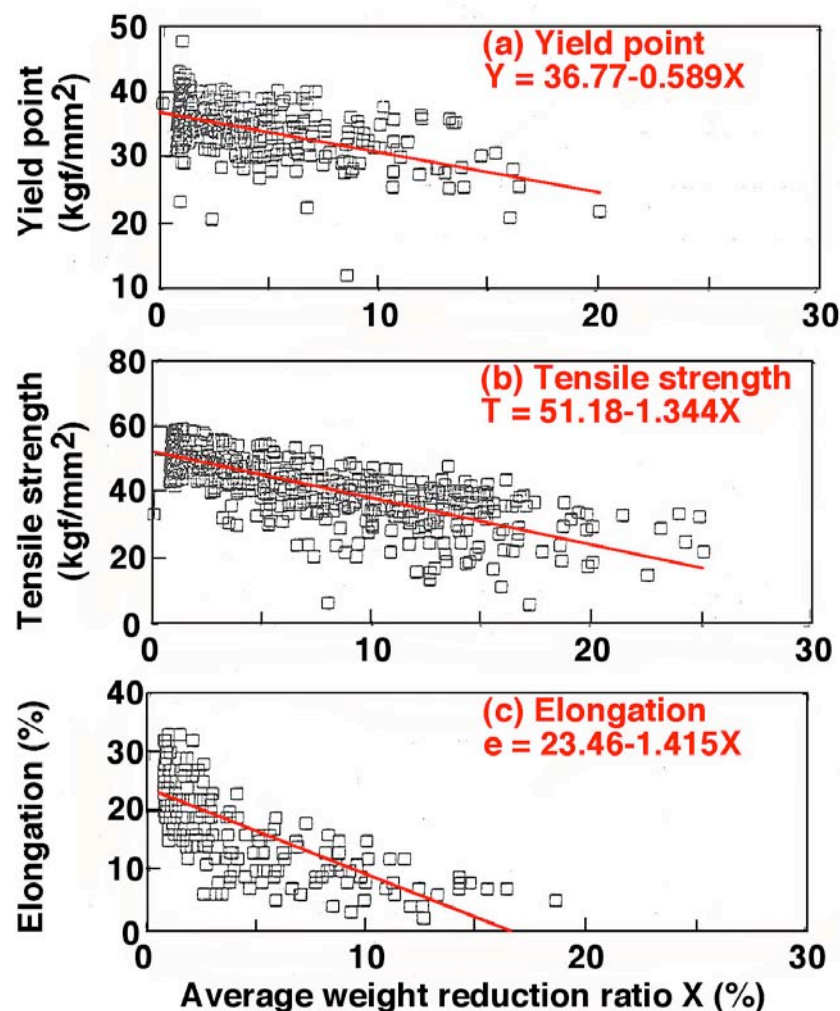
Figure 4.31 Properties of corroded steel reinforcement.

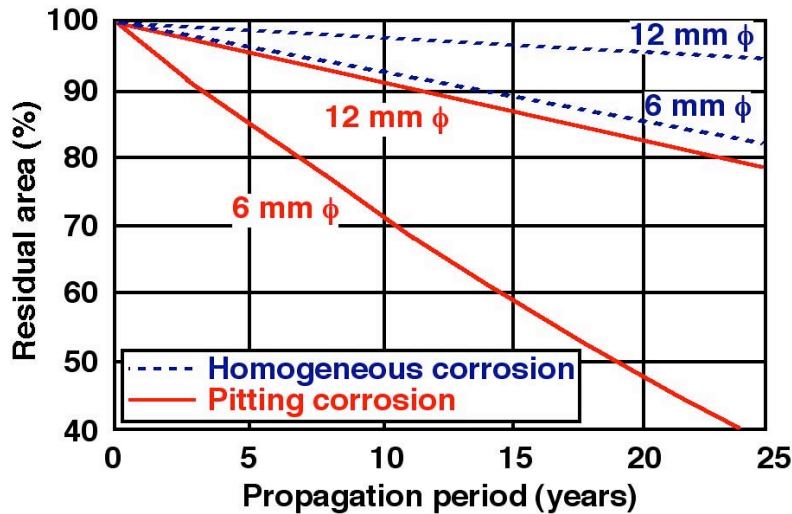
Figure 4.32 Residual cross-sectional area of steel reinforcement as a function of type and longevity of corrosion.

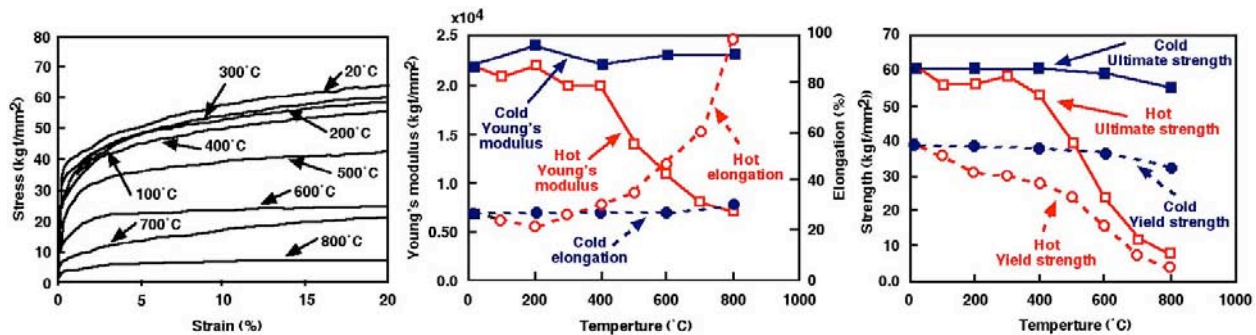
Figure 4.33 Effect of temperature on properties of a 3,500 kgf/cm² minimum specified yield strength steel bar.

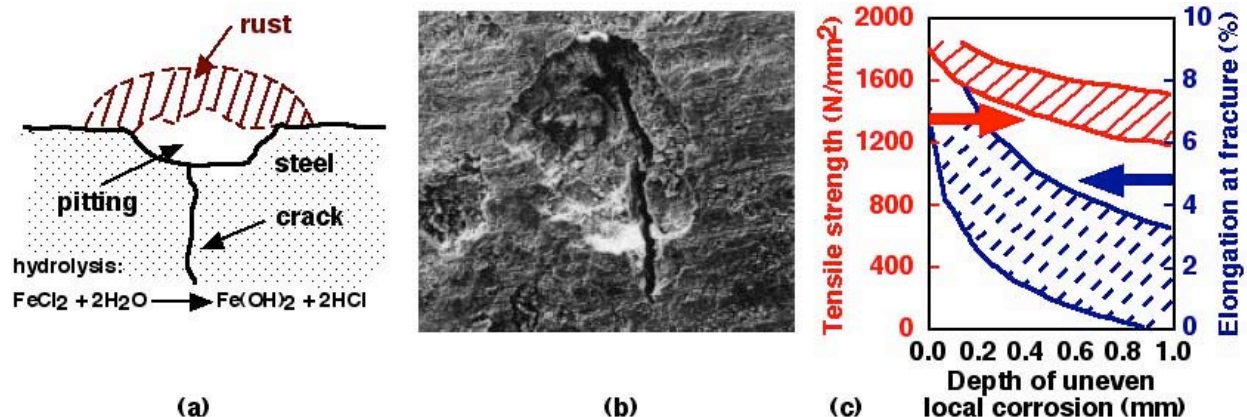
Figure 4.34 Pitting corrosion of prestressing steel: (a) mechanism, (b) pitting-induced stress-corrosion cracking, (c) effect of pit depth on tensile strength and elongation.
