Primer on Durability of Nuclear Power Plant Reinforced Concrete Structures - A Review of Pertinent Factors

Oak Ridge National Laboratory

**U.S. Nuclear Regulatory Commission
Office of Nuclear Regulatory Research
Washington, DC 20555-0001**

Manuscript Completed: November 2006

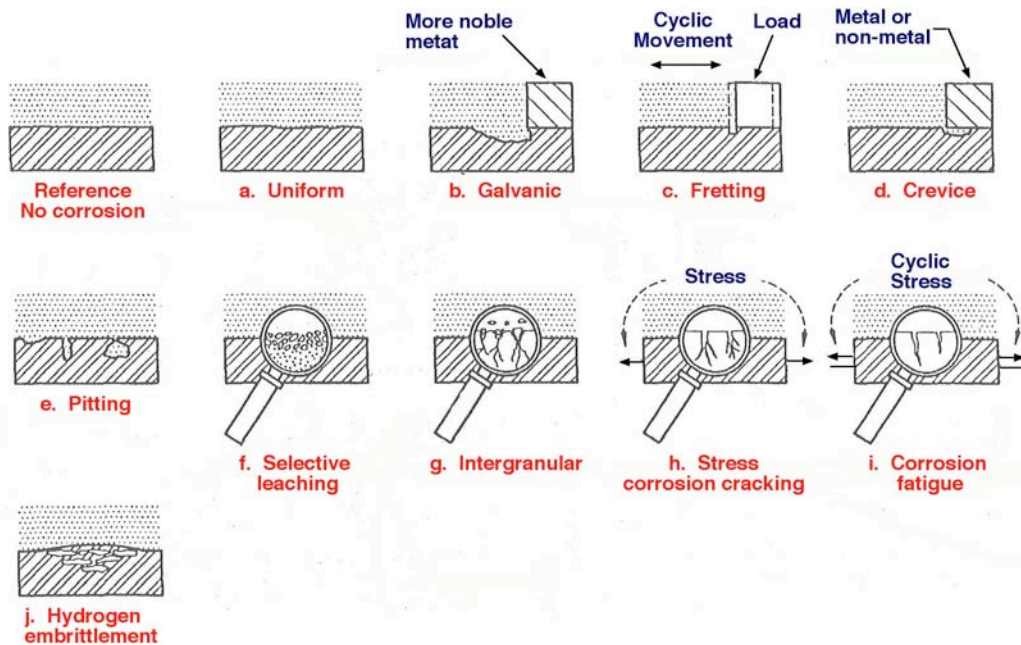
Figure 4.35 Schematic representations of forms of corrosion that may be found in metals.

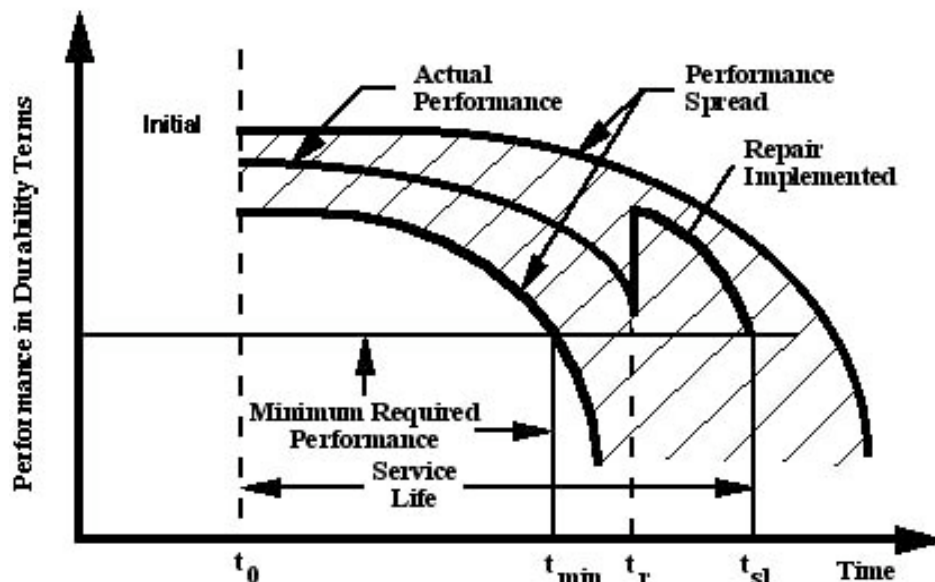
Figure 5.1 Relationship between performance and service life.

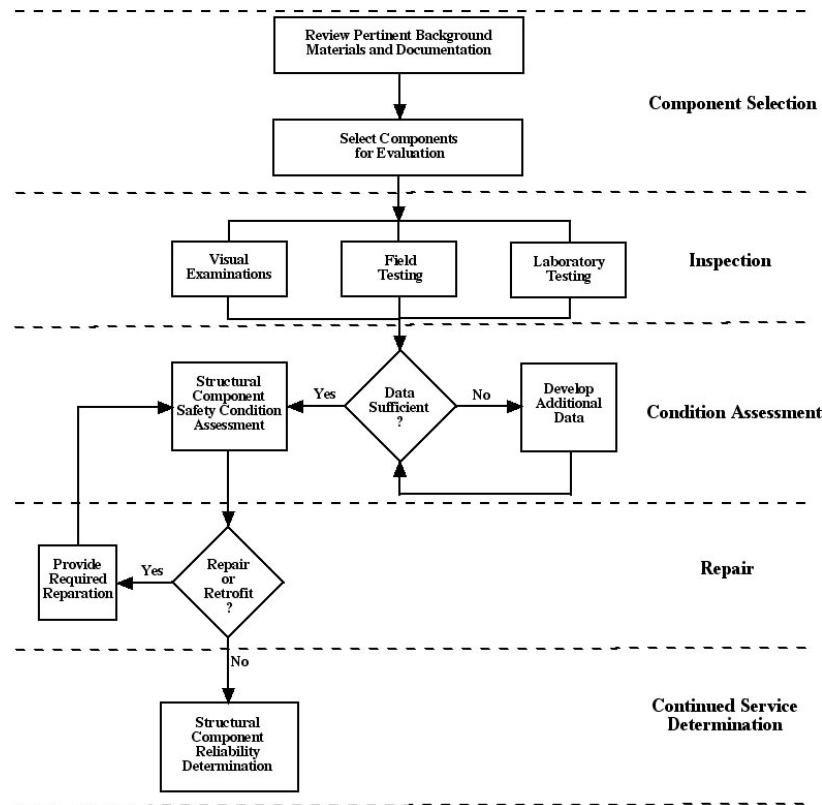
Figure 5.2 Evaluation methodology for nuclear power plant concrete structures.

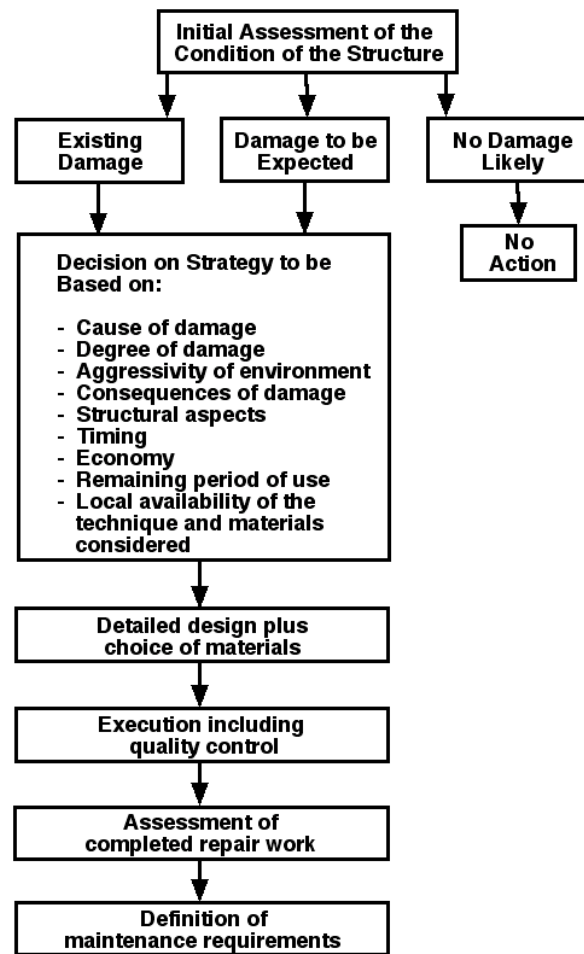
Figure 5.3 Steps to be taken in a repair process.

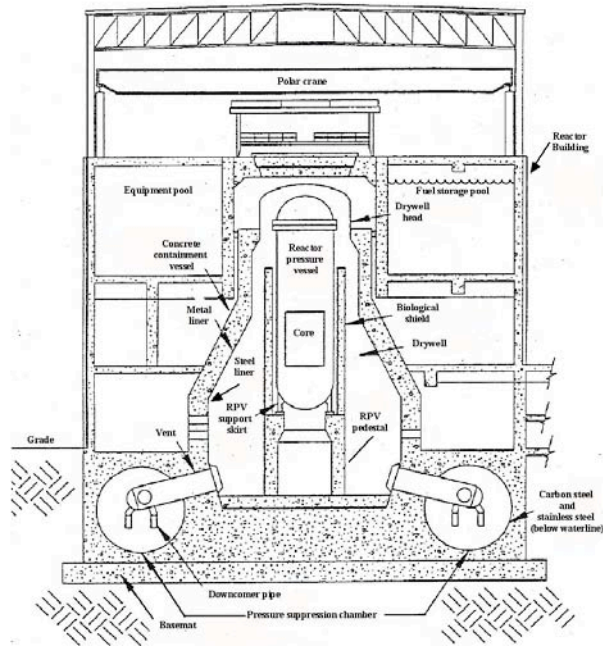
Figure A.1 BWR Mark I type reinforced concrete containment.

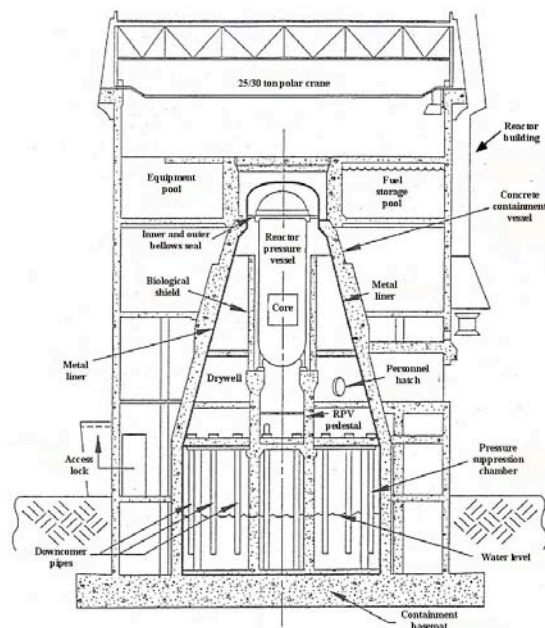
Figure A.2. BWR Mark II type reinforced concrete containment.

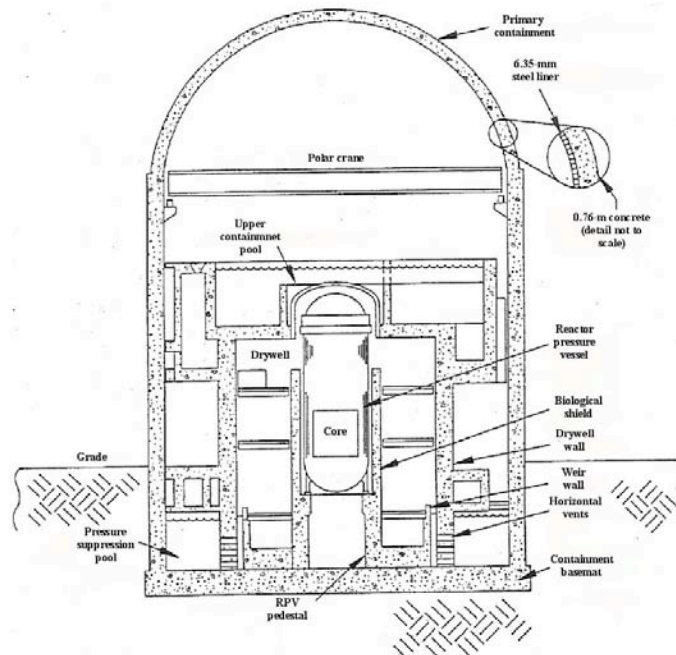
Figure A.3. BWR Mark III type reinforced concrete containment.

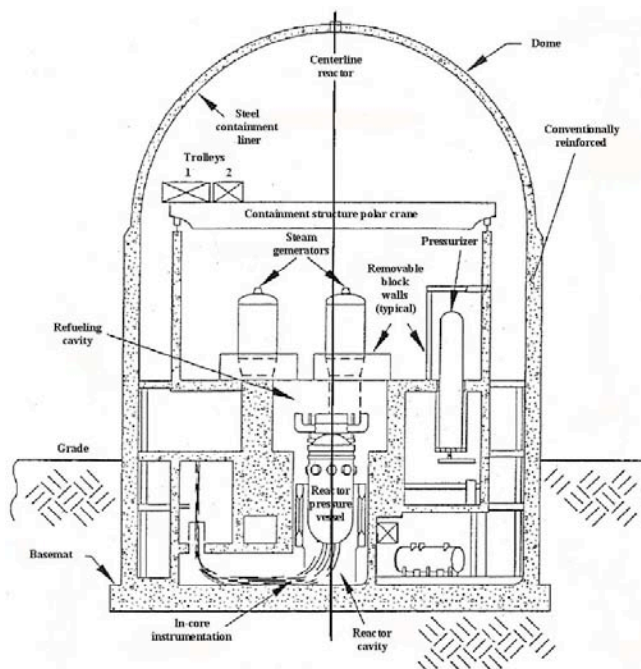
Figure A.4. PWR subatmospheric type reinforced concrete containment.

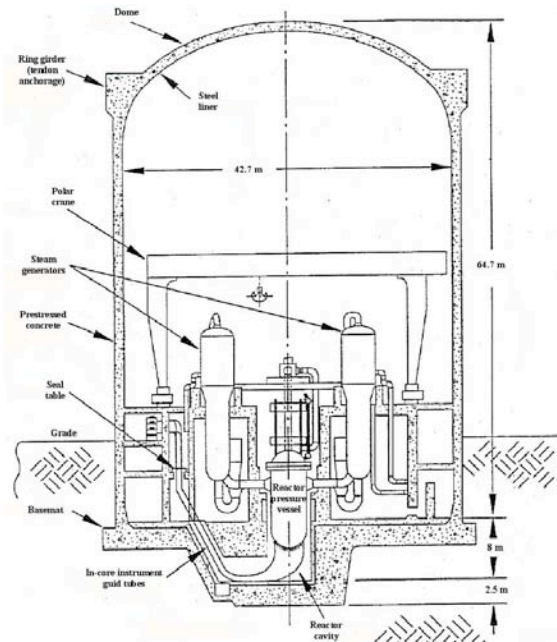
Figure A.6. PWR large dry prestressed concrete containment.

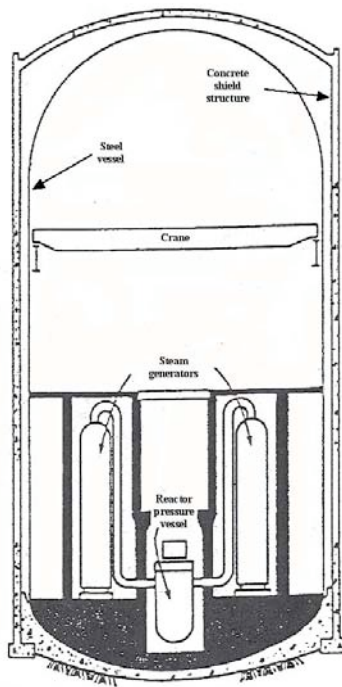
Figure A.7. PWR free-standing steel containment with elliptical bottom.

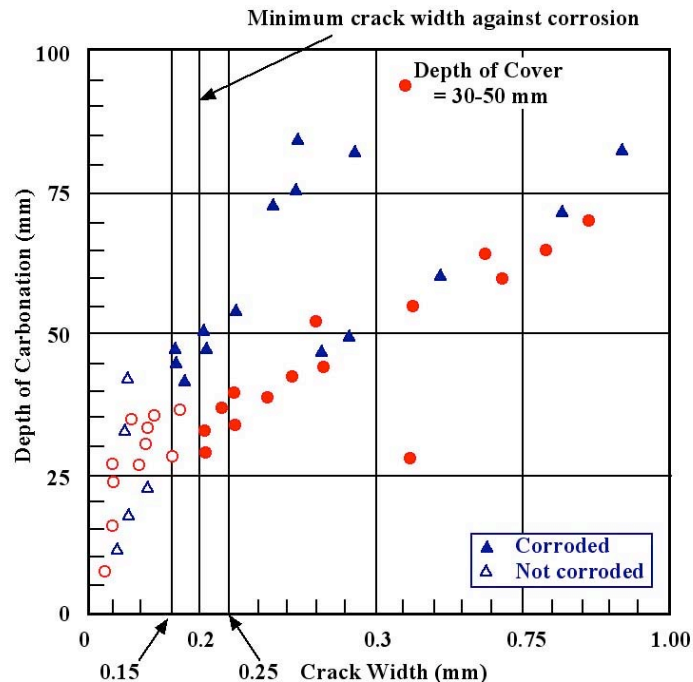
Figure C.1 Surface crack width, carbonation depth, and corrosion.

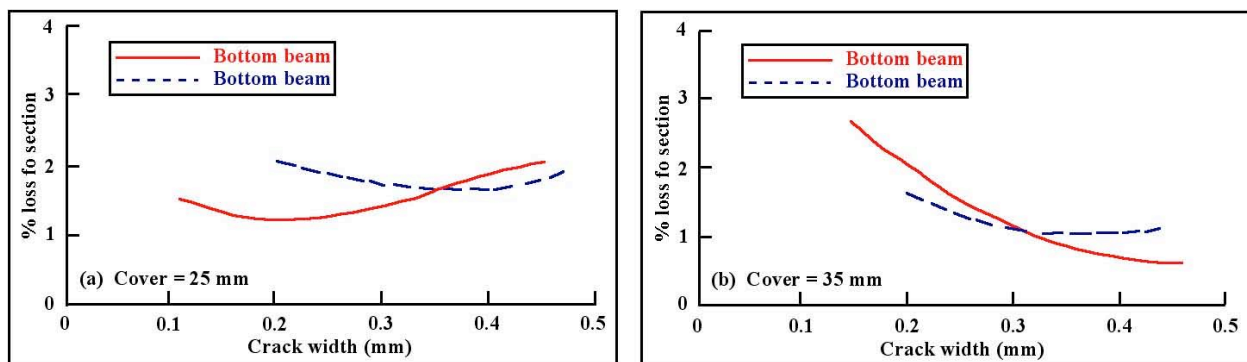
Figure C.3 Crack width and corrosion of 8-mm-diameter bar in marine environment (after 10-year exposure).

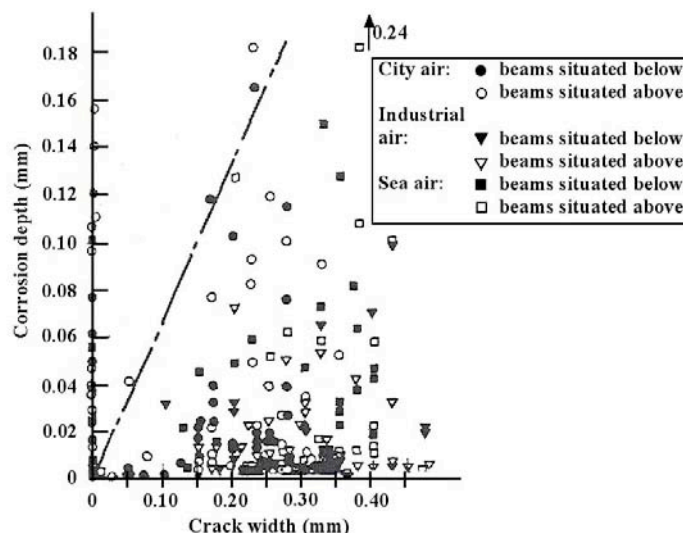
Figure C.4 Corrosion depth versus crack width after 10-year exposure.

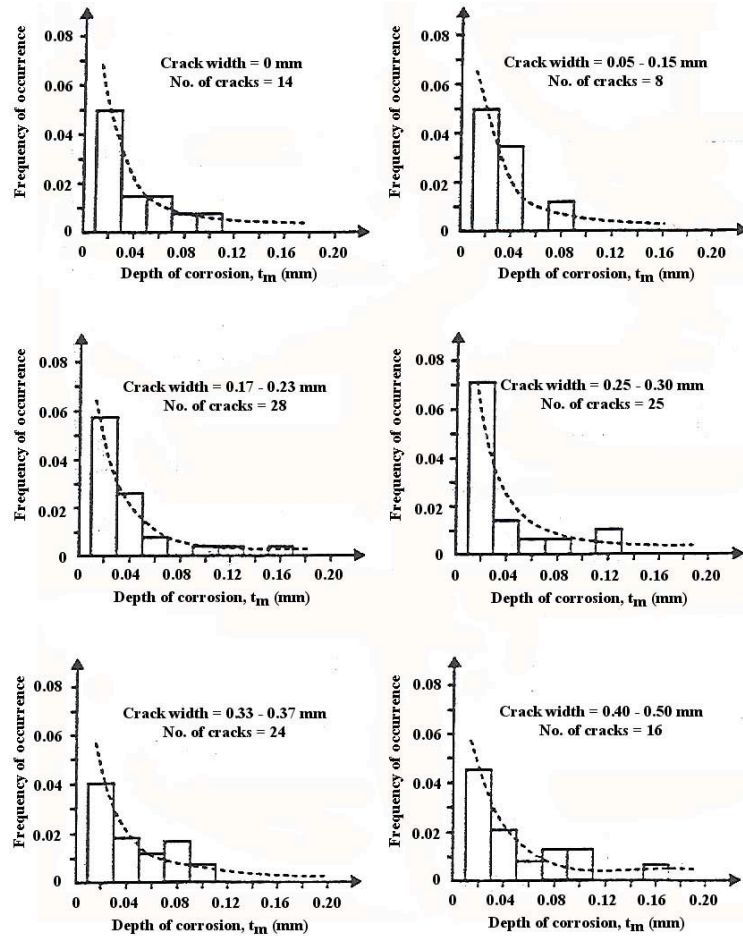
Figure C.5 Distribution of corrosion depths in Figure C.4.

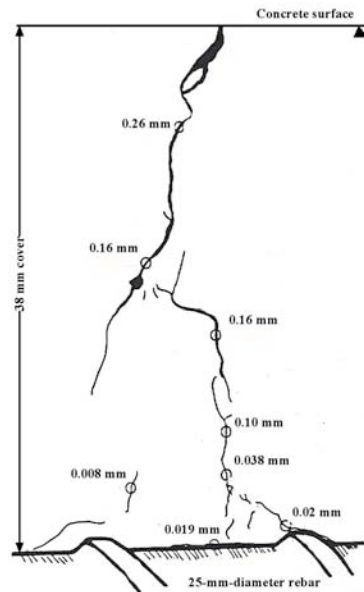
Figure C.6 Variation of crack width with depth.

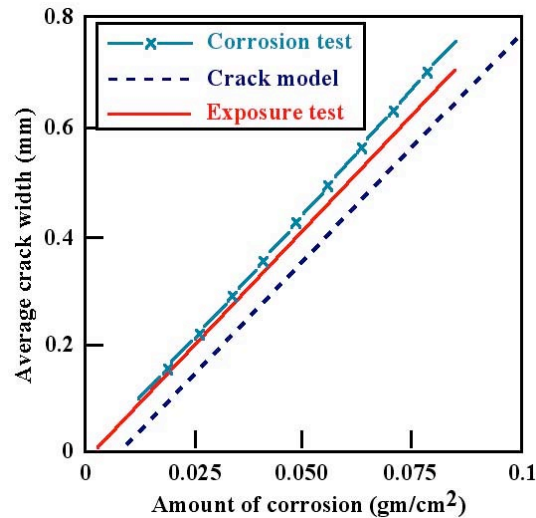
Figure C.7 Crack width versus amount corrosion.
