**ORNL /IAT ARMATURE DIAGNOSTICS
DEMONSTRATION TEST REPORT:
PART TWO: BENCH DEMONSTRATION**

Date Published: Dec 2005

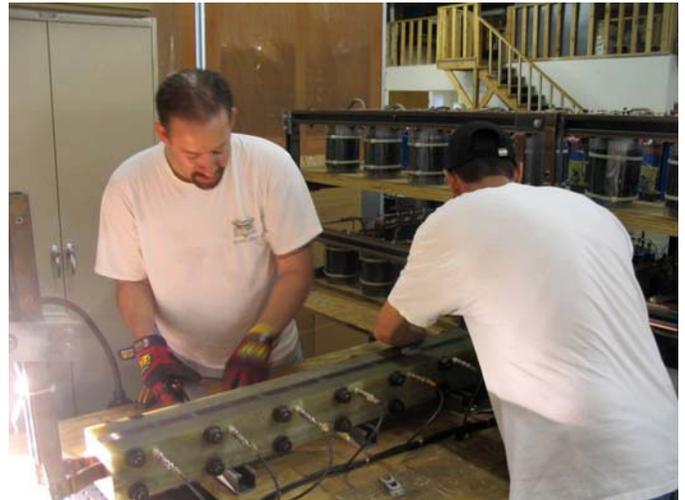
Figure 1 Benchtop railgun

The railgun is depicted in Figure 1 as it is being prepared. After several firings, the muzzle was modified to accommodate optical fiber probes. Figure 2 provides additional views. The bottom frame reveals the location of the two fiber probes. One senses the arrival of the armature, and the other delivers the excitation laser light and captures the fluorescence, directing it to a detector and data acquisition system.
