***FY 2013 Summary Report:
Post-Irradiation Examination
of Zircaloy-4 Samples in Target
Capsules and Initiation of
Bending Fatigue Testing for
Used Nuclear Fuel Vibration
Integrity Investigations***

Fuel Cycle Research & Development

*Prepared for
U.S. Department of Energy
Used Fuel Disposition Campaign
R. H. Howard, Y. Yan, J. Wang,
L. J. Ott, R. L. Howard
Oak Ridge National Laboratory
September 30, 2013
FCRD-UFD-2013-000369*

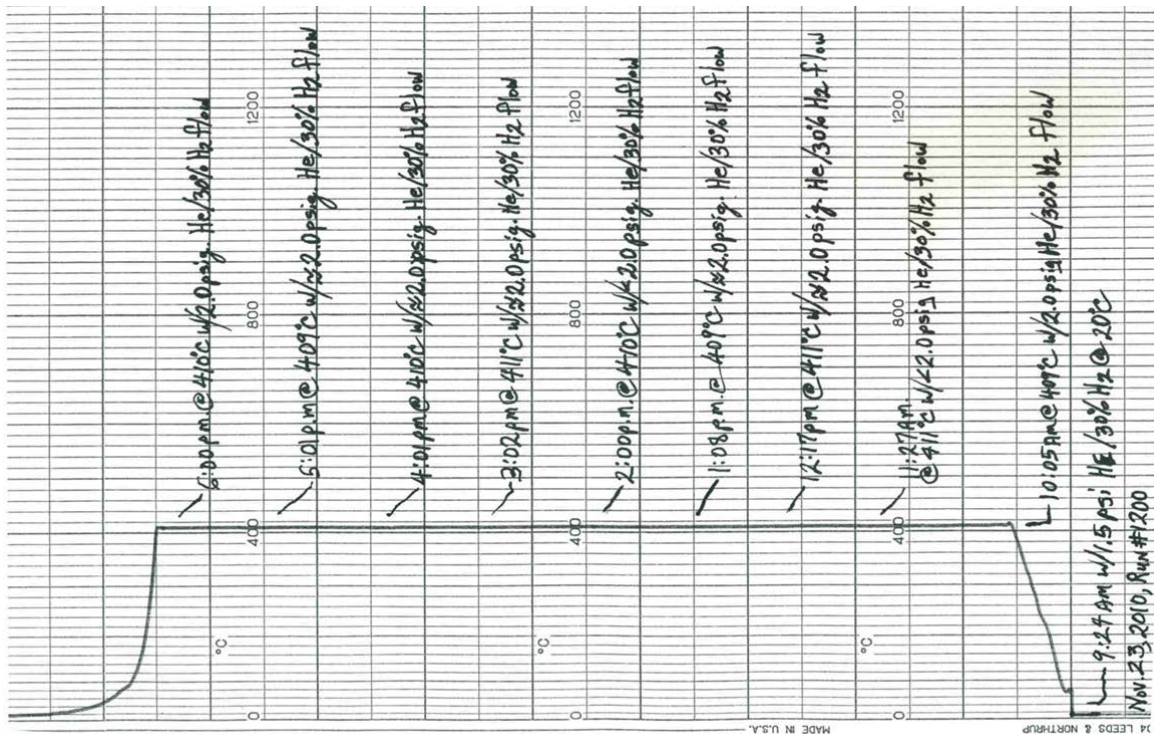
Figure 2. Temperature profile for hydriding cladding materials.

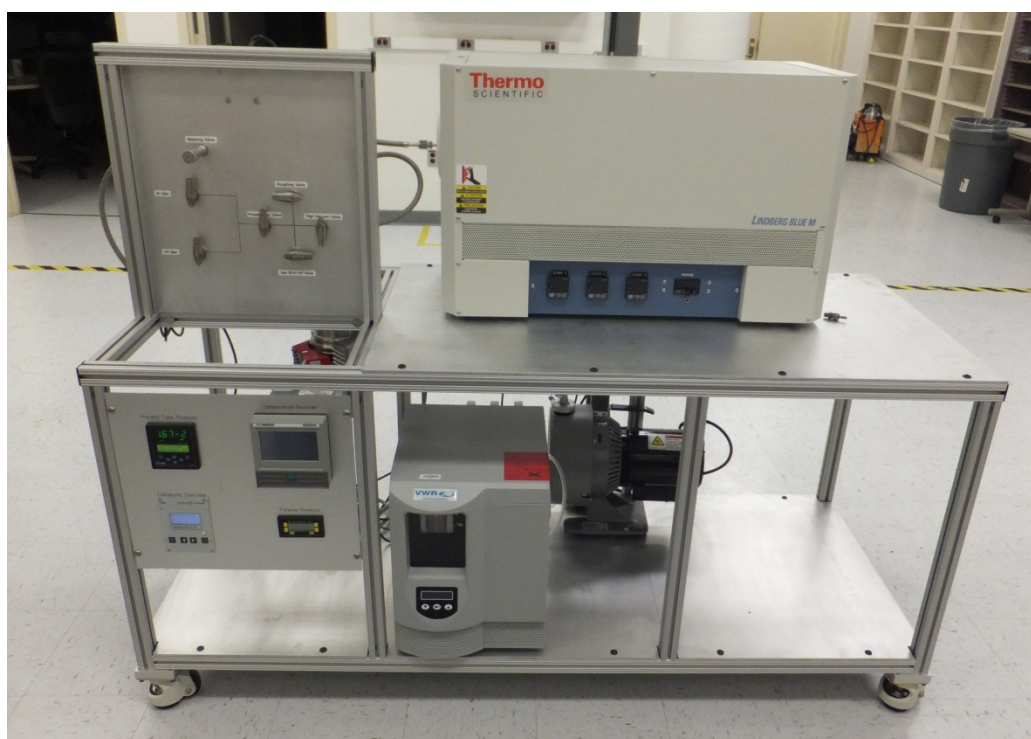
Figure 4. New static hydriding system.

The hydrogen content of the hydrided specimens was measured using the Vacuum Hot Extraction technique per ASTM E146-83. A LECO RH-404 Hydrogen Analyzer was used for hydrogen analysis, as shown in Figure 5. The equipment was verified using standards of known hydrogen content before each test. Under optimized test conditions, a relatively uniform hydrogen distribution along the axial direction was obtained (Figure 6). However, it was difficult to obtain repeatable hydrogen doping results with the 901 Brew Furnace. A new static system (Figure 4) was developed to improve material hydriding.

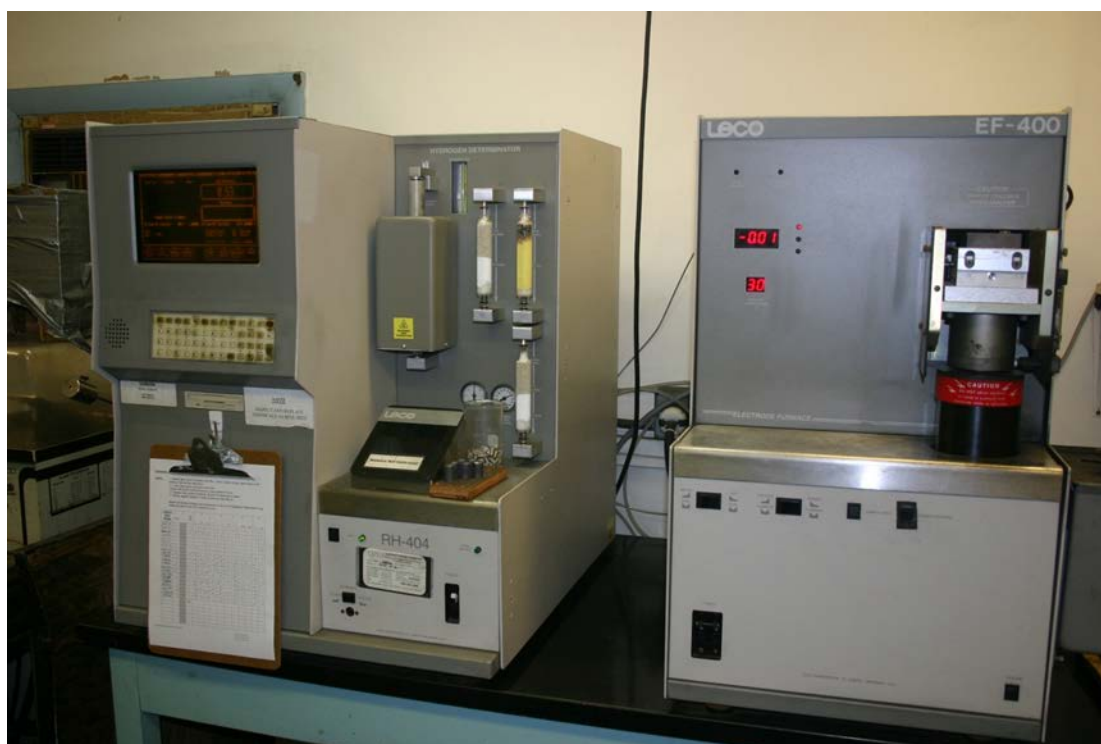
Figure 5. LECO RH-404 Hydrogen Analyzer used for determining the hydrogen content.

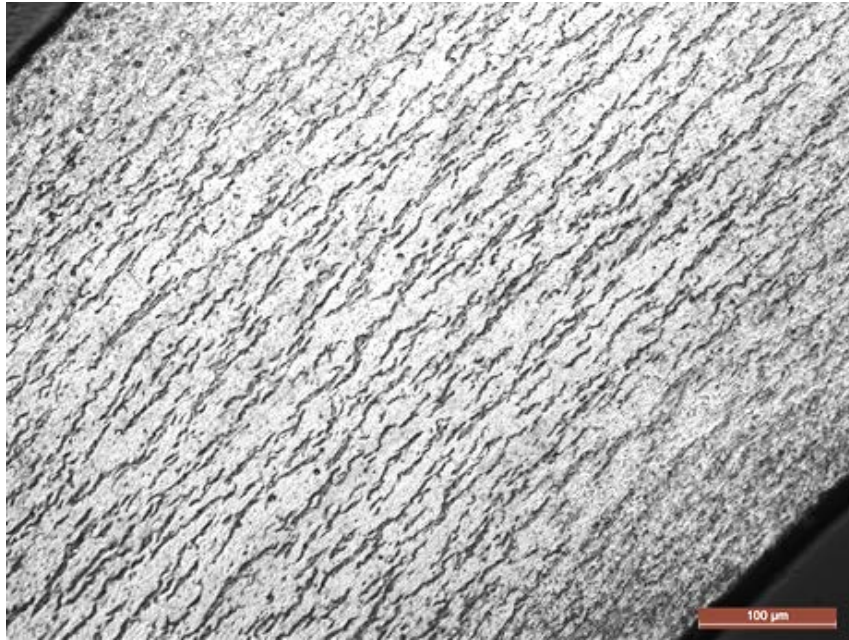
Figure 10. Micrographs showing hydride distributions in hydrogen-charged Zircaloy-4 samples. The average hydrogen content of this location is ≈ 610 wppm.

Metallographic examinations were performed on hydrided Zircaloy-4 samples. Although axial gradients in hydrogen content are sometimes observed in hydrided Zircaloy-4 samples, the ORNL hydriding procedure resulted in a uniform distribution of circumferential hydrides across the Zircaloy-4 wall. As shown in Figure 7–Figure 10, the hydride density increased as the hydrogen concentration in the sample increased. The measurements indicated the hydrogen content of the specimens shown in Figure 7–Figure 10 were from 70 to 610 wppm.

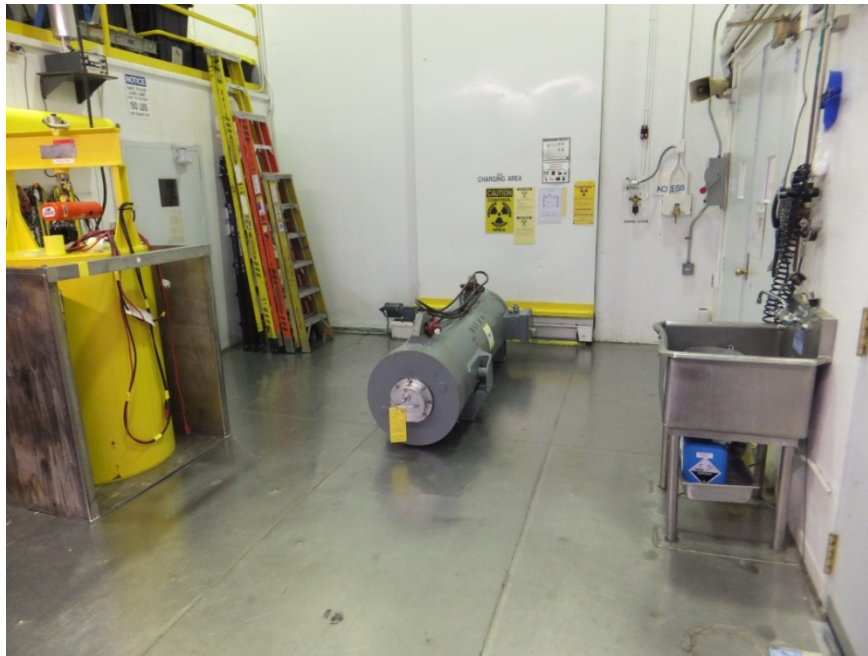
Figure 22. Loop cask for HYCD-1 and HYCD-2 (OD \times L = 2 ft \times 8 ft) at the IFEL.

After removal from the reactor, the HYCD-1 and HYCD-2 capsules were shipped to the Irradiated Fuel Examination Lab (IFEL) in a loop cask (Figure 22) for PIE. The cask arrived at the IFEL from the HFIR on November 6, 2012, approximately 4 months after HYCD-2 was removed from the HFIR reactor core. The two capsules were removed from the shipping cask and were loaded into the hot cell in January 2013 (Figure 23 and 24). They were identified by the labeling engraved on the capsule shroud tube as HYCD-1 and HYCD-2. The capsules appeared to be in good condition, and no unusual features were noted.

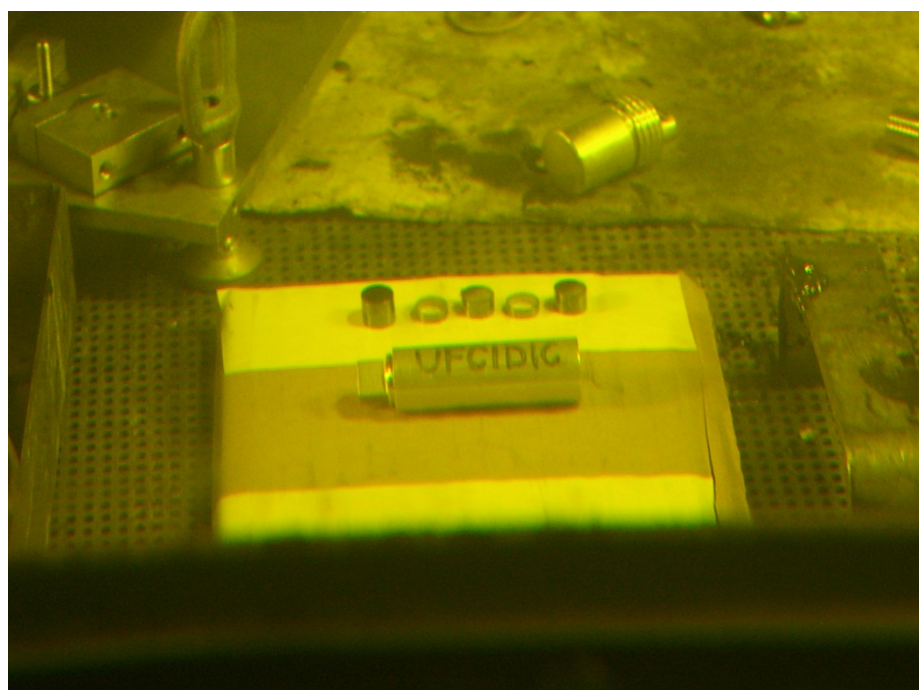
Figure 33. Five rings sectioned from Sample UFC1D1C, Capsule HYCD-1.

Sample UFC1D1C was selected from HYCD-1 capsule and LRR1D7 from HYCD-2 for microstructural examinations. Both samples were 1 in. long and were sectioned by a diamond saw (Figure 32) in the hot cell into five shorter rings, as shown in Figures 33 and 34. Two optical metallographic (MET) mounts, as listed in
